2018-05-25 AMQ Surface 200 Liters Hydraulic Oil

GN Reference #: 2018-196

Spill Description

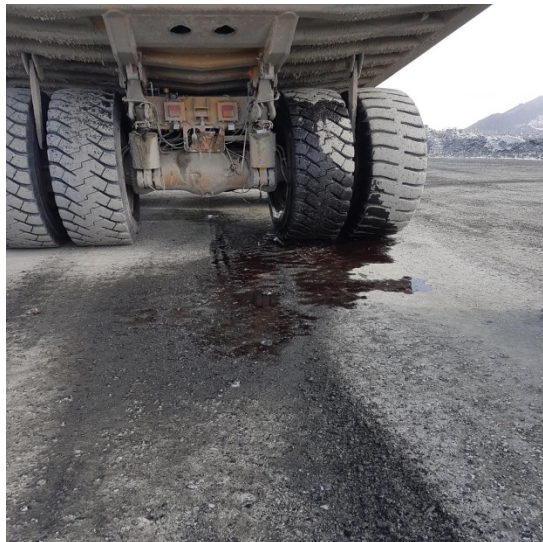
On May 25th 2018, during operations on road 15 of the Amaruq camp, a haul truck's hydraulic hose ruptured and caused a 200 liter hydraulic oil spill.

Location coordinates of the spill: Northing 65°23'57" Easting 96°40'43" on IOL.

There were no off site impact or discharge to any receiving watercourses.

The spill was caused by the hydraulic hose rupture.

The equipment was immediately parked and stopped at the discovery of the leak. A grader was called to make wind row with the contaminated soil on the road and a loader picked up the contaminated soil. Absorbent pads were put under the haul truck to recover the hydraulic oil until the haul truck was fixed. Once the mechanical problem was solved, the equipment was moved and a loader picked up the remaining contaminated soil. The absorbents were put in proper hazmat storage and the contaminated soil was brought to the Meadowbank mine landfarm.

The hydraulic system, including hoses on equipment, is inspected as part of the preventive maintenance program done on site. Pre-operation checks also include visual inspection of the hydraulic system. All equipment worn hoses should be replaced.
