2019-01-25 AMQ 100 liters Sewage spill

GN reference # : 2019-027

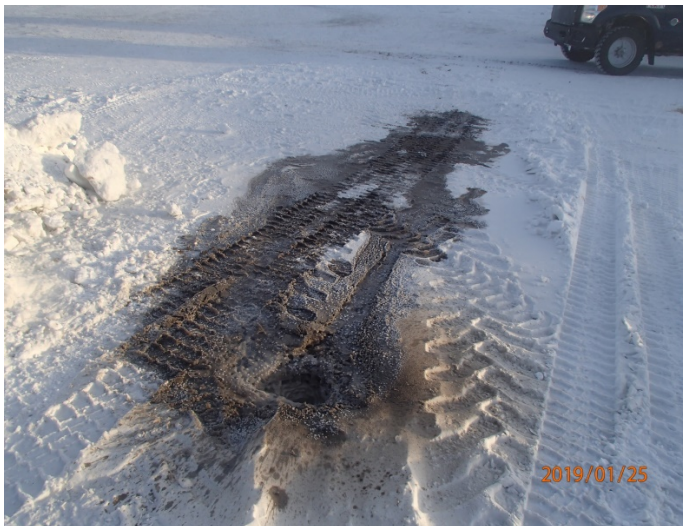
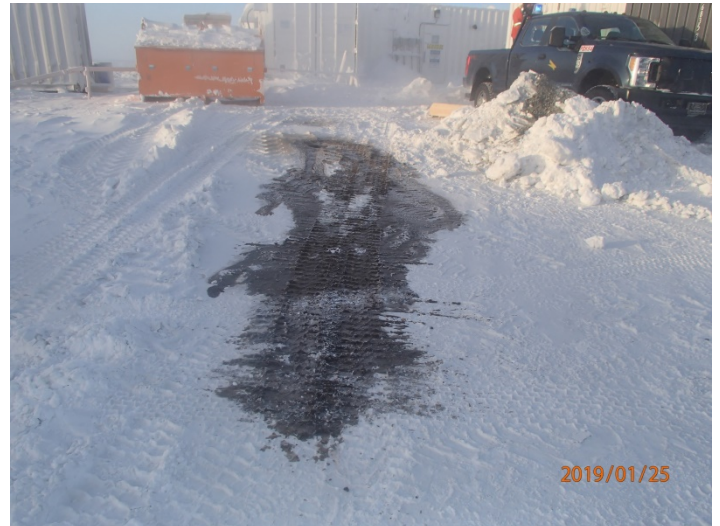
When the operator emptied the sludge from wastewater treatment plant with a vacuum truck, he saw an overflow coming from the tank.

Spill location: N 65 24'11.8 W 096 40'49.5

There were no off site impact or discharge to any receiving watercourses. The distance to the closest lake is estimated at 200 meters.

Before he starts to pump, the operator took a measure the tank to evaluate the volume can be pumped in the truck. But he did a mistake and the volume available has been over evaluated causing an overflow.

A reminder to all operators was giving on the importance to have the good evaluation of the volume available in the tank before starting the operation.
