2019-01-27 AMQ 5 L Engine oil spill

GN reference # : 2019-028

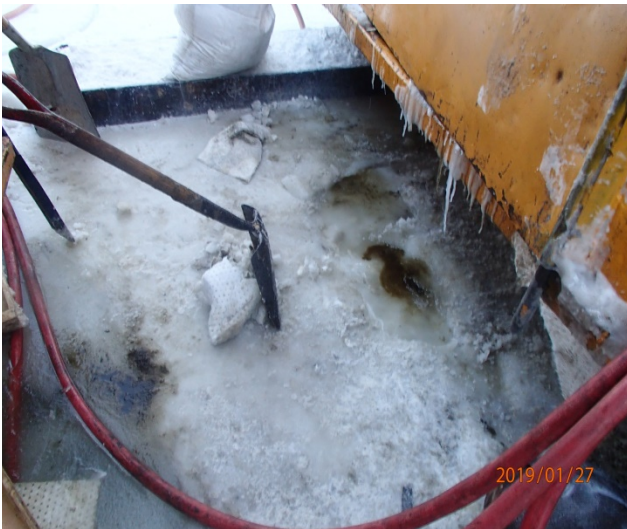
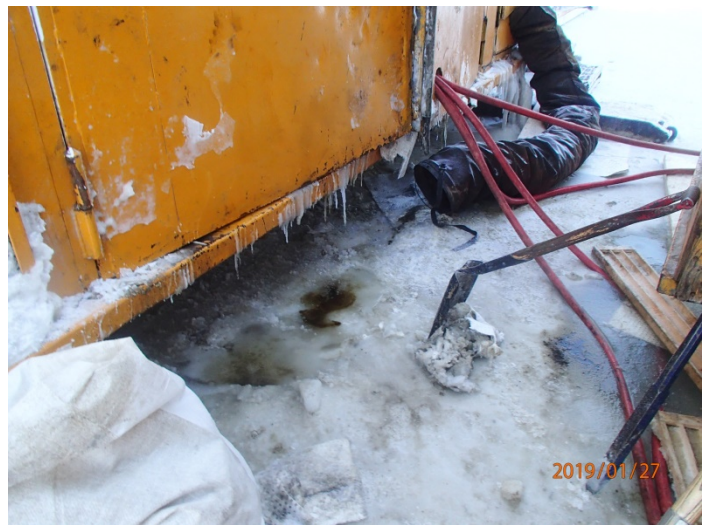
While the drill SH-61 #1 was operating on the Whale Tail North Lake, the hose feeding the cylinder busted causing 30L of engine oil to spill in the secondary containment but an overflow of 5 liters of Engine Oil got in contact with the ice.

The spill has been caused by a mechanical breakage of a hose feeding a hydraulic cylinder.

A routine visual inspection of all system is performed during pre-operations checks as a part of the preventive maintenance program.
