2019-02-03 AMQ 3 L Engine oil spill

GN reference # : 2019-038

Spill Description

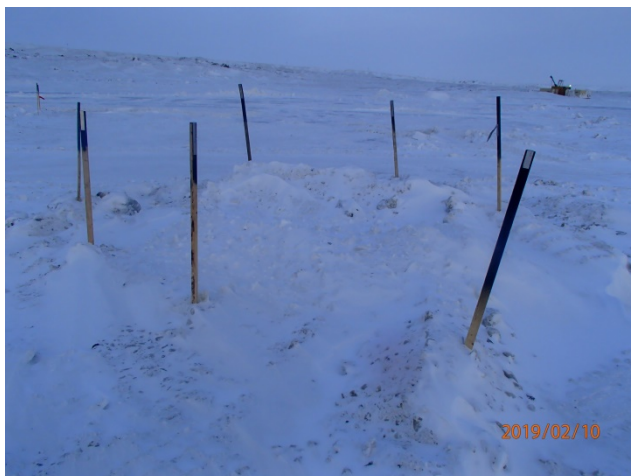
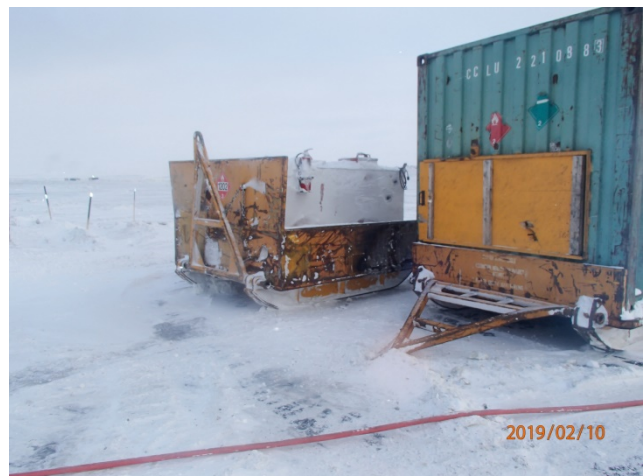
While the drill SH-64 was operating on the Whale Tail North lake, the seal gasket from the pump popped causing a spill in the secondary containment inside the drill. Unfortunately, 3 liter of engine oil got in contact with a snow outside the drill.

The spill has been caused by a seal popped on hydraulic system.

The drill operators used absorbent pads and shoveled the snow and disposed a contaminated material at the appropriated facility.

A routine visual inspection of all system is performed during pre-operations checks as a part of the preventive maintenance program.
