## 2019-02-06 AMQ 4 L Engine oil spill

GN reference # : 2019-044

Please find the following information as a follow up to the Spill report submitted February 6<sup>th</sup>, 2019 by Agnico Eagle Meadowbank division. This detailed report is submitted to the Inspector in compliance with the conditions under the Nunavut Water Board License 2BB-MEA1318, Part H, Item 5c.

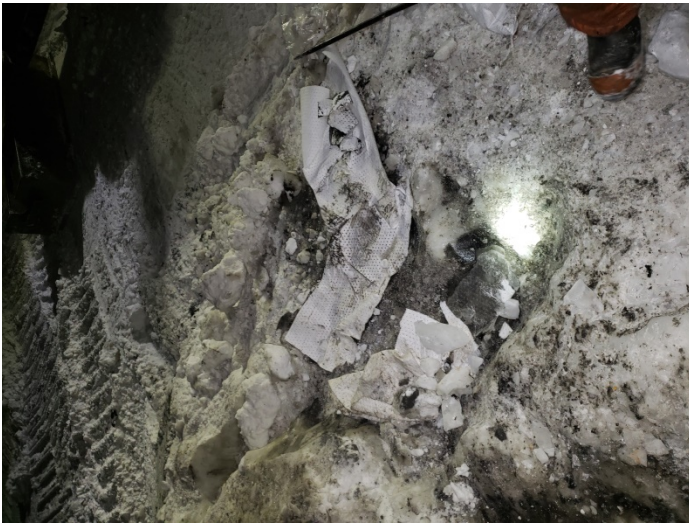
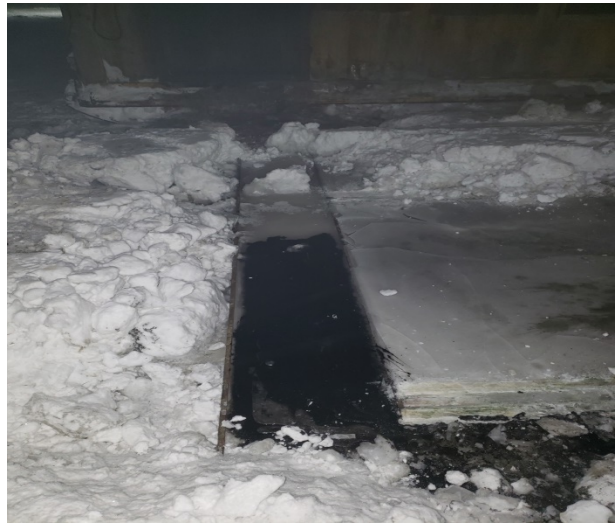
While the drill SH-47 was operating on the Whale Tail North lake, the motor broke down, engine oil leaked from the vent causing a spill in the secondary containment inside the drill but 4 liters of oil has overflowed the containment and goes on snow.

The spill has been caused by mechanical issue with the motor.

A routine visual inspection of all system is performed during pre-operations checks as a part of the preventive maintenance program.
