2022-03-18 WTP 1L Hydraulic Oil

GN reference #: 2022-087

Please find the following information as a follow up to the Spill report submitted March 19, 2022 by Agnico Eagle Meadowbank division. This detailed report is submitted to the Inspector in compliance with the conditions under the Nunavut Water Board License 2BB-MEA1828, Part H, Item 5c.

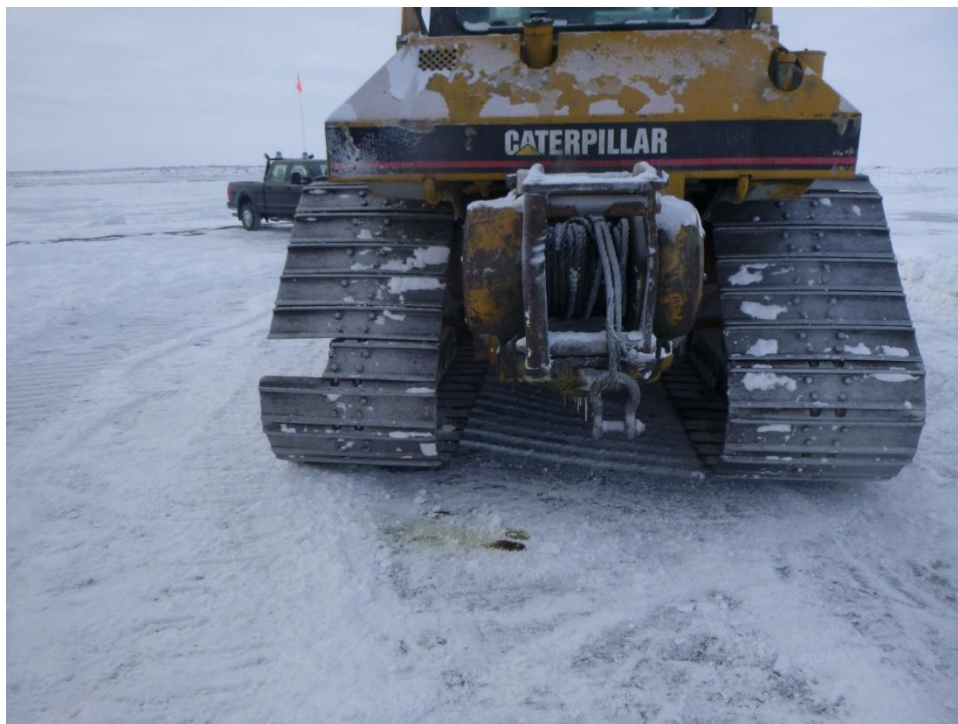
During operations at Whale Tail pit, the dozer operator noticed a stain of hydraulic oil under the winch on the dozer. The dozer was working on Mammoth Lake.

Spill location: 65°24'05.9" 96°43'41.8" on IOL.

The spill occurred on Mammoth Lake.

Failed seal on Dozer winch.
