WATER LICENCE INSPECTION FORM

Licensee	Licensee Representative
2BB-MEL1424	Phillip Roy
Licence No. / Expiry	Representative's Title
July 21st, 2024	Environmental Technician
Land / Other Authorizations	Land / Other Authorizations
2BW-MEL1525	N2013C0002
Date of Inspection	Inspector
June 9 th , 2015	WRO Wilson
Activities Inspected	
<div><input checked="" type="checkbox"/> Camp<input type="checkbox"/> Drilling<input type="checkbox"/> Mining<input type="checkbox"/> Construction<input type="checkbox"/> Reclamation<input type="checkbox"/> Fuel Storage</div> <div><input checked="" type="checkbox"/> Roads/Hauling<input checked="" type="checkbox"/> Other: Water Discharge<input type="checkbox"/> Other:</div>

PHOTO LOG

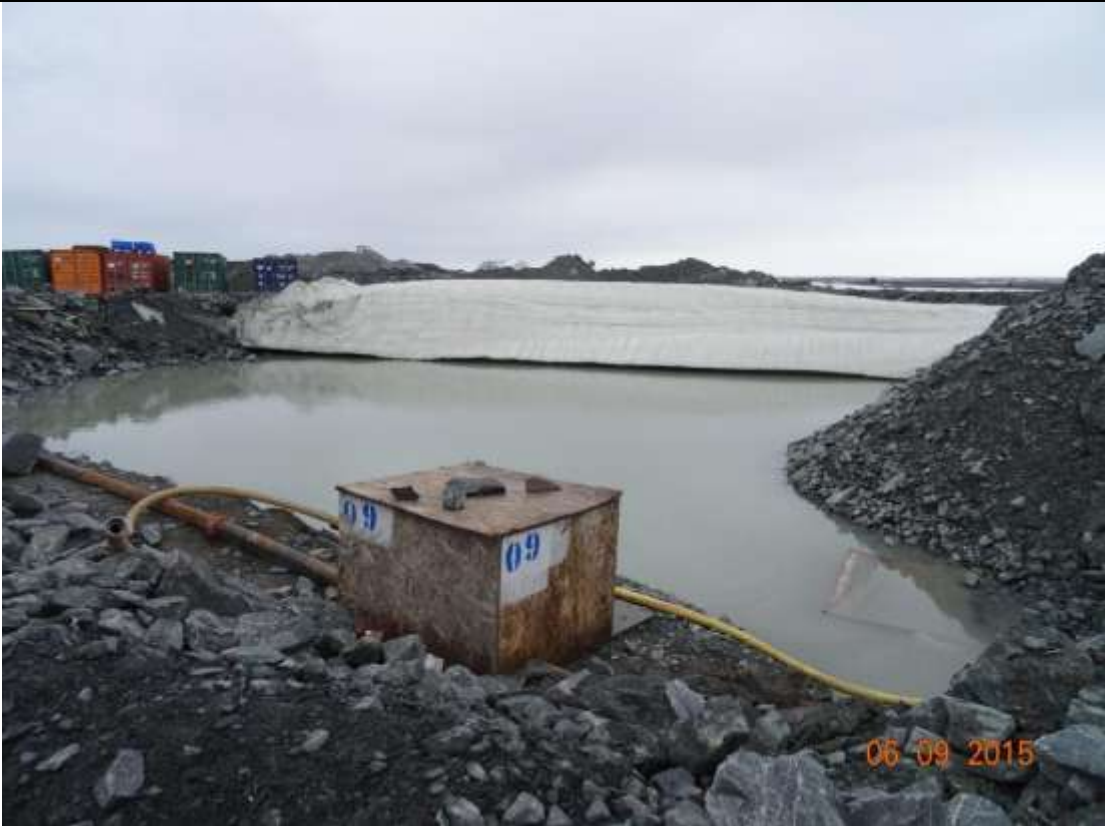
Date:	Authorization Number:	Camera/Model:	Inspector
June 9 th , 2015	2BB-MEL1424	Sony DSC-HX50V Cyber shot	WRO Wilson
Locations name:		Lat/Long (DD.MM.SS.SS, NAD83)	
Photo 1		N63° 1' 36.47", W92° 12' 40.433"

Descirption:
Portal Surface Sump

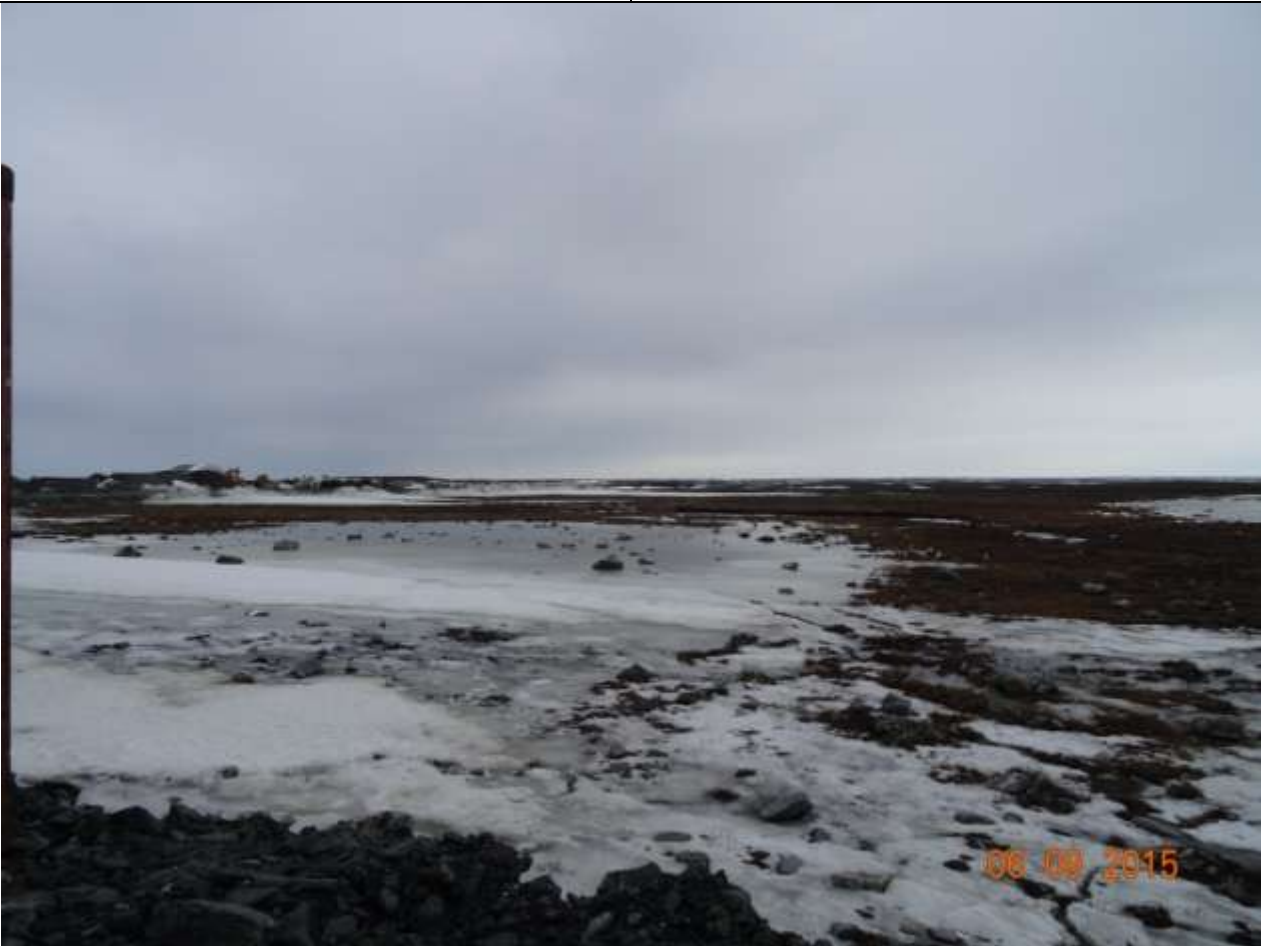
Locations name:	Lat/Long (DD.MM.SS.SS, NAD83)
Photo 2	N 63° 1' 34.4819" W 92° 12' 34.09"

Description:
Pond of water adjacent to Portal Surface Sump and Silt Fensing up gradient from Peanut Lake.

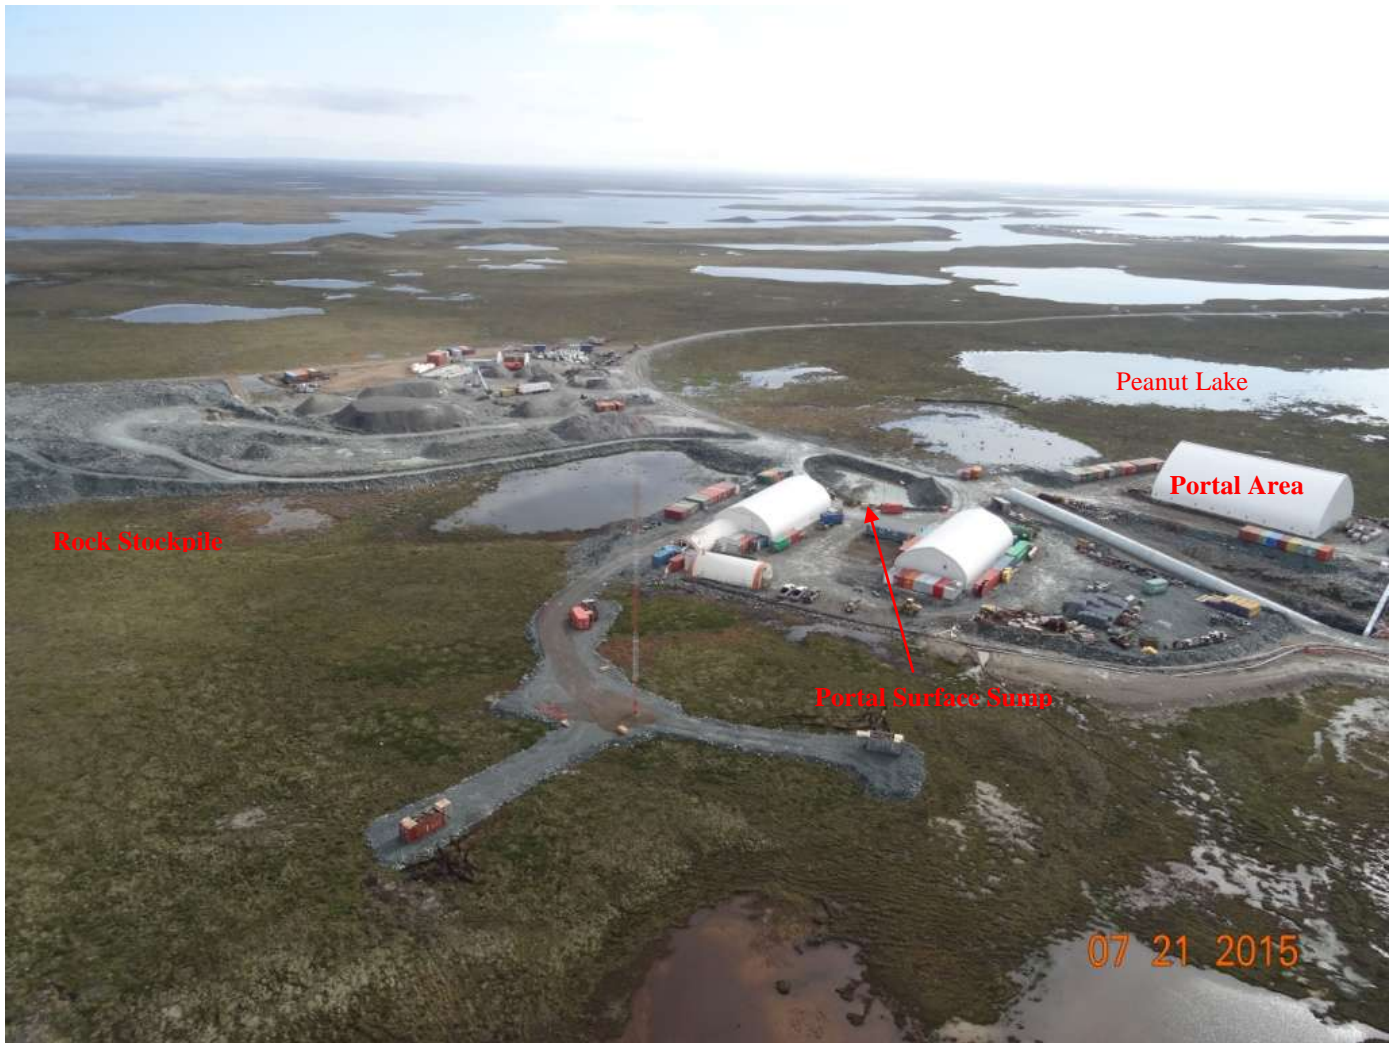
Locations name:	Lat/Long (DD.MM.SS.SS, NAD83)
Photo 3 (picture from July 21 st , 2015)

Description:
Spacially reference of Portal and Rock Stockpile Areas

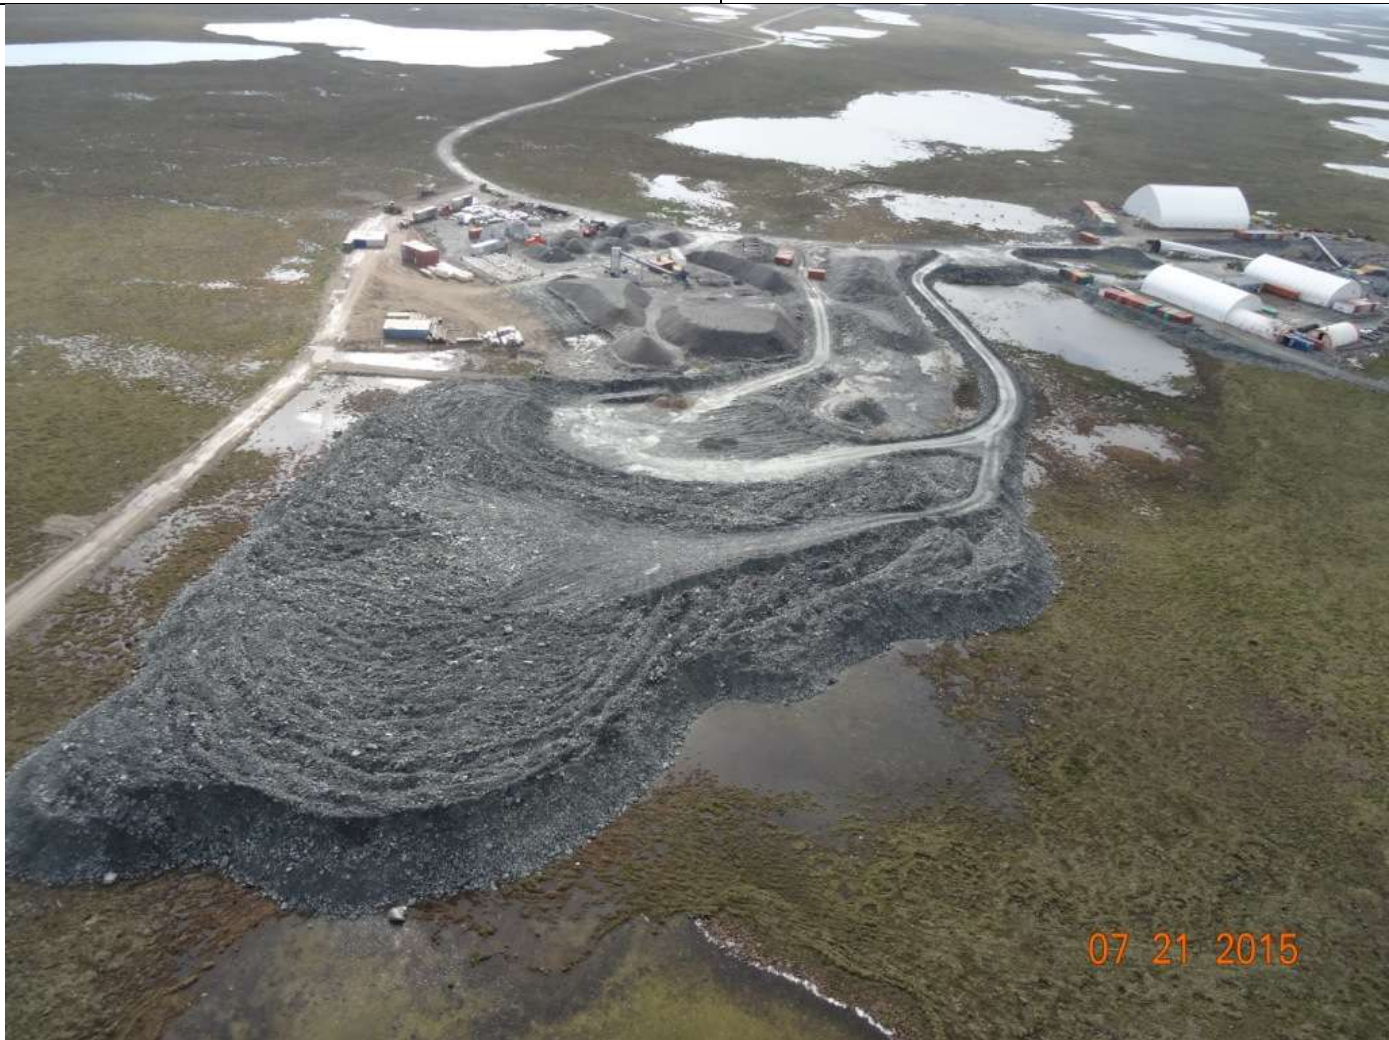
Photo 4 (picture from July 21st, 2015)

Ore and Rock Stockpiles
