WATER LICENCE INSPECTION FORM

PHOTO LOG

**Re: Meliadine – 2BB-MEL1424
Meliadine Portal Area – Water Quality Monitoring in Lake A54
Adverse Trends Noted – Mitigation Measures being implemented**

TYPICAL SECTIONS OF P1 WATER MANAGEMENT
INFRASTRUCTURE FOR FRESHET 2016

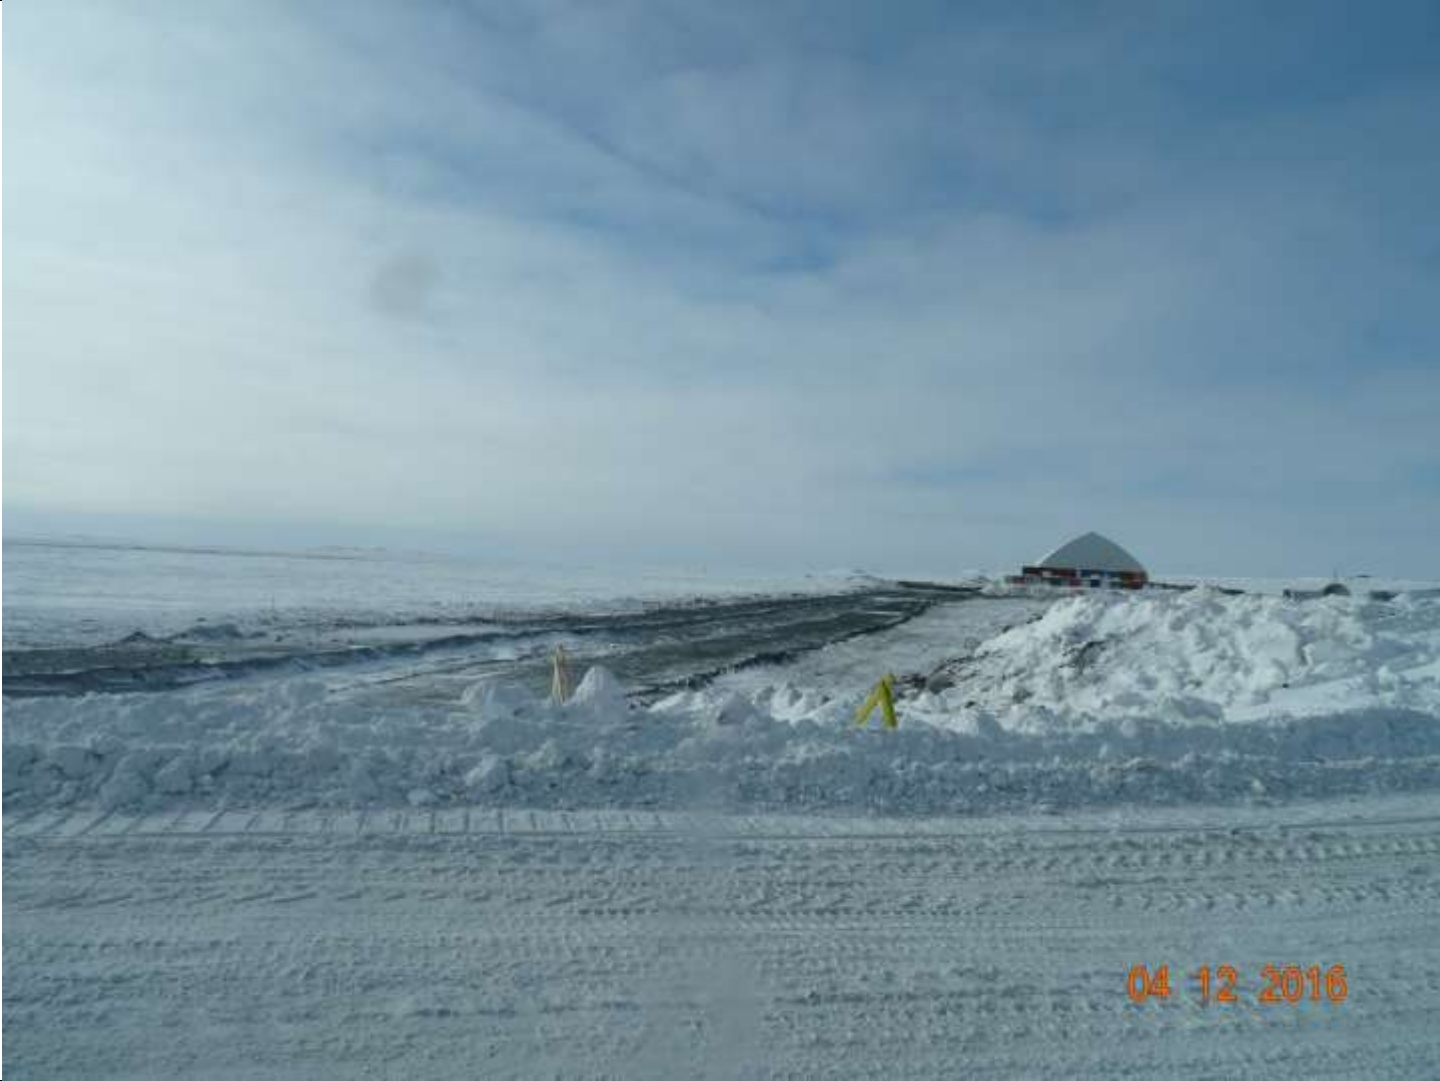
Date:	Authorization Number:	Camera/Model:	Inspector
April 12 th , 2016	2BB-MEL1424	Sony DSC-HX50V Cyber shot	WRO Wilson
Photo No.		Lat/Long (DD.MM.SS.SS, NAD83)	
Photo 1		N63° 1' 43.33", W 92° 12' 27.3"

Description:
Facing South South West DP3-A

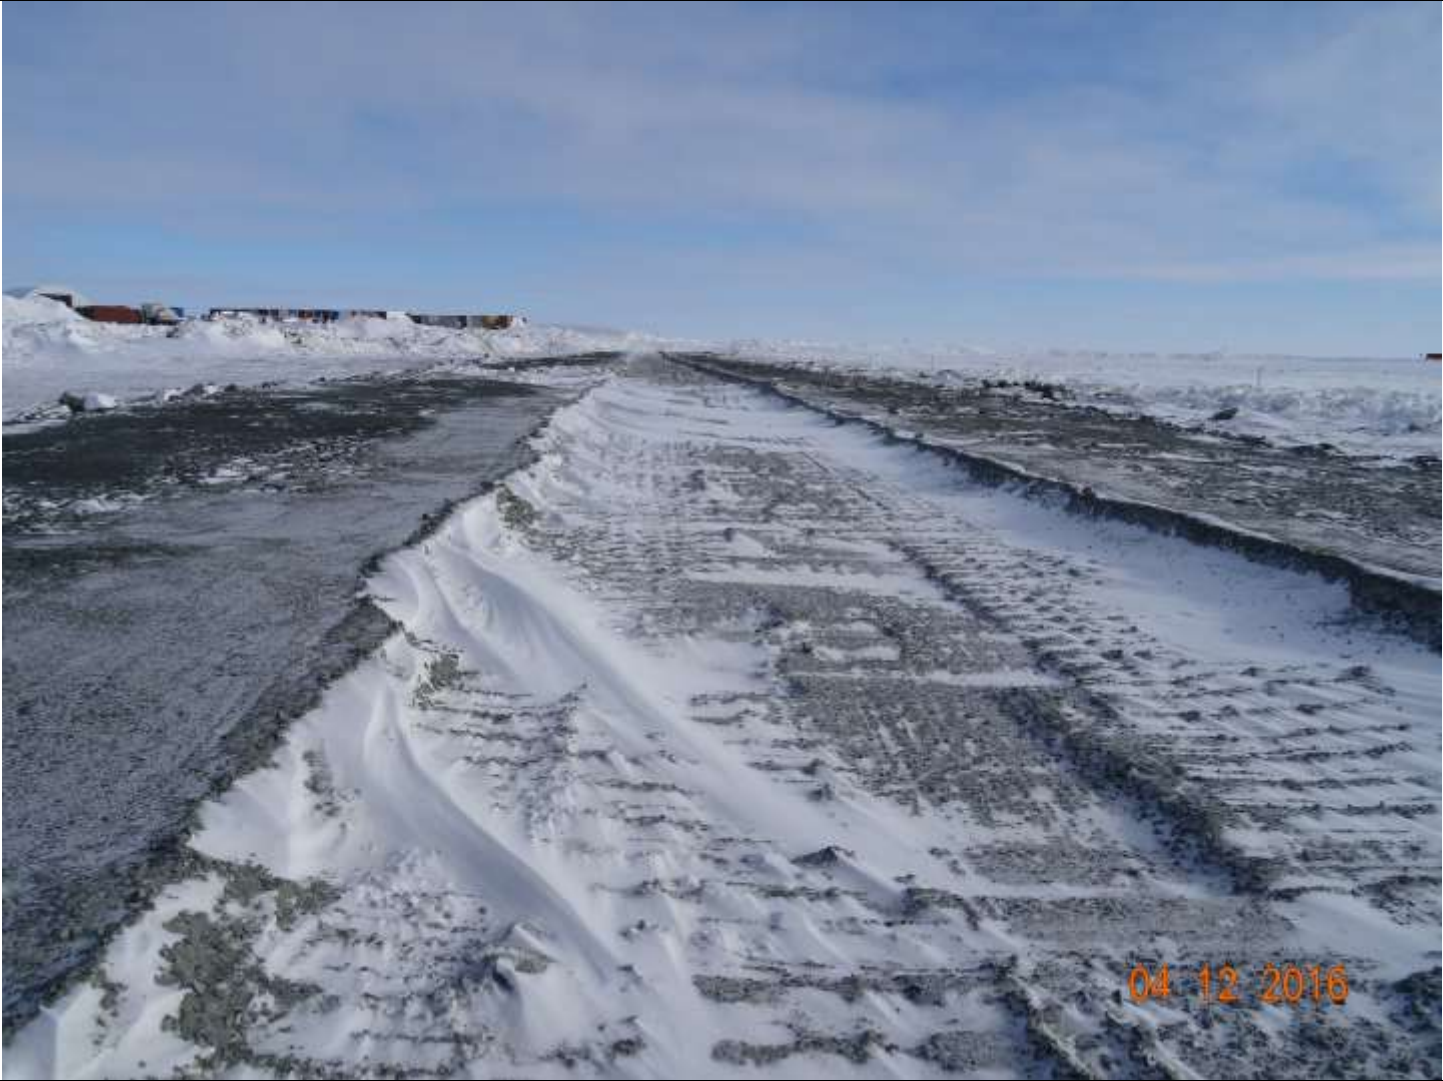
Locations name:	Lat/Long (DD.MM.SS.SS, NAD83)
Photo 2	N63° 1' 37.1", W 92° 12' 32.08"

3. The design of the structures are as follows; crushed rock (0-30mm) is used in the 'core' of the berm , the crushed rock is applied as lifts and compacted, each lift of the crushed rock is saturated with water and allowed to freeze, a sample is taken from each lift and analysed for percentage of ice saturation (85% or above). The frozen core is then covered with a thermal capping.

4. The dyke design has been modified as construction has progressed through the analysis of test plots. One of the first lifts of DP3-A was determined to be off specifications. Tetra Tech was able to identify this and rapidly improve the materials mixture to make changes as necessary.

Description
Looking North North East: DP3-A, first lift of the frozen core.

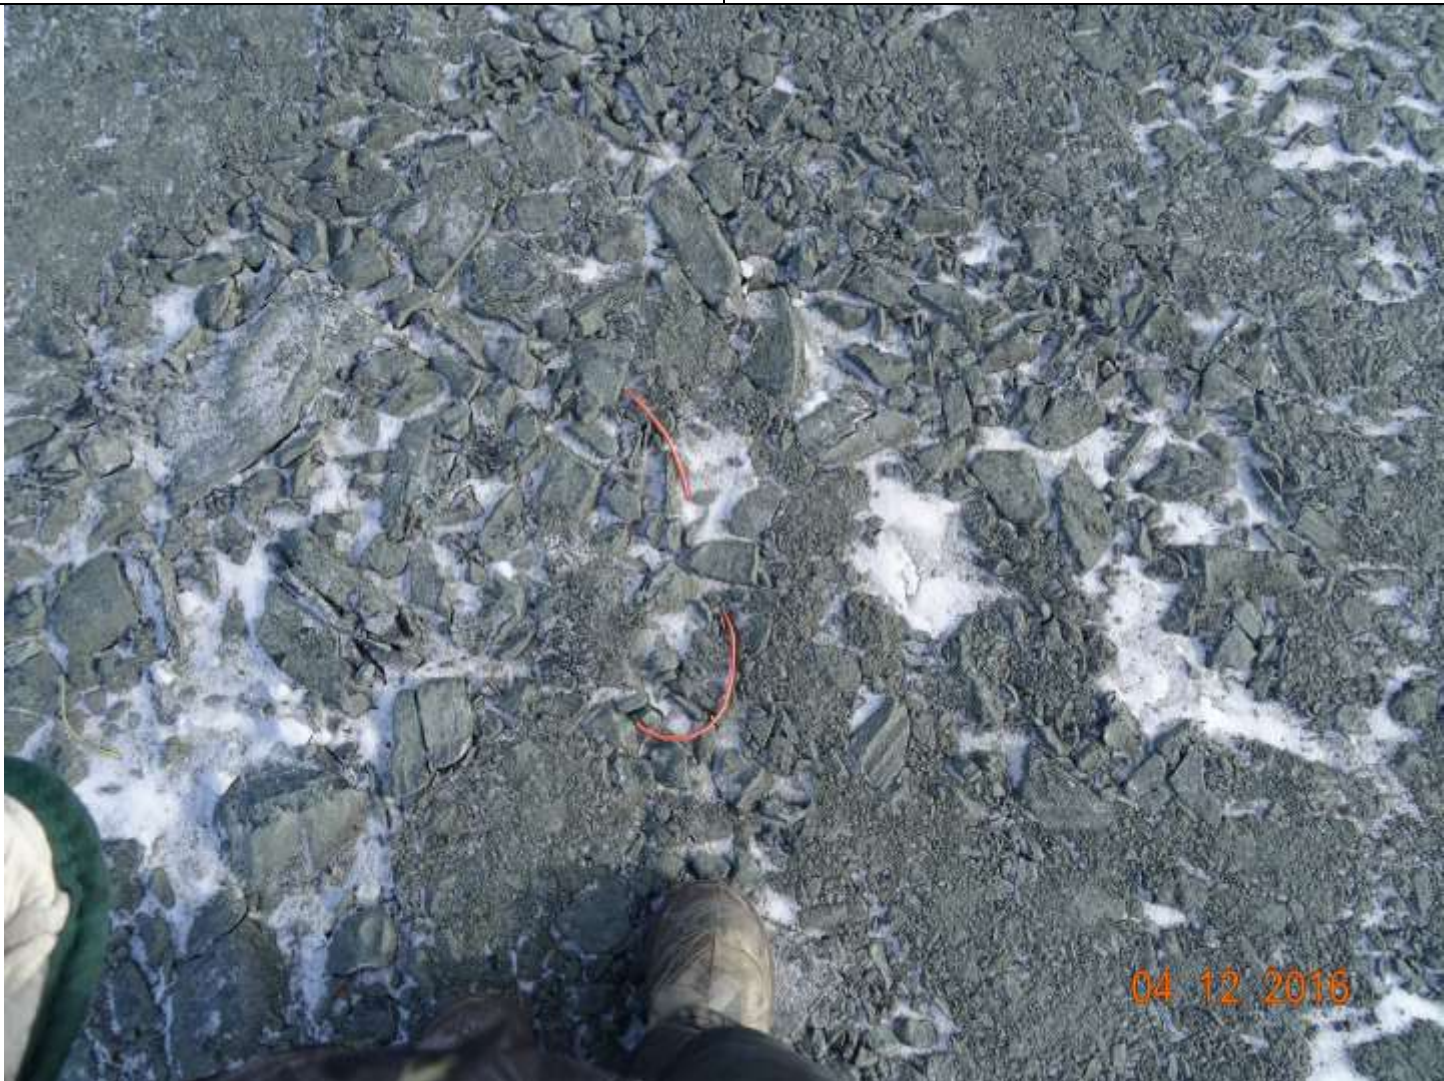
Photo 3

5. Tetra Tech will be present and supervising the entirety of the project.
6. The material used in the construction of the dykes is waste rock. The rock appears to have blasting wire and debris within it. The inspector was concern this rock may also be contaminated with ammonia and chloride as it was blasted from the underground.

DP3-A - Orange Wire in material

- AEM will prepare a Freshet Action Plan that will address P1 containment facility, and all other water management structures at Meliadine Project. This Plan will be submitted to the Board by April 29th, 2016.
- AEM shall provide sampling results of the materials used in the construction of the DP3-A, to the Board before April 29th, 2016.
- AEM will record water used for the construction of the P1 containment facility. This volume will be reported separately from the explorative/ domestic totals in the monthly monitoring report.
- AEM will arrange a meeting with regulators to discuss; the scope of the current licences (2BB-MEL1424 and 8BC-MEL1516); clarify the use of the P1 containment facility; clarify which undertaking the P1 containment facility supports and which licence will be amended to authorize this activity.

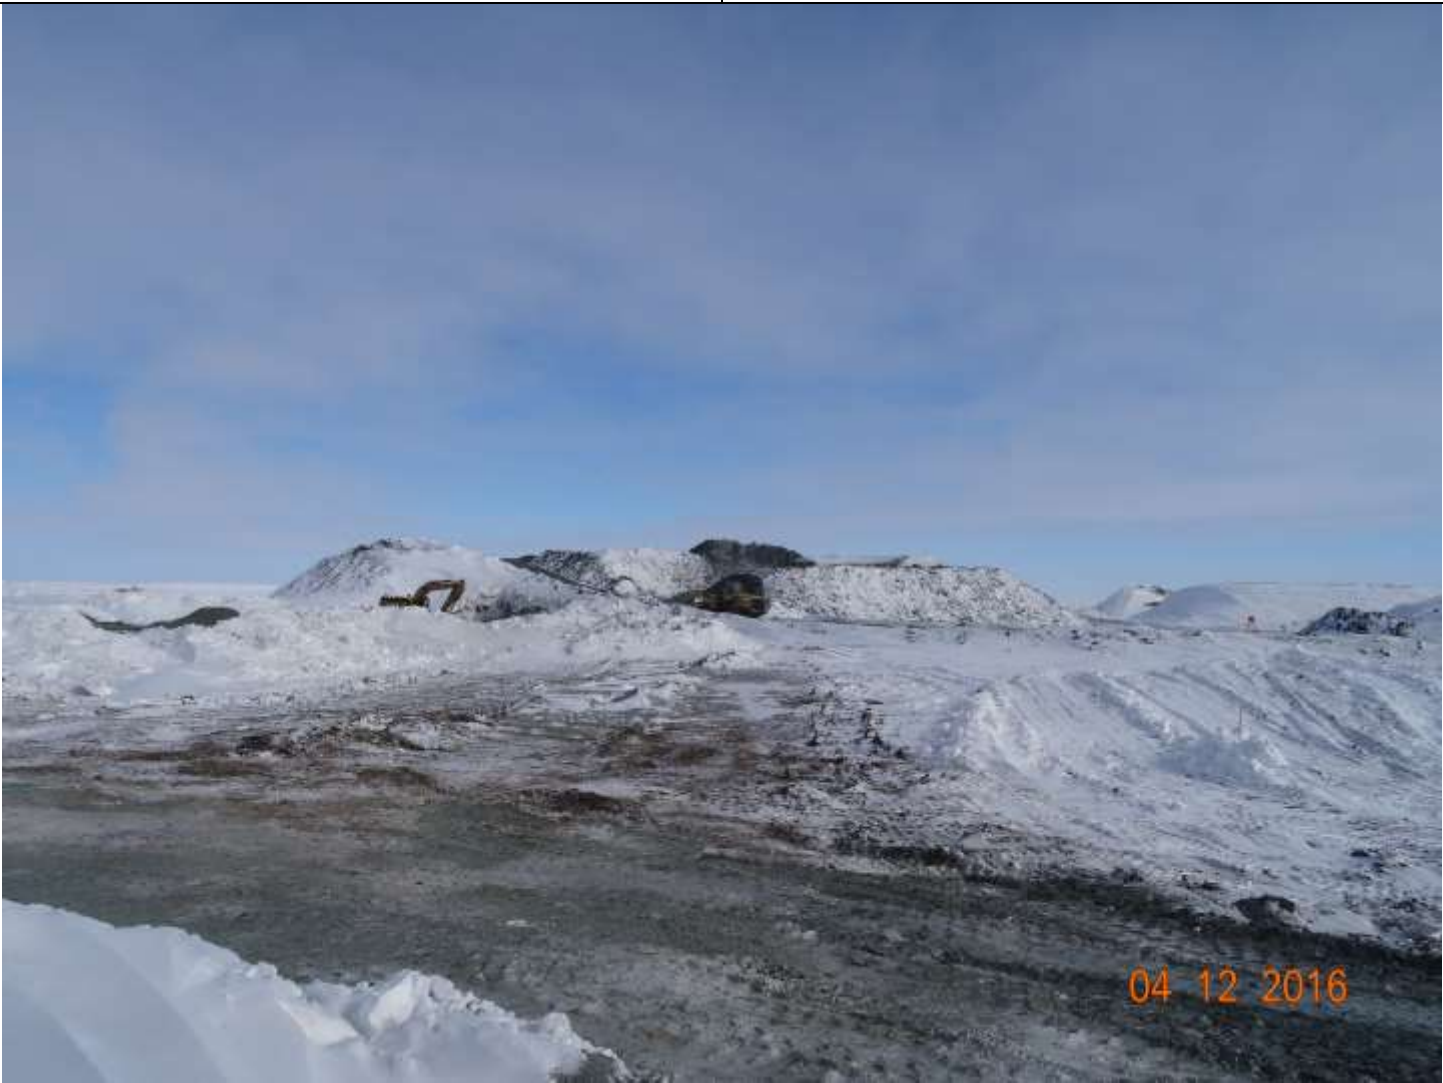
Photo 5

Facing North: Waste Rock Storage Area.

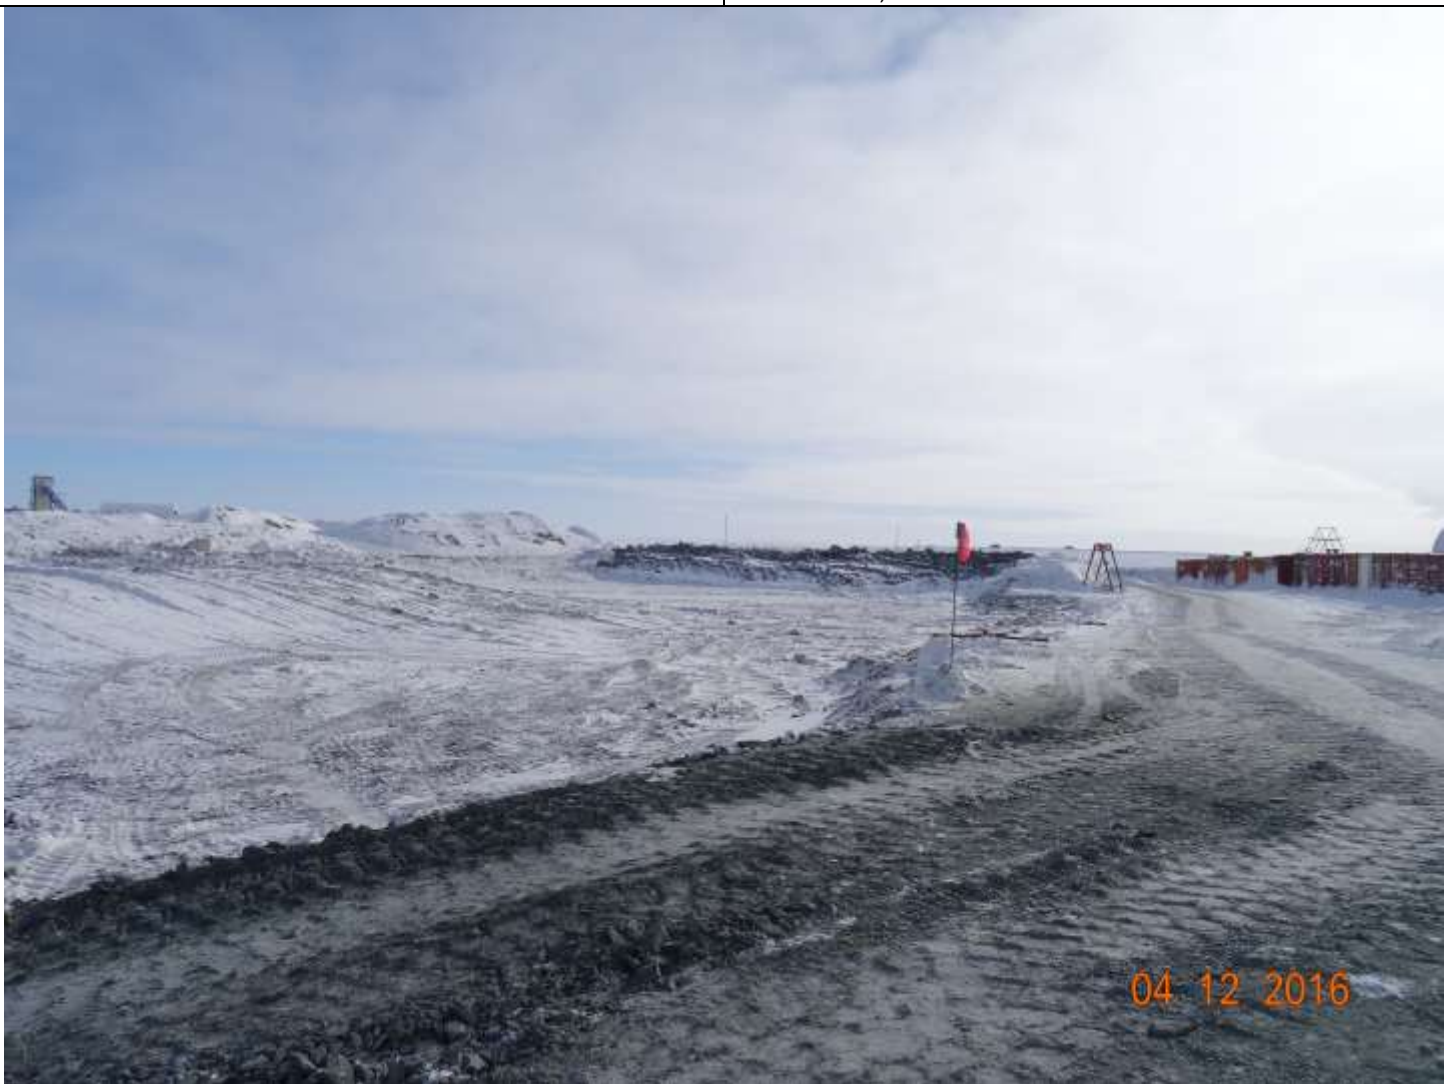
Photo 6

Facing North East South East: Primary containment Pond (P1)

- I. Take such measure necessary to stop the release of water from containment pond P1 and the portal surface sump into the receiving environment.
- II. Within 60 days of completion of DP1-B, DP1-A, DP2-A, DP3-A, and the water collection system, submit to the Board, a construction summary report along with stamped as-build plans and drawings, providing explanation to reflect any deviations from the construction drawings taking into account construction and field decisions and how they affect the performance of each structure.

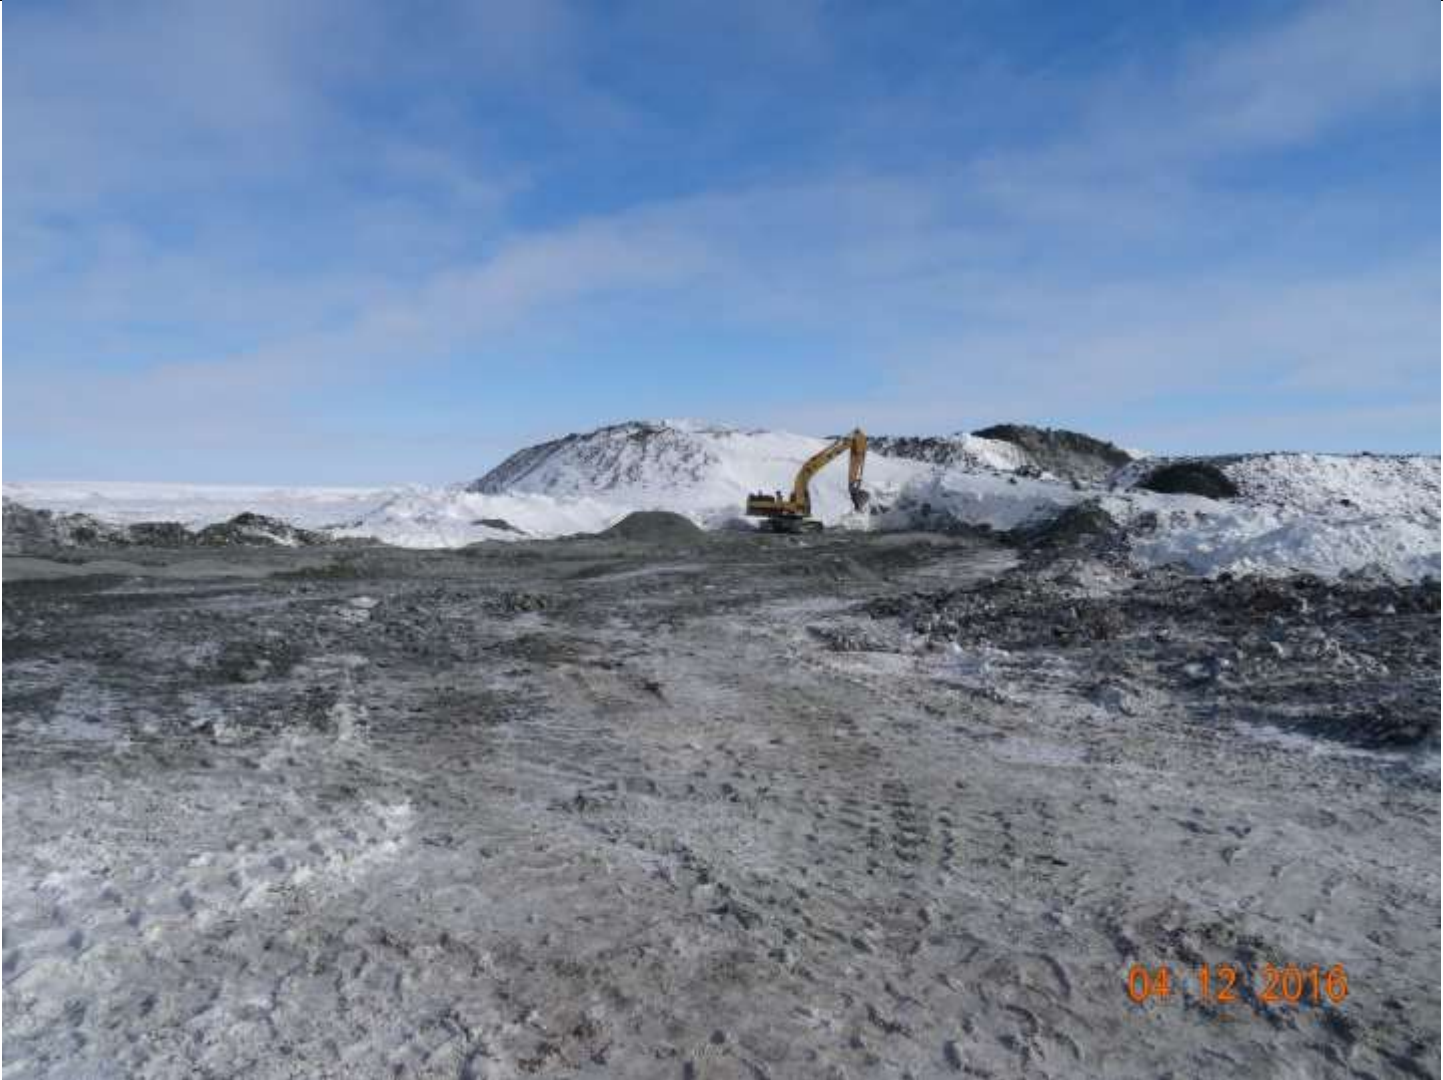
Locations name:	Lat/Long (DD.MM.SS.SS, NAD83)
Photo 6	N63° 1' 40.51", W 92° 12' 50.78"

Description
Facing North East: Fore ground: DP1-A Back ground: Waste Rock Storage Area

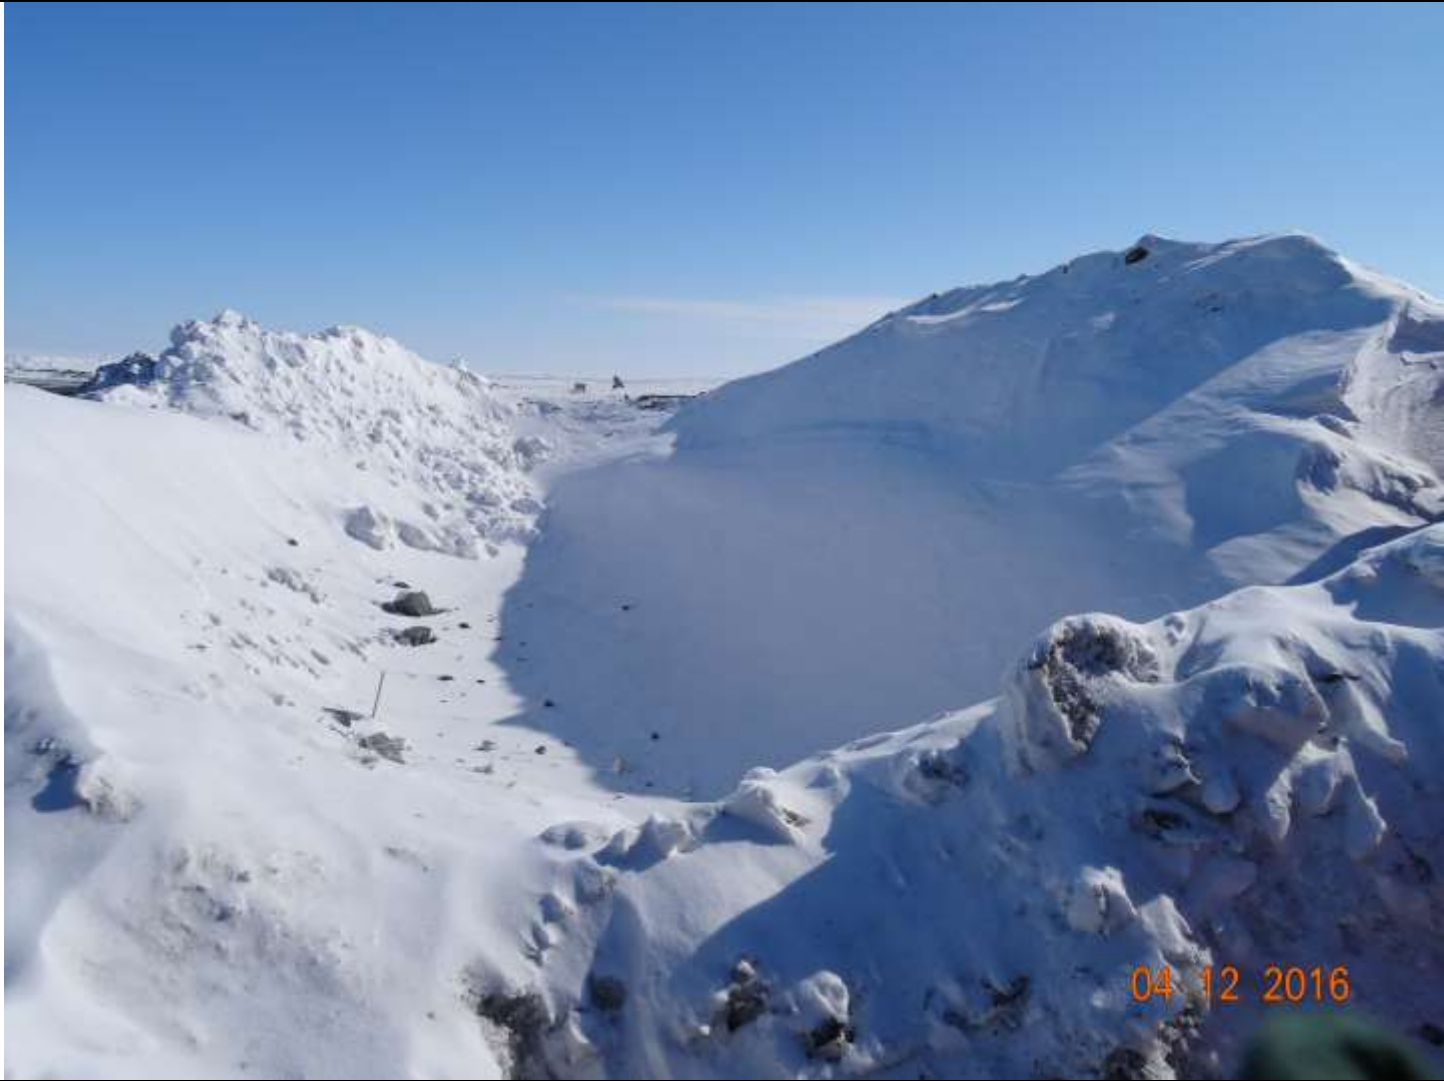
Photo 8

Facing East: Portal Surface Sump

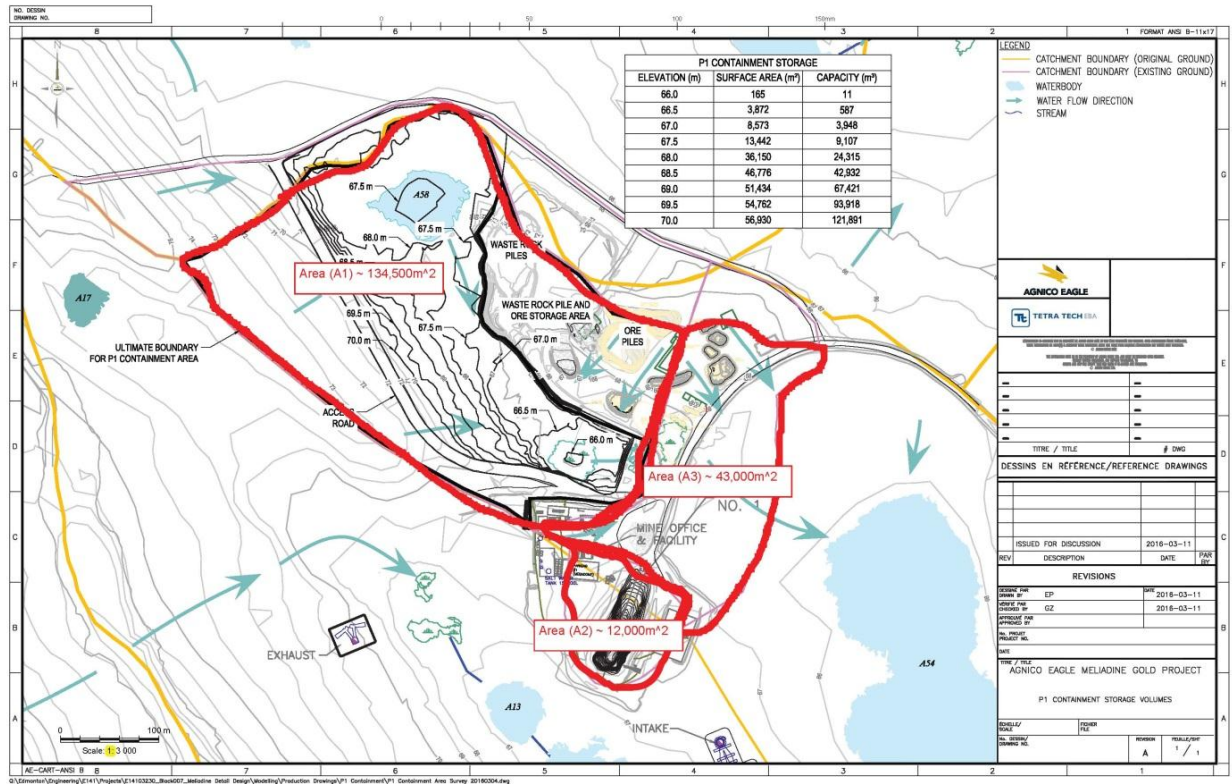
Figure 2: Meliadine Decline Surface Containment Pond P1 - Watershed Areas

The watershed associated with containment pond P1 is shown as area A1 in Figure 2. Sub-watershed A1 has an area of about 134,500 m². It is limited to the north by some high ground (around elevation 68.0 m) and to the south-east by a platform and a rockfill road (south road) acting as a confining structure. Natural flow from the P1 containment pond area is toward the south-east toward Lake A54 (often referred as Peanut Lake due its shape). Containment pond P1 is limited to the south by some high ground and the portal platform.

The amount of water contained in pond P1 varies seasonally, typically growing with the spring freshet, diminishing over the drier summer months and then increasing again with the fall rains. A constructed rockfill road (south road) serves to cut off the natural drainage outflow from containment pond P1. The upstream side of this roadway contains a geotextile liner designed to filter out solids but not to be impermeable, although it should be noted that this confining structure has been able to contain water quite effectively over the past years. Under the approved WMP, water quality in P1 was to be assessed and can only be discharged if water quality met the criteria for discharge. The discharge standard to be met was the standard contained in the Metal Mining Effluent Regulation under the Fisheries Act. Historically, water was discharged (pumped) via a culvert set at an elevated level within the north end of the rock fill roadway cutting off containment pond P1 from its natural drainage pathway towards Lake A54 (see Figure 2).

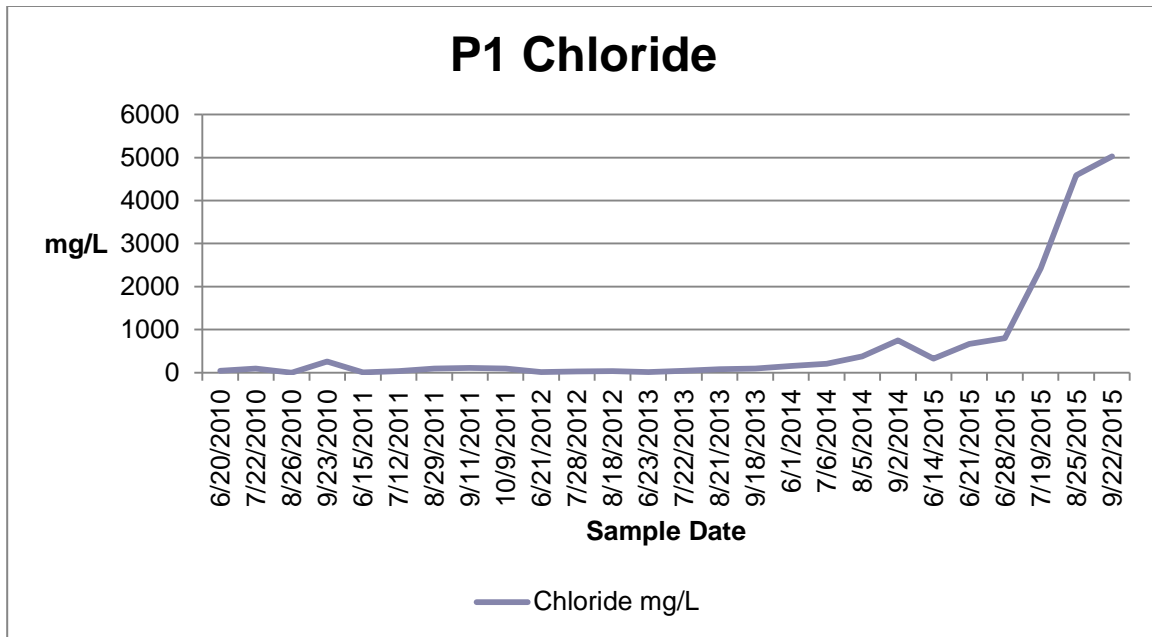
Figure 4: Measured Chloride Concentrations in UG Decline Containment Pond P1

Analysis of this water quality monitoring data conducted in preparing the 2015 annual report shows a fairly rapid increase in chloride concentrations in Lake A54 starting in mid-June of 2015. This coincides with a similar trend increase in chloride concentrations in containment Pond P1 suggesting that something changed in the source loading for chloride coming into containment pond P1 that starts somewhere around mid-June of 2015 and that water is exiting containment pond P1 into Lake A54 in a means other than being pumped or overflowing through the installed roadway culvert (most likely seepage through the roadway – see Figure 1). A similar trend in chloride concentrations is seen in Pond A38 downstream of Lake A54. At Lake A8 water quality monitoring indicates that chloride concentrations are above the natural background of around 10 mg/l, trending around 40 mg/l in past years but now trending around 50 mg/l in the summer of 2015 and have spiked previously in summer months (as high as 90 mg/l in one sample in 2014) but have always been below the CCME long term guidance of 120 mg/l for protection of freshwater aquatic life. There is no MMER discharge standard for chloride (see Figures 4, 5, 6 and 7).

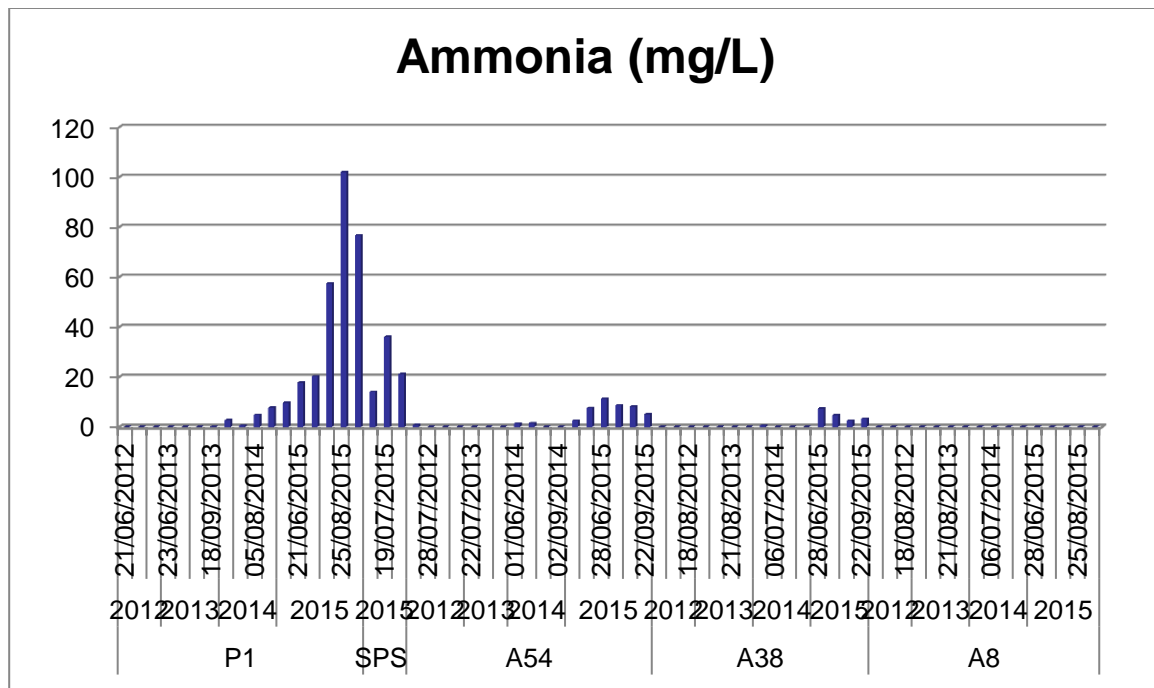
Figure 8: Measured Ammonia Concentrations in Containment Pond P1, Surface Sump, Lake A54, Pond A38 and Lake A8

Analysis of the water quality monitoring data also shows a change in the trend of ammonia concentrations measured in containment pond P1 again starting in mid-June of 2015 (see Figure 8).

It is our belief that the probable source of this increase in chloride and ammonia concentrations has to be from the underground mine development activities, chloride from the salt used in drilling and/or from increased inflow of higher salinity groundwater from the surrounding rock and from explosive use underground and possibly from surface management issues of the calcium chloride stored on surface and from snow management. We are currently having development activity occurring below the permafrost but are experiencing low ground water inflow in these areas.
