WATER LICENCE INSPECTION FORM

Licensee	Licensee Representative
2BB-MEL1424	Jeffrey Pratt
Licence No. / Expiry	Representative's Title
July 21st, 2024	Environment Division
Land / Other Authorizations	Land / Other Authorizations
IOL	--
Date of Inspection	Inspector
April 10 th , 2017	WRO C. Wilson
Activities Inspected	
<div><input type="checkbox"/> Camp<input type="checkbox"/> Drilling<input type="checkbox"/> Mining<input type="checkbox"/> Construction<input type="checkbox"/> Reclamation<input type="checkbox"/> Fuel Storage</div> <div><input type="checkbox"/> Roads/Hauling<input checked="" type="checkbox"/> Other: Spill no. 17-103<input type="checkbox"/> Other:</div>

Spill no. 17-103 4.10.2017

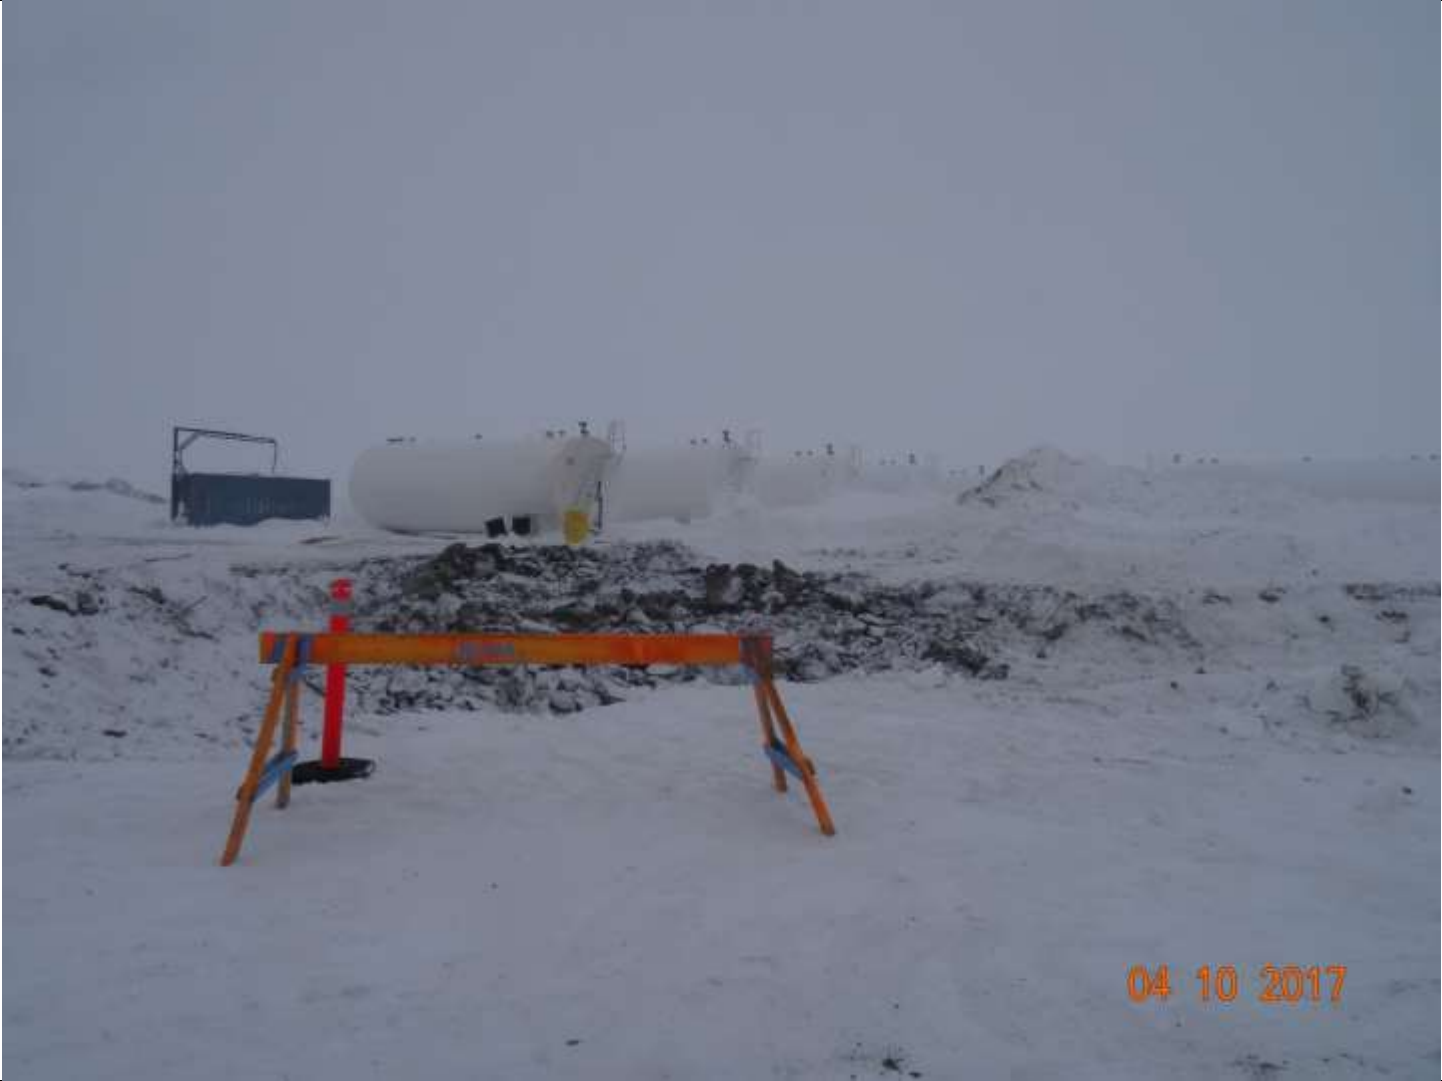
Date:	Authorization Number:	Camera/Model:	Inspector
April 11 th , 2017	2BB-MEL1424	Sony DSC-HX50V Cyber shot	WRO Wilson
Photo No.		Lat/Long (DD.MM.SS.SS, NAD83)	
Photo 1		N63° 1' 23.00", W 92° 11' 7.5"

Description:
Looking North from Bypass road: Source (Tank 18) and general area of excavation.

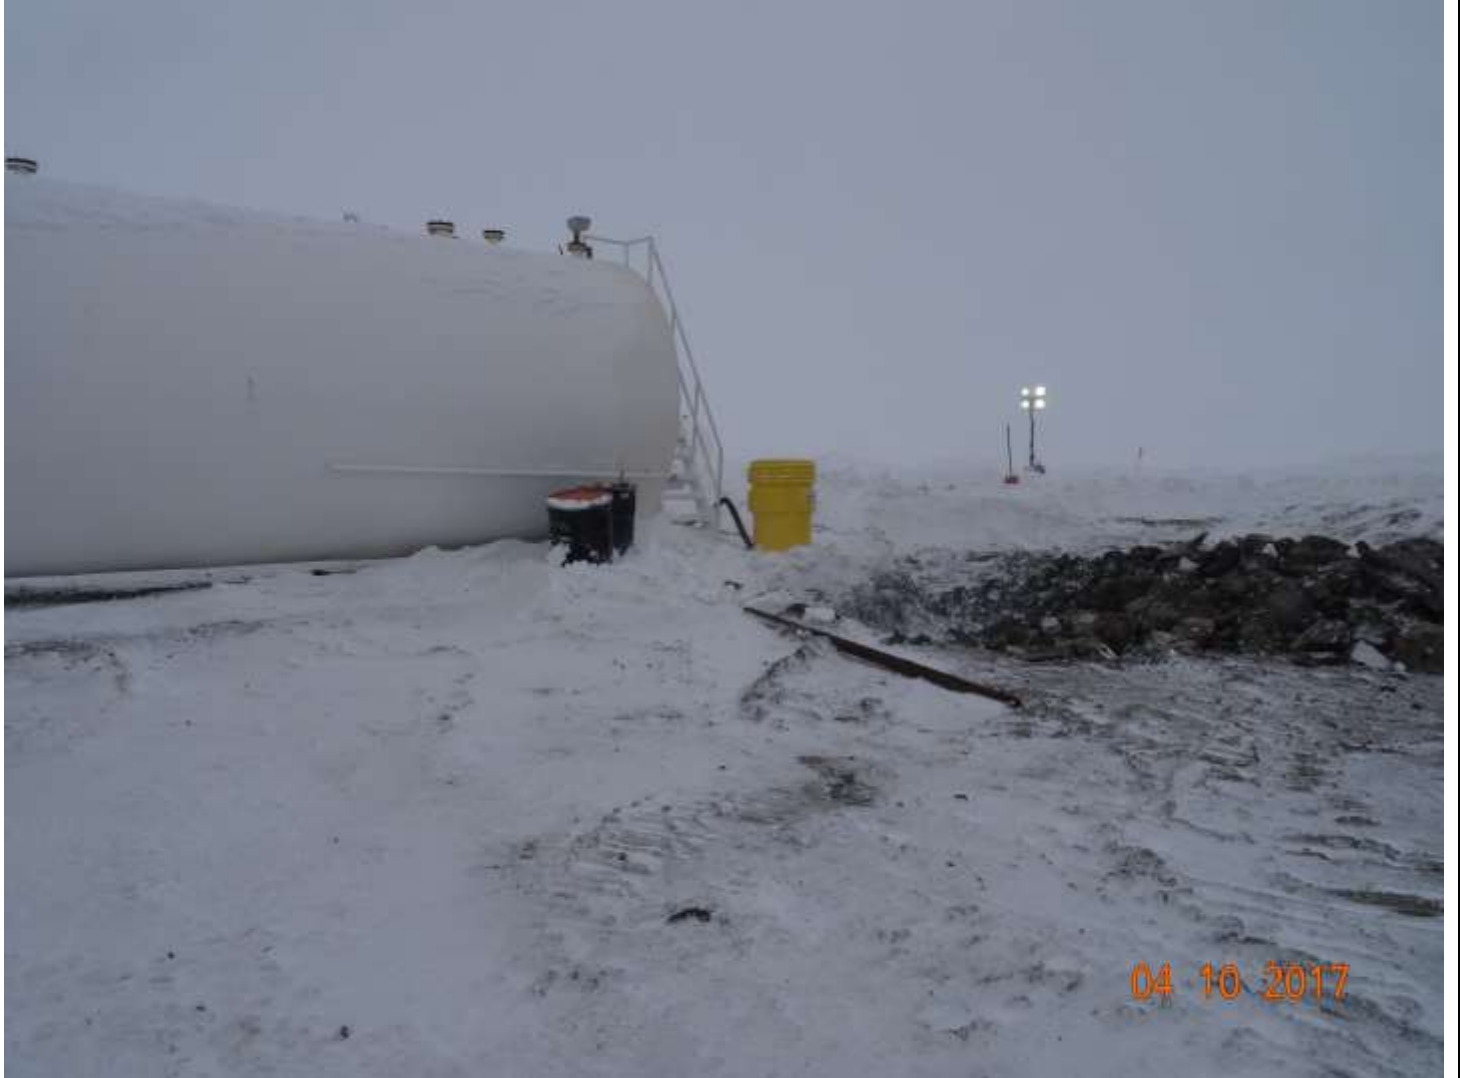
Locations name:		Lat/Long (DD.MM.SS.SS, NAD83)
Photo 2		N/A

Description	
Looking East: Source (Tank 18), fuel transfer location, general area of spill.

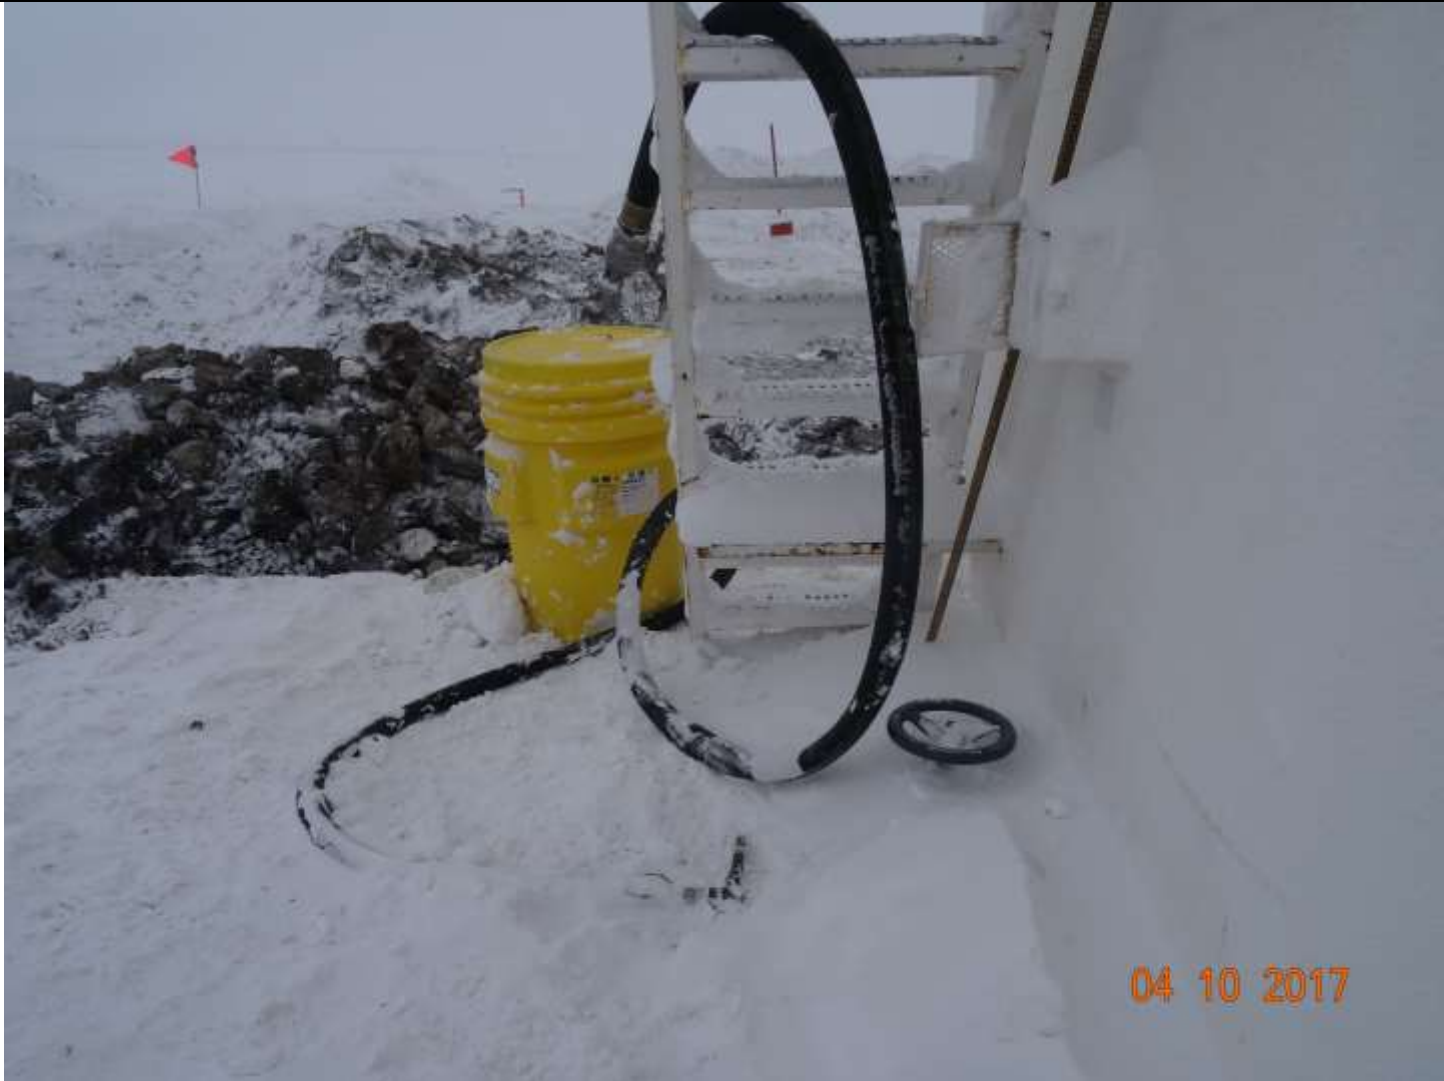
Photo 4

Looking West: Source (tank 18), valve and hose system.

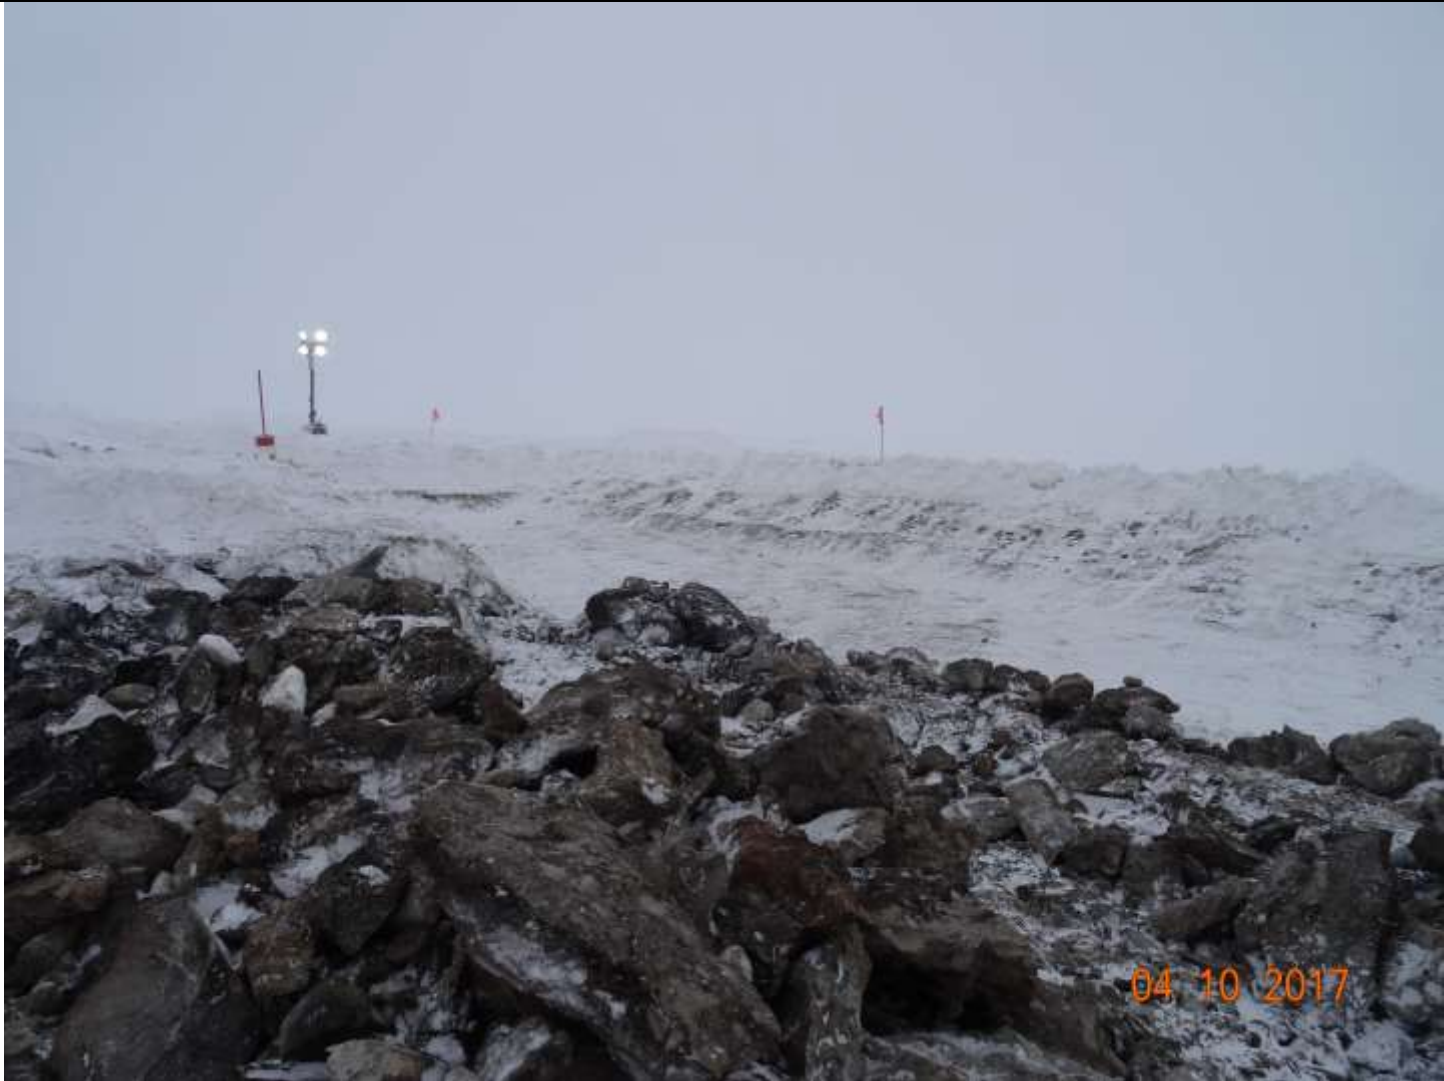
Photo 5

Looking South from tank 18: Excavated area and bypass road.

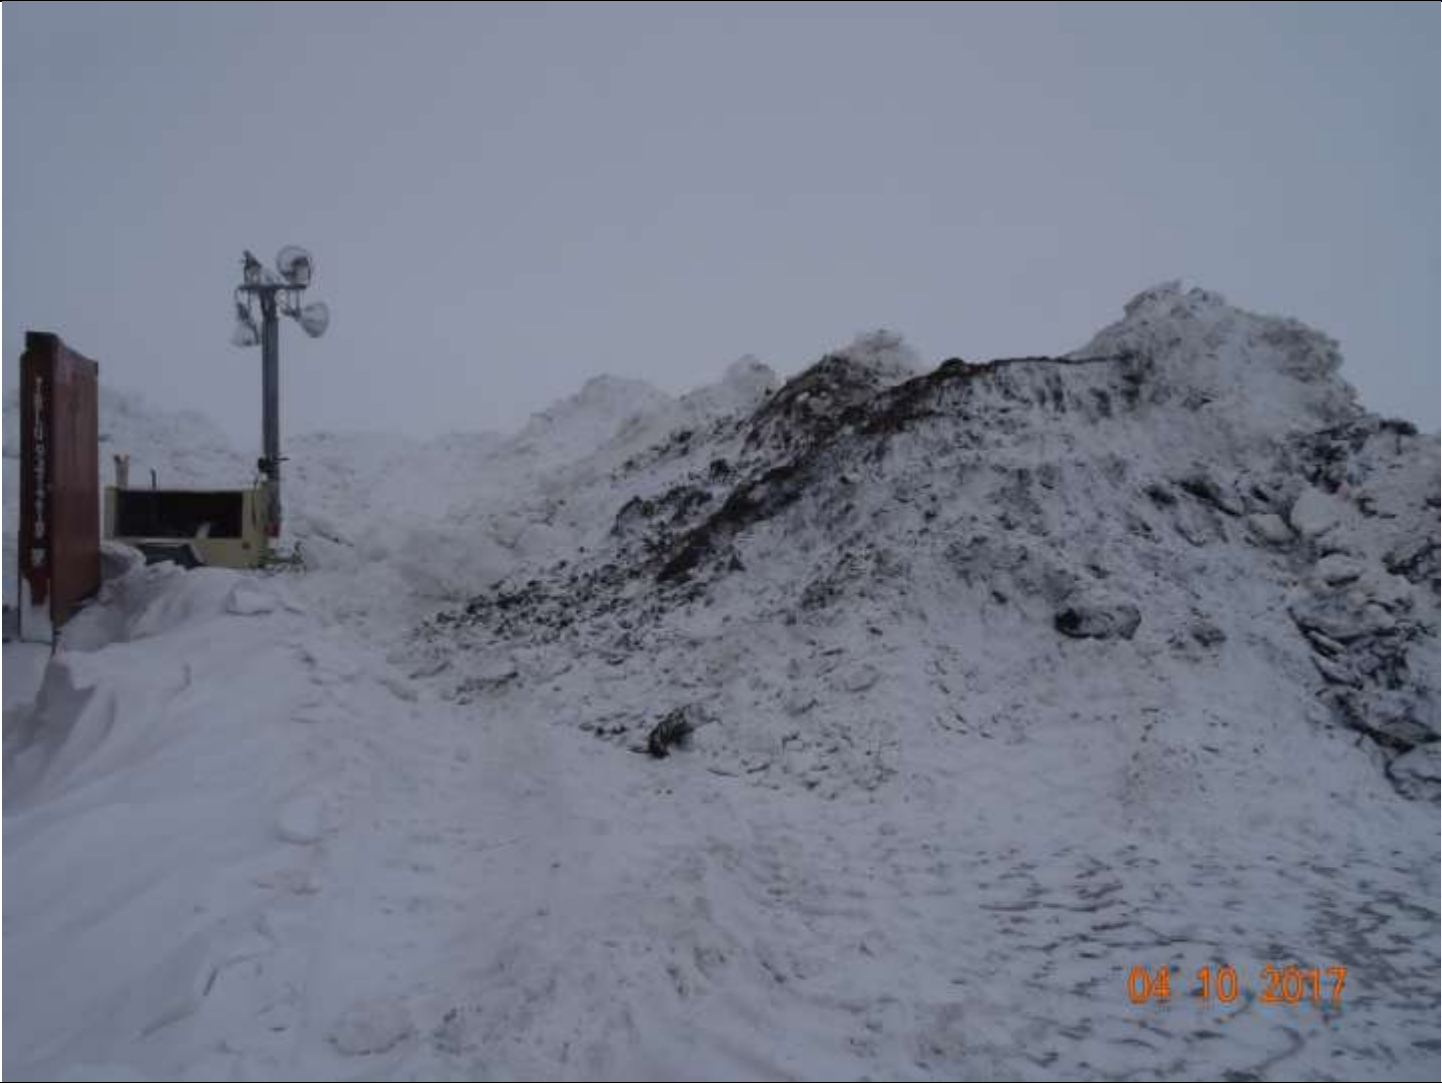
Photo 6

Looking North west: Contaminated snow/ soil material in Meliadine Advance Exploration Landfarm.

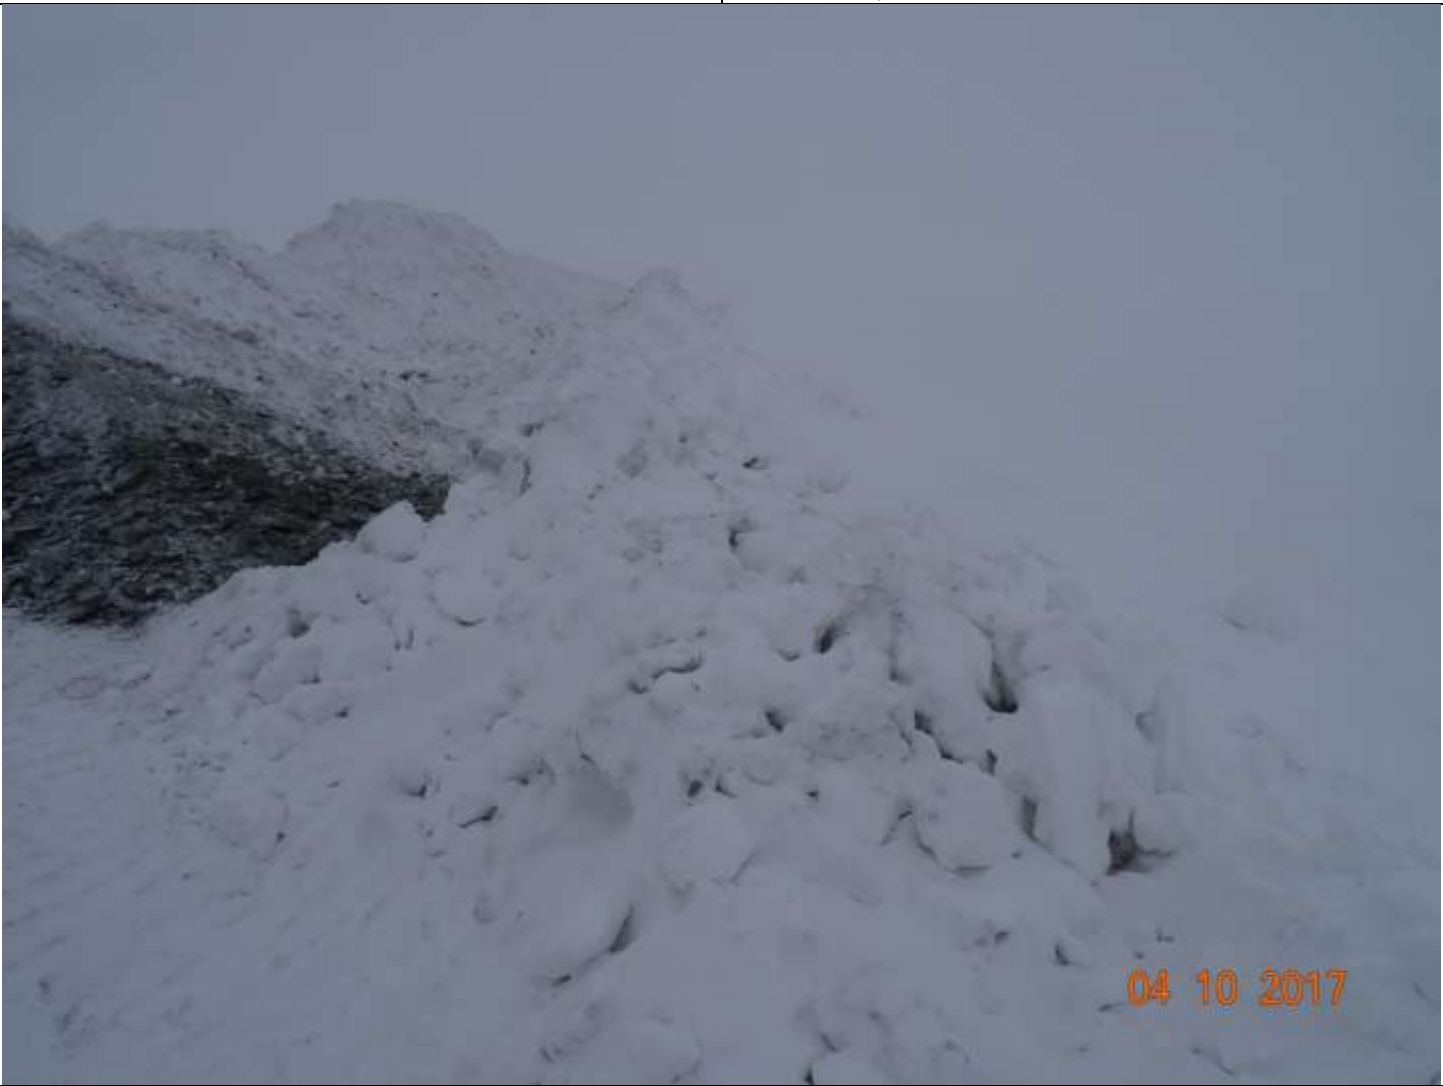
Photo 7

Looking North North West: Snow block

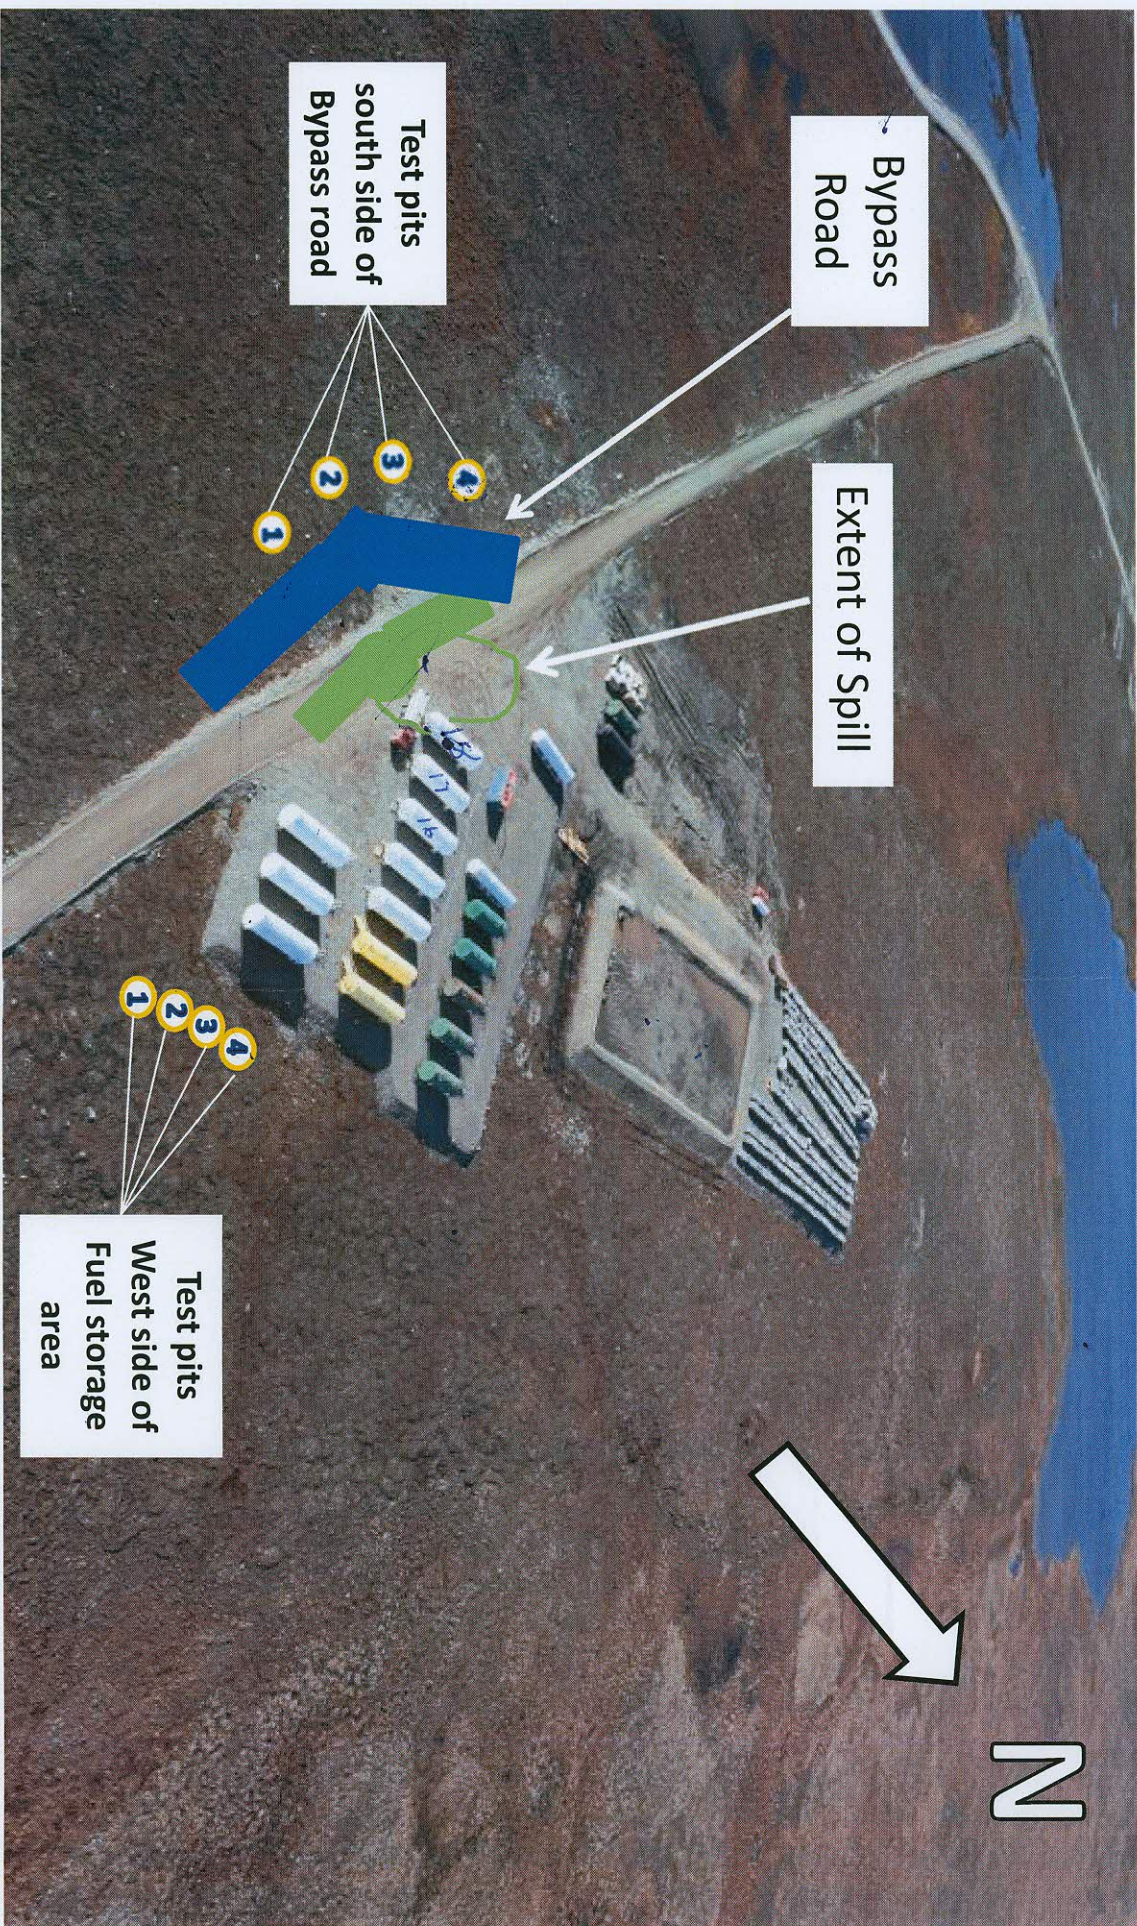
AGNICO EAGLE - MELADINE GOLD PROJECT
FIGURE 4.1 WATERSHED AND WATERBODIES
AFFECTED BY SITE INFRASTRUCTURE

21. AEM has hired a third party contractor to consult on a strategy specifically for freshet and reclamation.
22. J5 appears to be the closes lake to the spill approximately 160m the south west (appendix 4 and appendix 5)
