WATER LICENCE INSPECTION FORM

☐ Original  
☒ Follow-Up Report

On May 8<sup>th</sup>, 2017 Indigenous and Northern Affairs Canada’s Water Resource Officer, Christine Wilson conducted a follow up to the April 10<sup>th</sup> inspection of Agnico Eagle Mines Limited’s (‘AEM’) Meliadine Advanced Exploration project, water licence 2BB-MEL1424. The inspection was completed with the assistance of AEM’s, Environmental Technician, Philip Roy.

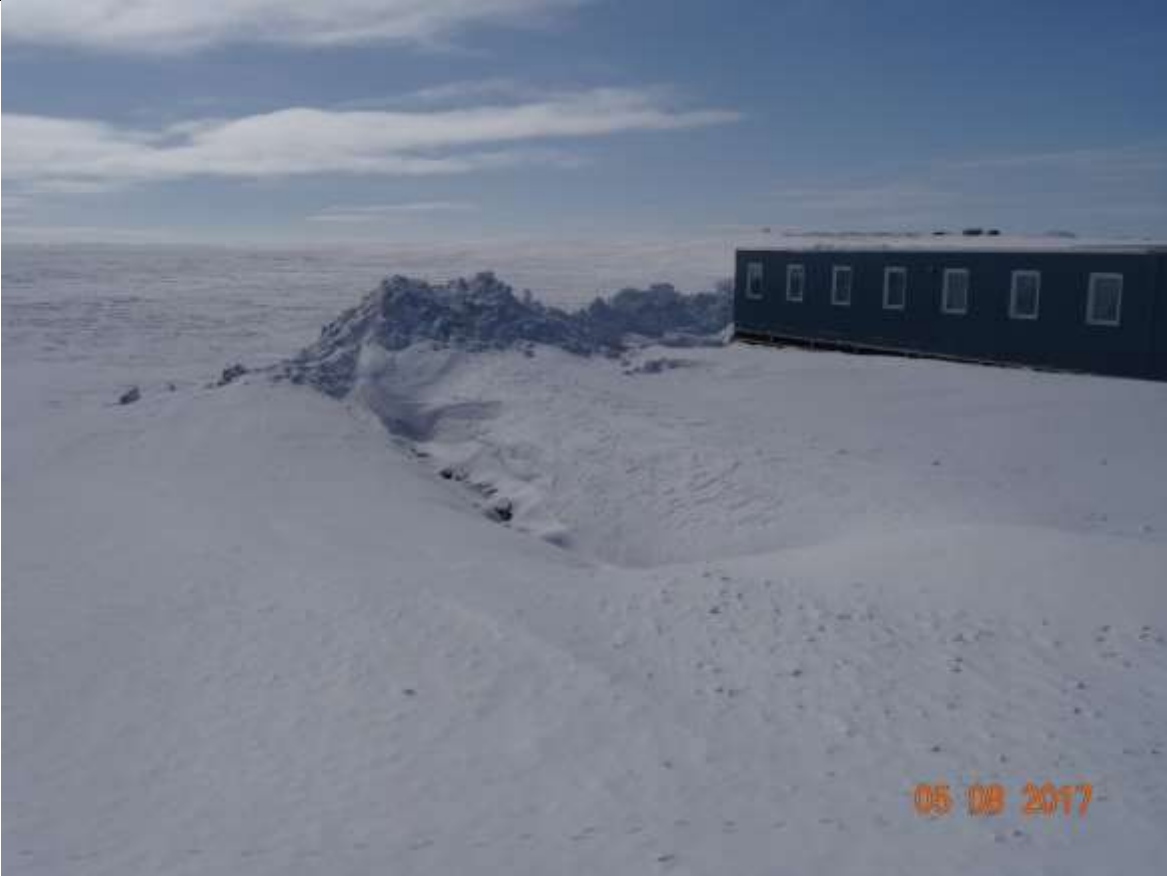
Date:	Authorization Number:	Camera/Model:	Inspector
May 11th, 2017	2BB-MEL1424	Sony DSC-HX50V Cyber shot	WRO Wilson
Photo No.		Lat/Long (DD.MM.SS.SS, NAD83)	
Photo 1		N63° 1' 43.58", W 92° 10' 9.85"

- Effluent from the Sewage Treatment Plant (STP) is sent through pipe to a rock dissipation channel (photo 1). This channel, though outside in the cold climate remains open and flowing during the winter months under the snow cover (photo 2). Water was observed flowing from this location freely through the rock fill (photo 3) and eventually down to Meliadine Lake.

**Description:**  
Mel-7 Sewage Treatment Plant outfall looking south.

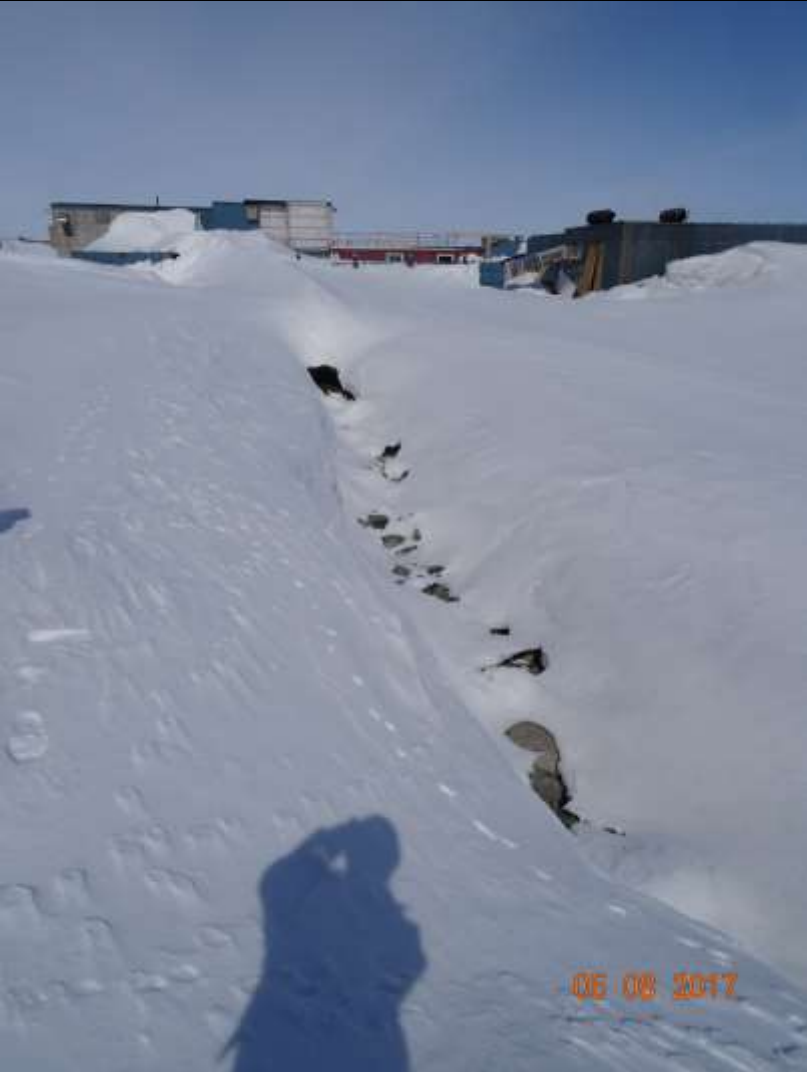
Locations name:	Lat/Long (DD.MM.SS.SS, NAD83)
Photo 2	N63° 1' 42.62", W 92° 10' 8.69"

**Description**  
Looking North: STP outfall and dissipation channel

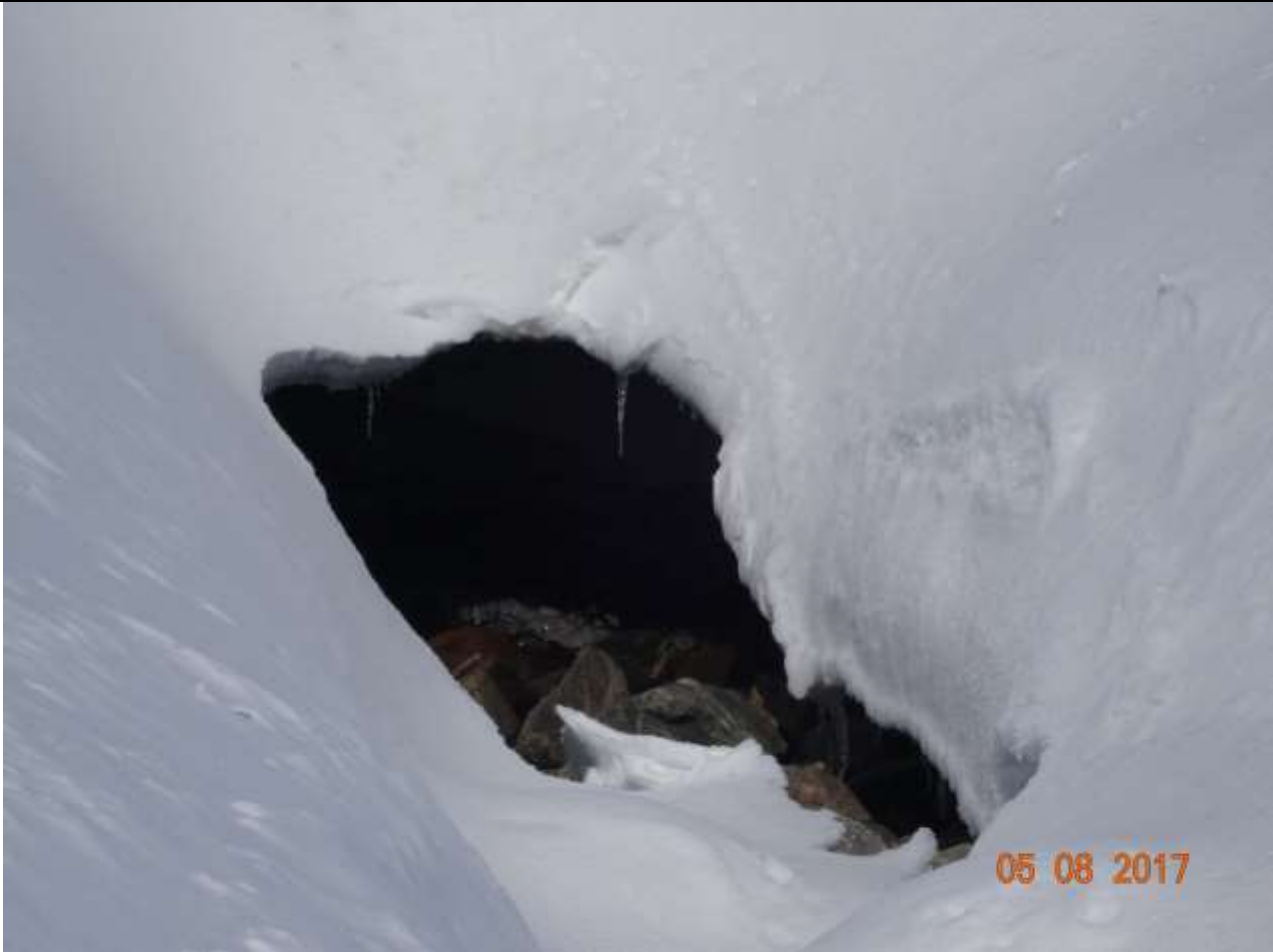
Locations name:	Lat/Long (DD.MM.SS.SS, NAD83)
Photo 3	N 63° 1' 42.50", W 92° 10' 8.29"

Description
MEL-7 outfall

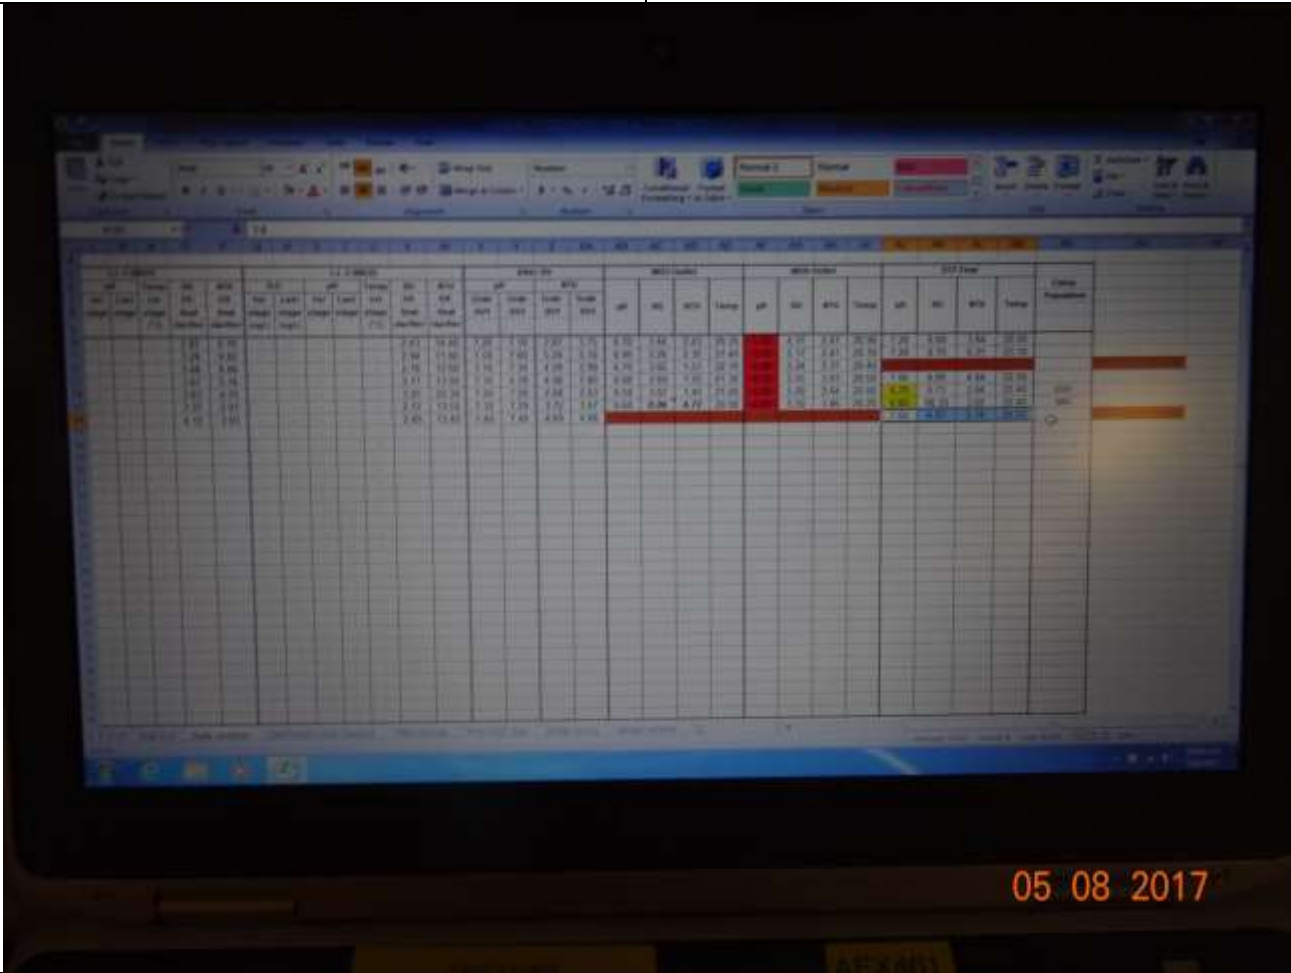
Locations name:	Lat/Long (DD.MM.SS.SS, NAD83)
Photo 4	N/A

- The bionest system has been providing good treatment for turbidity but averaging a low pH. BIO4 is producing a pH of around 4.8 while BIO3 has a pH of around 6.6. Both these reading were taken onsite (photo 4).

Description
Bionest parameter table

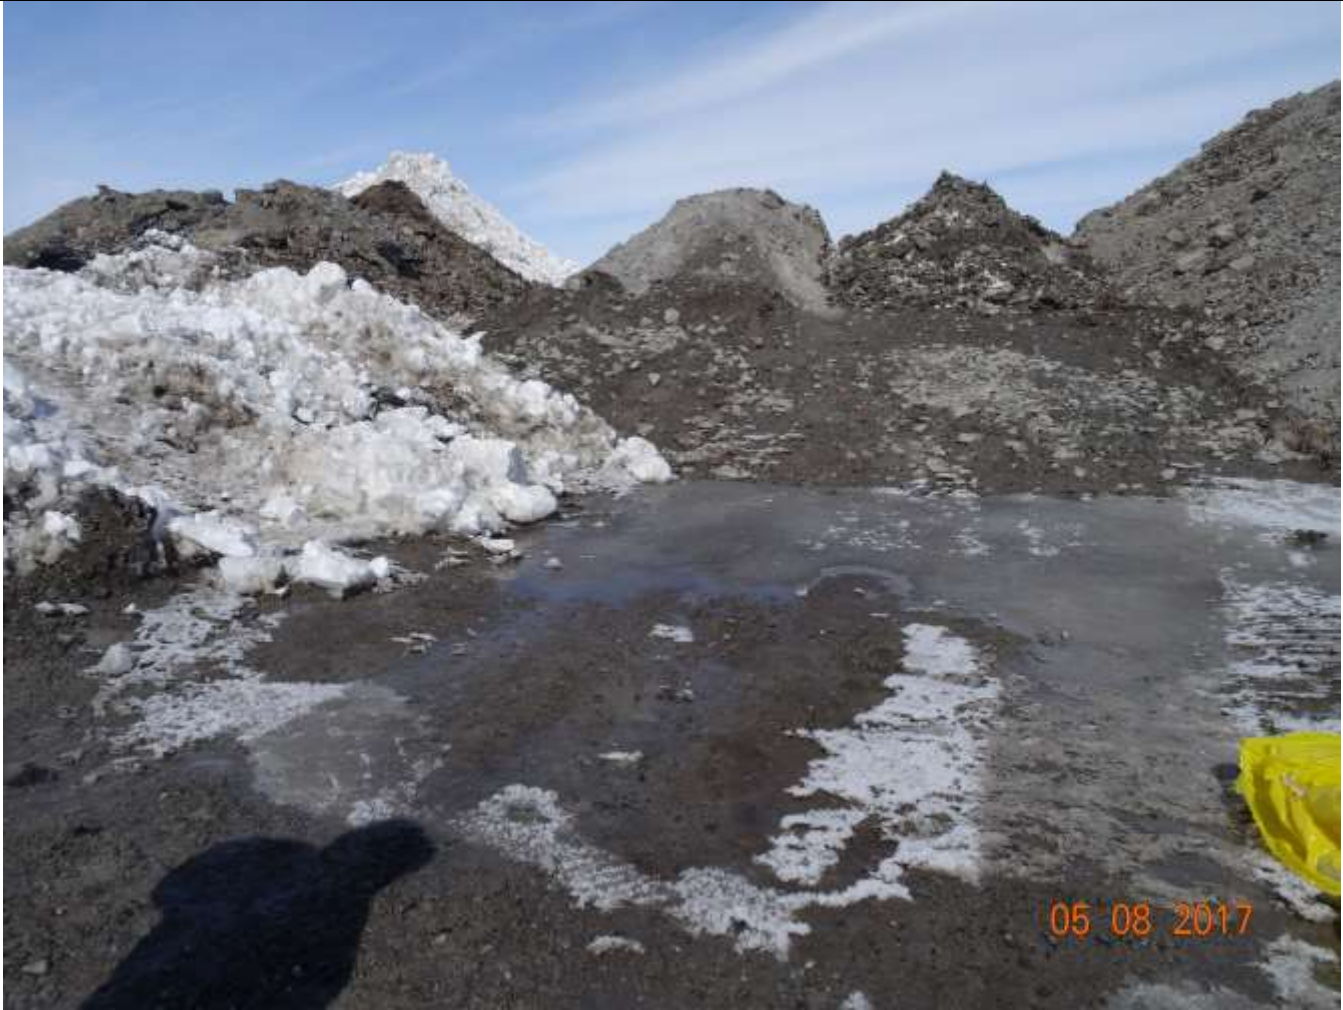
Photo 7

- The access ramp to the landfarm has contaminated material at the same elevation as the berm walls allowing potentially contaminated water to escape the land farm containment. The inspector is concerned with the lack of freeboard for containment of freshet water (photo 7).

Access ramp to the landfarm, the ramp slopes to the north allowing water to escape the containment of the landfarm.

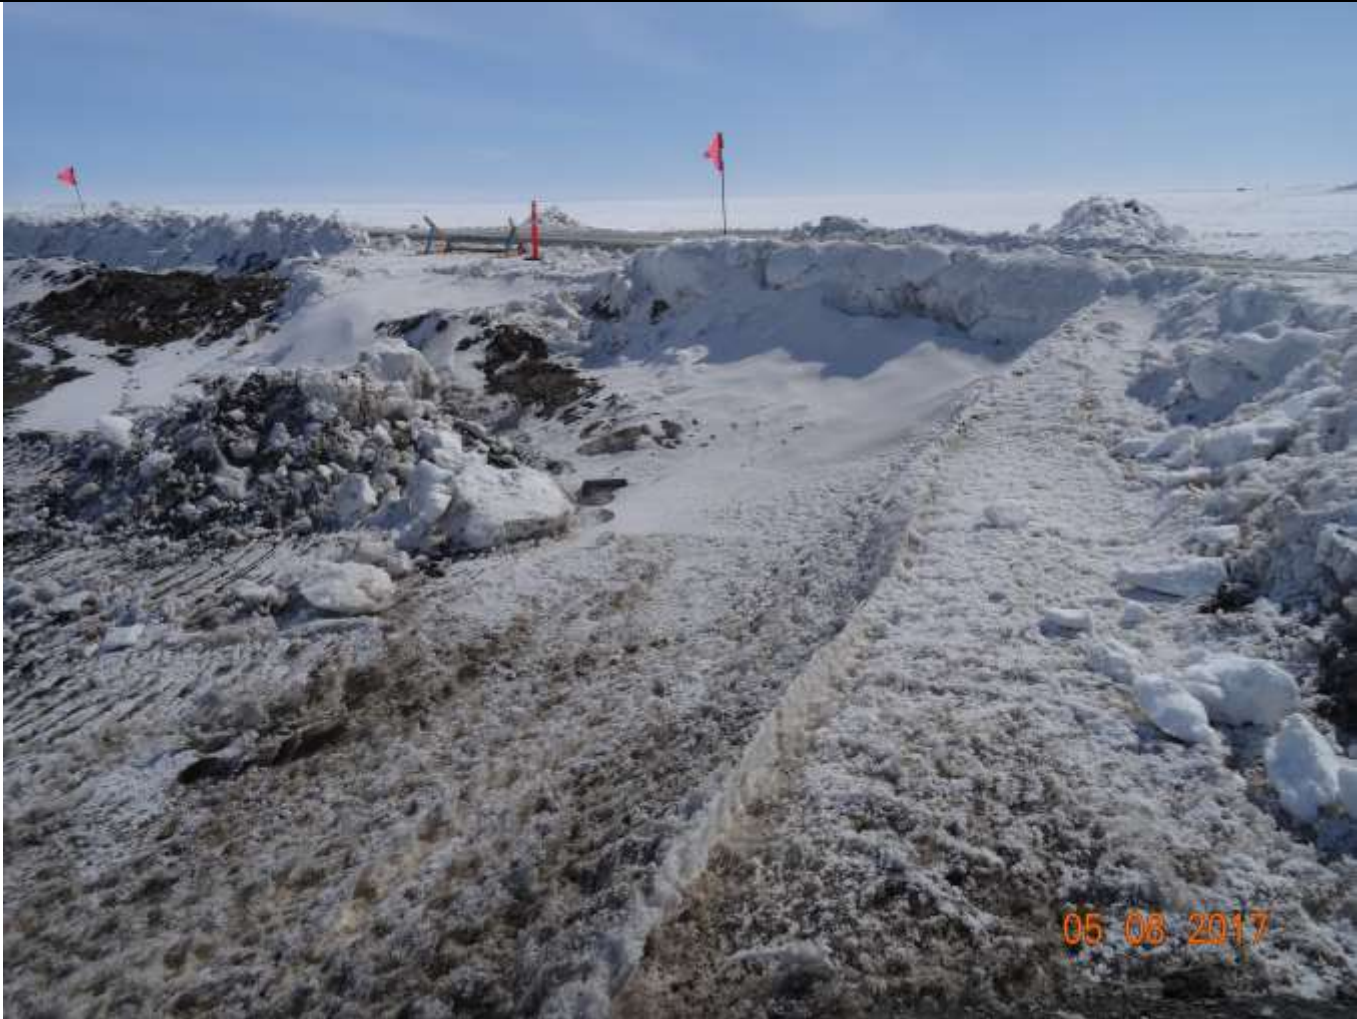
Photo 8

- A portion of the contaminated soil will remain in place until decommissioning of the tankfarm. This portion is located under the remaining tanks. AEM has covered part of this section with a HDPE liner and clean fill to protect the already cleaned area from further contamination (photo 8, 9 and 10).

Looking East South East: Photo A of excavation sequence, the bypass road and the south portion of the excation

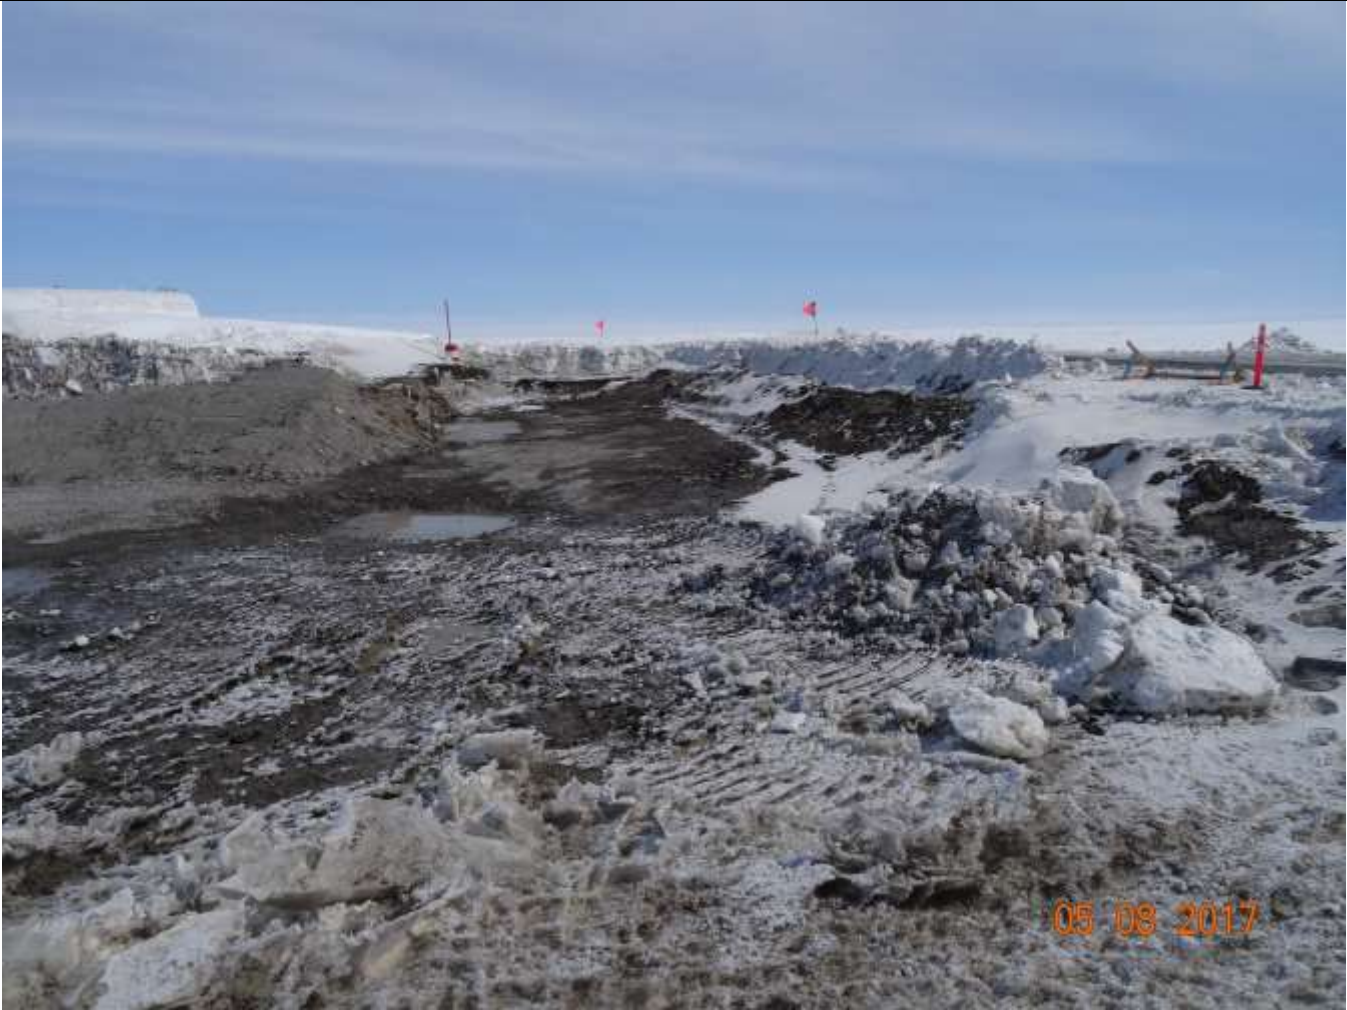
Photo 9

Looking East: Photo B of excavation

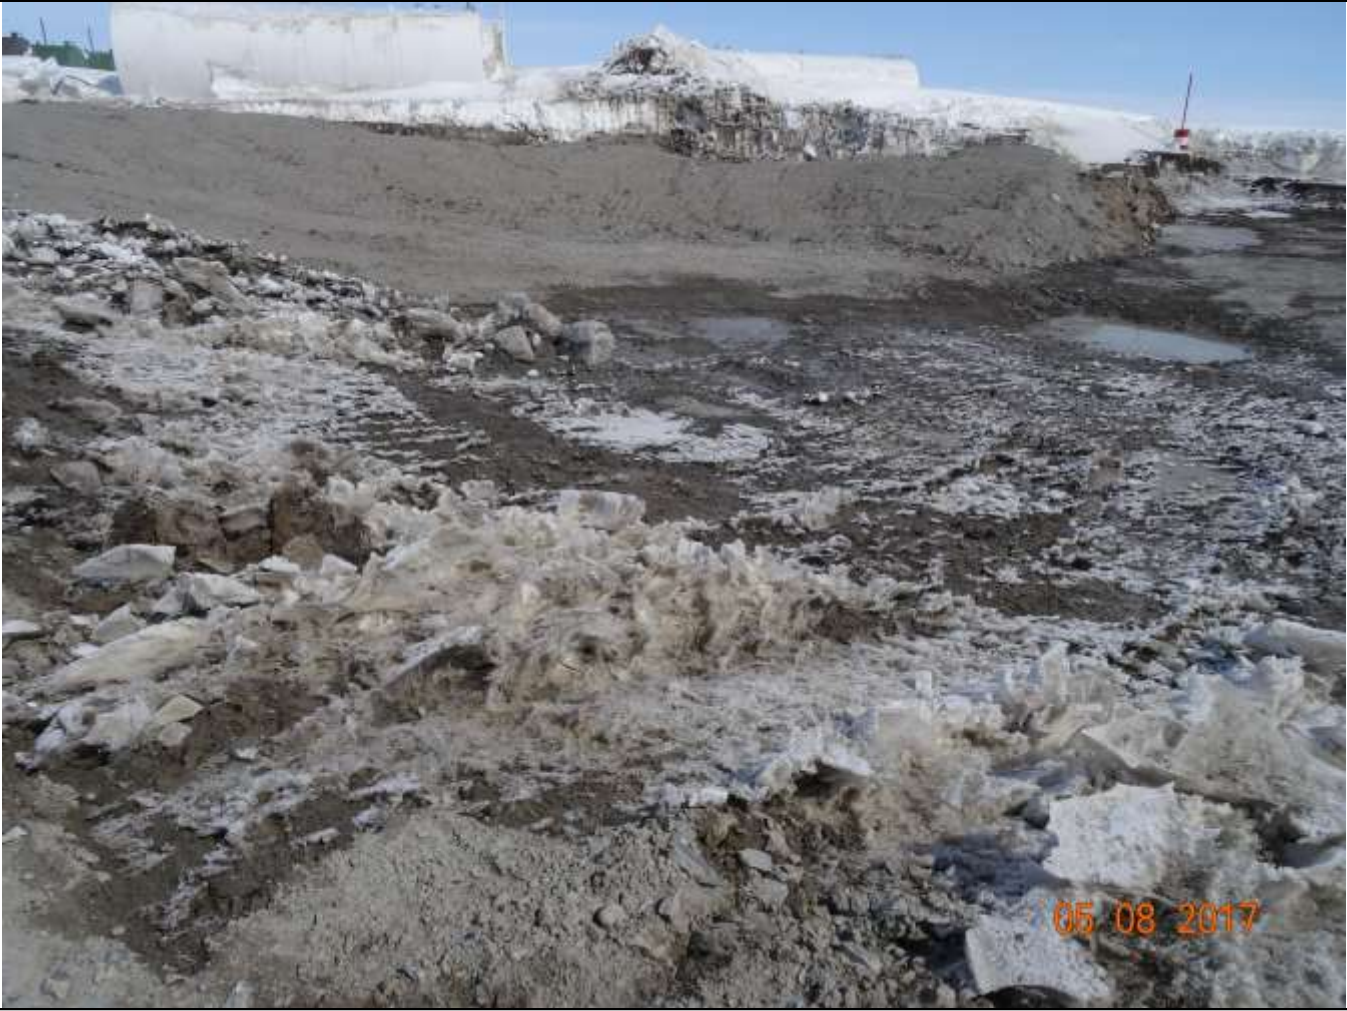
Photo 10

Looking North East: Photo C of excavation

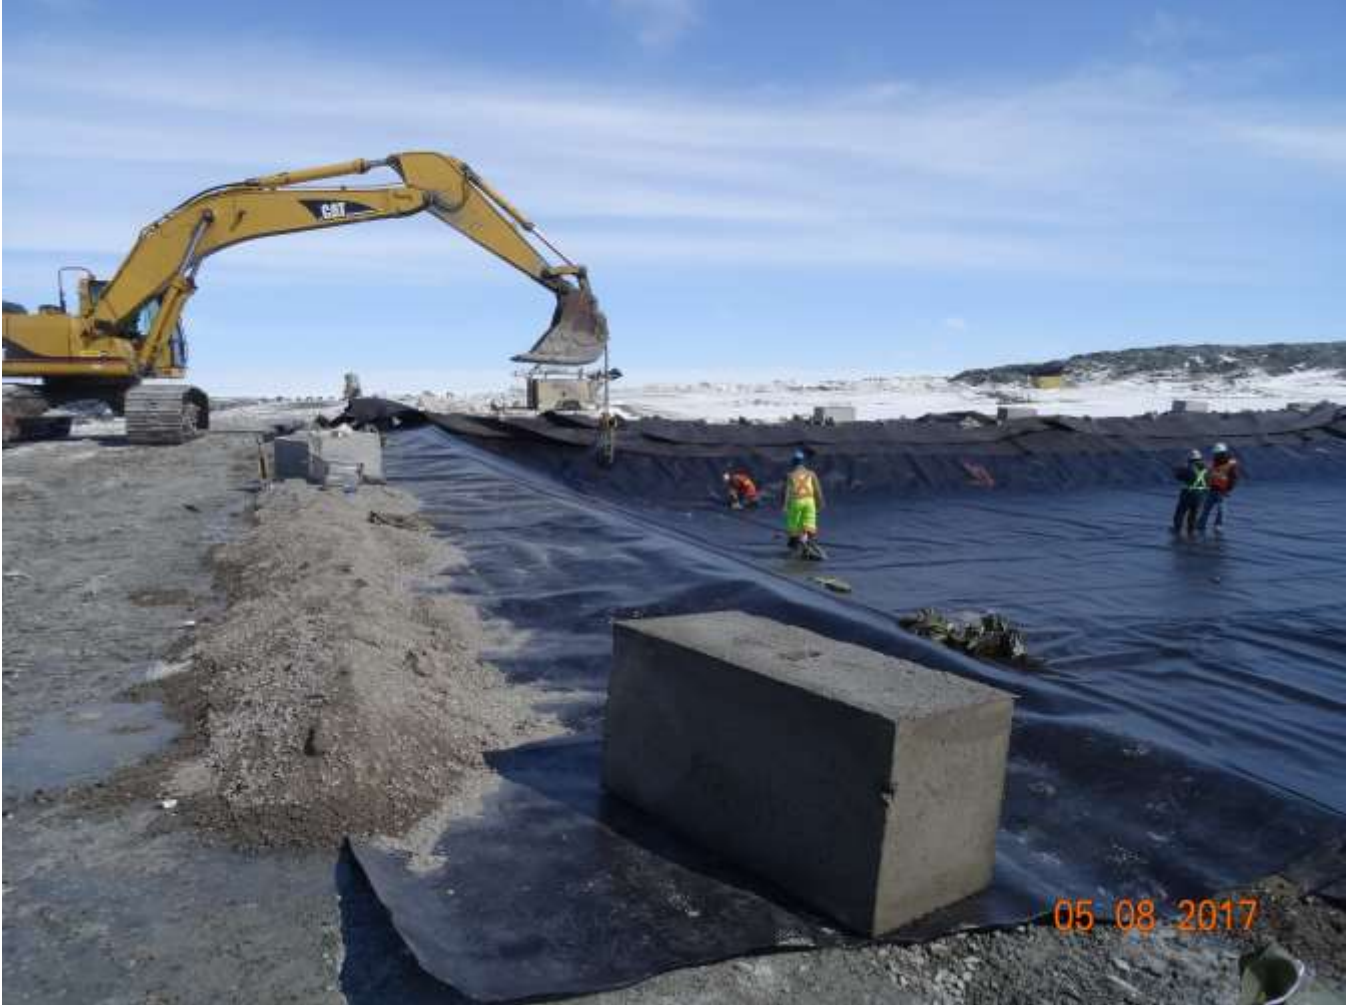
Locations name:  
Photo 11

- AEM confirmed that no contamination has been found on the south side of the road (see attached 1, page 3, General Environment, plan view map).
- The current focus of the reclamation is on the construction of the snow management cell (photo 11, 12, and 13).

Description  
Looking East: Snow cell 1

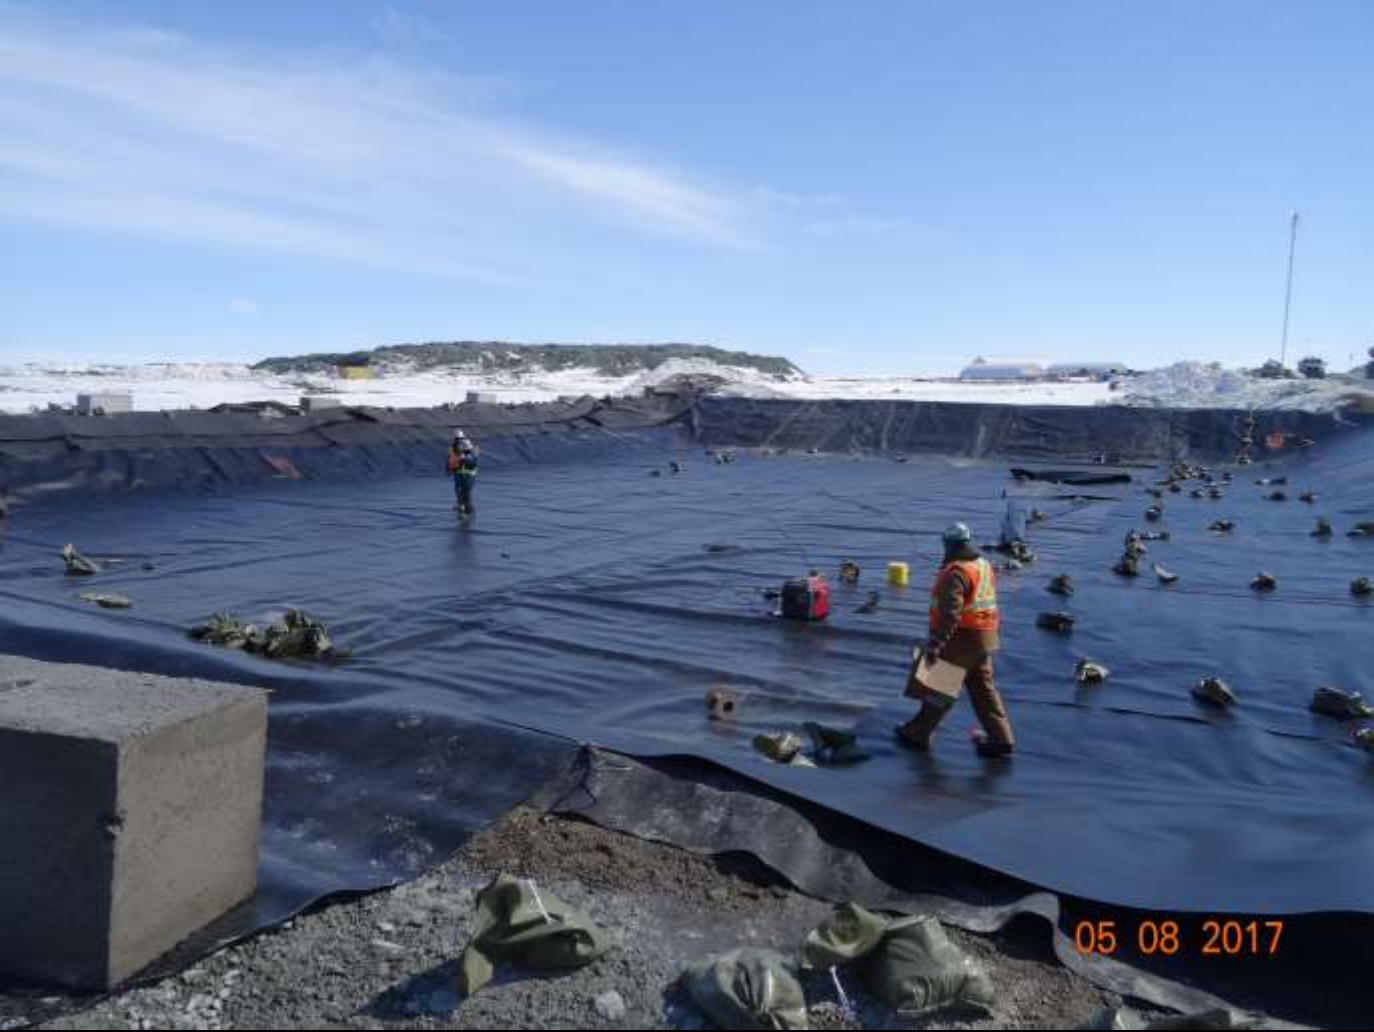
Locations name:  
Photo 12

Description  
Looking South East: Snow cell 2

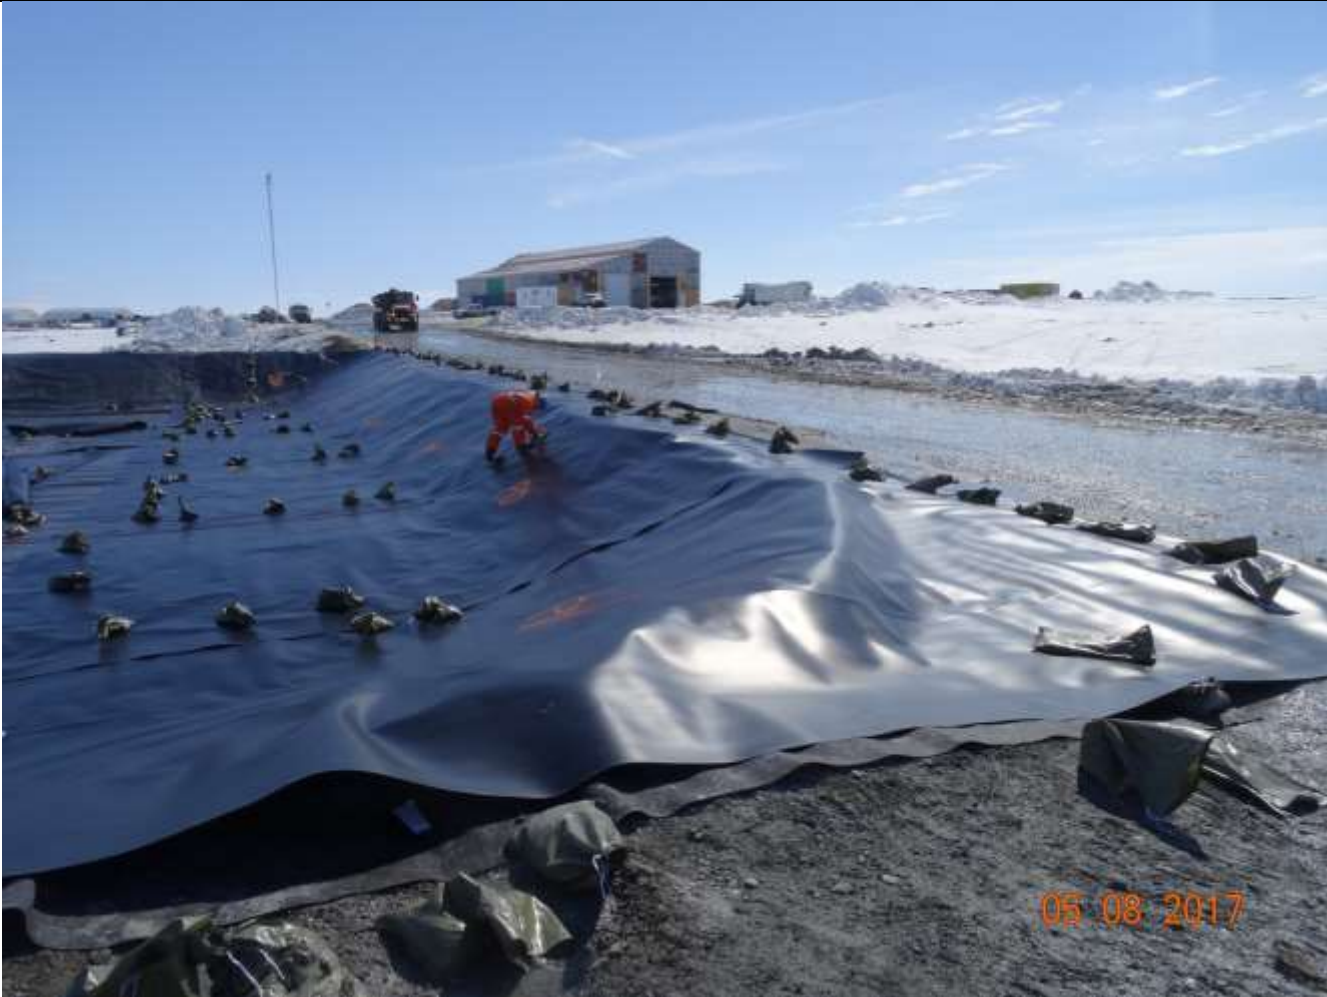
Photo 13

Looking South: Snow Cell 3

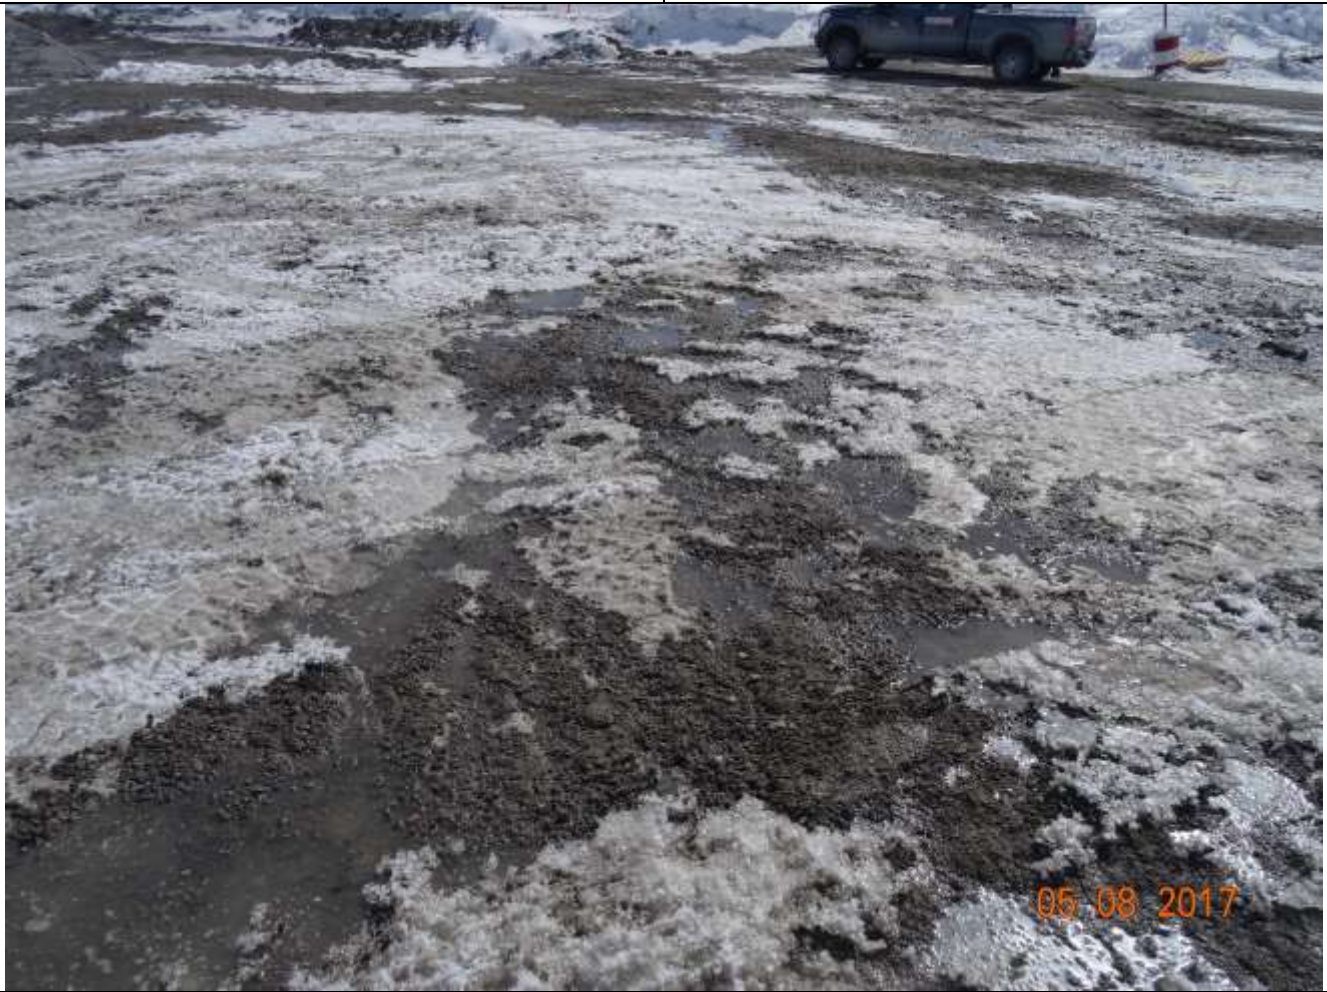
Photo 14

- With the increased temperatures, water puddles are beginning to form and water is starting to flow from the site.
- Water has started to pool at a location near the entrance to tank farm/land farm area. The contaminated water from the land farm, tank farm and spill area appears to be flowing in this general direction. The inspector was concerned that if the water is not diverted that there could be off site impacts (photo 14)

Melting water( spill excavation site in the background). Slope from left to right in frame.

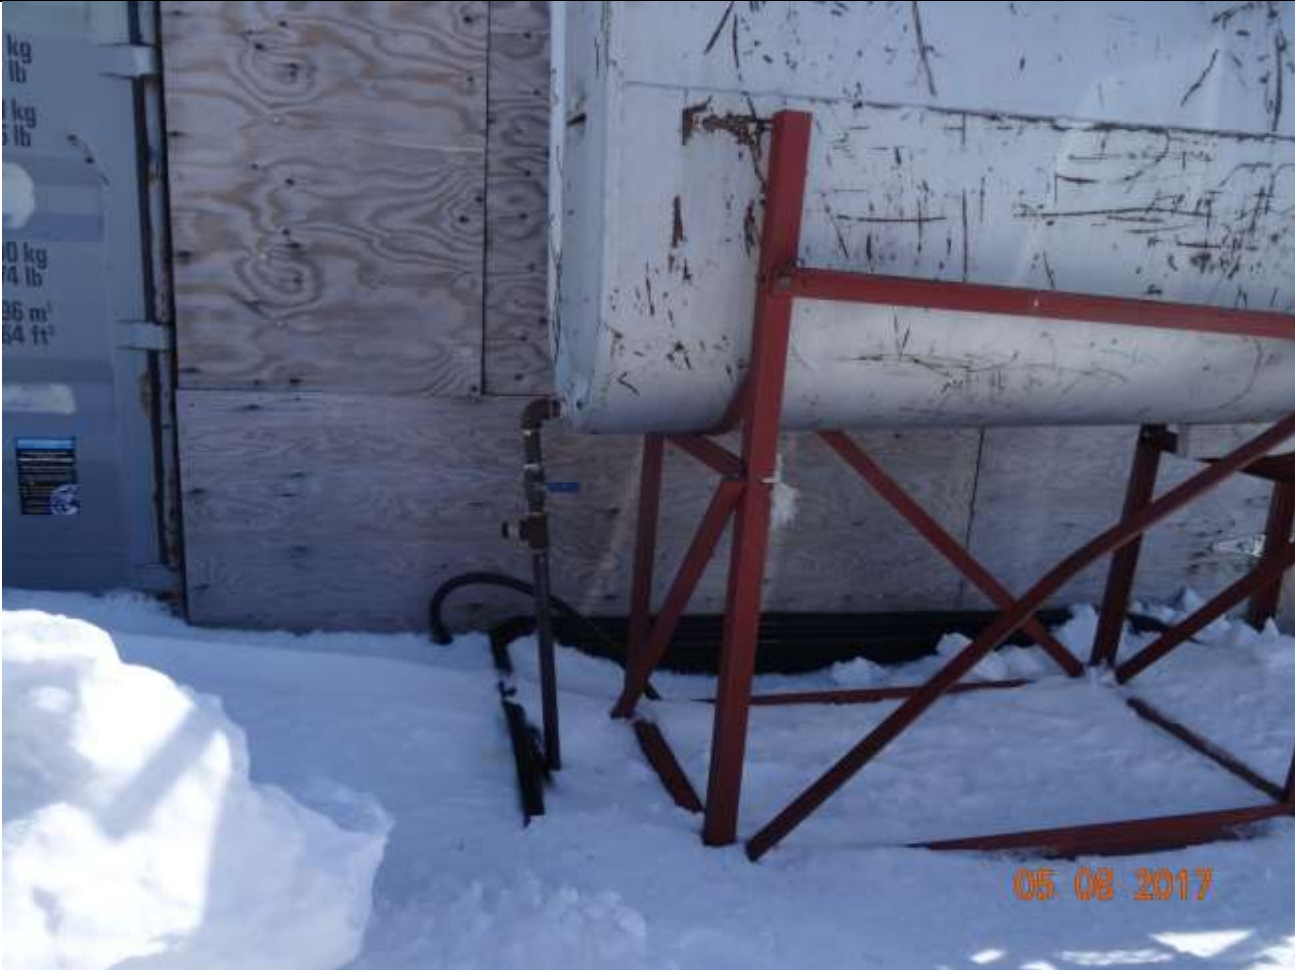
Photo 15

20. The tankfarm is used by both the exploration camp and the mine. AEM informed the inspector that the intended plan is to start construction of the portal fuel farm this month and decommission the exploration tank farm to begin proper reclamation of the site.
21. AEM has informed the inspector that a final report is being produced by the third party consultant that will be submitted to the inspector for review before June 2<sup>nd</sup>, 2017.
22. A number of fuel storage structures around the camp were inspected. A summary of the general concerns noted; the lack of spill kit or accessibility to spill kits, spillage around tanks (inside and outside tanks), snow accumulation around the tanks making it difficult to thoroughly inspect or draw fuel from them (in the inspector opinion) responsibly (photo 15, 16, 17 18, and 19).

Full tank of fuel outside the scope of regular environmental inspections.

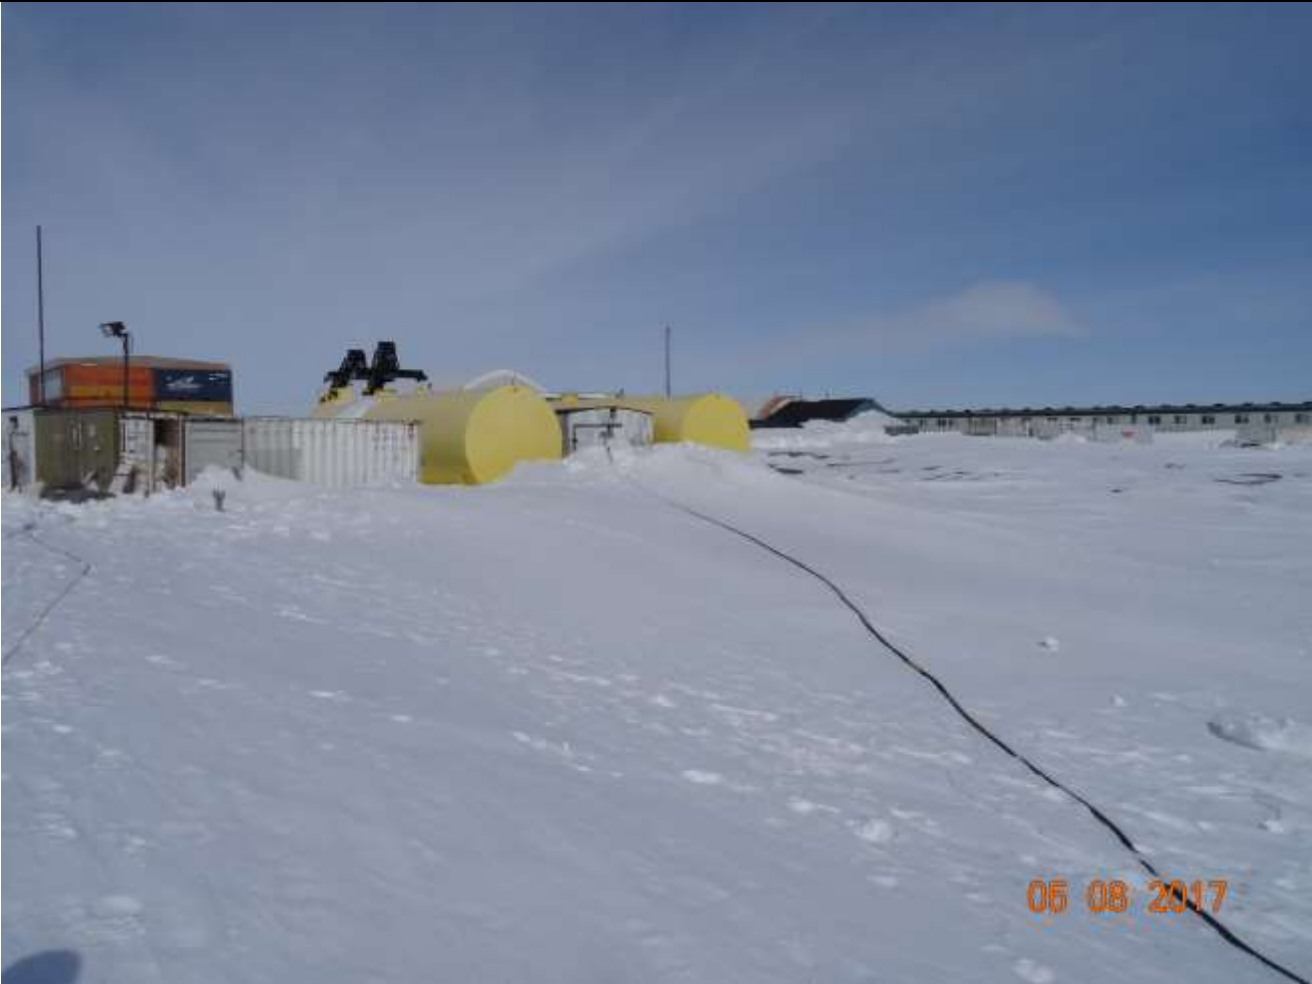
Photo 16

50ft plus Jet A fuel line outside the scope of AEM environment inspections

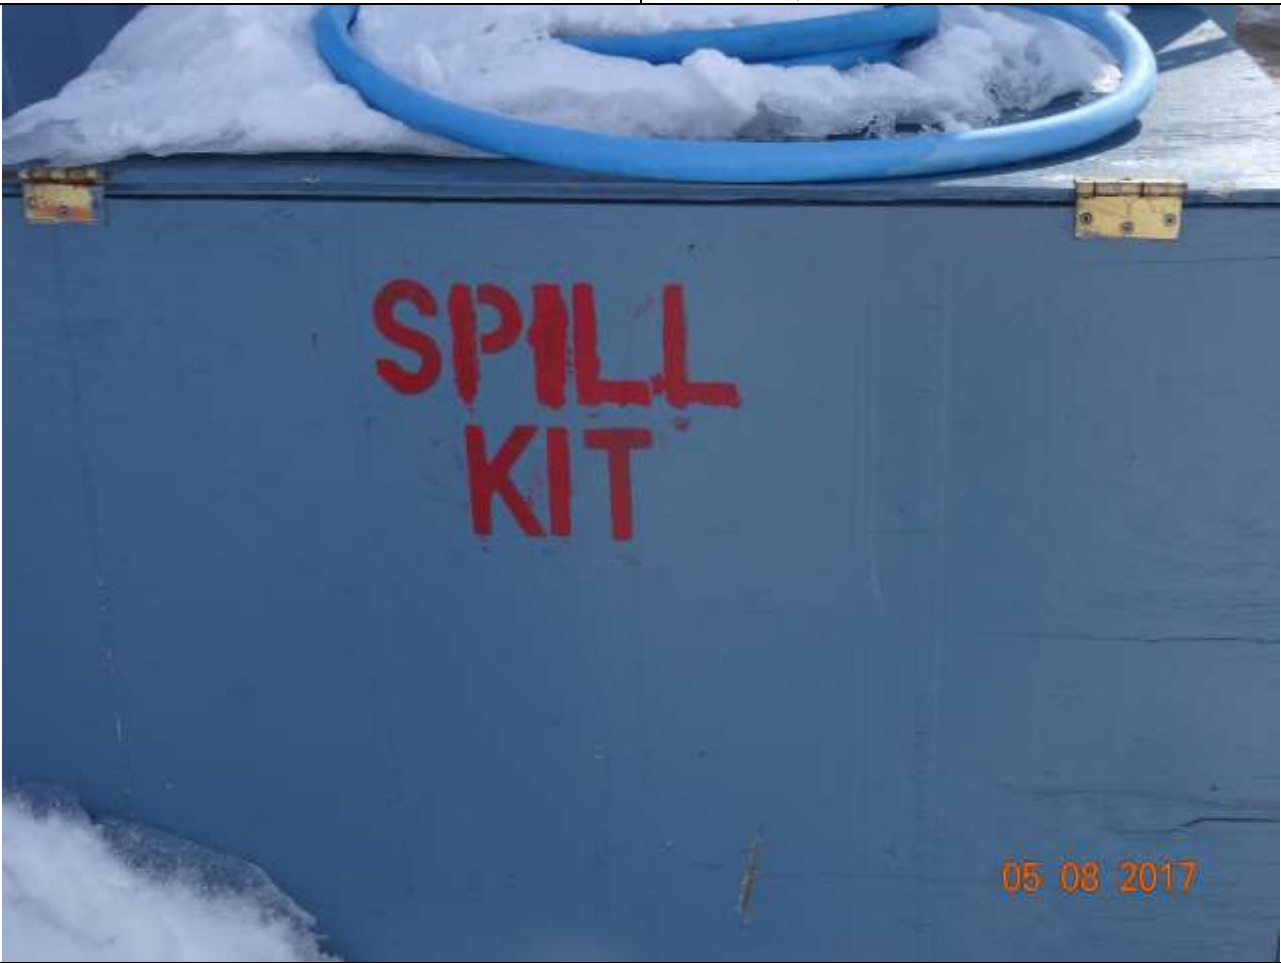
Photo 17

Spill kit, broken open and filled with snow; not accessible.

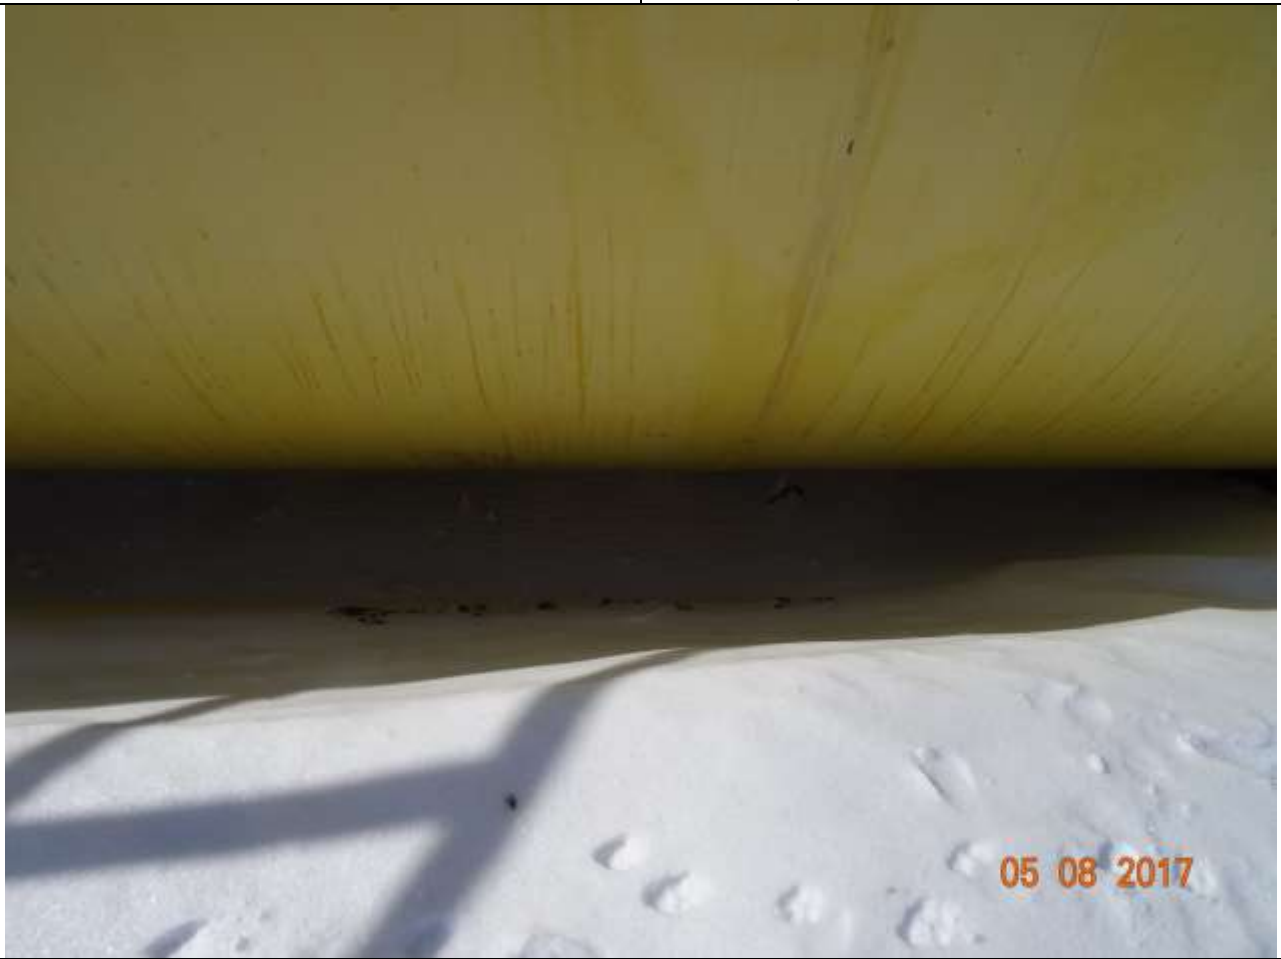
Photo 18

Diesell fuel spilled from tank vent
