WATER LICENCE INSPECTION FORM

☐ Original  
☒ Follow-Up Report

On May 8<sup>th</sup>, 2017 Indigenous and Northern Affairs Canada’s Water Resource Officer, Christine Wilson conducted a follow up to the April 10<sup>th</sup> inspection of Agnico Eagle Mines Limited’s (‘AEM’) Meliadine Advanced Exploration project, water licence 2BB-MEL1424. The inspection was completed with the assistance of AEM’s, Environmental Technician, Philip Roy.

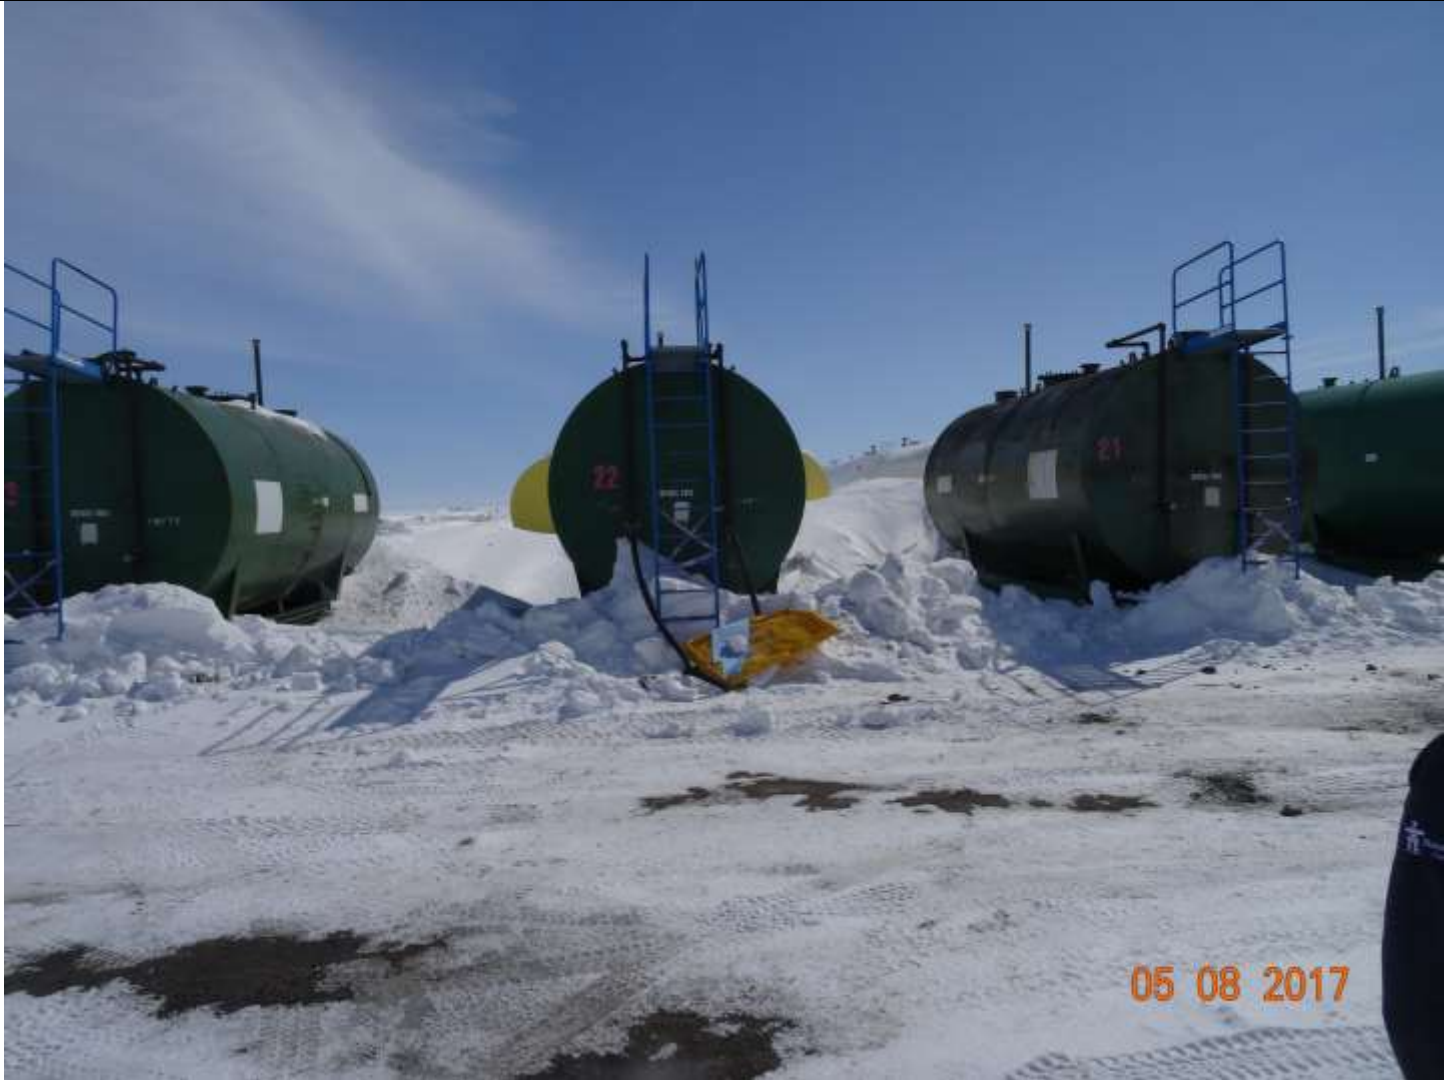
Locations name:	Lat/Long (DD.MM.SS.SS, NAD83)
Photo 19	N63° 1' 25.94", W 92° 11' 7.26"

20. The tankfarm is used by both the exploration camp and the mine. AEM informed the inspector that the intended plan is to start construction of the portal fuel farm this month and decommission the exploration tank farm to begin proper reclamation of the site.
21. AEM has informed the inspector that a final report is being produced by the third party consultant that will be submitted to the inspector for review before June 2<sup>nd</sup>, 2017.
22. A number of fuel storage structures around the camp were inspected. A summary of the general concerns noted; the lack of spill kit or accessibility to spill kits, spillage around tanks (inside and outside tanks), snow accumulation around the tanks making it difficult to thoroughly inspect or draw fuel from them (in the inspector opinion) responsibly (photo 15, 16, 17 18, and 19).

Description
Diesel fuel tank 22 with fuel in drip tray; tray compromised. Snow around valves making it unnecessarily difficult to draw fuel.
