WATER LICENCE INSPECTION FORM

| 2BB-MEL1424 | David Frenette |
| May 10 <sup>th</sup> 2018 | WRO C. Wilson |

On May 10<sup>th</sup>, 2018 an inspection was conducted of Agnico Eagle Mines’ (‘AEM’), spring drilling campaign, authorized under water licence no. 2BB-MEL1424. The inspection was completed by Indigenous and Northern Affairs Canada’s Water Resource Officer, Christine Wilson and Atuat Shouldice.

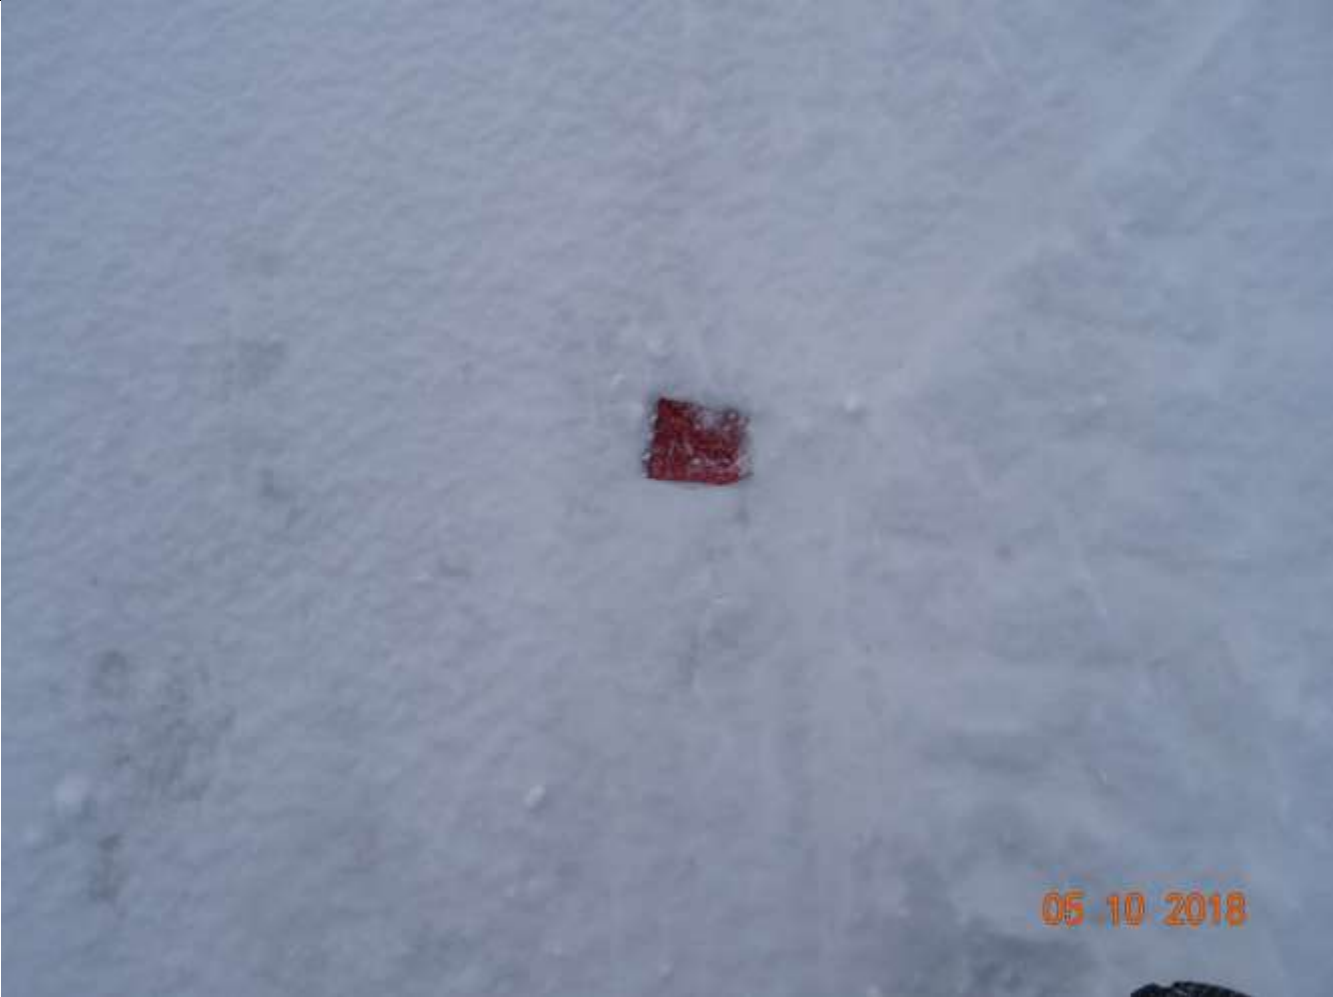
| Date: | Authorization Number: | Camera/Model: | Inspector |
|---|---|---|---|
| Photo 1 | | N63° 00' 59.4", W92° 18' 06.4" | |

- The inspector noted small amounts of garbage (e.g.: wire, hoses and spill pads) at every drill site which fails to comply with PART I Item 10.

Description:  
Garbage on lake

- AEM’s Environment Department will revisit the drill sites prior to summer to recover garbage as required by PART I item 10.
- AEM will provide a copy of the water sample laboratory analysis report taken at M18-2445 to the inspector before May 31<sup>st</sup>, 2018.

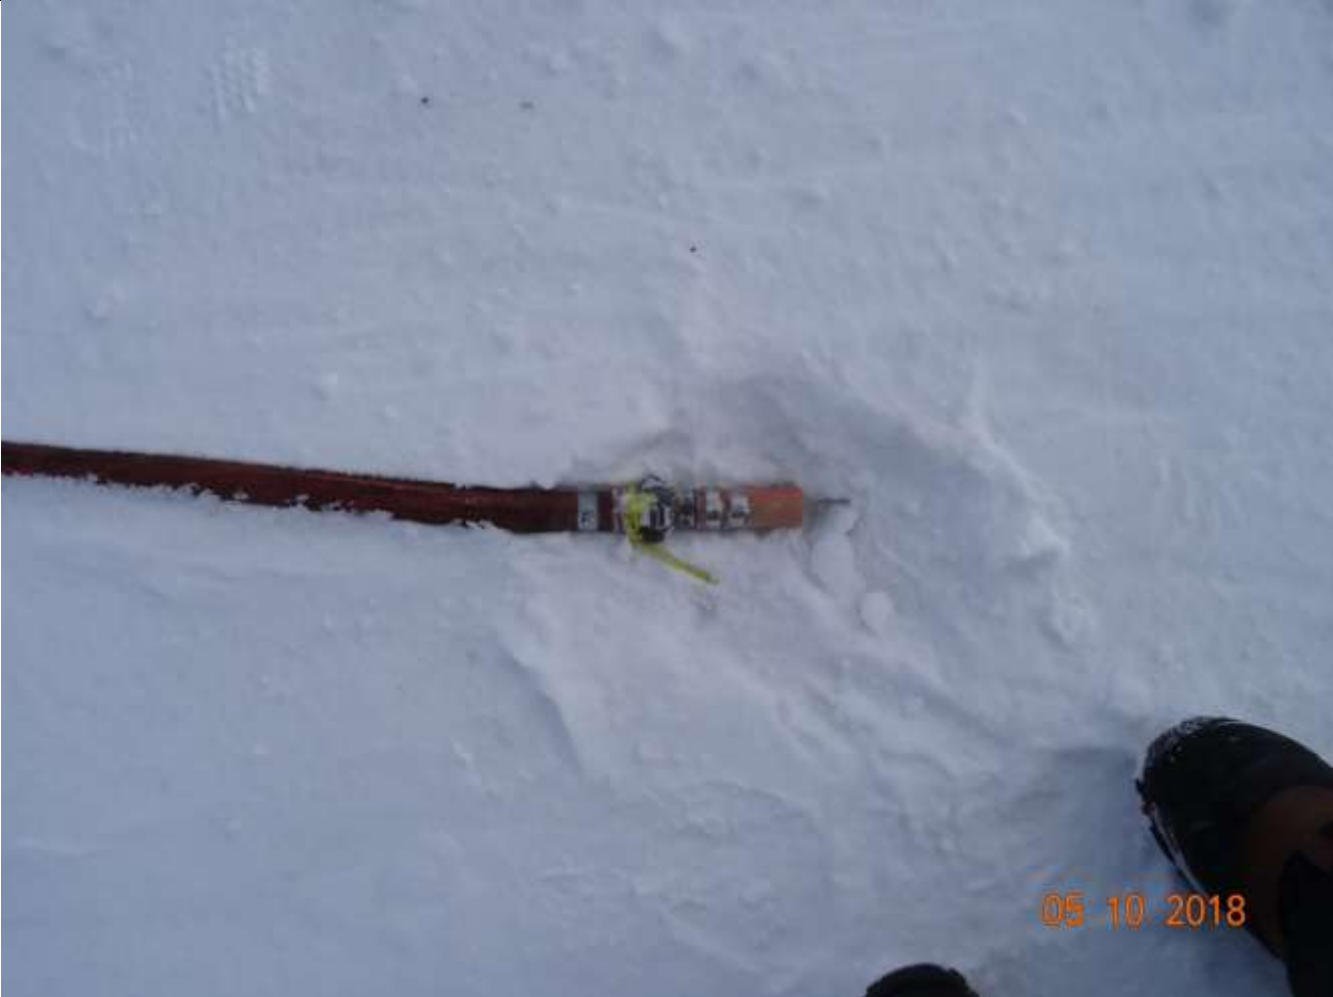
| Locations name: | Lat/Long (DD.MM.SS.SS, NAD83) |
|---|---|
| Photo 2 | N63° 00' 59.4", W92° 18' 06.4" |

Description  
Water supply hose frozen into the ice. A rope has been tied to in so that it can be removed in the summer.

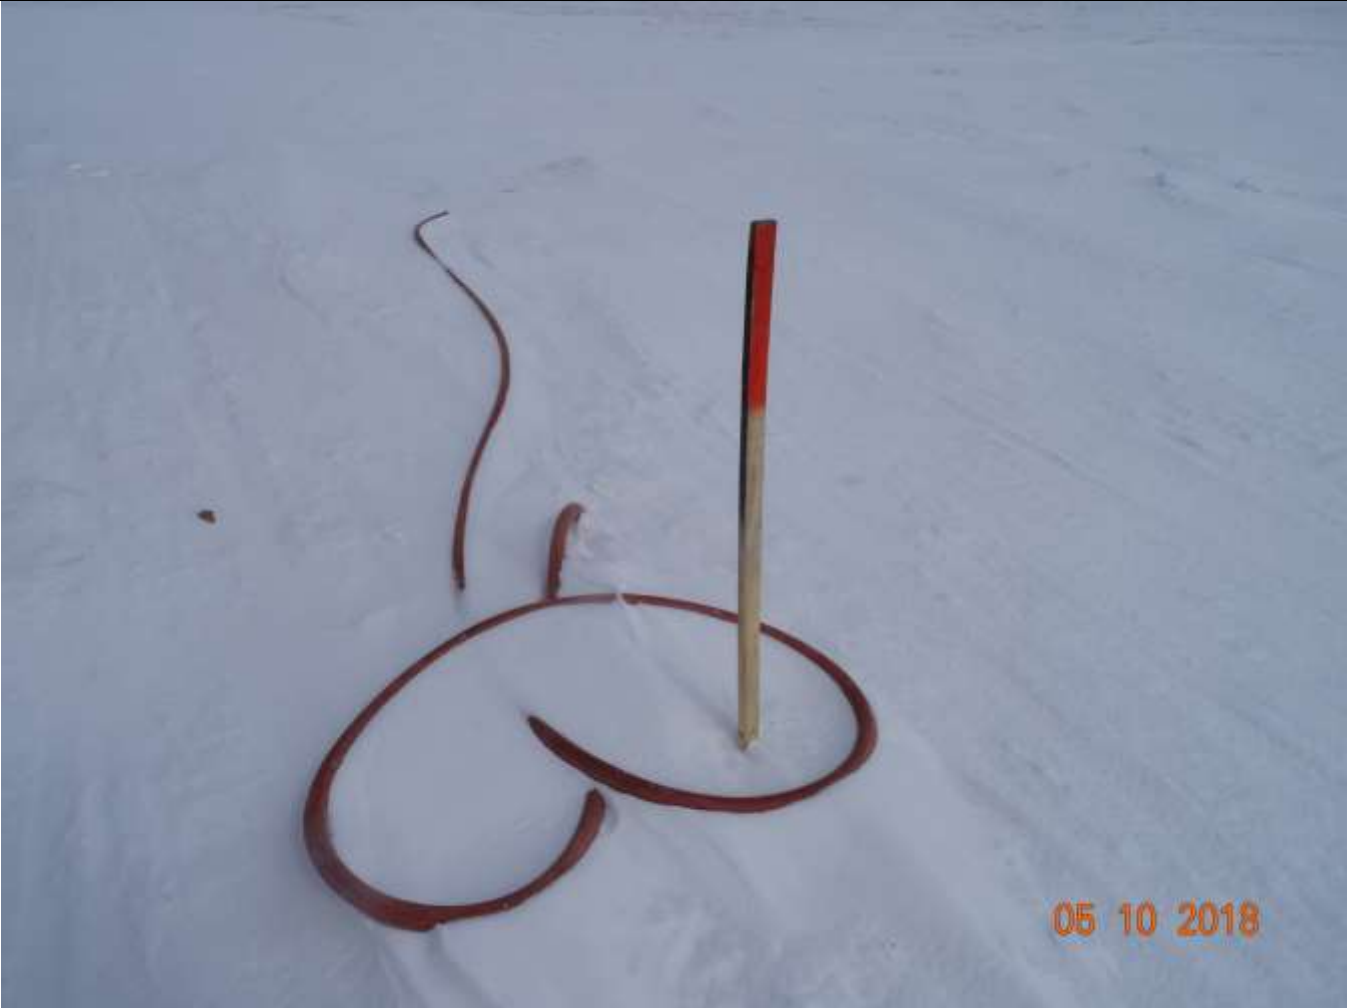
| Locations name: | | Lat/Long (DD.MM.SS.SS, NAD83) |
|---|--|---|
| Photo 3 | | N 63° 1' 3.27", W 92° 18' 9.57" |

| Locations name: | | Lat/Long (DD.MM.SS.SS, NAD83) |
|---|--|---|
| <b>Description</b><br>Water supply hose frozen in the ice, see comments above on photo 2. | | |

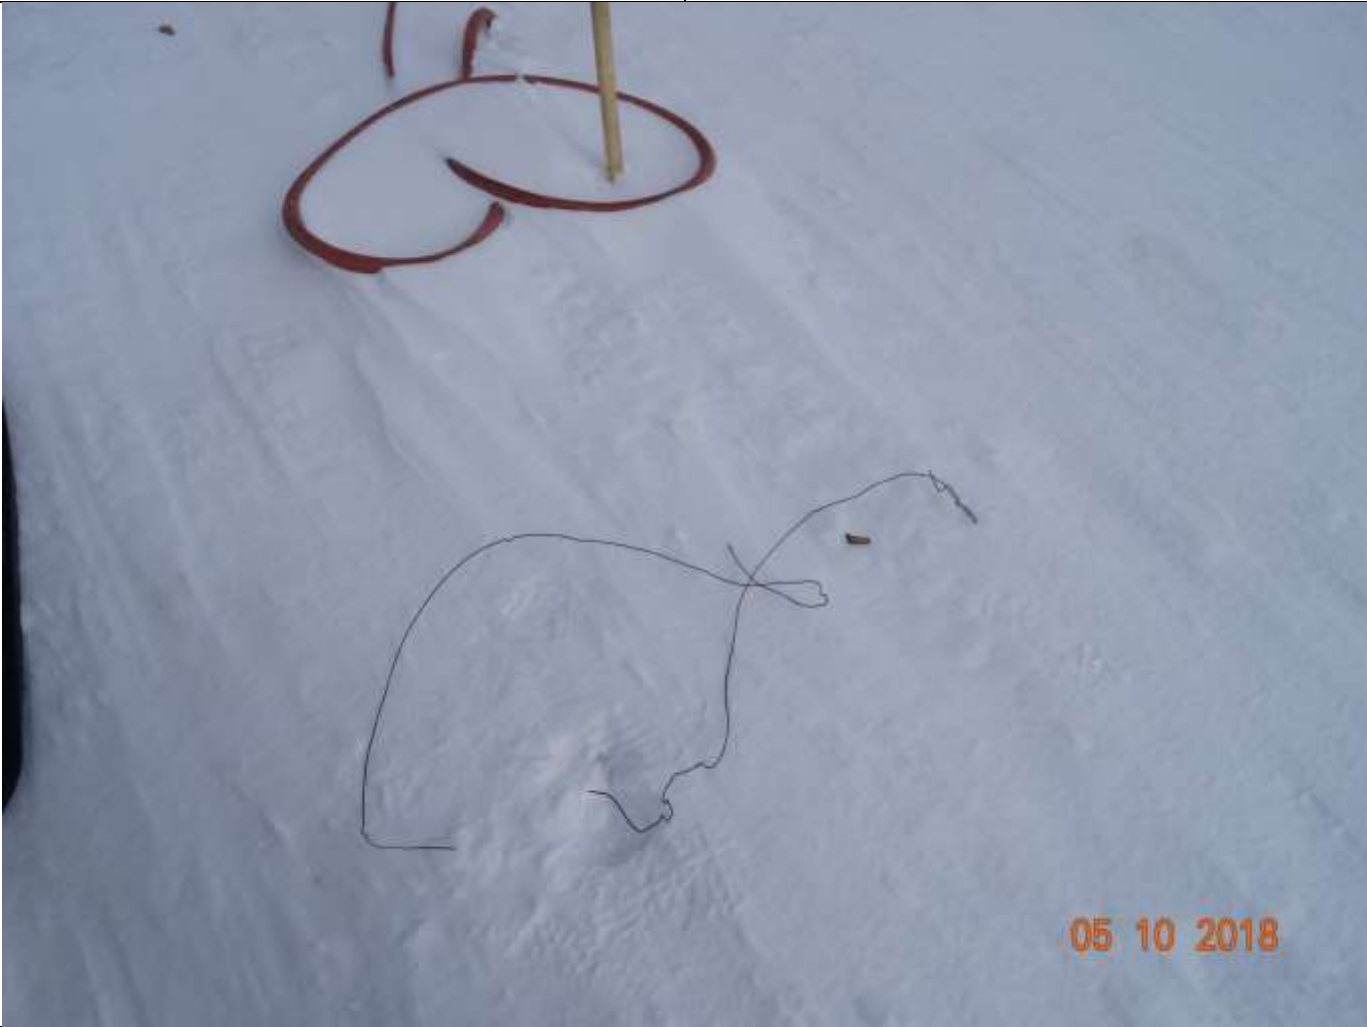
| Locations name: | | Lat/Long (DD.MM.SS.SS, NAD83) |
|---|--|---|
| Photo 4 | | N/A |

| Locations name: | | Lat/Long (DD.MM.SS.SS, NAD83) |
|---|--|---|
| <b>Description</b><br>Wire collected along the overland haul trail | | |

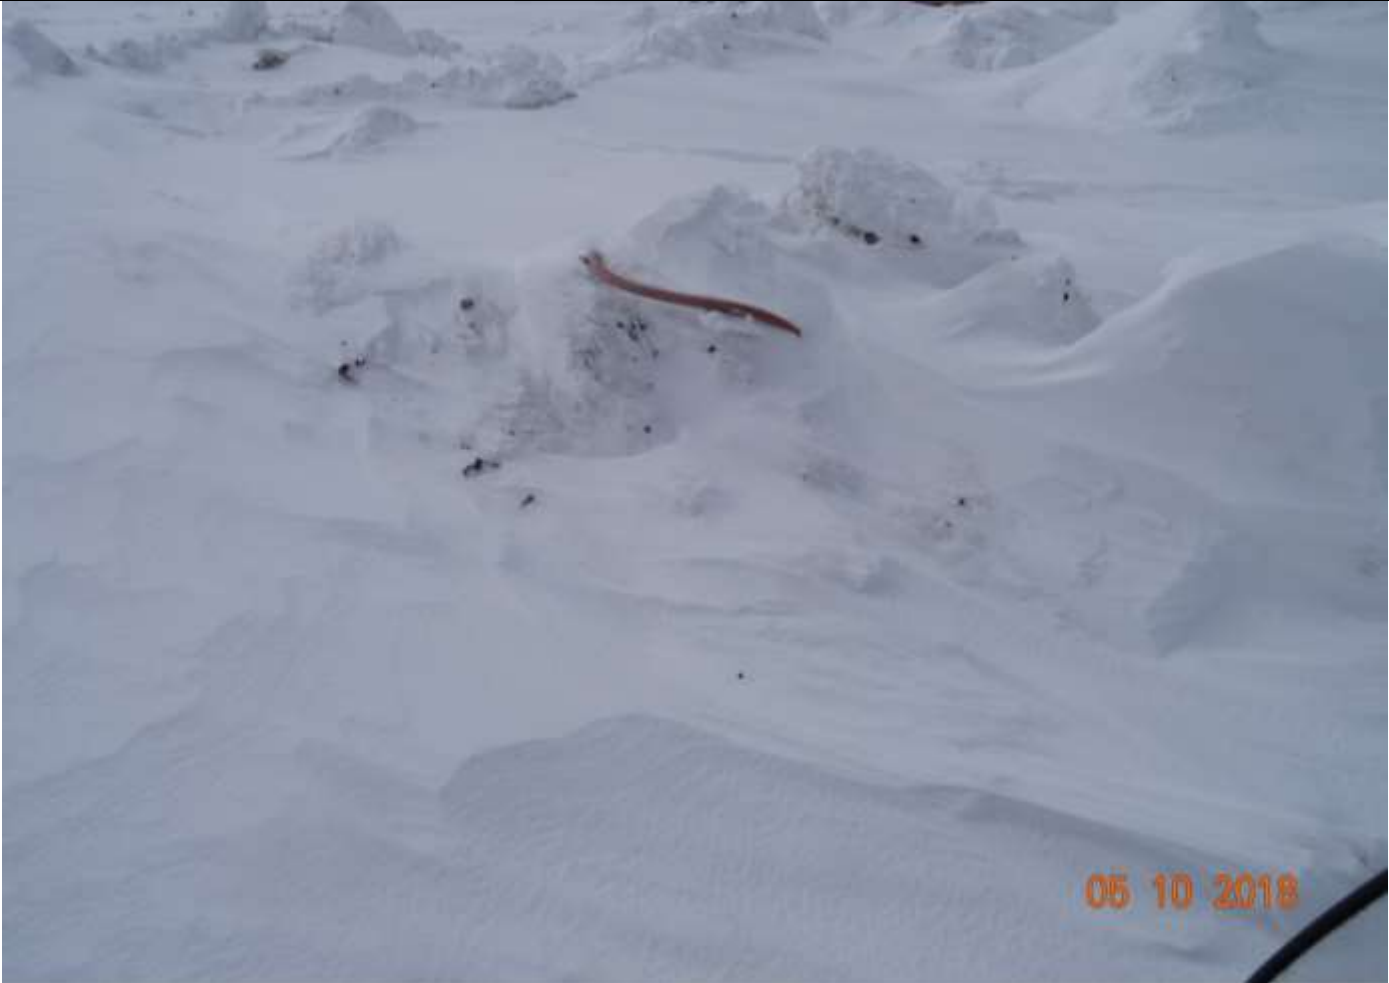
Photo 5

Garbage on overland haul route.

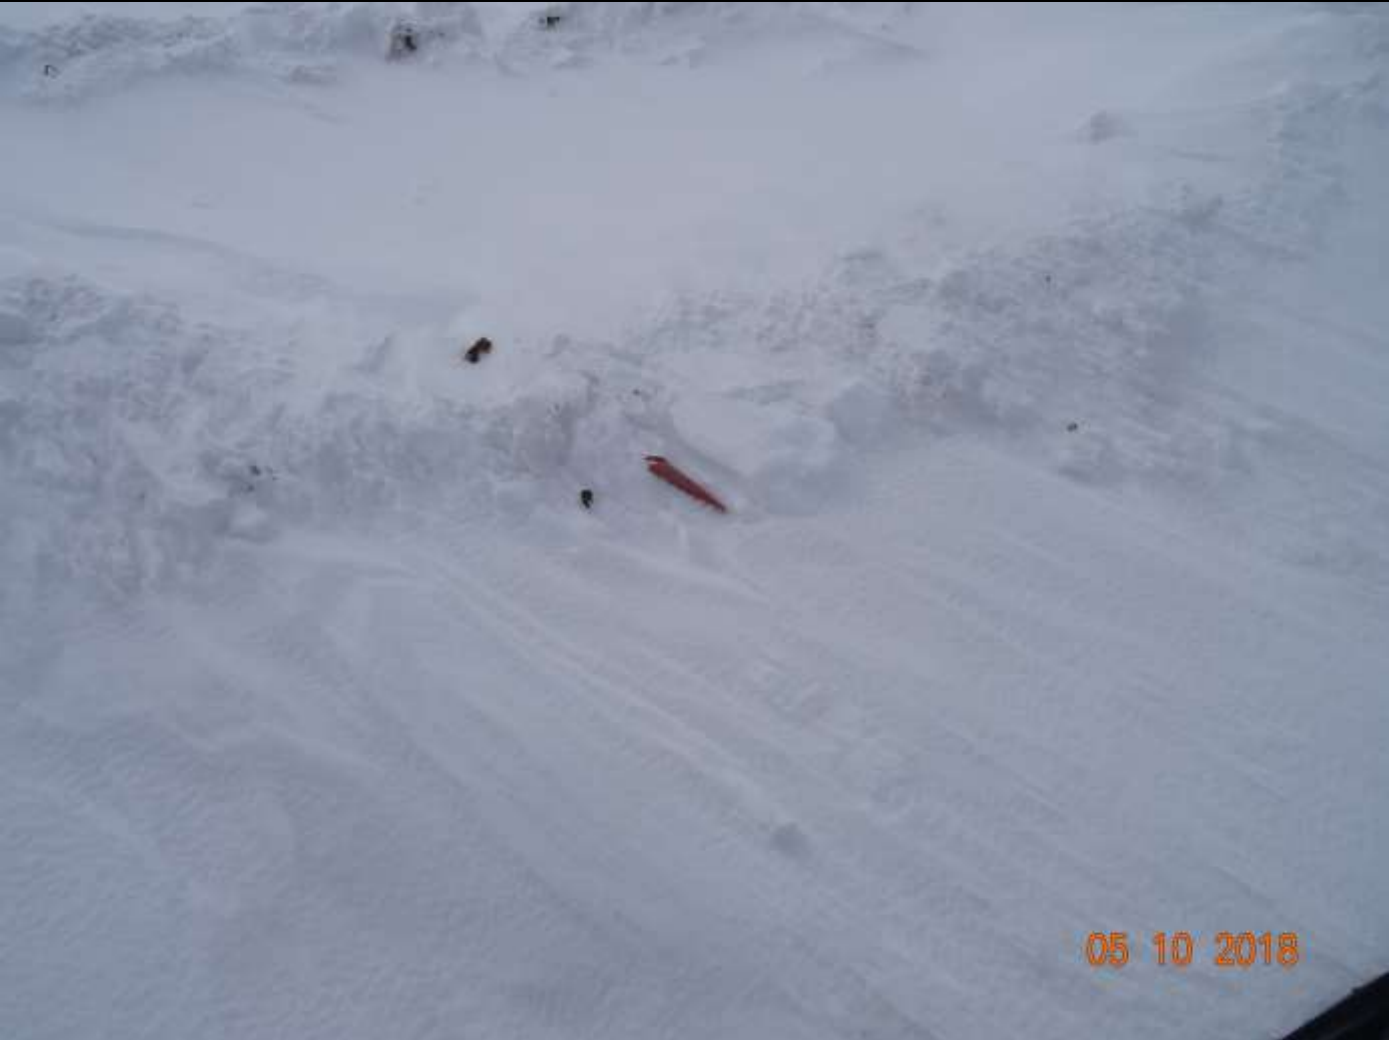
Photo 6

Garbage on overland haul route.

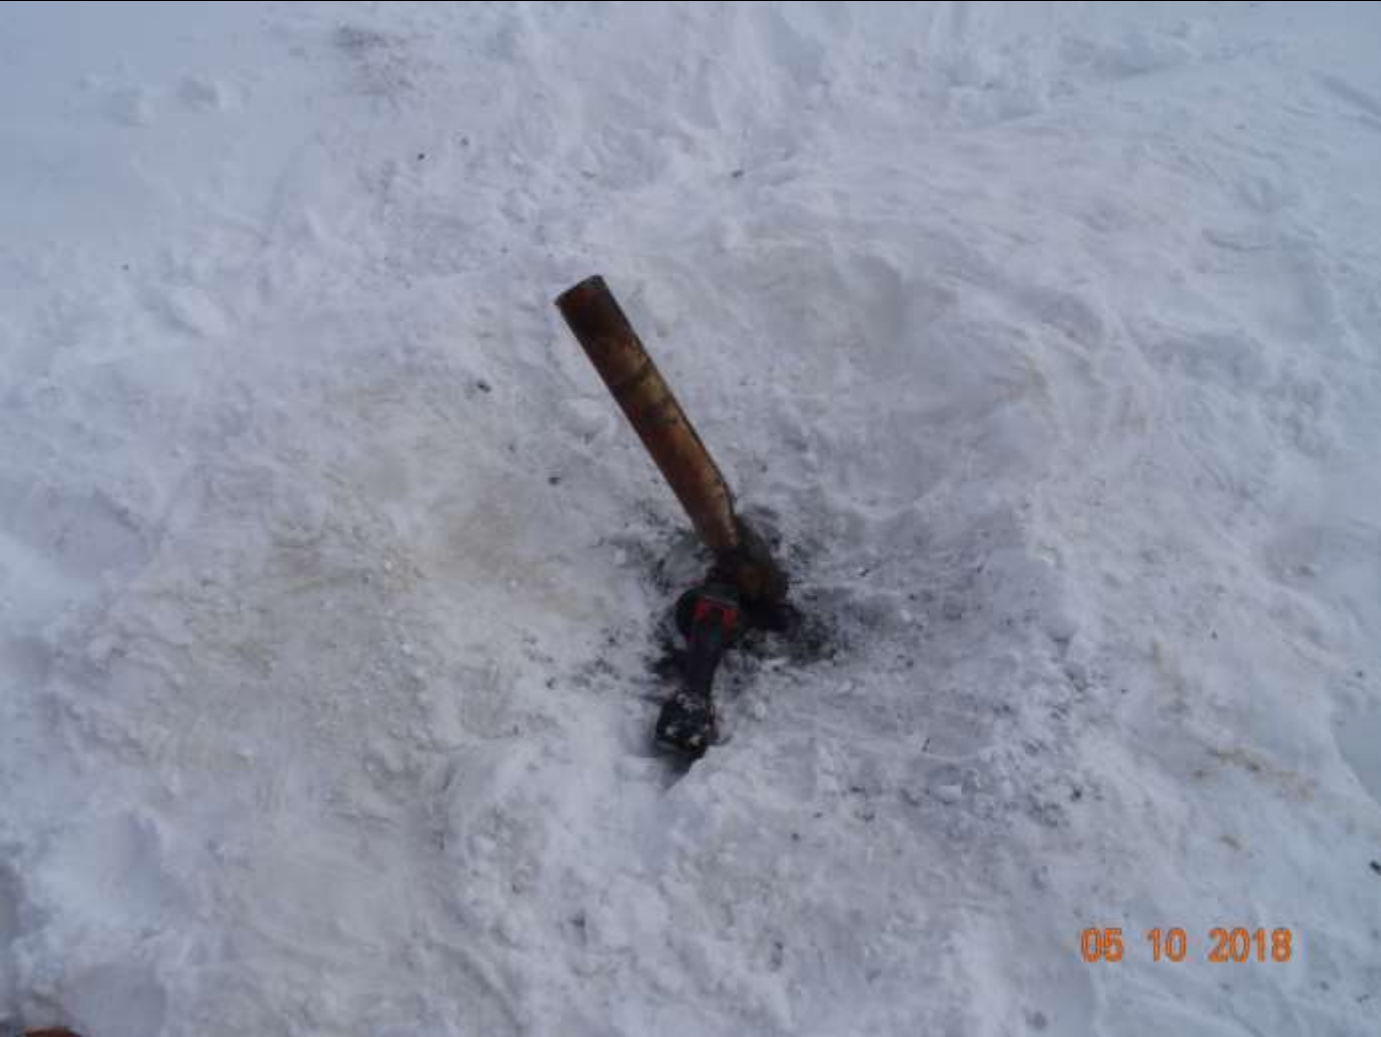
| Locations name: | | Lat/Long (DD.MM.SS.SS, NAD83) |
|---|--|---|
| Photo 7 | | N63° 1' 19.27", W 92° 18' 44.08" |

- At M18-2448, an AEM employee was reclaiming the drill site by cutting the collar off at ground level. Though this method does not comply with PART I item 10 “(...) removal of any drill casing materials”, it does comply with the KIA land authorization. The inspector had no concerns, but would continue to encourage AEM to remove drill casing material whenever possible.

| Locations name: | | Lat/Long (DD.MM.SS.SS, NAD83) |
|---|--|---|
| M18-2448 Drill casing. Employee onsite cutting the casing off at ground level. A common practice when the casing is stuck in the over burden. | | |

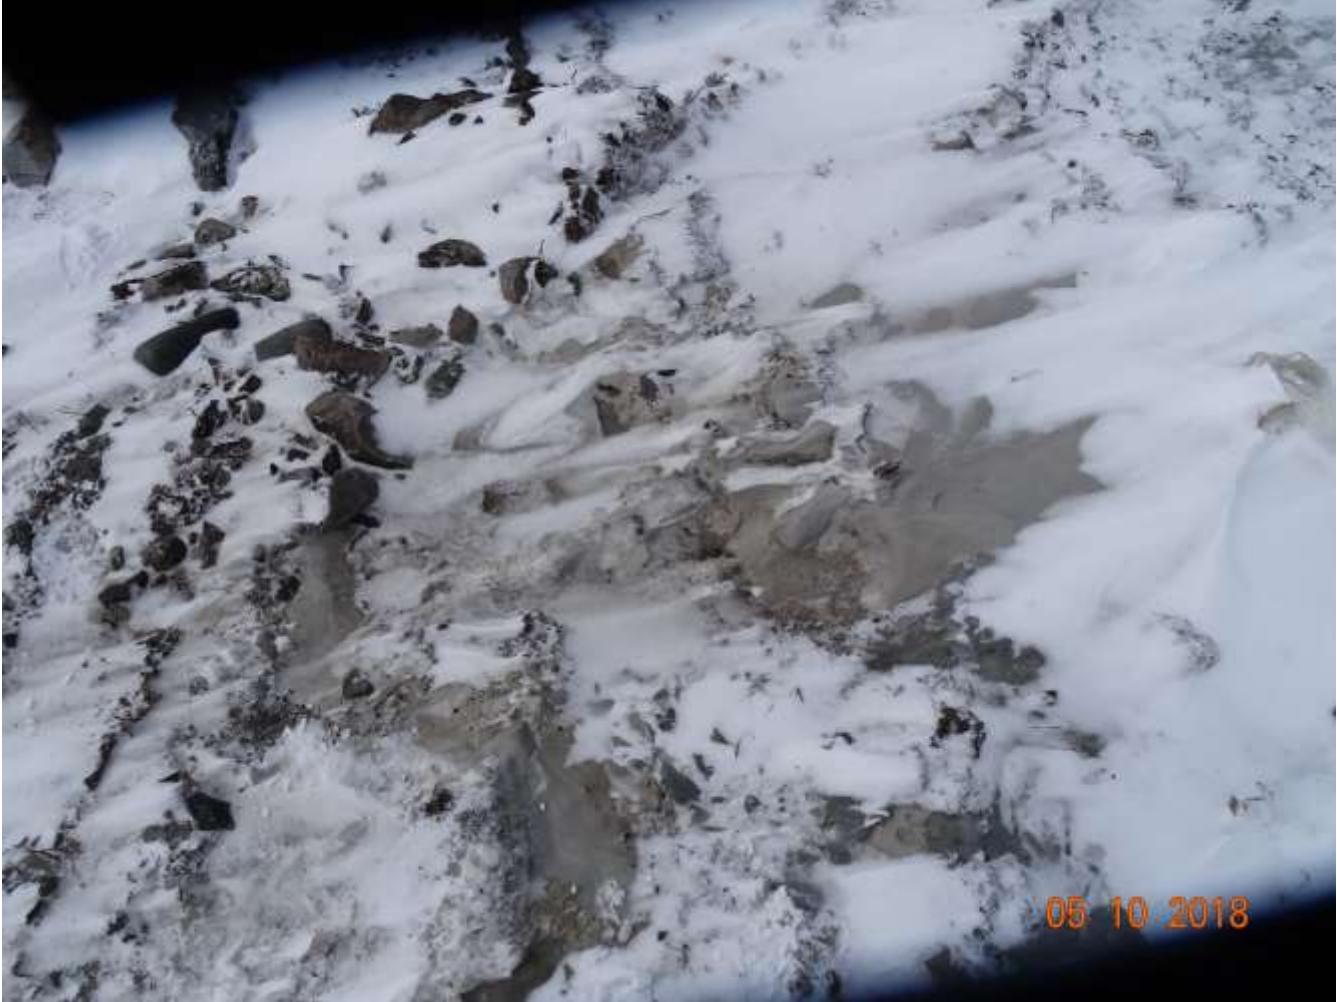
| Locations name: | | Lat/Long (DD.MM.SS.SS, NAD83) |
|---|--|---|
| Photo 8 | | N63° 1' 23.44", W 92° 11' 8.85" |

| Locations name: | | Lat/Long (DD.MM.SS.SS, NAD83) |
|---|--|---|
| Land based drill cuttings, drill site no. M18-2446. | | |

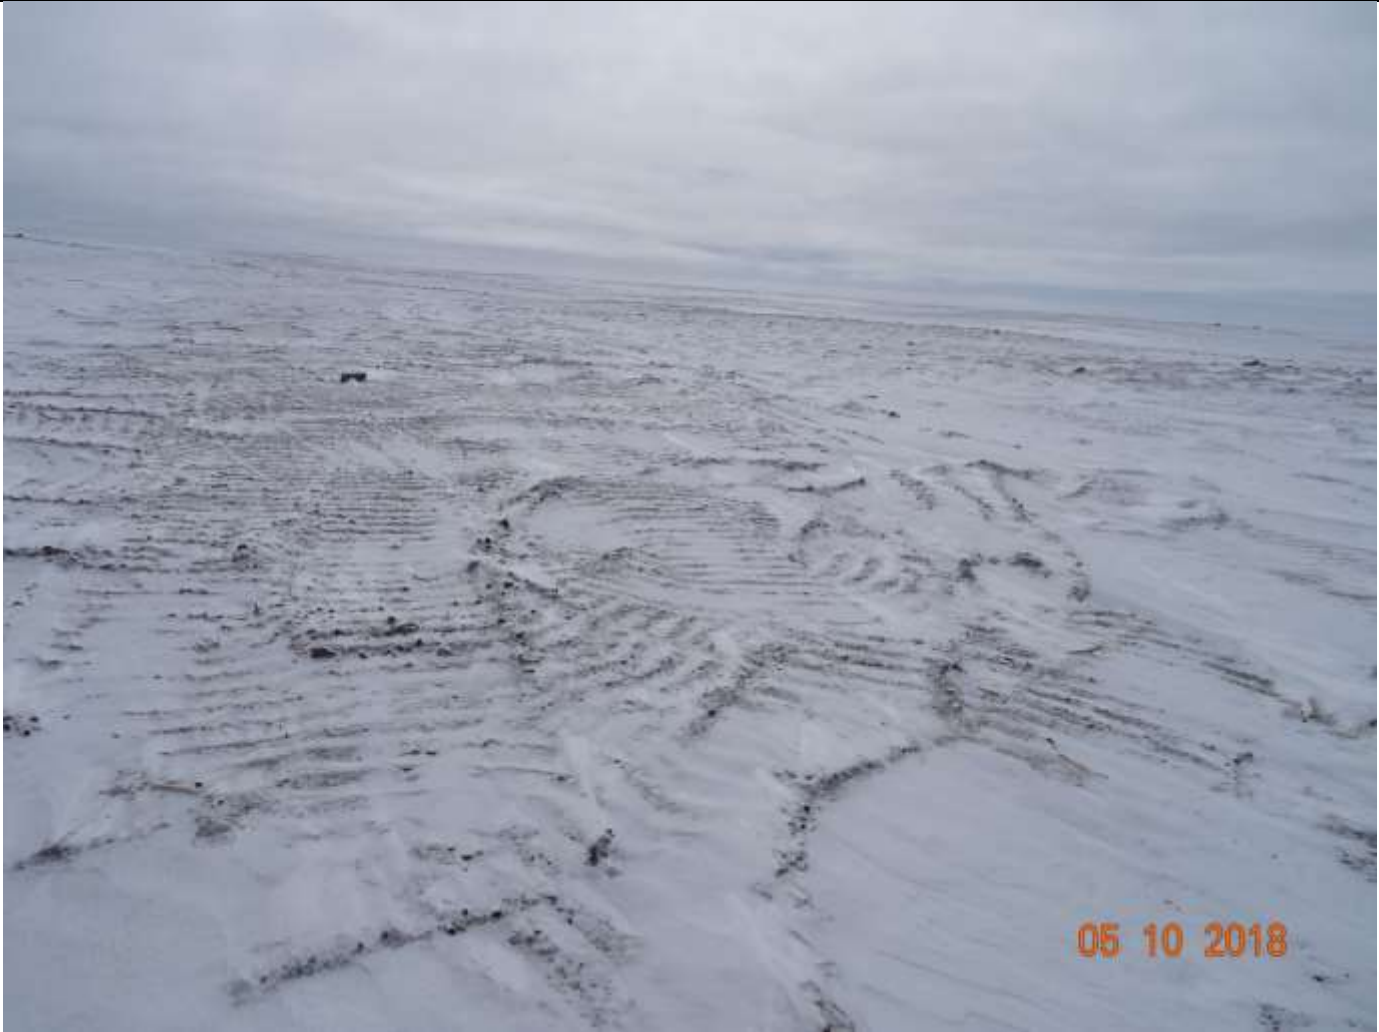
Photo 9

Tracked Equipment operating on bare ground.

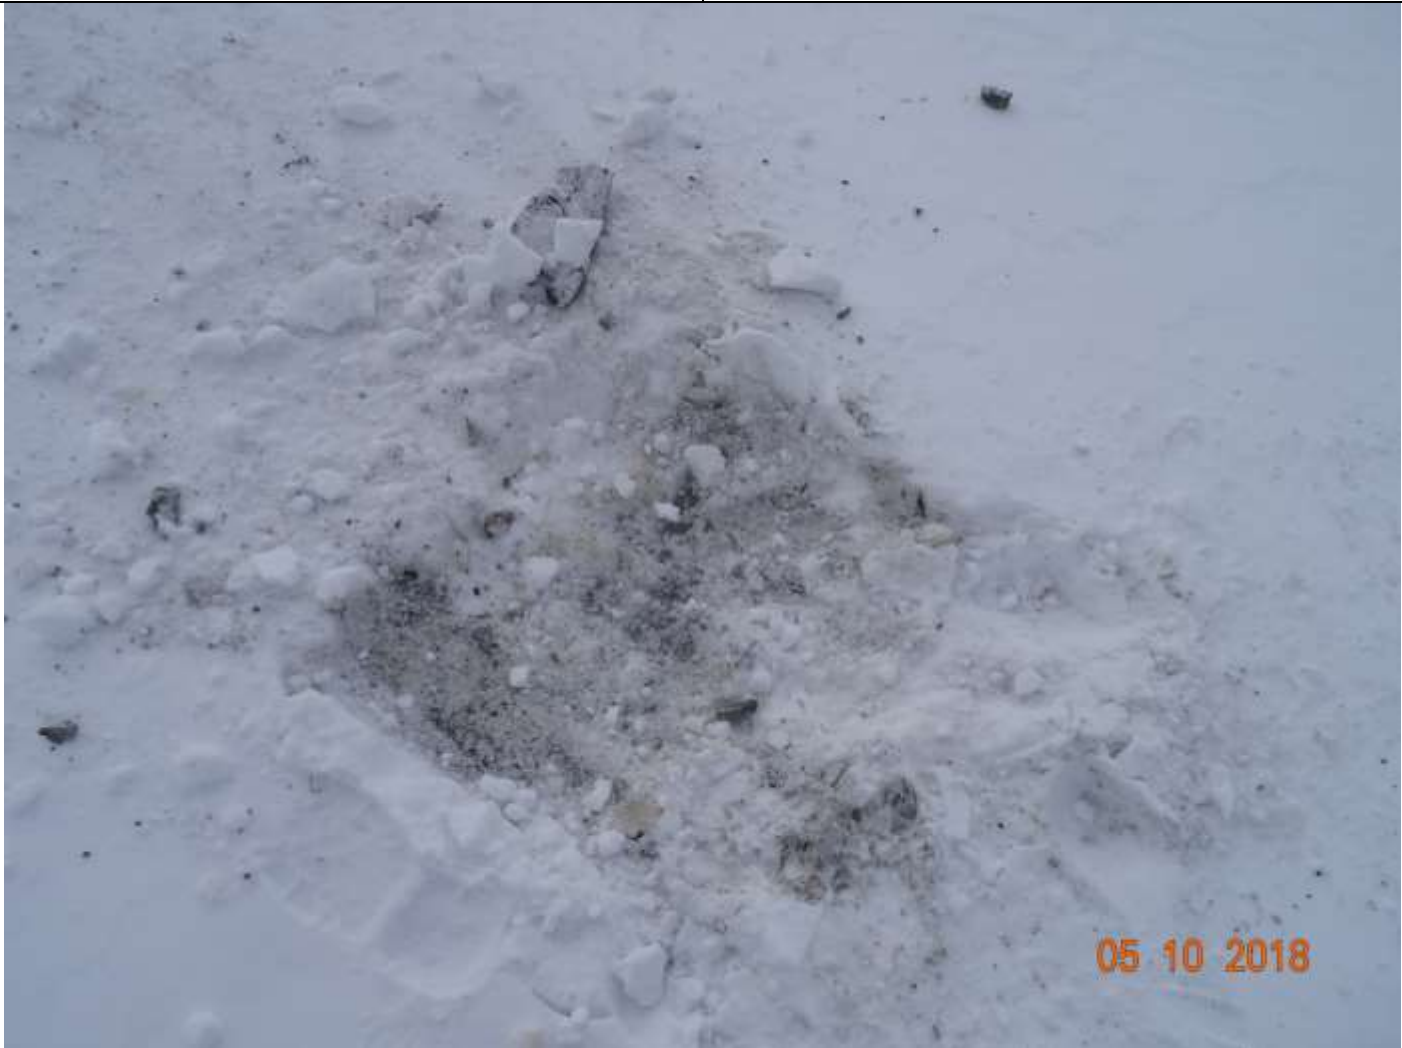
Photo 10

- At drill site M18-2445 cutting were observed on the surface of the ice, as well as in the ice itself, failing to comply with PART F item 2.
- In many location the trails, used for the overland transfer of the drills, the ground was bare though no rutting was observed which would be in compliance with PART E item 20.

Cuttings on the ice surface, Drill site M18-2445
