WATER LICENCE INSPECTION FORM

| 2BB-MEL1424 | David Frenette |
| May 10 th 2018 | WRO C. Wilson |

PHOTO LOG

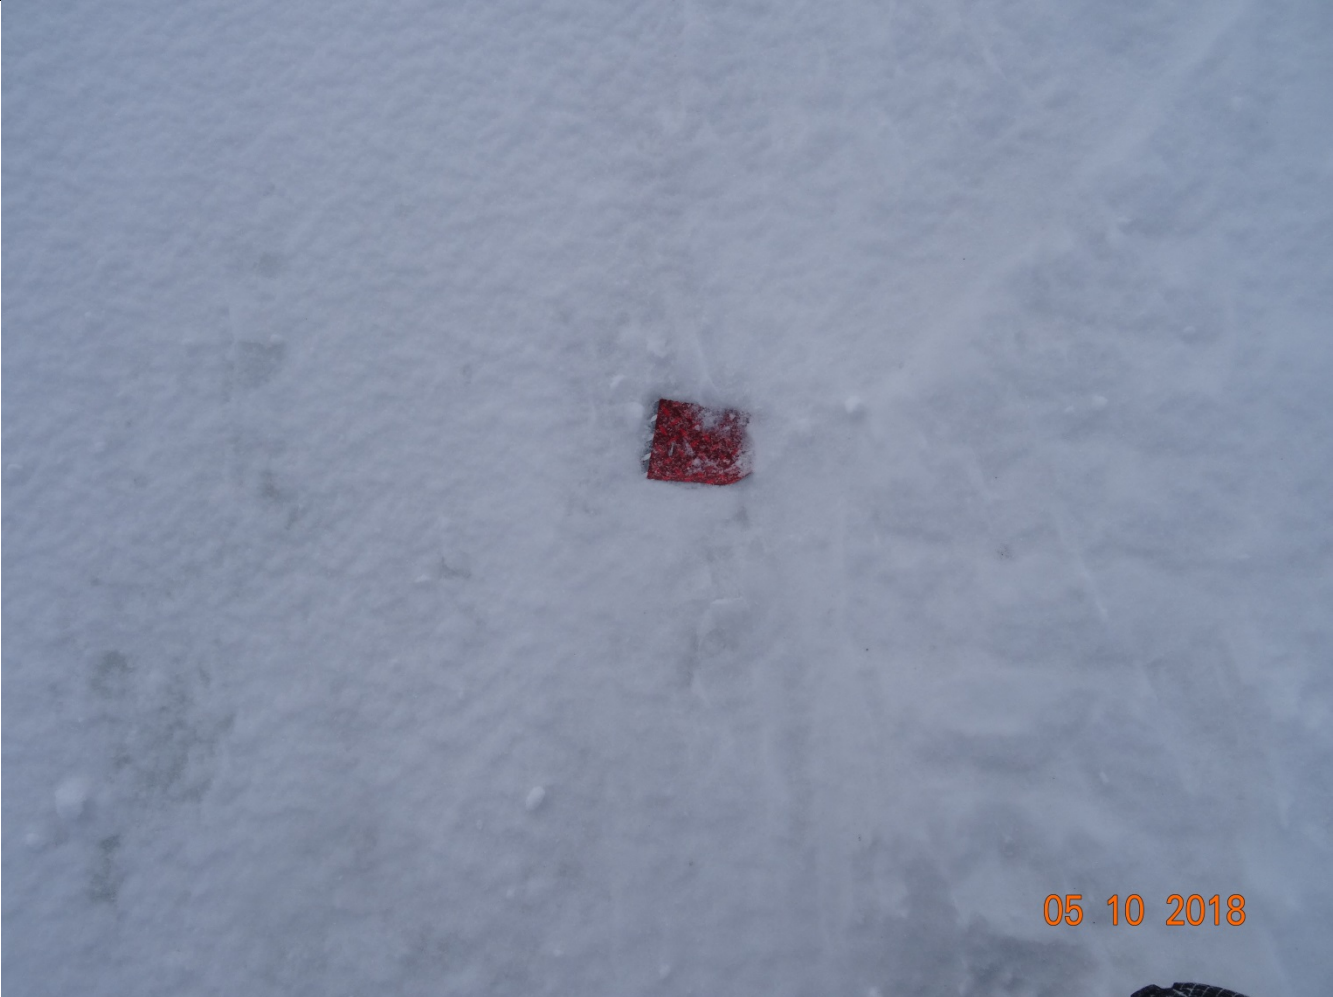
| Date: | Authorization Number: | Camera/Model: | Inspector |
|---|---|---|---|
| Photo 1 | | N63° 00' 59.4", W92° 18' 06.4" | |

- The inspector noted small amounts of garbage (e.g.: wire, hoses and spill pads) at every drill site which fails to comply with PART I Item 10.

Description:
Garbage on lake

-AEM’s Environment Department will revisit the drill sites prior to summer to recover garbage as required by PART I item 10.

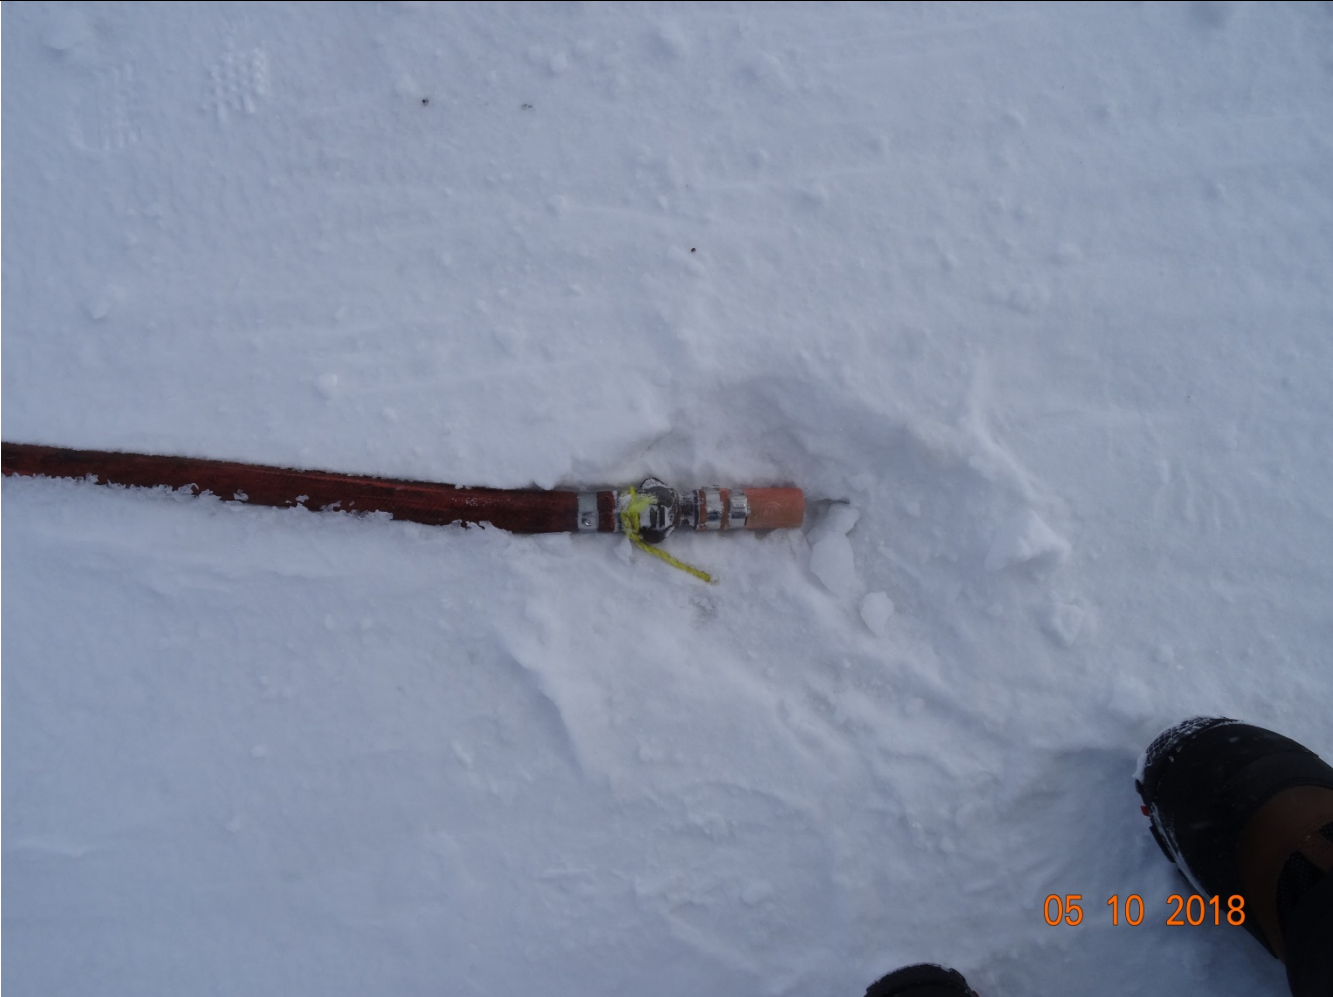
| Locations name: | Lat/Long (DD.MM.SS.SS, NAD83) |
|---|---|
| Photo 2 | N63° 00' 59.4", W92° 18' 06.4" |

Description
Water supply hose frozen into the ice. A rope has been tied to in so that it can be removed in the summer.

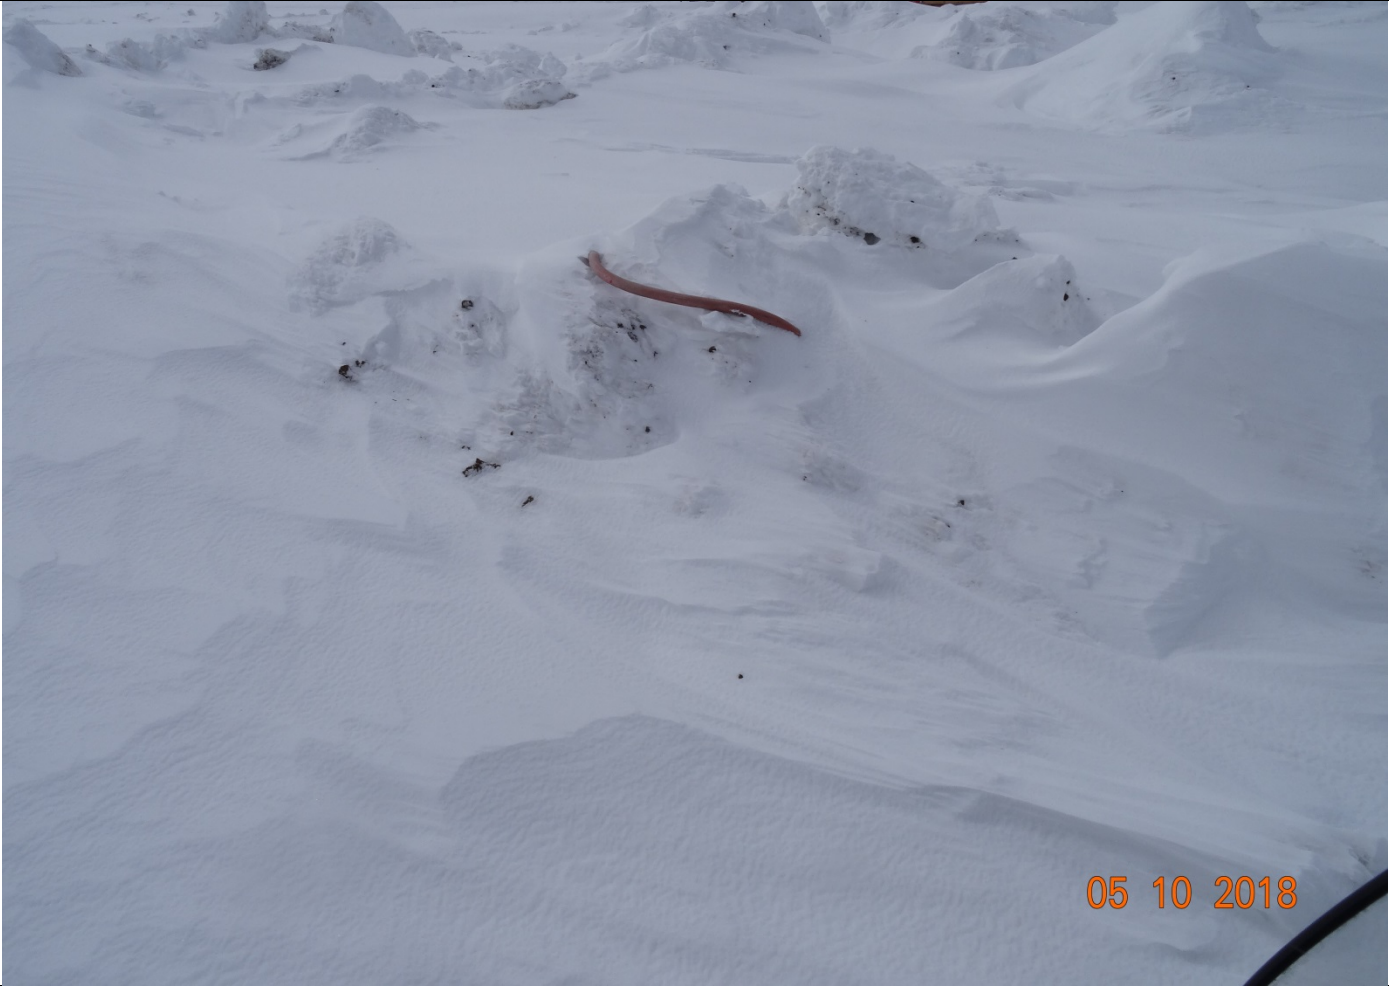
Photo 5

Garbage on overland haul route.

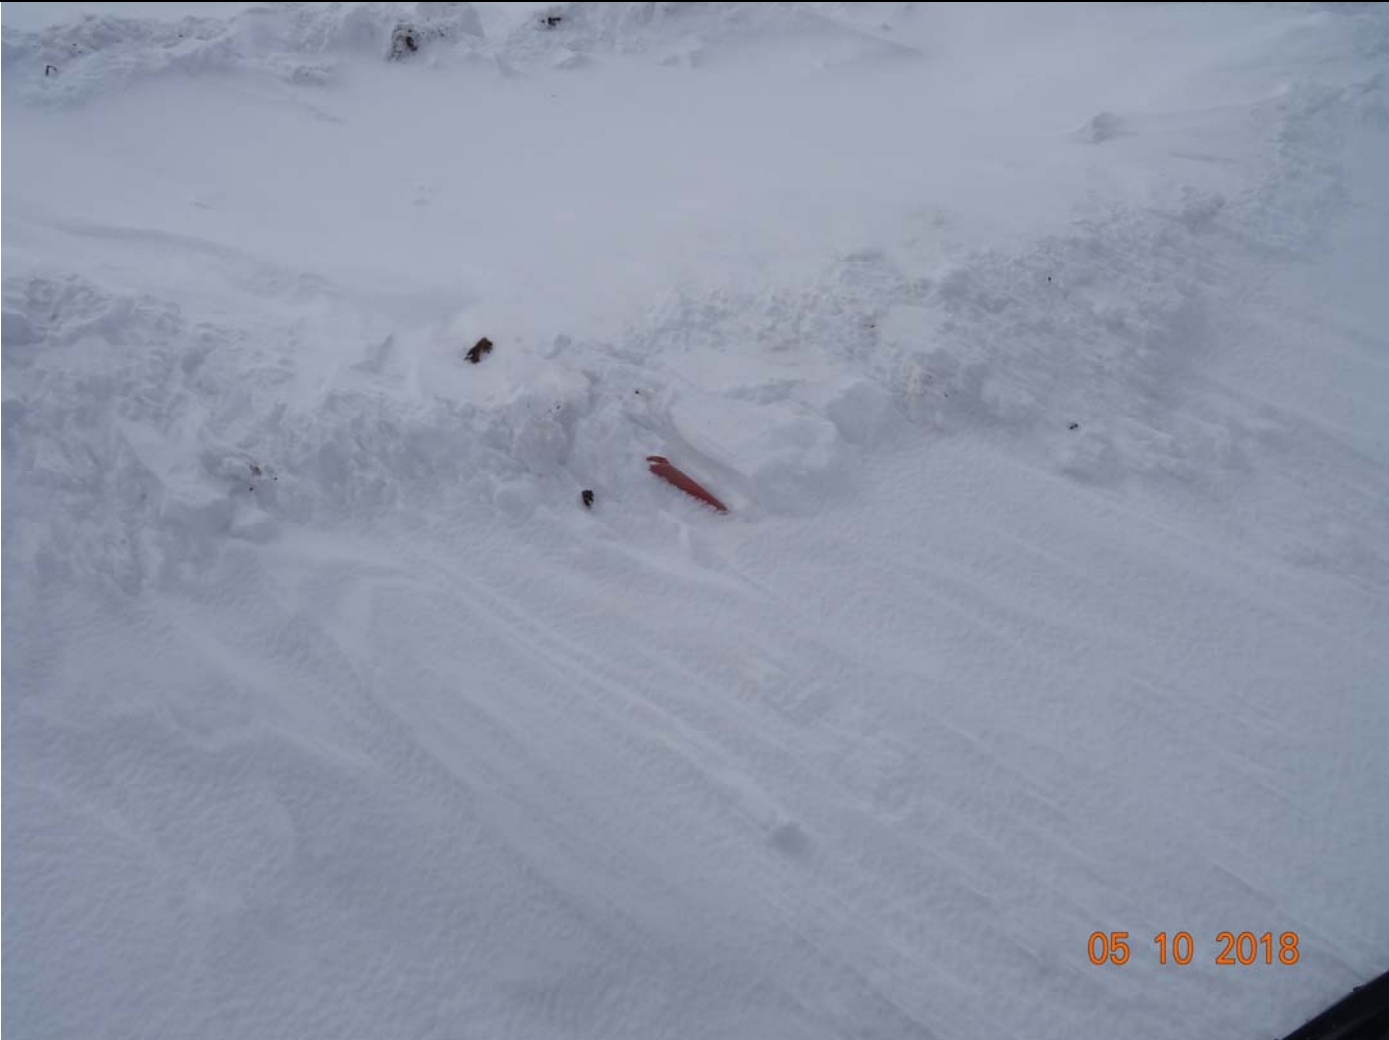
Photo 6

Garbage on overland haul route.

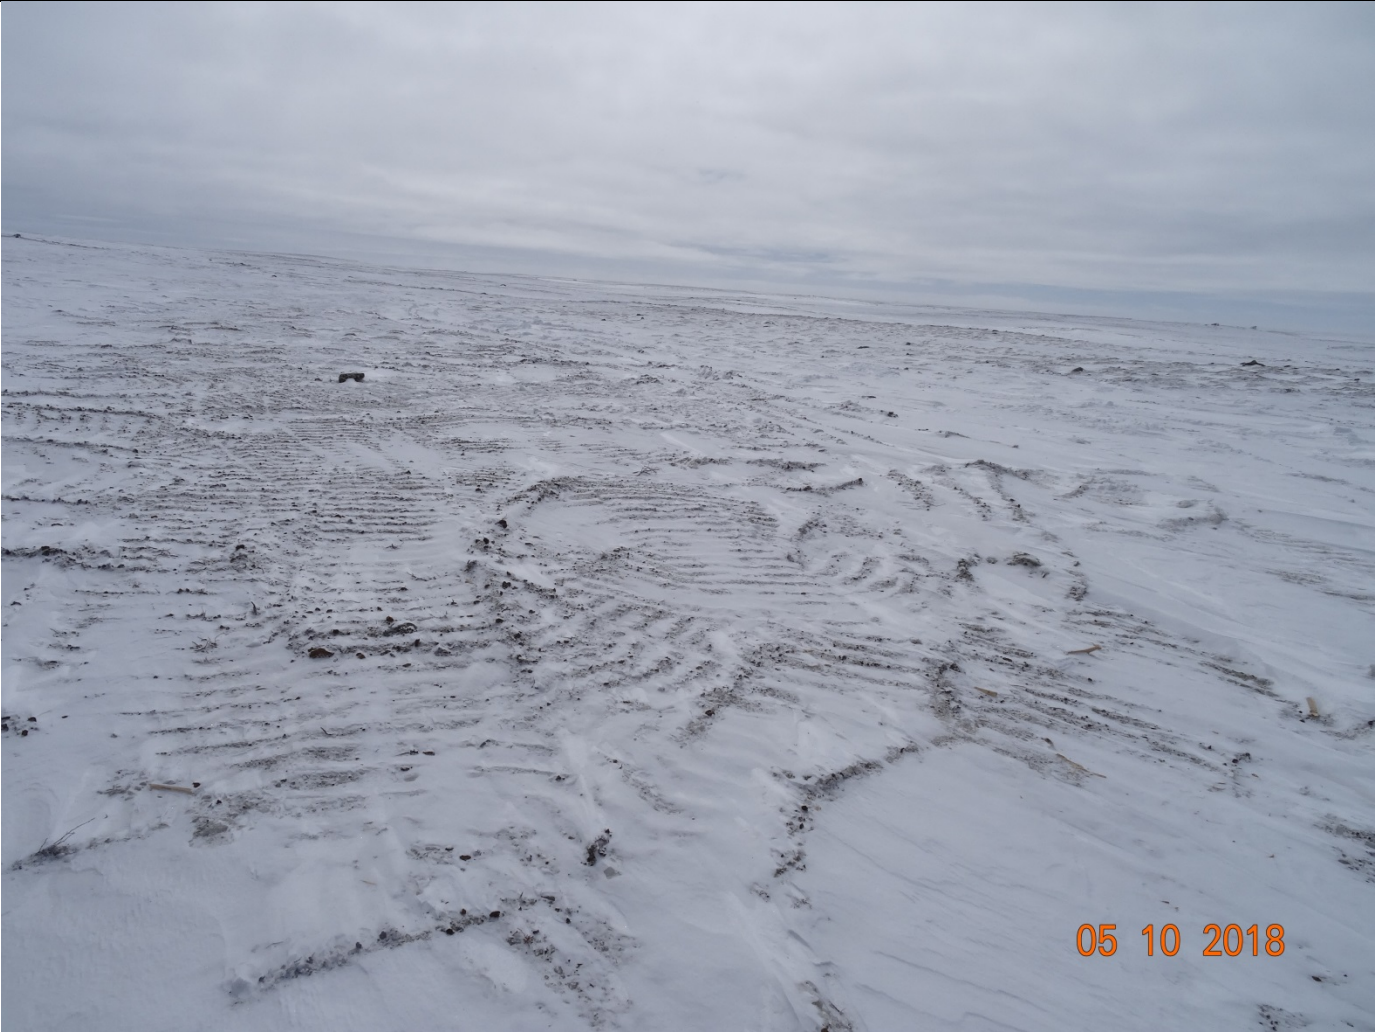
Photo 9

- At drill site M18-2445 cutting were observed on the surface of the ice, as well as in the ice itself, failing to comply with PART F item 2.
- In many location the trails, used for the overland transfer of the drills, the ground was bare though no rutting was observed which would be in compliance with PART E item 20.

Tracked Equipment operating on bare ground.

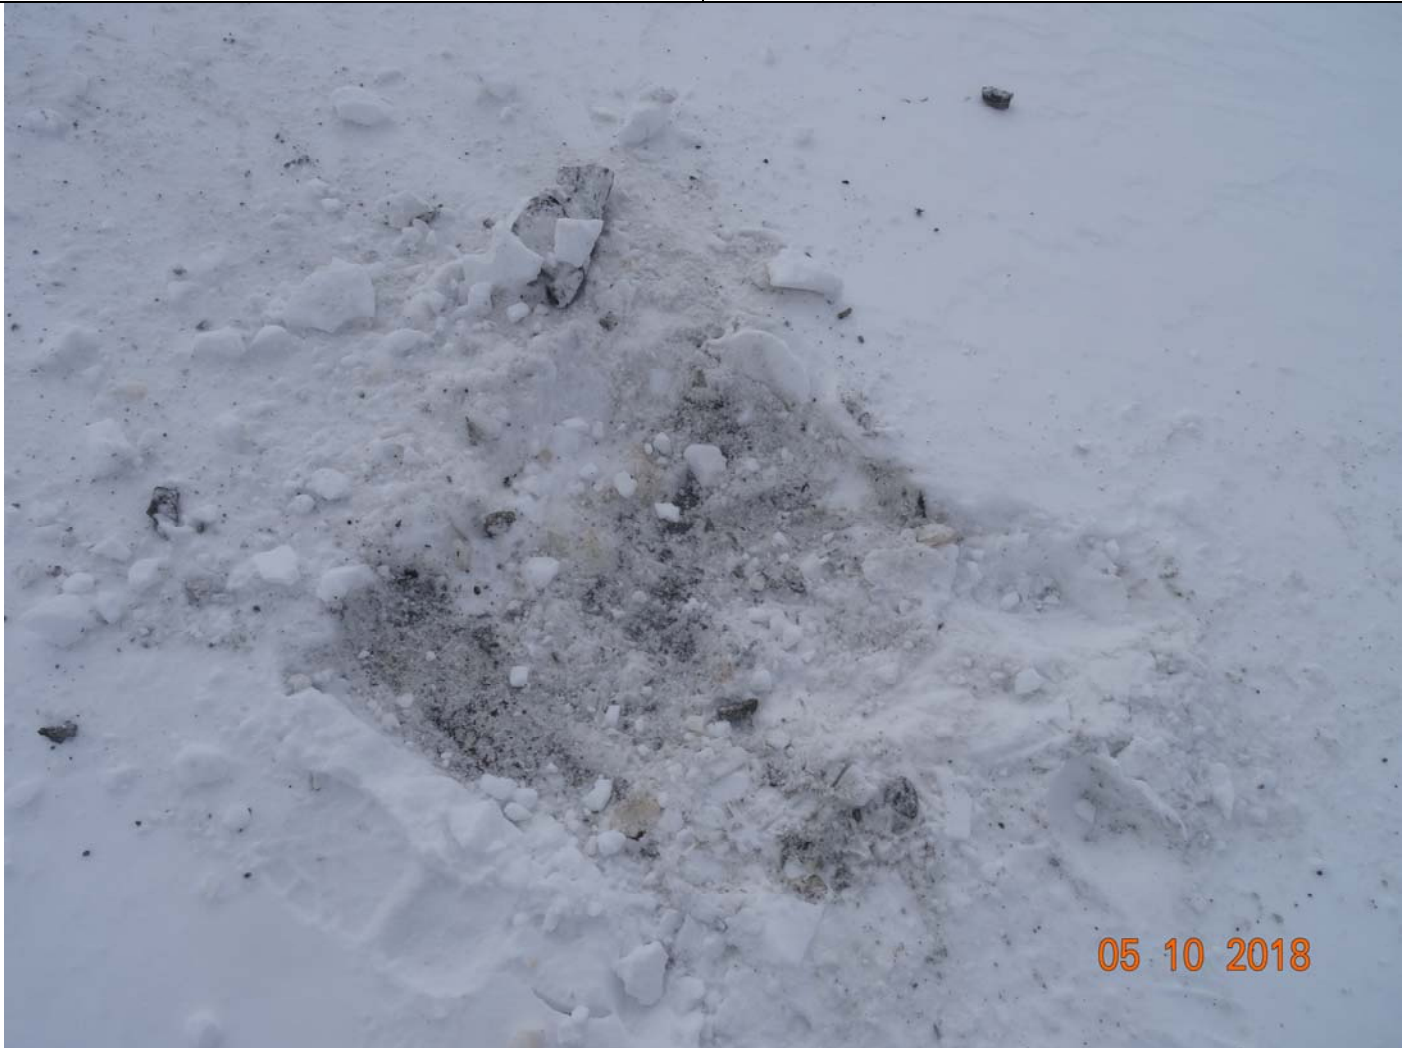
Photo 10

- PART I item 10, failure to restore drill site to natural condition.
- PART F item 2, failure to dispose drill waste thirty one (31) meters from the ordinary high water mark.

Cuttings on the ice surface, Drill site M18-2445

-AEM will provide a copy of the water sample laboratory analysis report taken at M18-2445 to the inspector before May 31st, 2018.
