WATER LICENCE INSPECTION FORM

Licensee	Licensee Representative
2BB-MEL1424	Mario Bolduc
Licence No. / Expiry	Representative's Title
July 21st, 2024	P.Geo
Land / Other Authorizations	Land / Other Authorizations
IOL	--
Date of Inspection	Inspector
June 8th 2018	WRO C. Wilson
Activities Inspected	
<input type="checkbox"/> Camp	<input checked="" type="checkbox"/> Drilling
<input type="checkbox"/> Roads/Hauling	<input type="checkbox"/> Mining
	<input type="checkbox"/> Construction
	<input type="checkbox"/> Reclamation
	<input type="checkbox"/> Fuel Storage
	<input checked="" type="checkbox"/> Other: Water Supply
	<input type="checkbox"/> Other:

PHOTO LOG

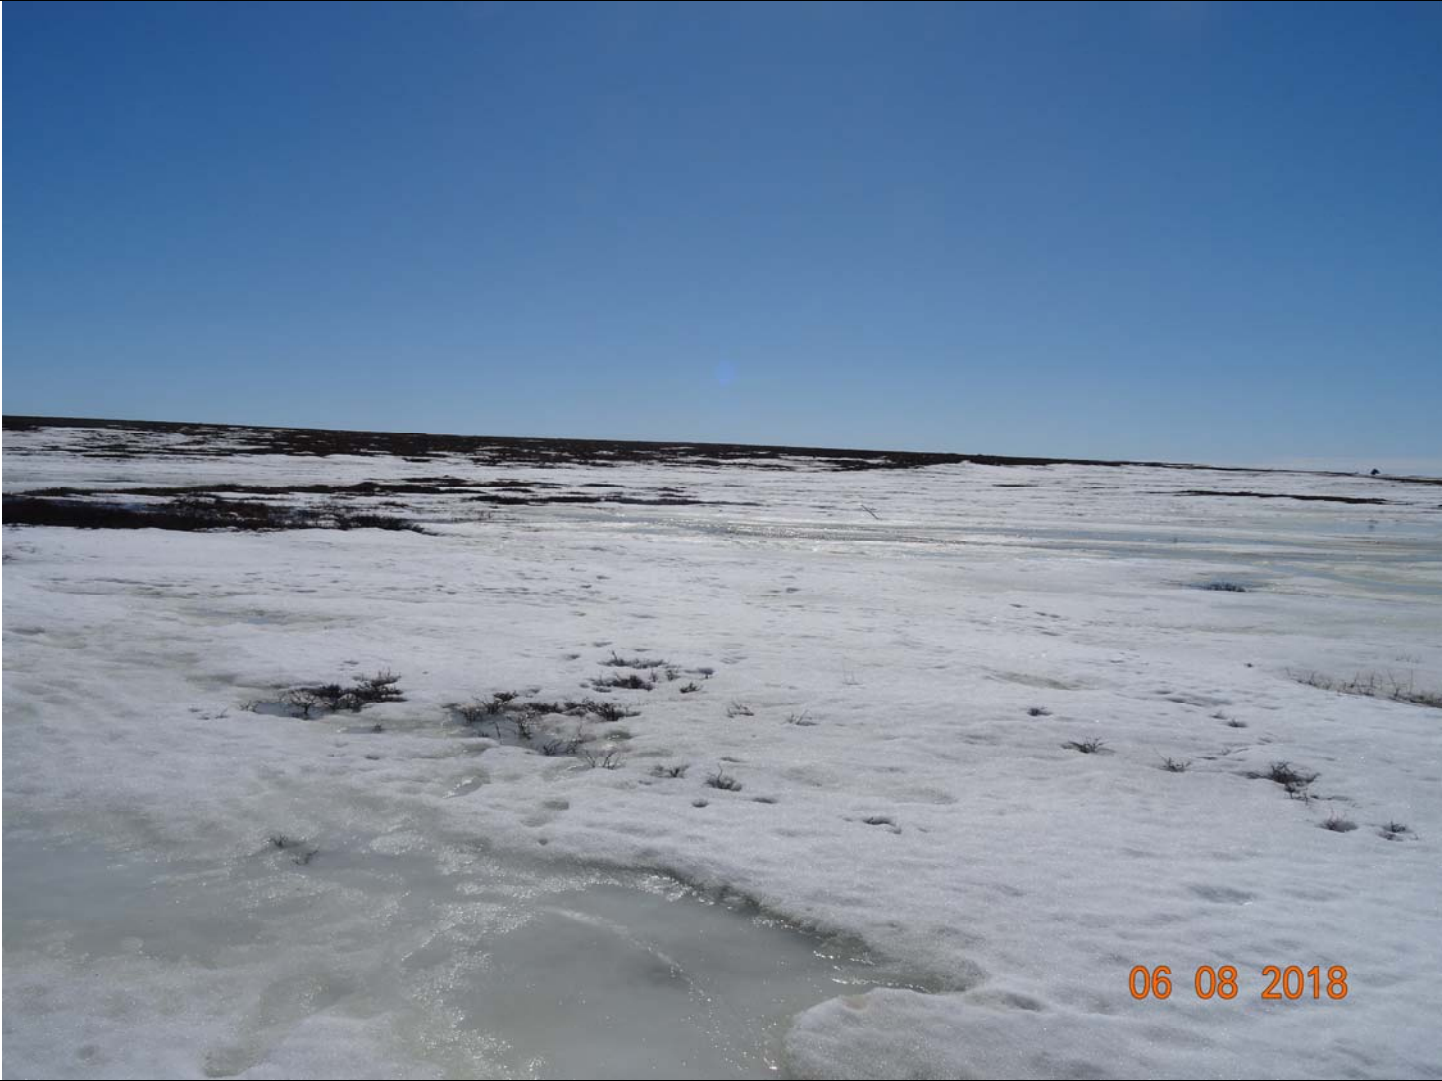
Date:	Authorization Number:	Camera/Model:	Inspector
June 8th, 2018	2BB-MEL1424	Sony DSC-HX50V Cyber shot	WRO Wilson
Photo No.		Lat/Long (DD.MM.SS.SS, NAD83)	
Photo 1		N63° 00' 6.46", W92° 9' 29.78"

Description:
Mid frame: flowing stream between to lakes.
