WATER LICENCE INSPECTION FORM

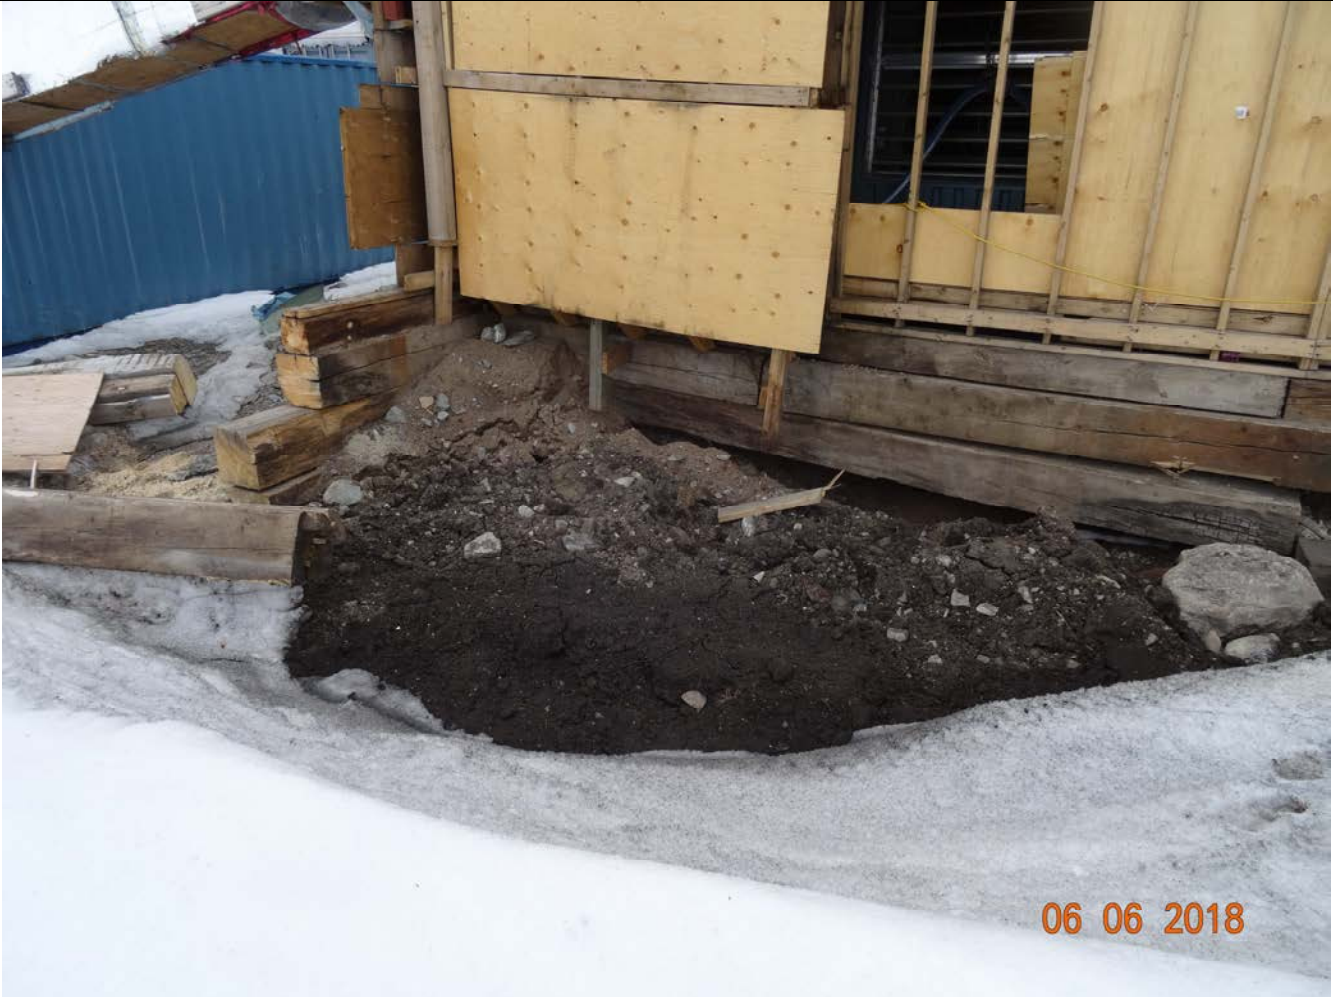
Date:	Authorization Number:	Camera/Model:	Inspector
June 7th, 2018	2BB-MEL1424	Sony DSC-HX50V Cyber shot	WRO Wilson
Photo No.	Lat/Long (DD.MM.SS.SS, NAD83)		
Photo 1	N63° 1 43.78, W92° 10 9.25

Description:
Spill 2017-434, genset building, stained ground.

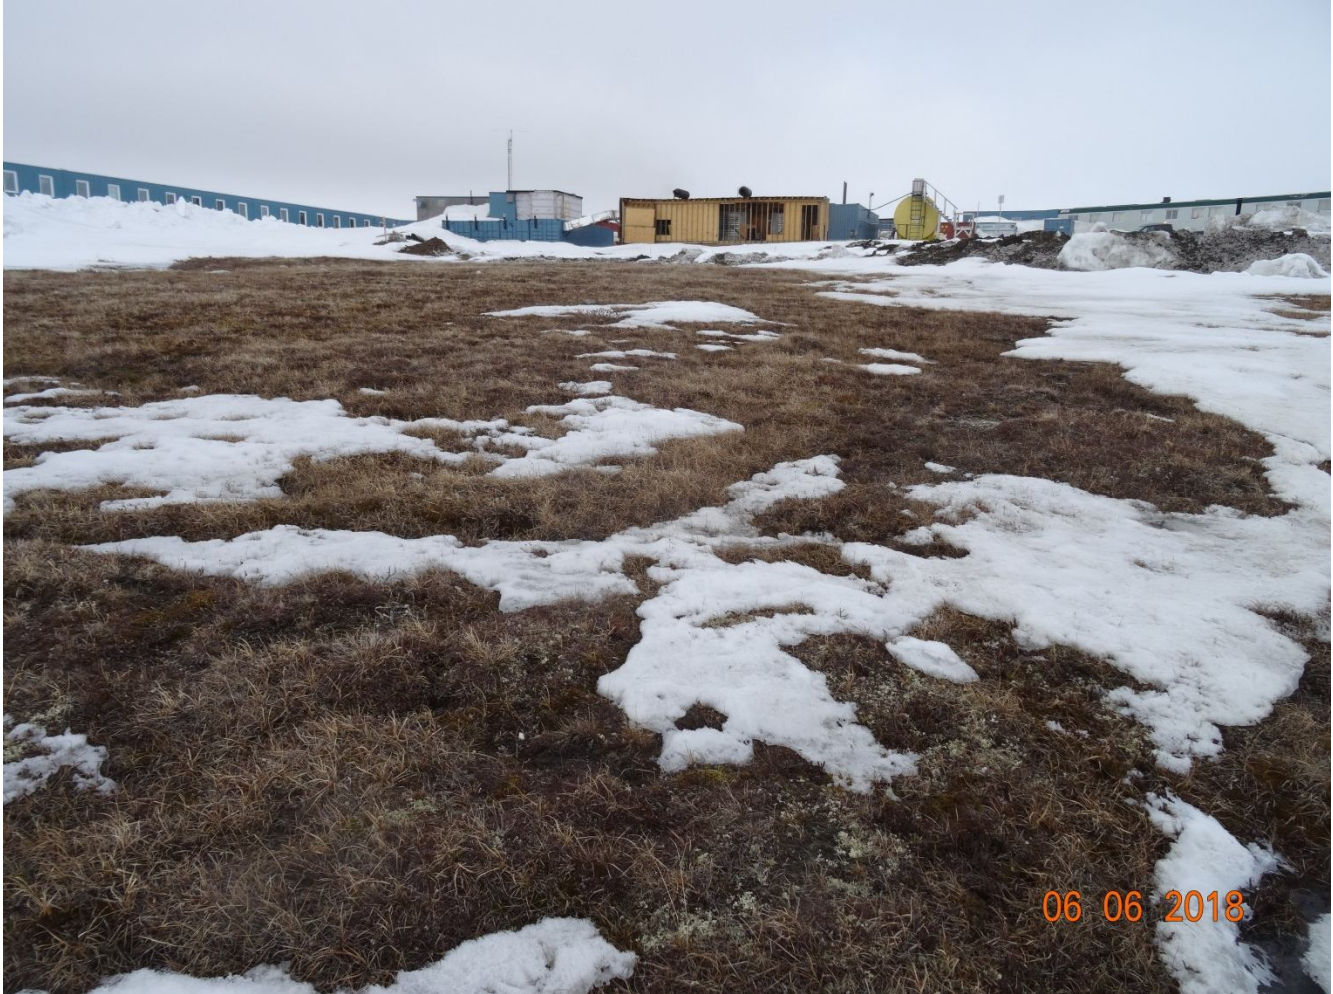
Photo No.	Lat/Long (DD.MM.SS.SS, NAD83)
Photo 2	N63° 1 42.85, W92° 10 4.36

Description:
Meliadine Lake facing up slope to the genset.

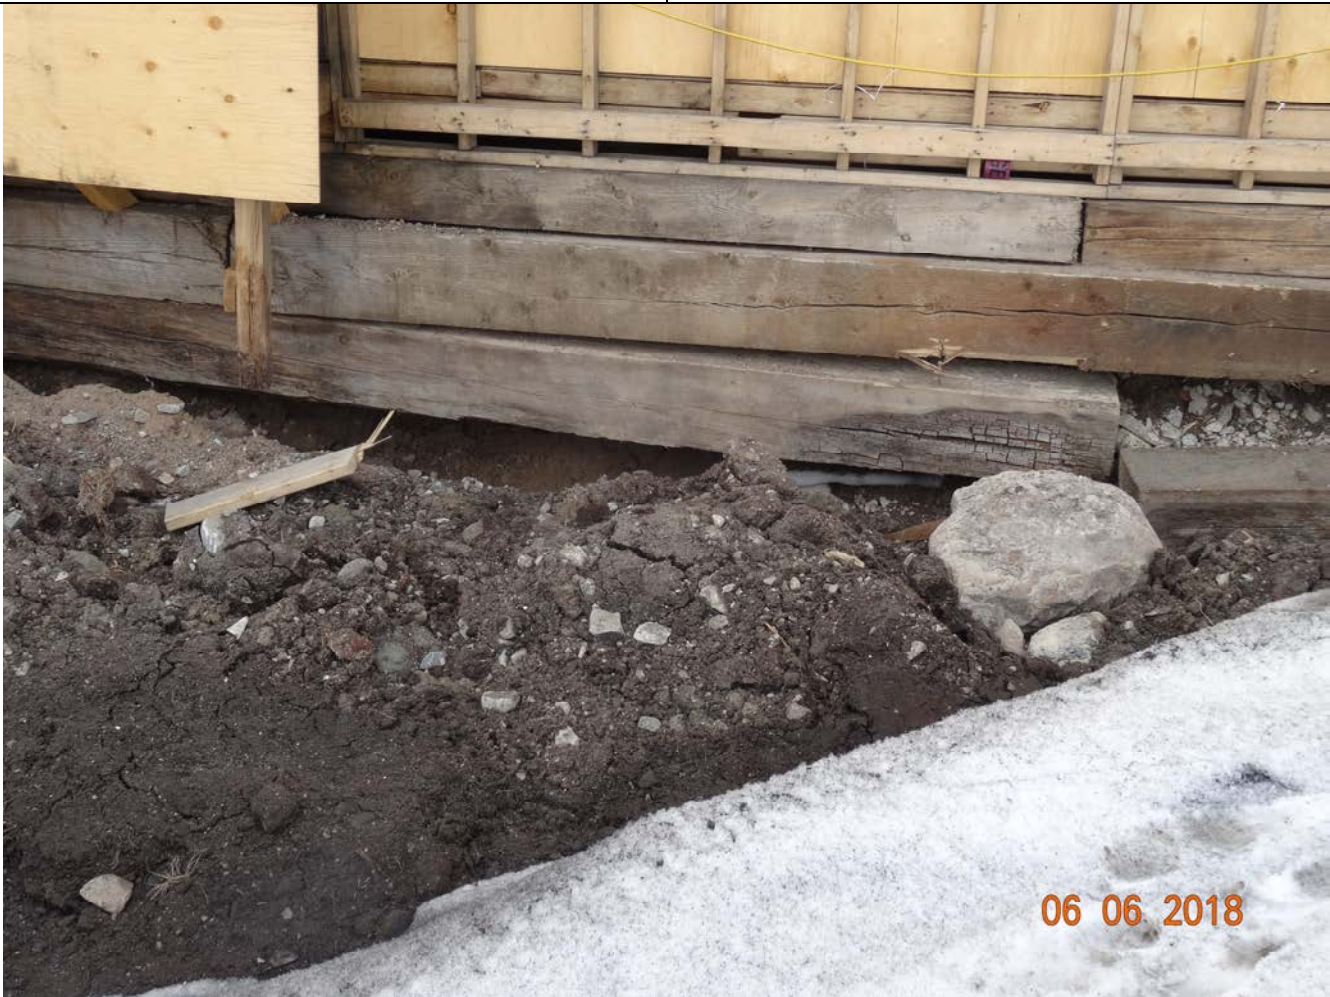
Photo No.
Photo 3

Description:
Stained ground under genset building.

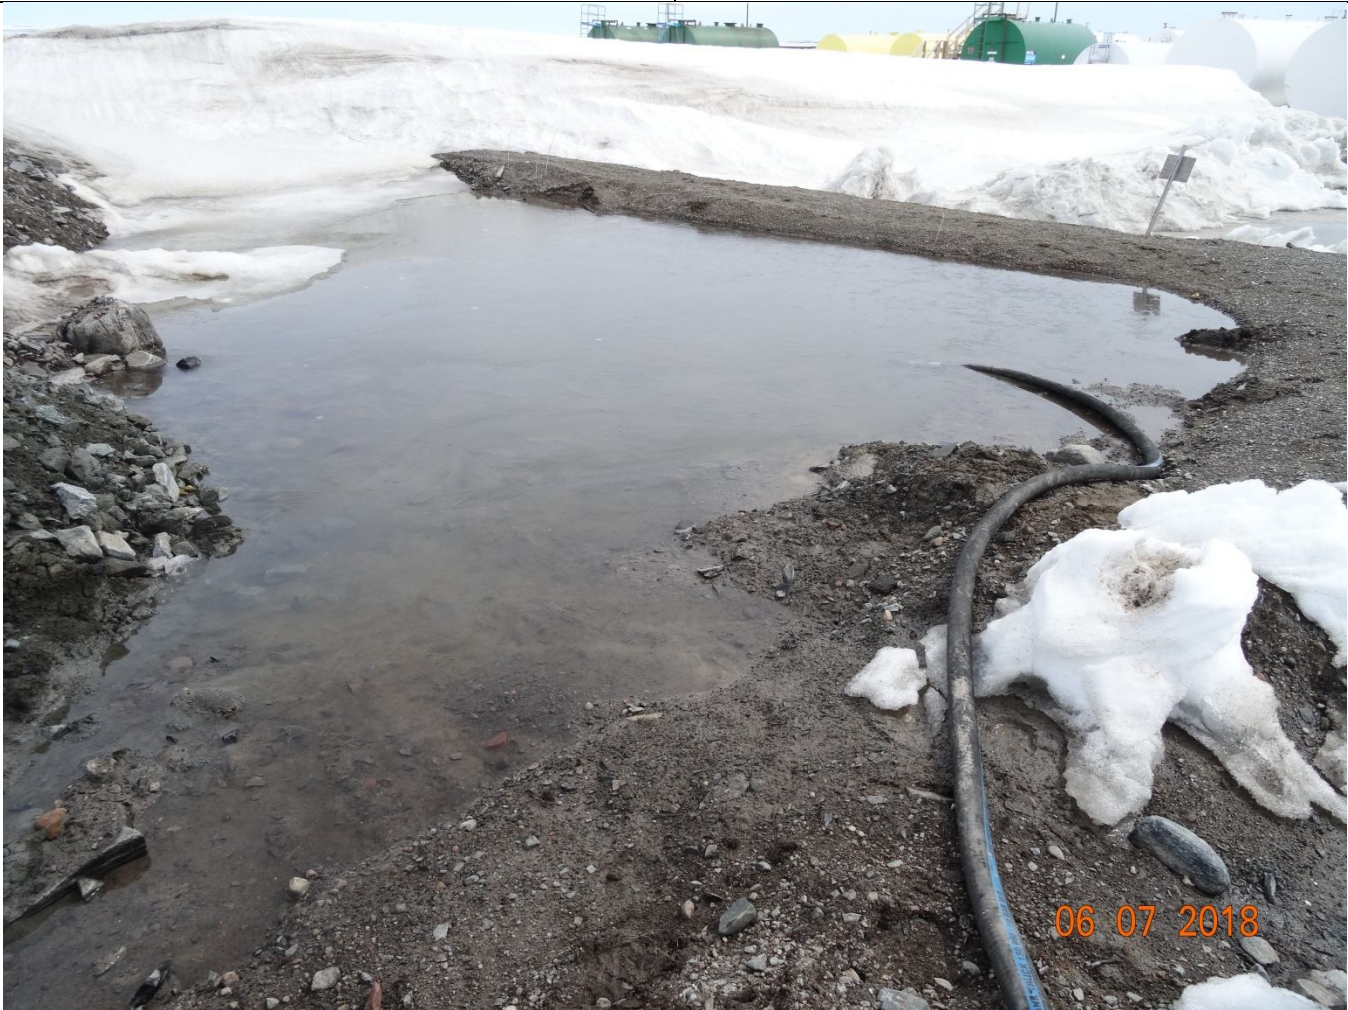
Photo No.
Photo 4

Description:
Saturated ground on ramp at landfarm

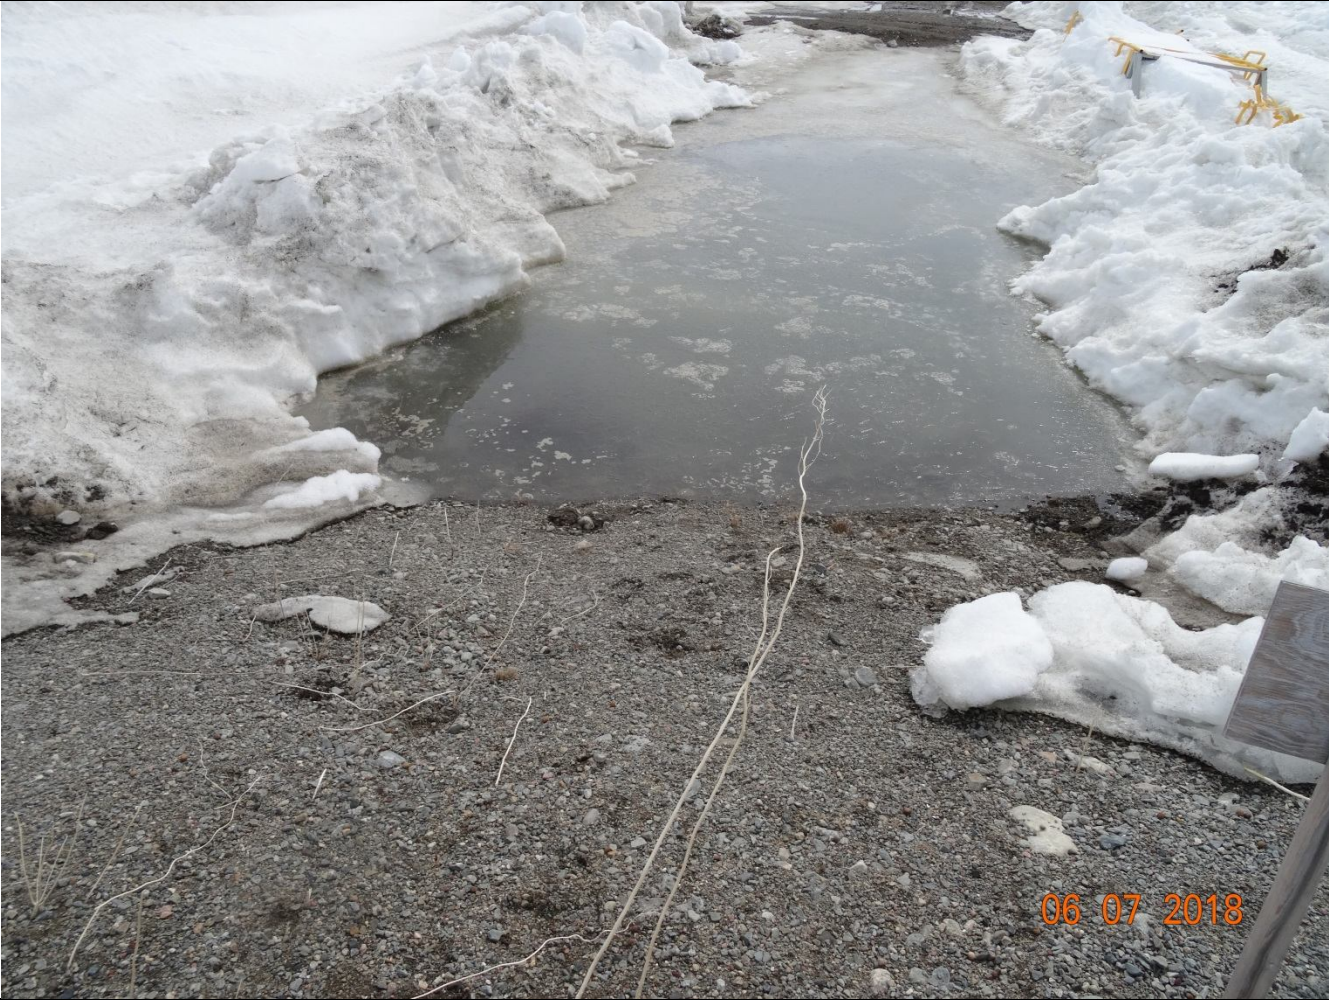
Photo No.
Photo 5

Description:
Water pooling on south side of landfarm

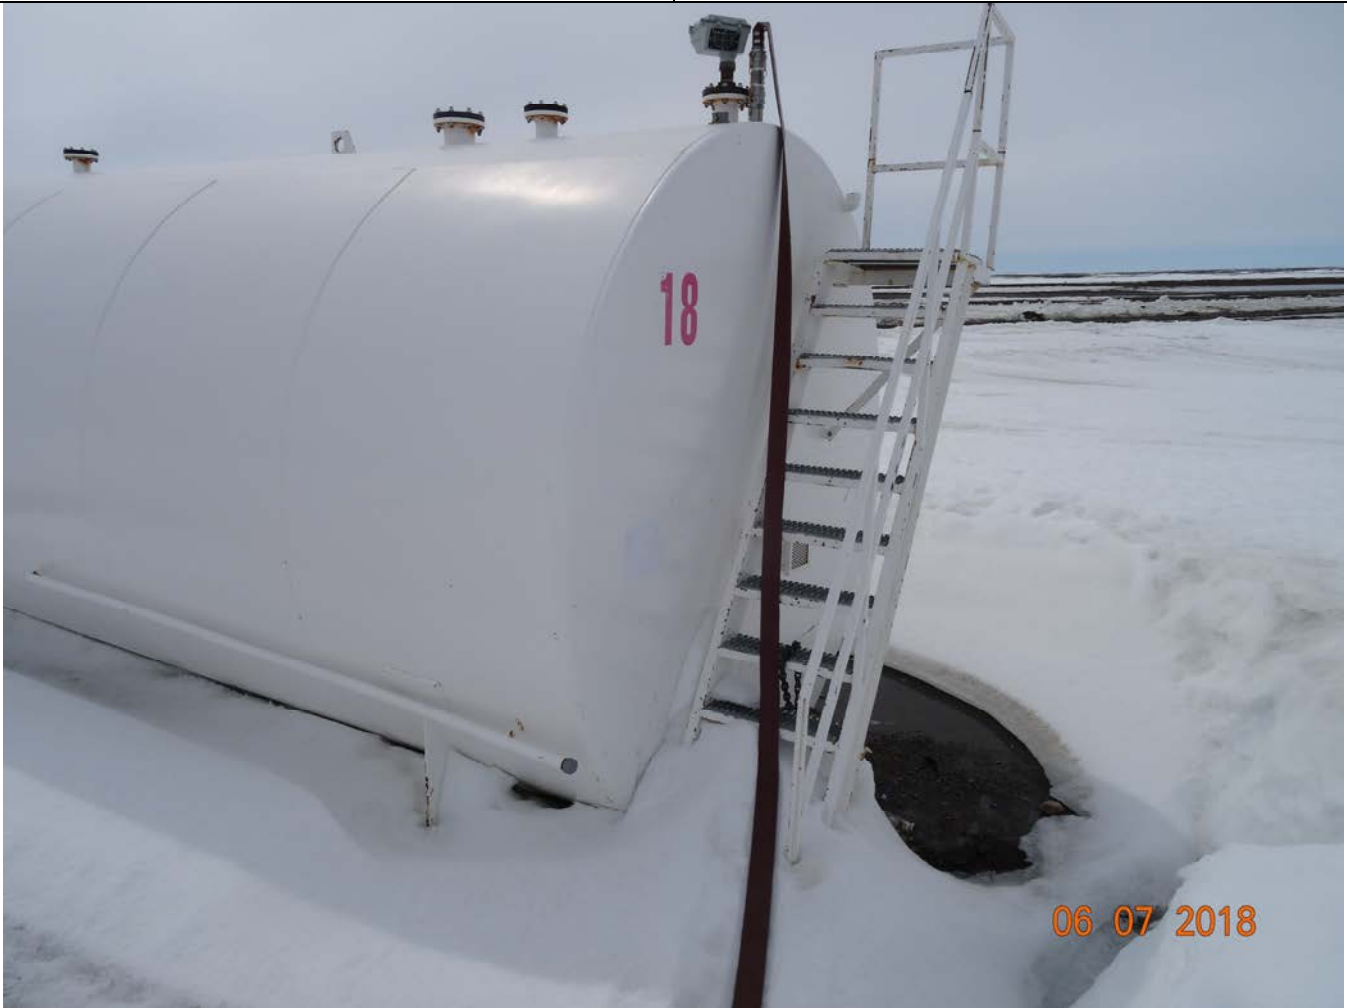
Photo No.
Photo 6

Description:
Strong odor of fuel and sheen in water below tank.

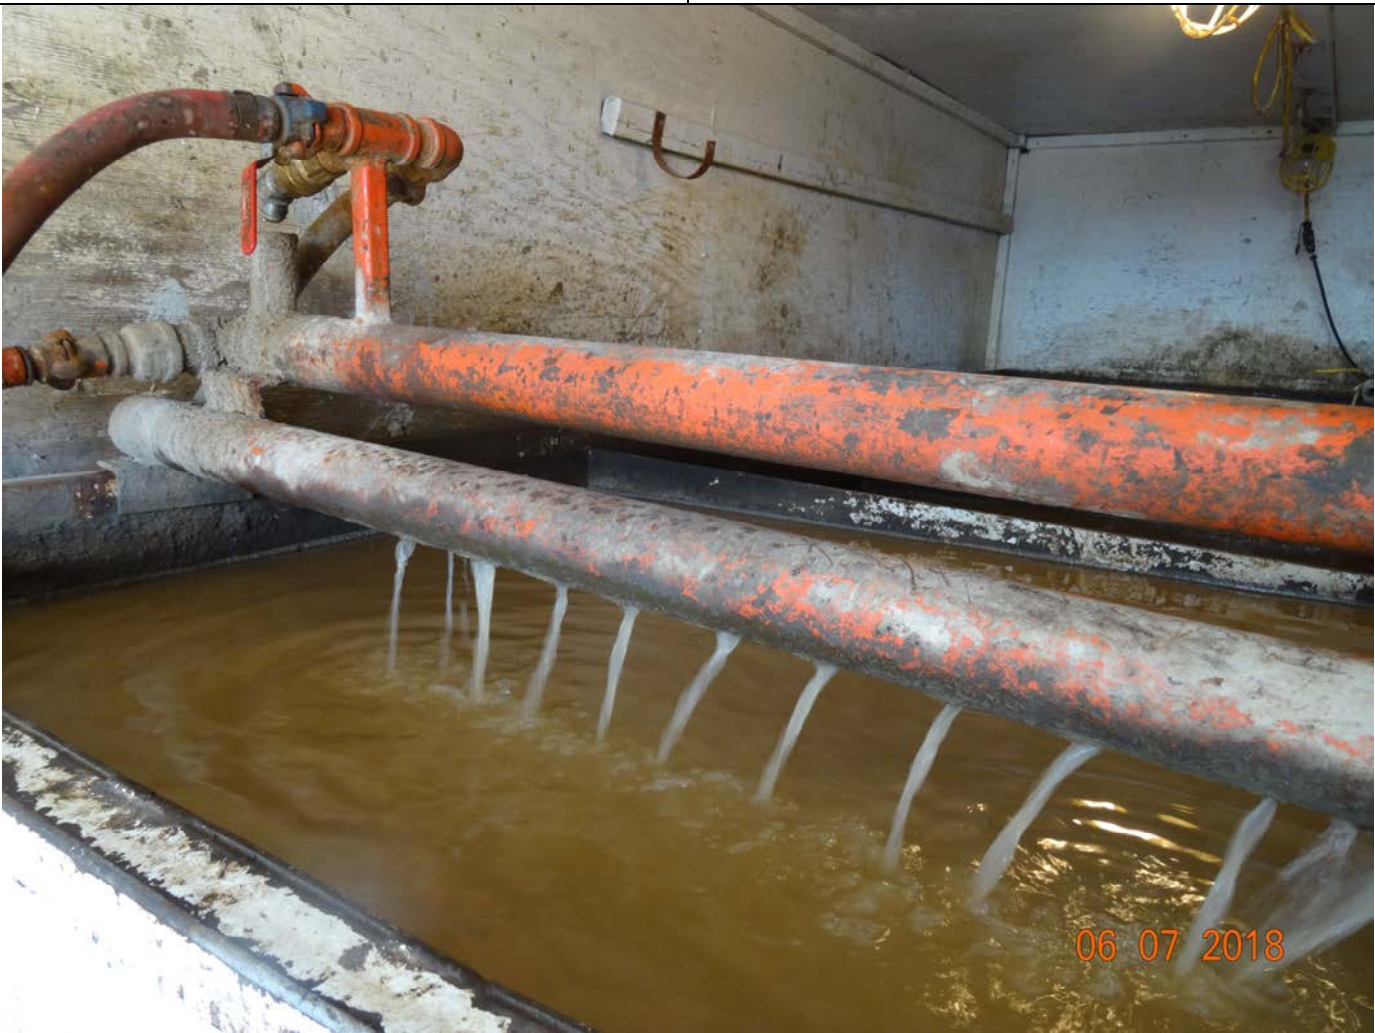
Photo No.
Photo 7

Description:
Drill 1: Settling tanks inside Orbit Garant drill.

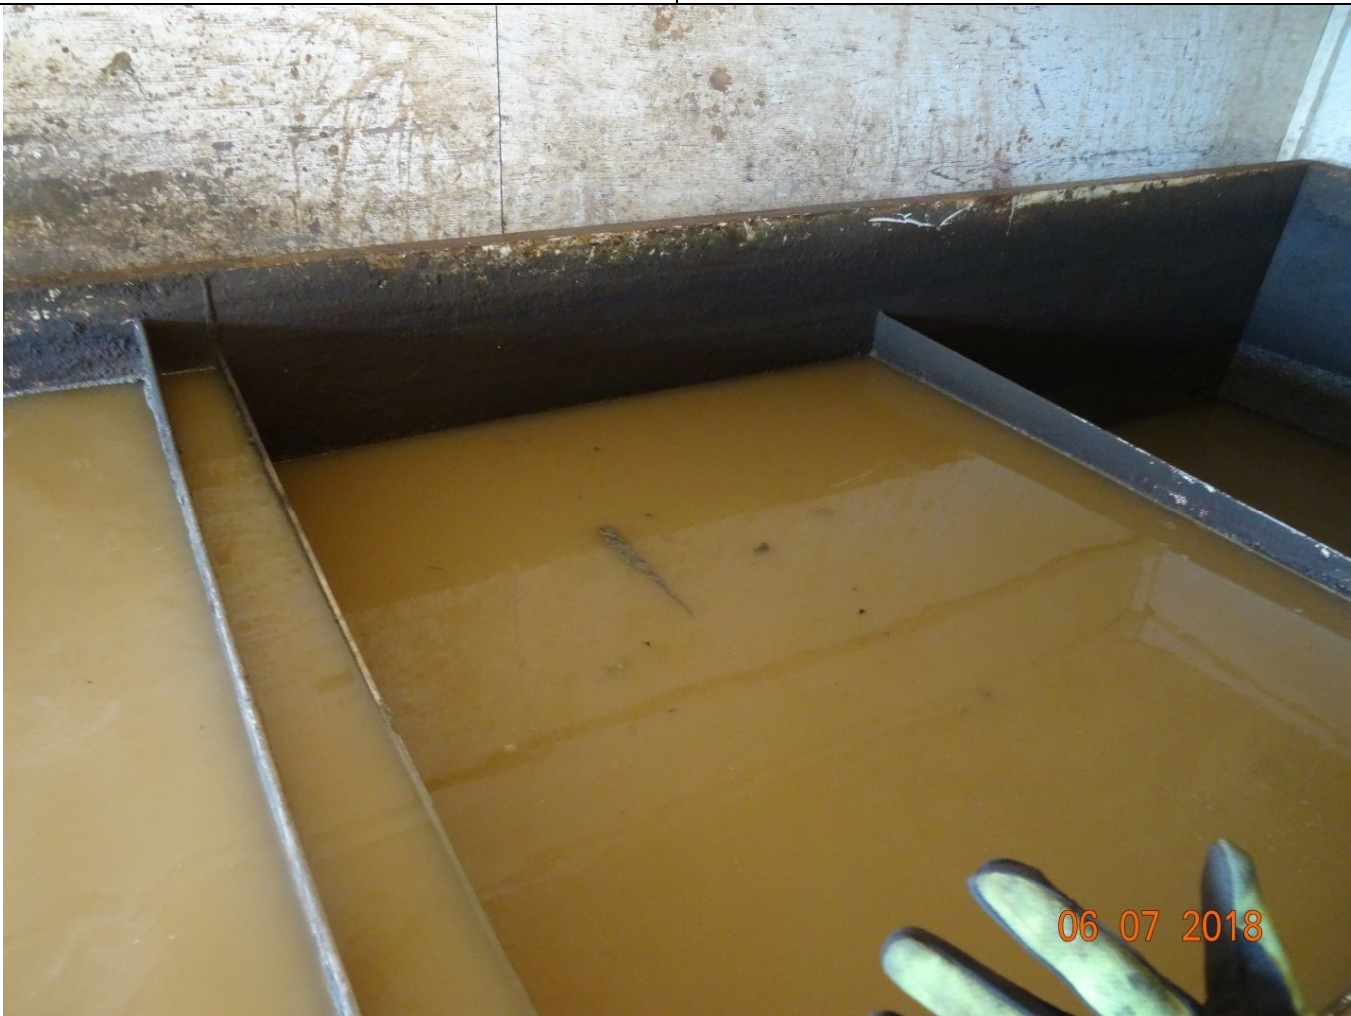
Photo No.
Photo 8

Description:
Drill 1: Three stage settling tank with flocculants inside Orbit Garant Drill.

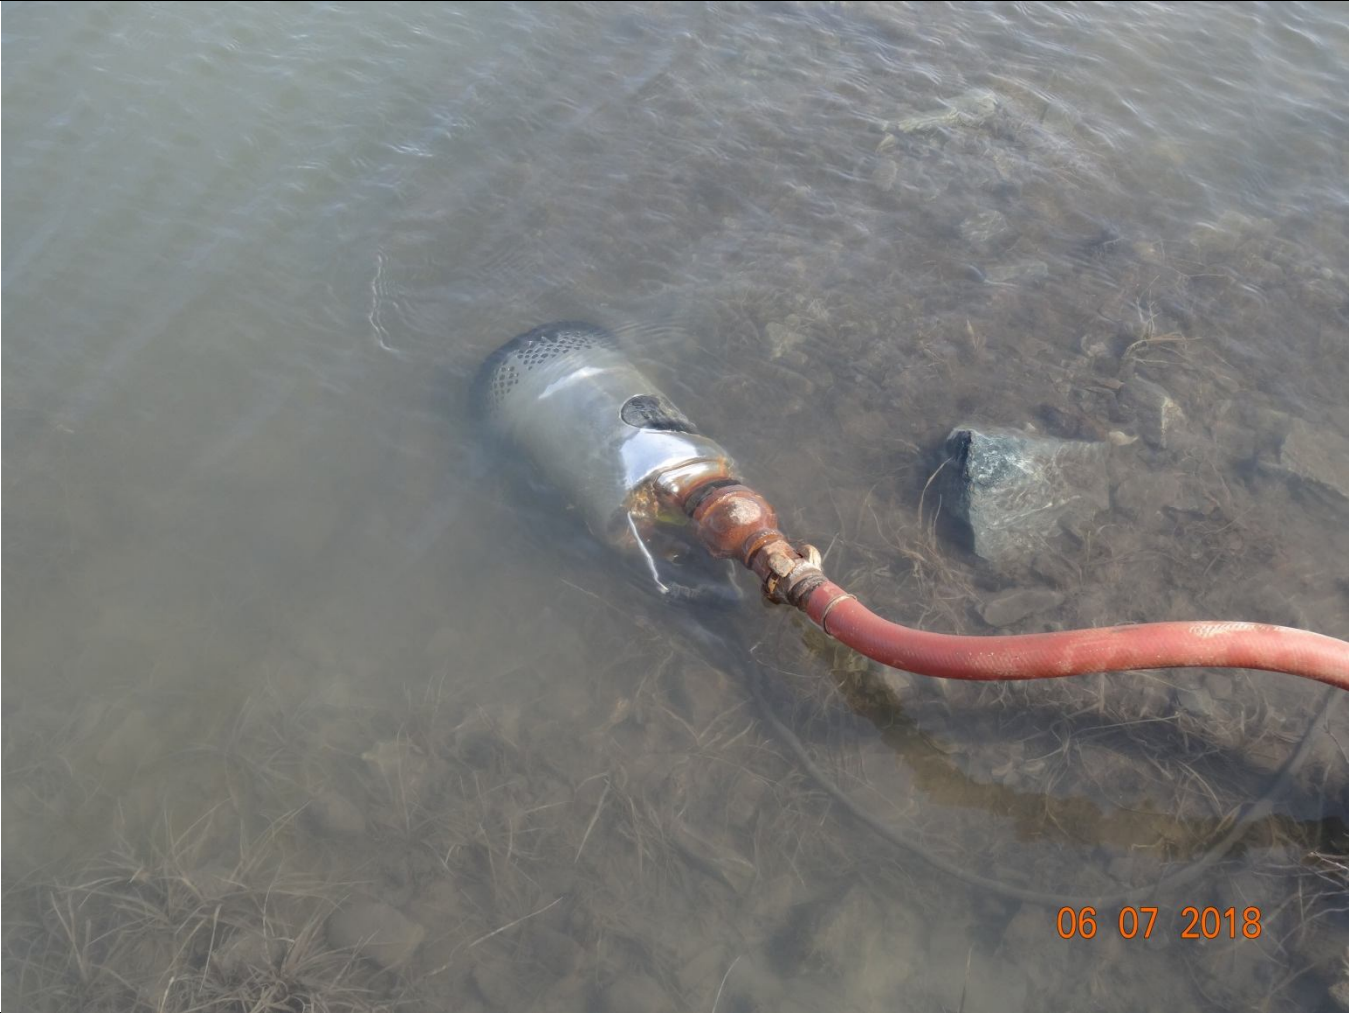
Photo No.
Photo 9

Description:
Drill 1: Reclaim water source, screened water intake.

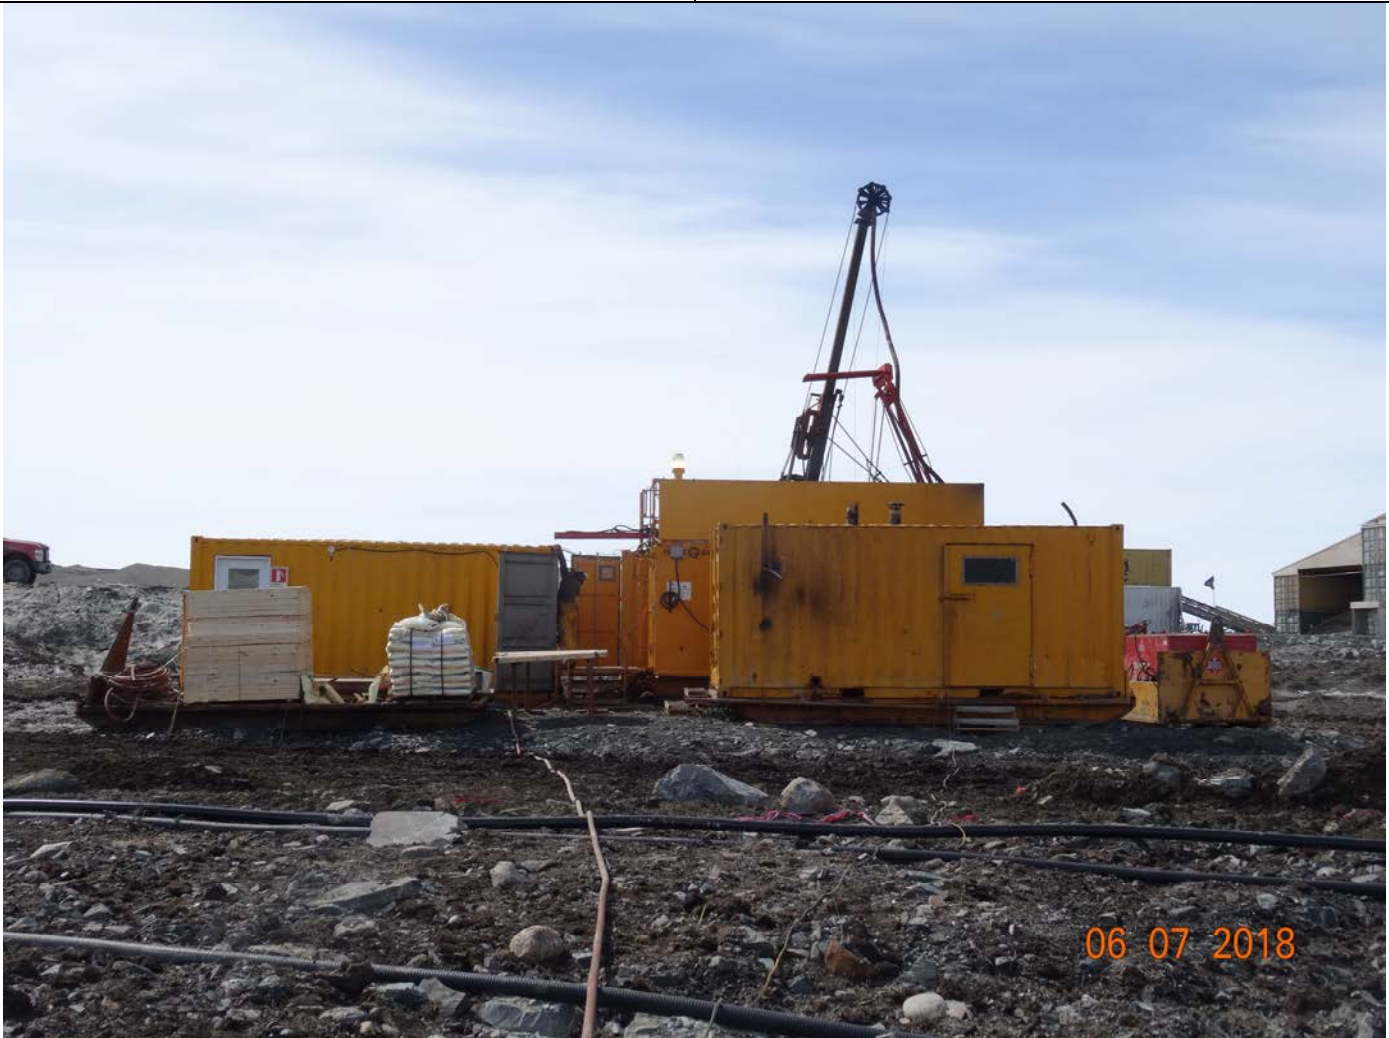
Photo No.
Photo 10

Description:
Drill 1: Rig and ancillary on skids.

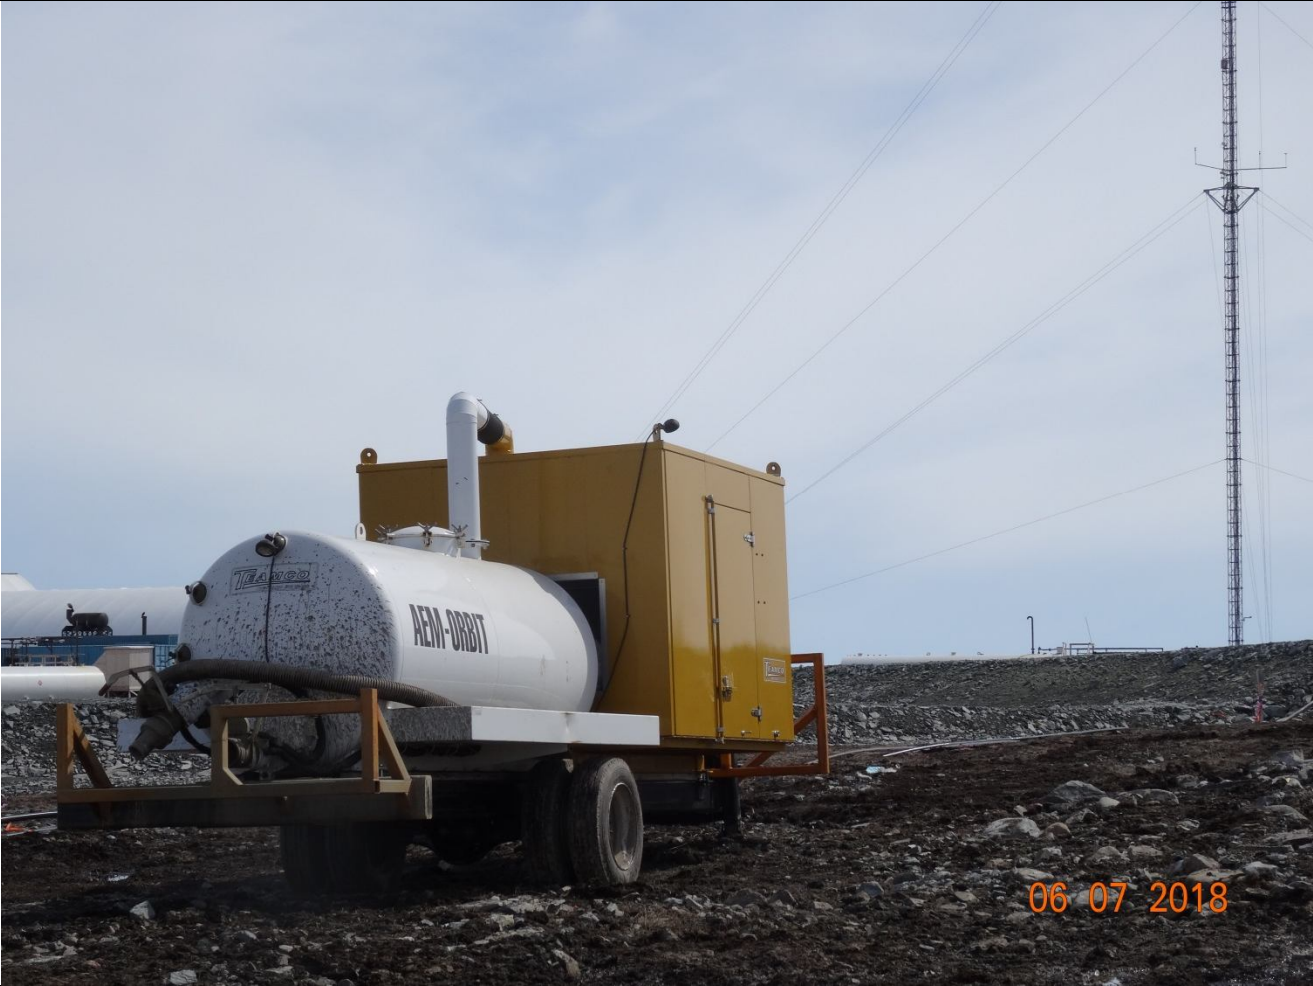
Photo No.
Photo 11

Description:
Drill 1: Vacuum equipment for removing cutting from settling tanks.

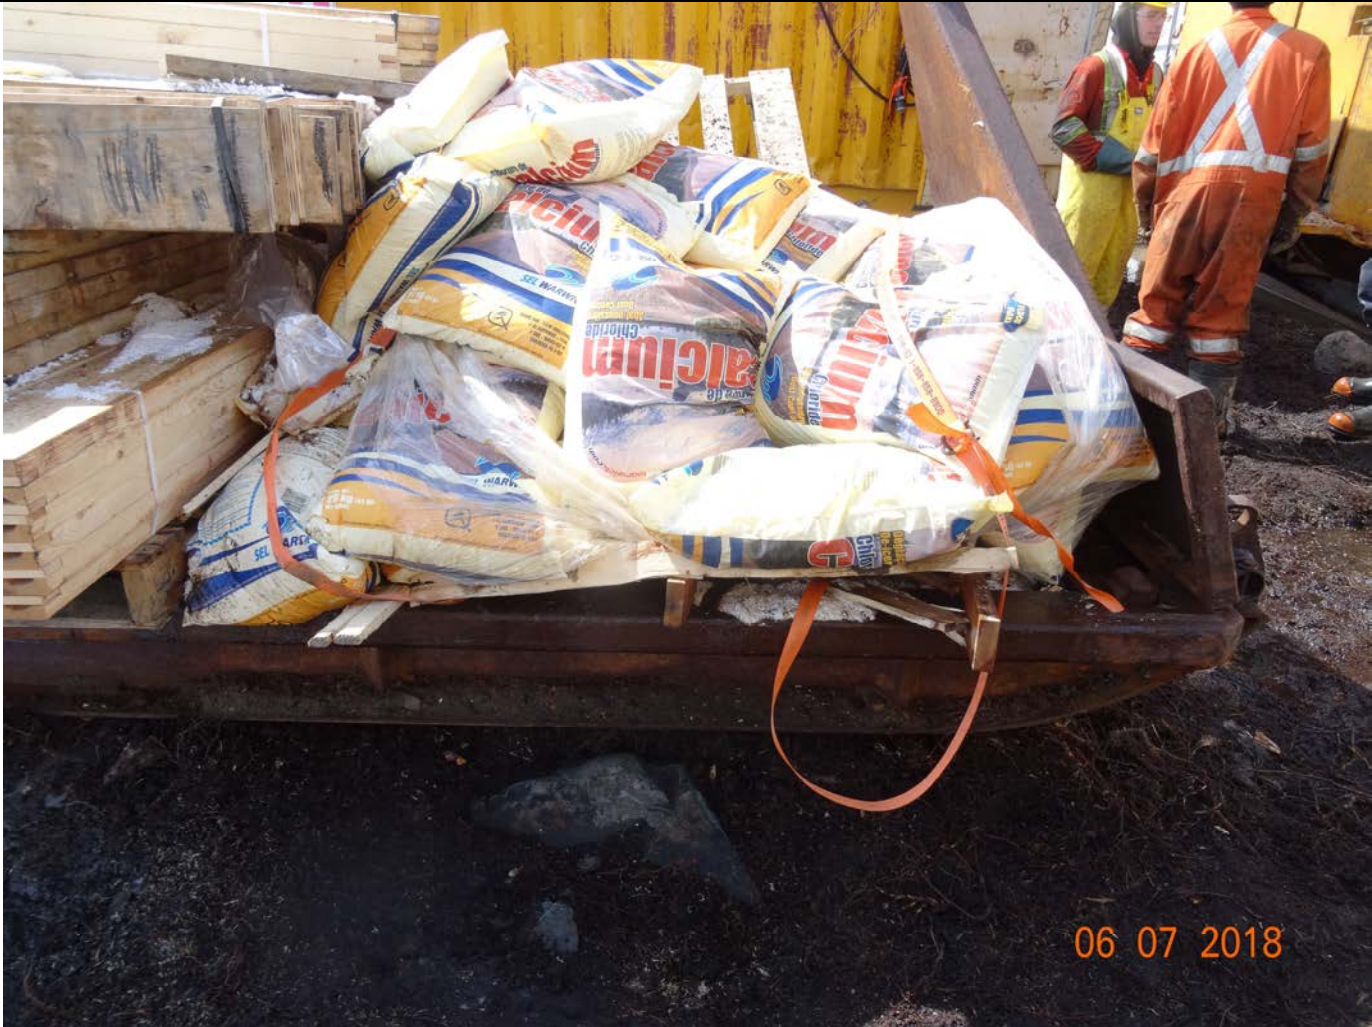
Photo No.
Photo 12

Description:
Drill 2: Damaged calcium chloride bags

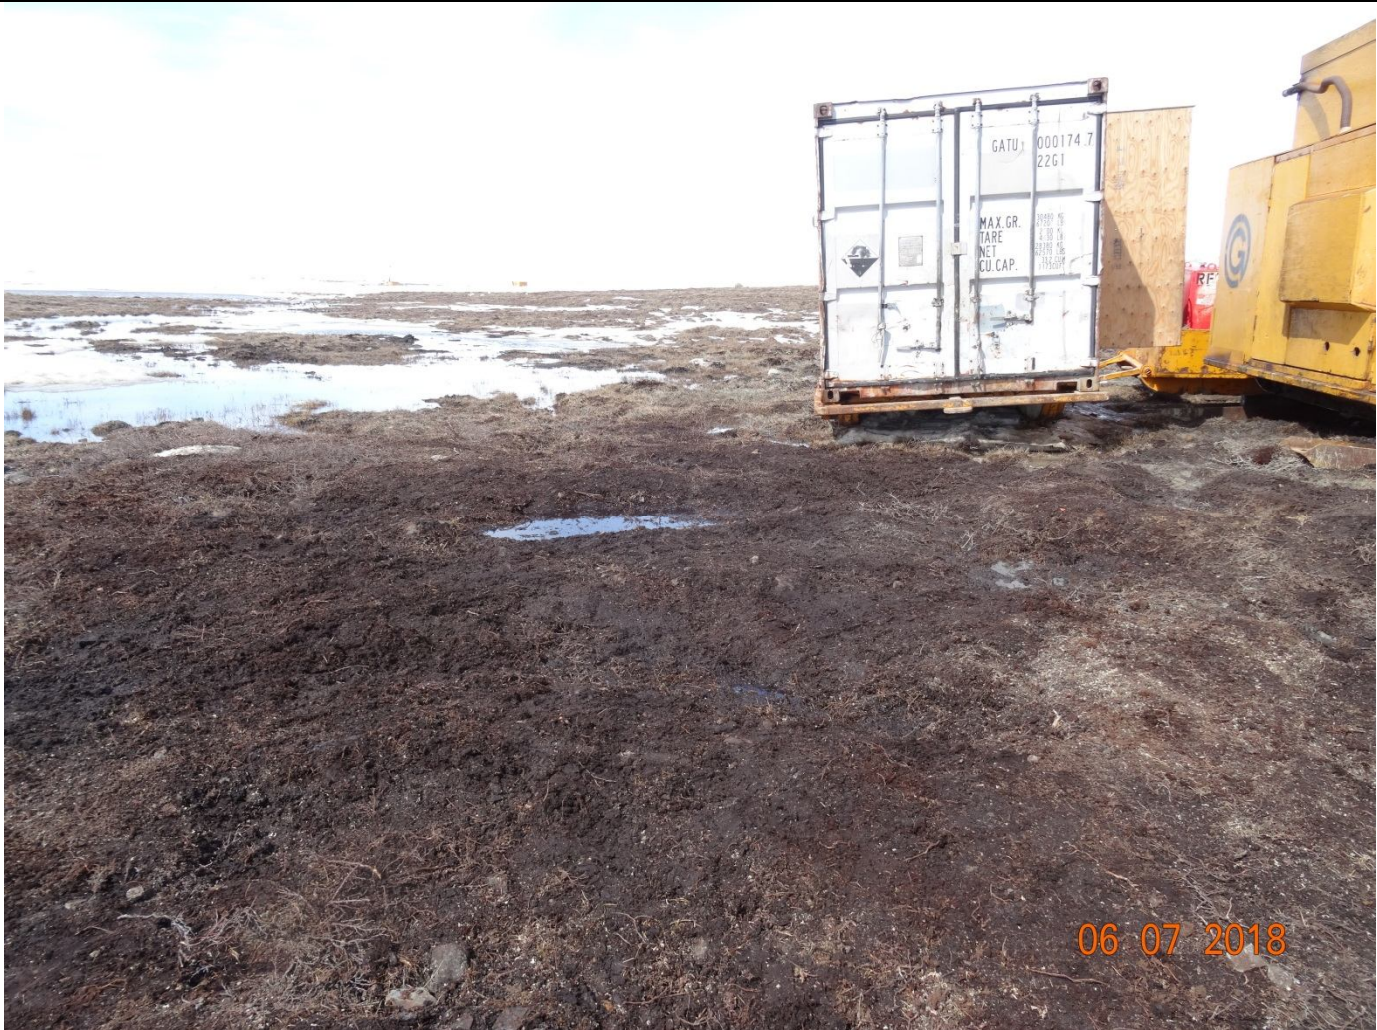
Photo No.	Lat/Long (DD.MM.SS.SS, NAD83)
Photo 13	N63° 1' 28.34", W92° 13' 55.55"

Description: Drill 2: Drilling within 31 meters of a waterbody.

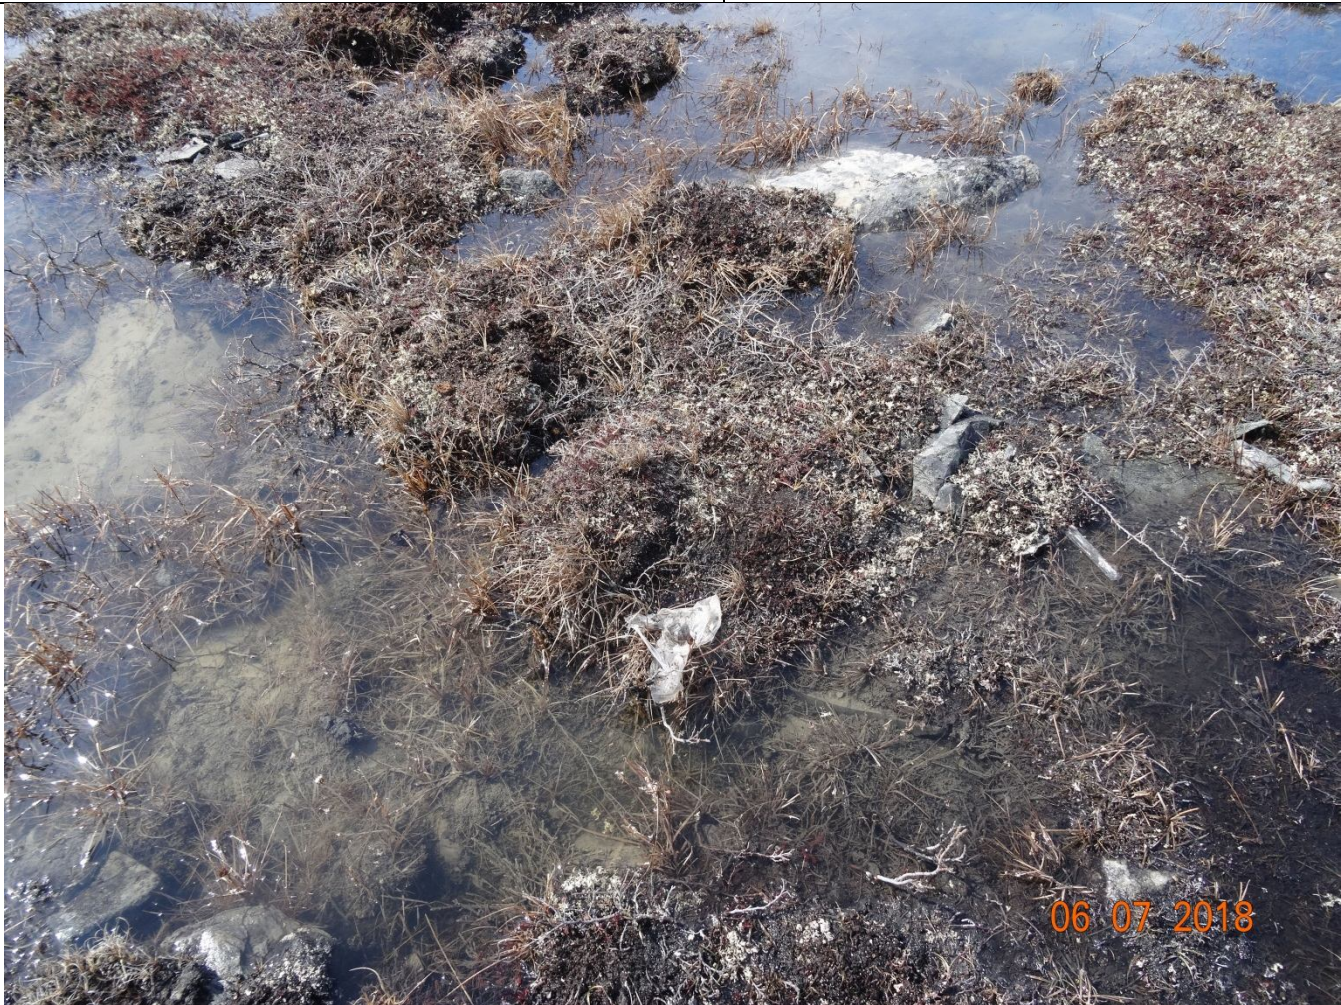
Photo No.	Lat/Long (DD.MM.SS.SS, NAD83)
Photo 14	N63° 1' 28.35", W92° 13' 54.2"

Description: Drill 2: cuttings and cuttings water in water flowing from Lake B8 and B9.

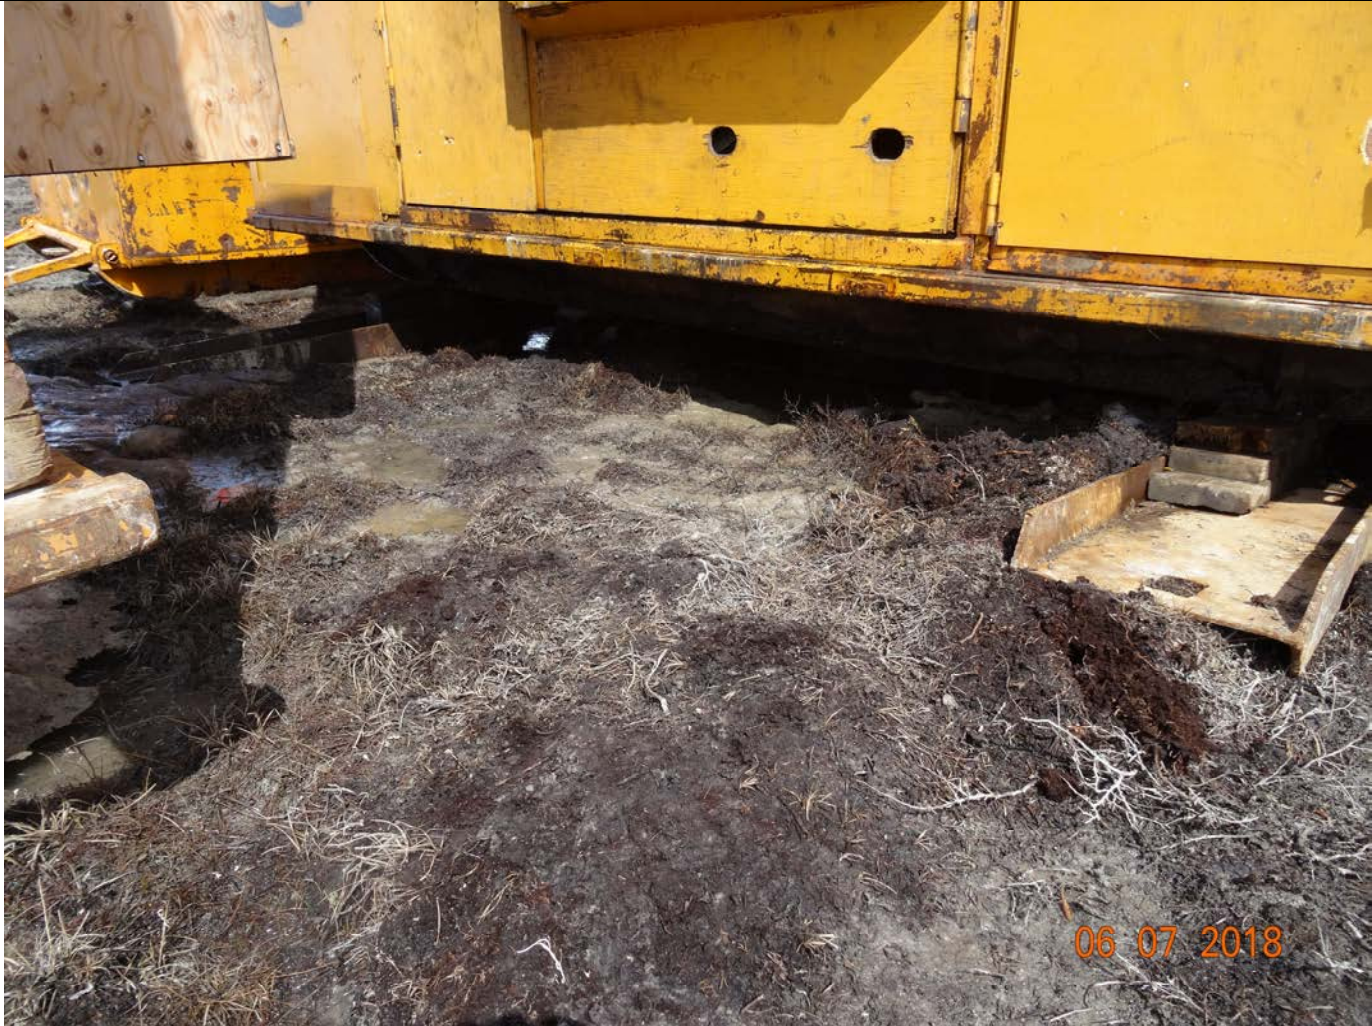
Photo No.
Photo 15

Description:
Drill 2: Cutting on the ground under the rig.

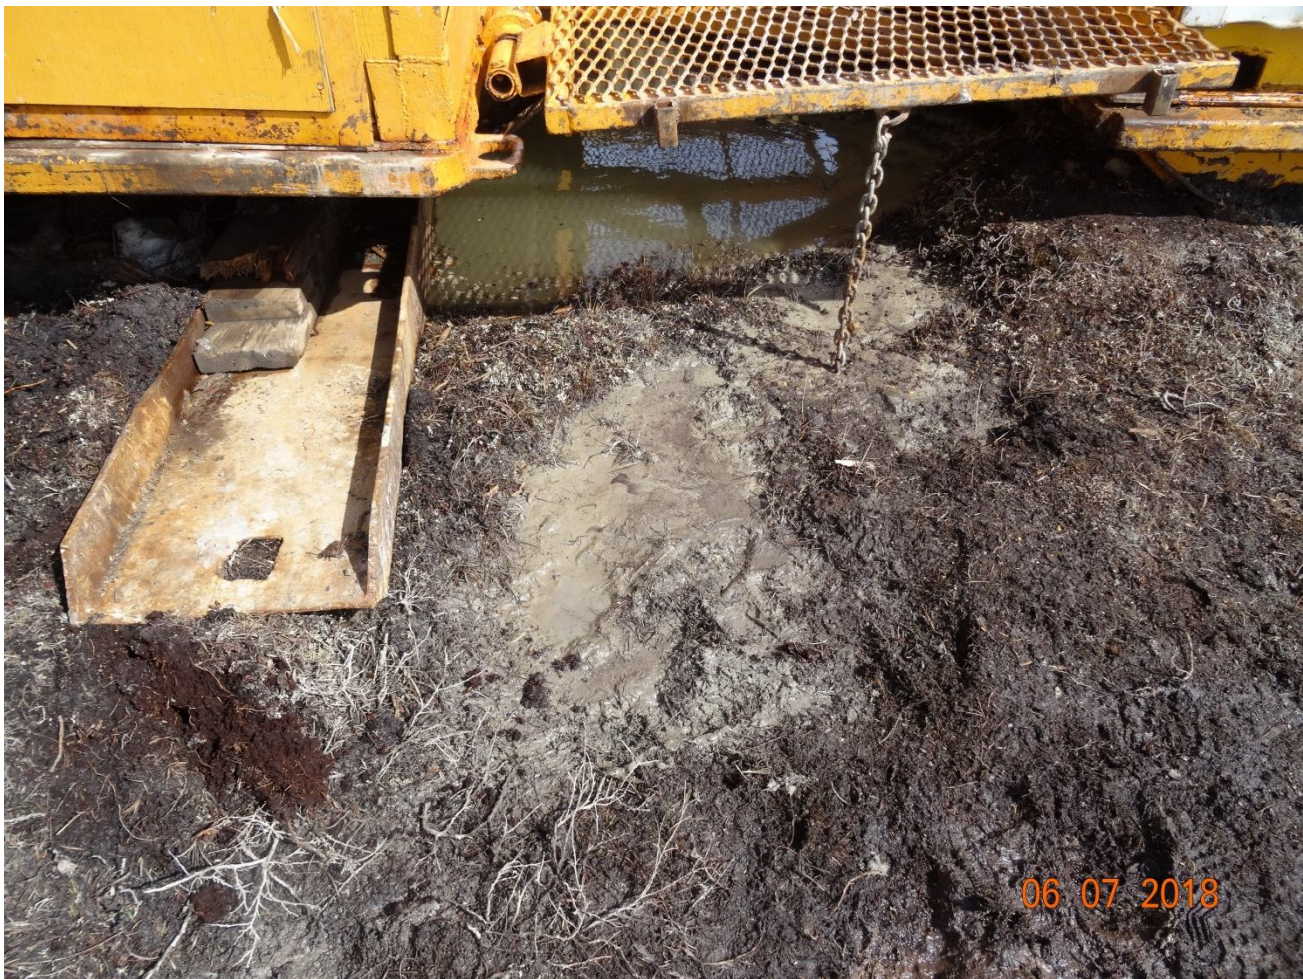
Photo No.
Photo 16

Description:
Drill 2: Drilling within 31 meters of a waterbody.
