WATER LICENCE INSPECTION FORM

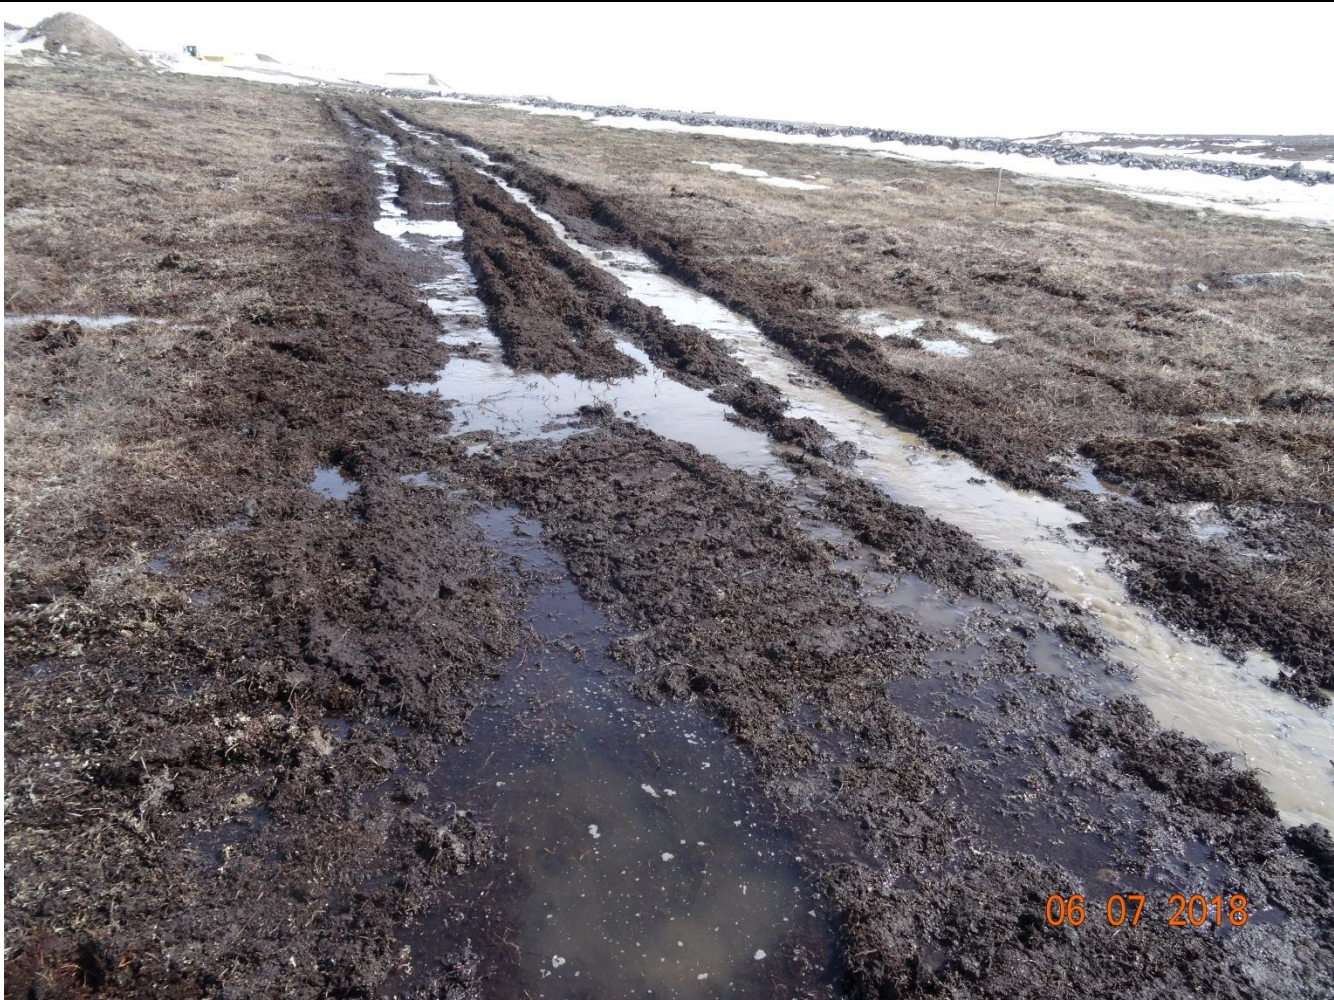
Photo No.	Lat/Long (DD.MM.SS.SS, NAD83)
Photo 17	N63° 1' 27.95", W92° 13' 51.77"

Description:
Drill 2: Rutting from Meliadine Esker to Lake B8-B9 drainage

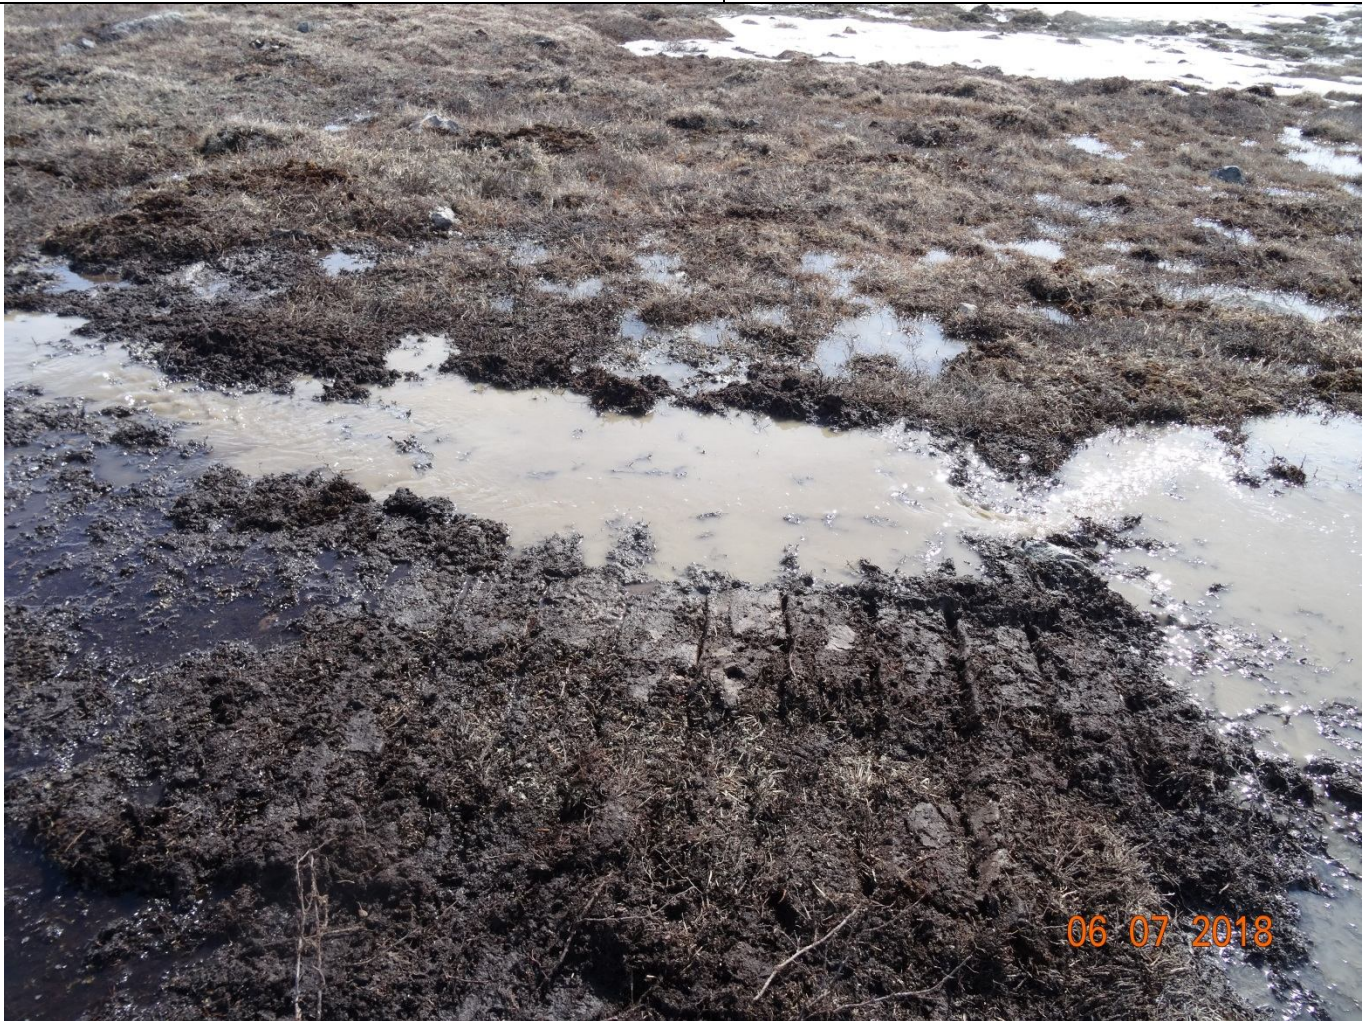
Photo No.	Lat/Long (DD.MM.SS.SS, NAD83)
Photo 18	N63° 1' 28.35", W92° 13' 54.2"

Description:
Drill 2: Brown water flowing through ruts to Lake B8 and B9.

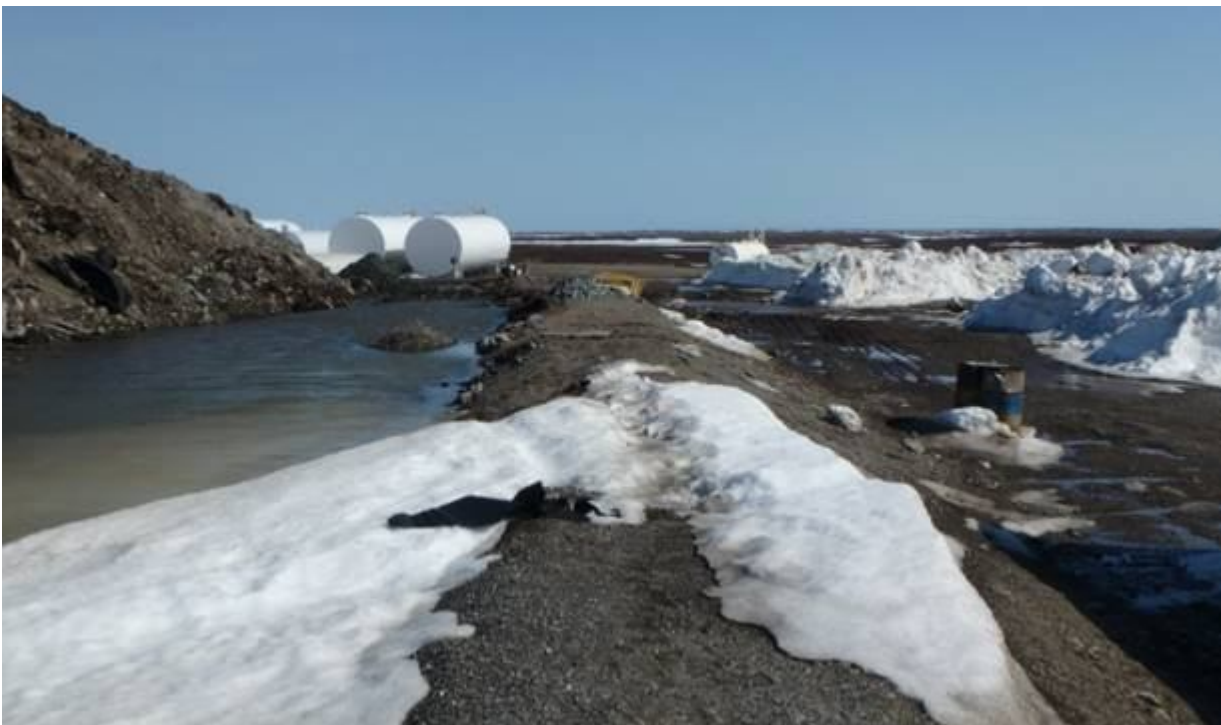
Figure 1: Snow removal and clear access to Landfarm ramp and berm – Looking south from west side of Landfarm Berm

- Snow has been removed to allow access to the landfarm ramp and empty fuel storage tank that is stores adjacent and east of the landfarm (Figure 1).
- Fuel has not been observed under the fuel storage tank, however, absorbent booms have been placed downstream of the melt from under the tank as a precaution (Figure 2a and 2 b).

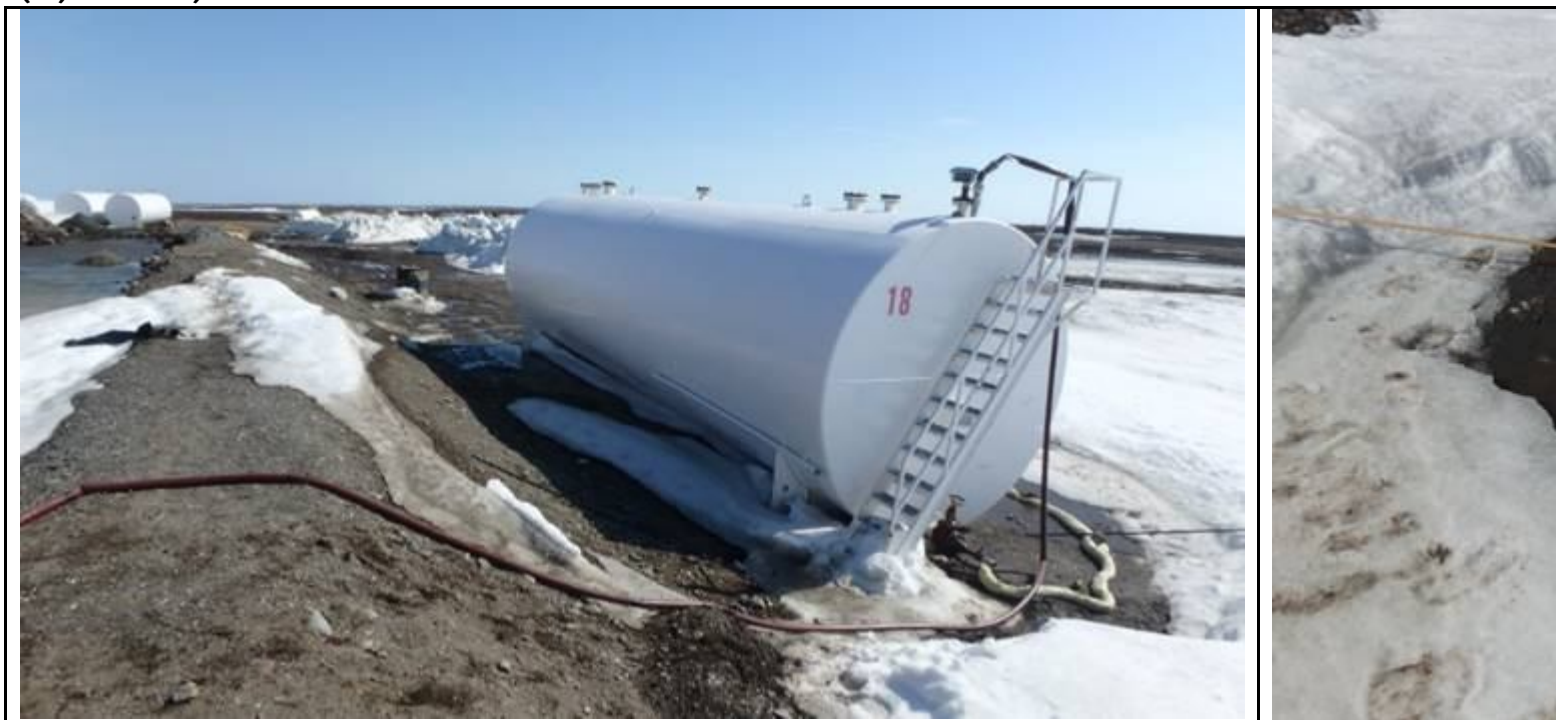
Figure 2a and 2 b: Absorbent boons placed downstream of snow melt under fuel storage tank (looking (2a) south and (2b) northeast)

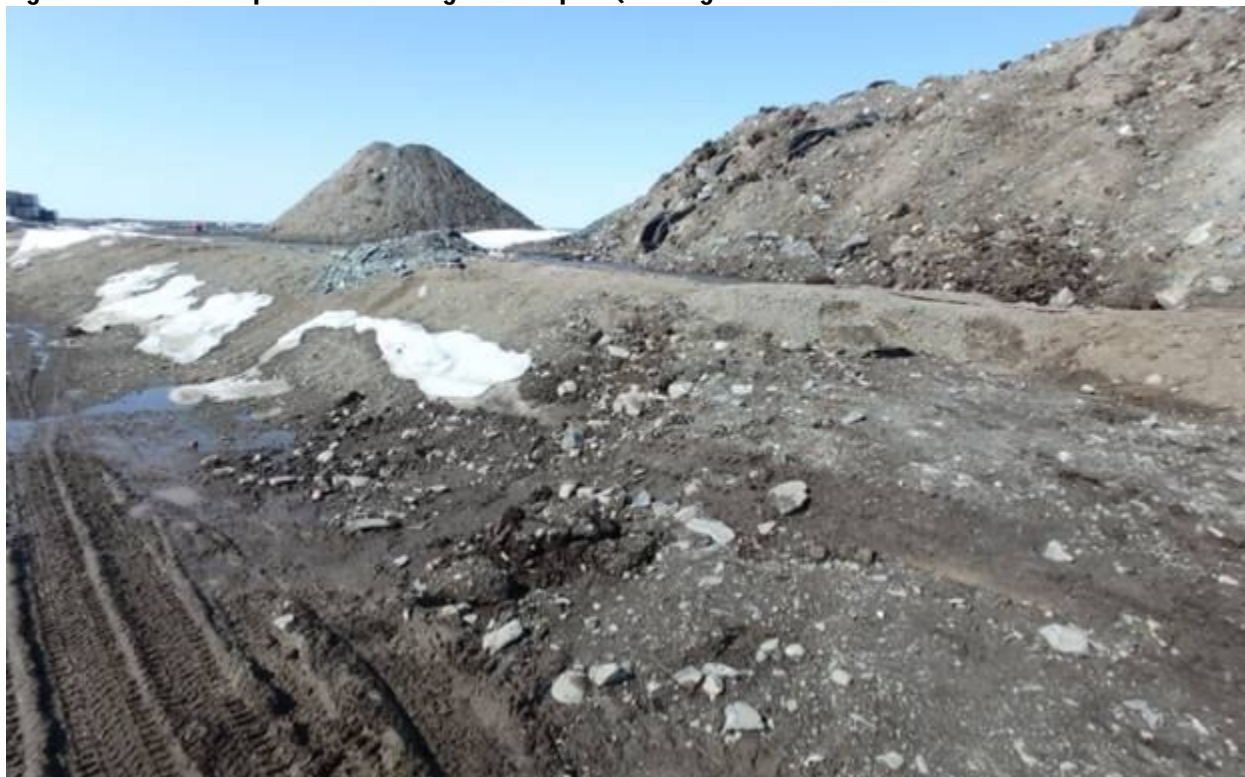
Figure 3: Raised ramp and containing berm repair (looking northeast from west side of landfarm berm)

- The berm and landfarm ramp has been raised and filled to contain water within the landfarm berm (Figure 3).
- Water contained within the landfarm berm is pumped daily to lower water levels as snow continues to melt.

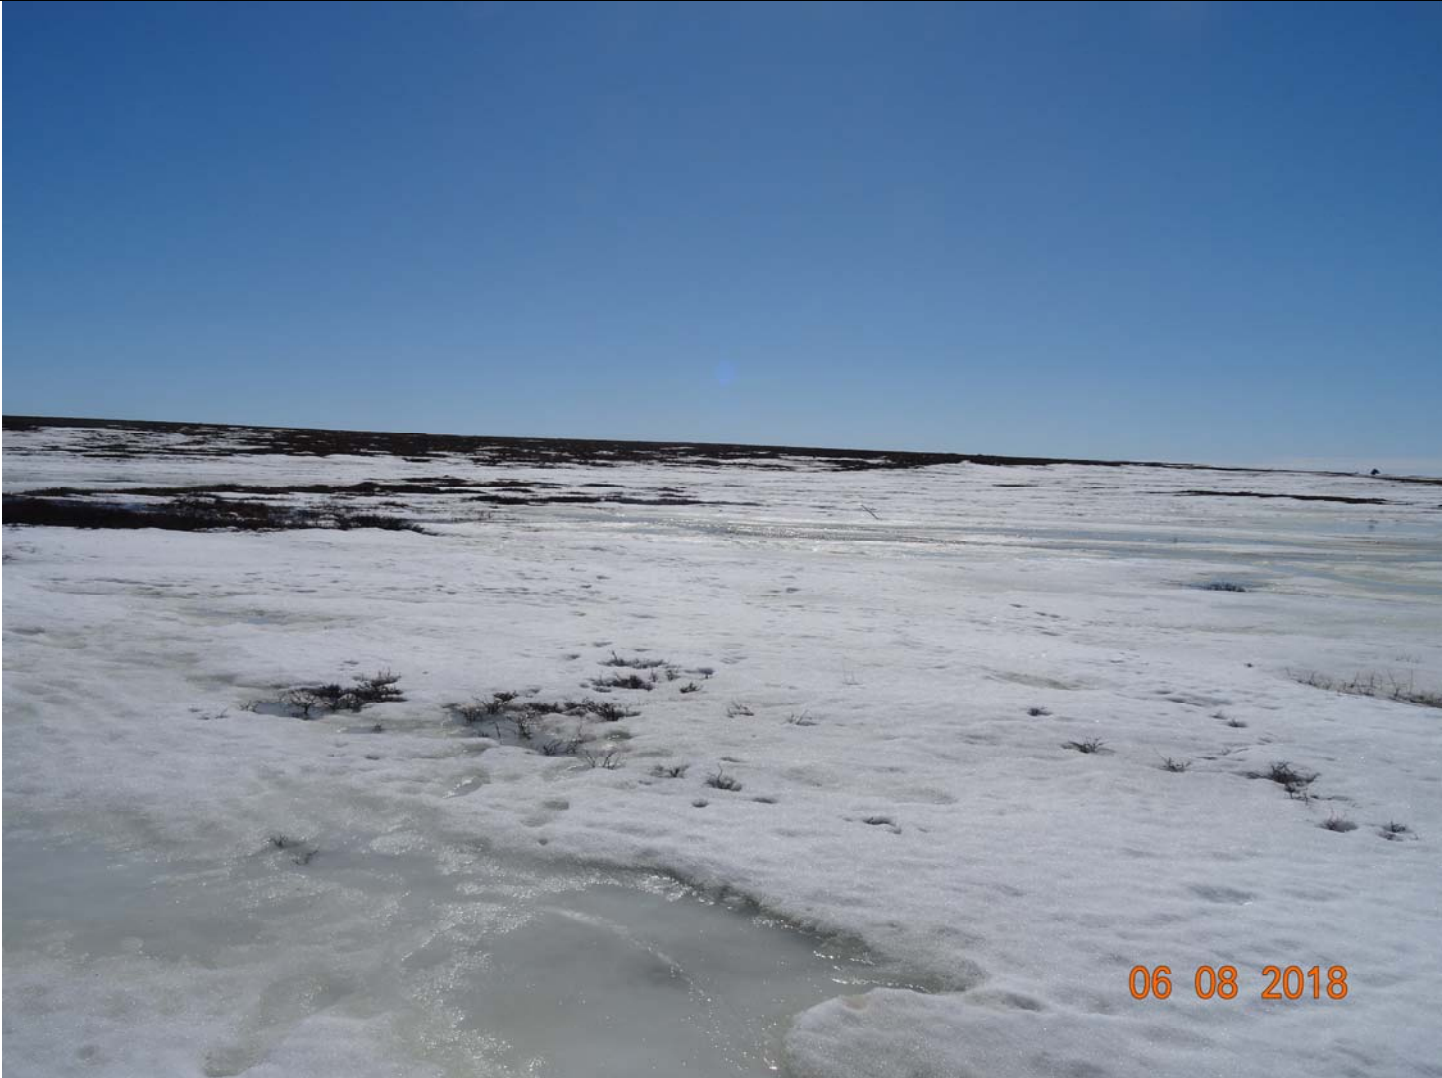
Date:	Authorization Number:	Camera/Model:	Inspector
June 8th, 2018	2BB-MEL1424	Sony DSC-HX50V Cyber shot	WRO Wilson
Photo No.		Lat/Long (DD.MM.SS.SS, NAD83)	
Photo 1		N63° 00' 6.46", W92° 9' 29.78"

Description:
Mid frame: flowing stream between to lakes.
