Meliadine Exploration Project

Response to  
Water licence 2BB-MEL1424 Inspection Report  
Inspection conducted by INAC's inspector on  
June 8<sup>th</sup>, 2018

Prepared by:  
Agnico Eagle Mines Limited, Exploration Division

Submitted to INAC  
July 6<sup>th</sup>, 2018

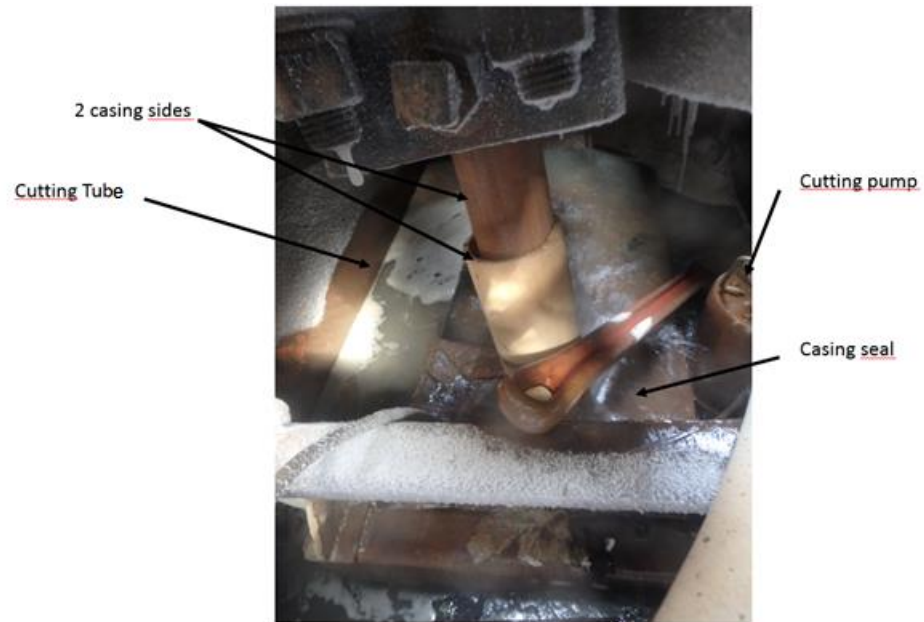
Figure 1, Cuttings tube around casing

- When drilling on ice, Agnico Eagle Exploration Division’s drilling contractor installs 3 casings with a tube and seal around them to prevent cuttings from spilling on the ice (Figure 1). The waste water is then pumped in the decantation system allowing solid particles to settle in the bottom of the tank and the treated water to be reused for drilling (Figures 2 and 3). The settled cuttings is then pumped, transported on land and disposed of. It has been determined that the cuttings present on the ice during the inspection was a spill that occurred during a move of the tank. The spill should have been cleaned directly by the drilling company as soon as it occurred. Instructions on this procedure were recalled by the geologist in charge and these cuttings on the ice were shoveled by the geology team as shown on Figure 4.

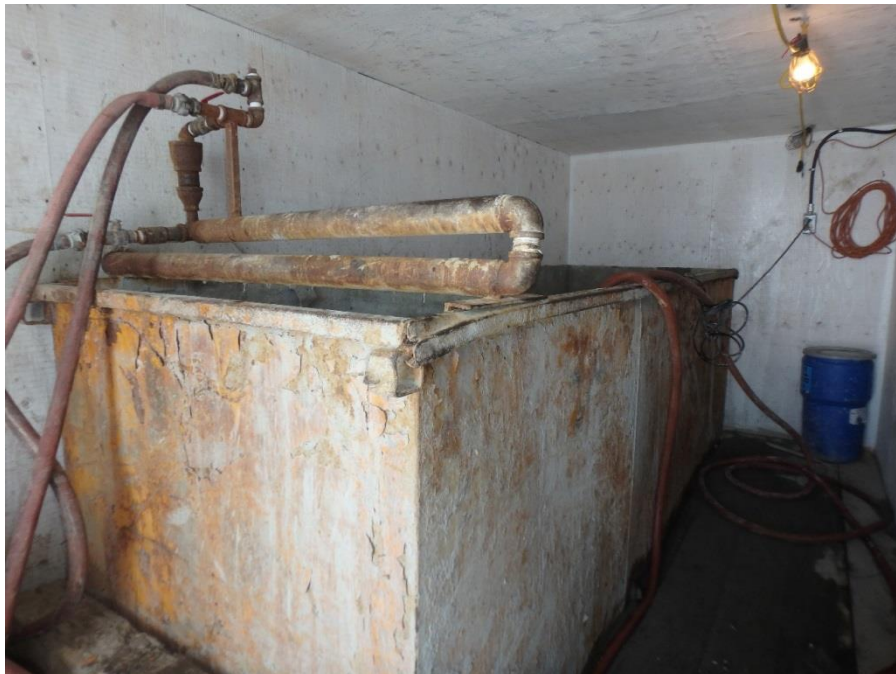
Figure 2, Waste water settling tank

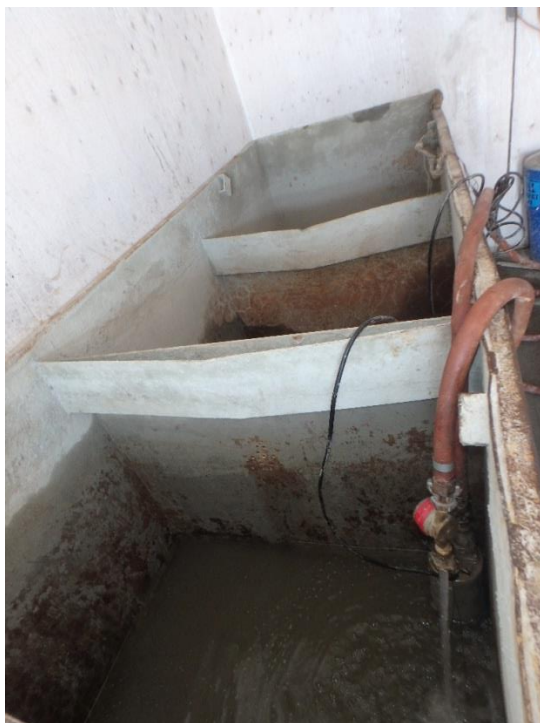
Figure 3, Waste water settling tank

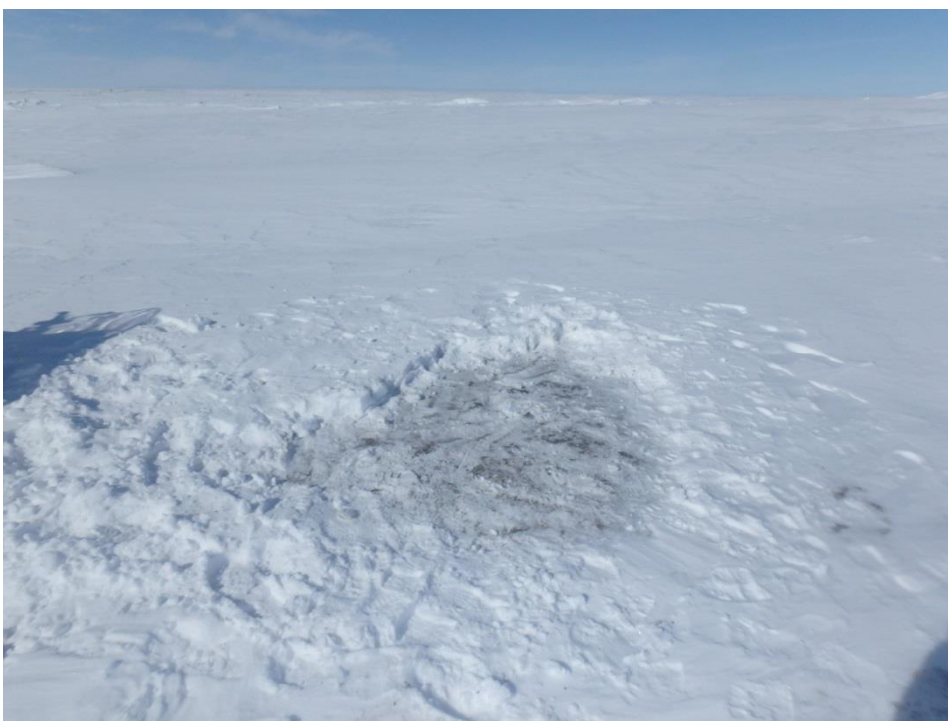
- ✓ Concerning the failure to dispose drill waste thirty one (31) meters from the ordinary high water mark described in the May 10<sup>th</sup> 2018 inspection report. The situation was related to cuttings present on the ice.

Figure 4, Cuttings removal at hole M18-2445

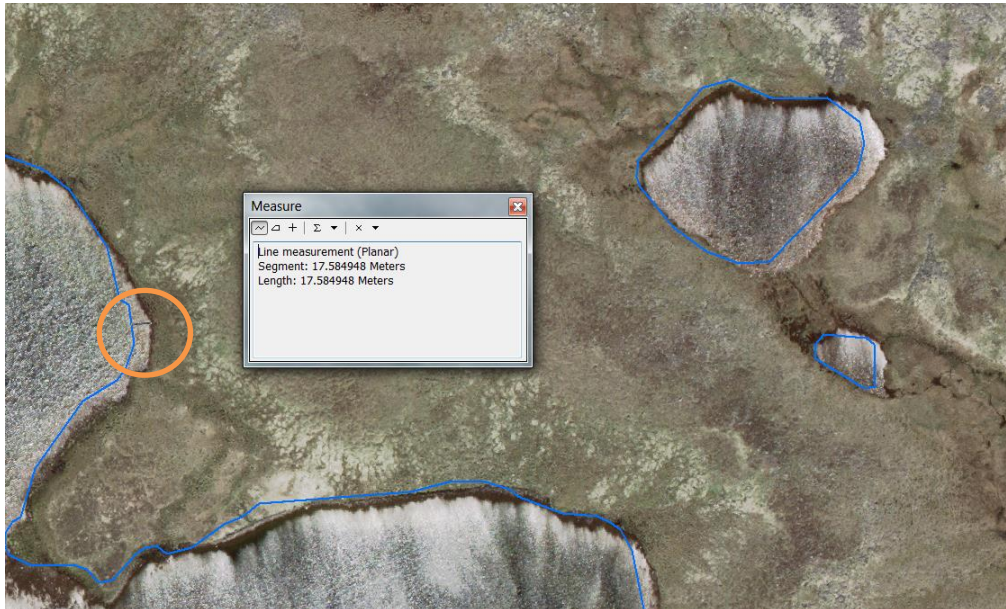
- A verification of the precision between the lake and creek shapefiles coming from the government of Canada vs the high resolution satellite pictures bought by AEM showed that a gap between the locations of the water boundaries exists between these tools. This gap is, in certain situations, large enough to create potential non-compliances with the licence and this, mainly during the winter period. For this reason, following the assessment of the situation, the procedure EXP-ENV-001 now includes an improved procedure for the planning of drilling sites, thus reducing the associated risks.

Figure 5, Example of gap between lake boundaries

- The procedure EXP-ENV-001 has been updated to reduce the environmental risks related to exploration activities and to ensure compliance with the authorizations. The procedure is attached and available for comments. Adjustments to the tools and procedure used to localize the drilling and cuttings disposal in regard to the water bodies is now described in the procedure and this will improve the confidence about the respect of the 31 meter buffer zone, even during the winter period when the high water mark can be difficult to localize on the field.

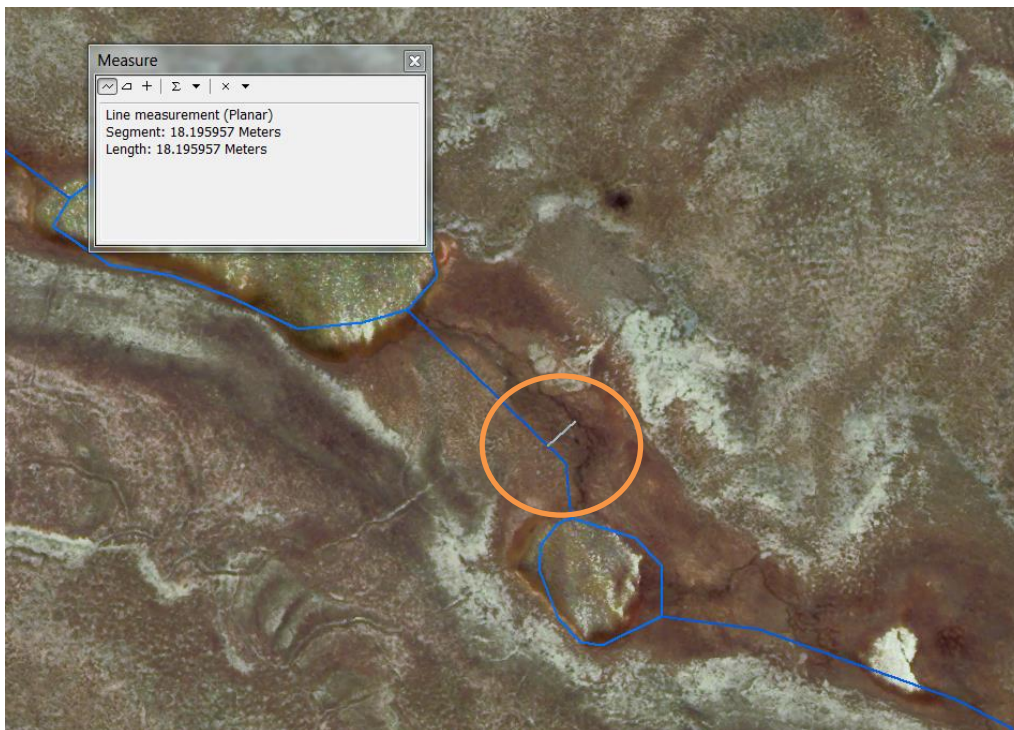
Figure 6, Example of gap between river/creek location

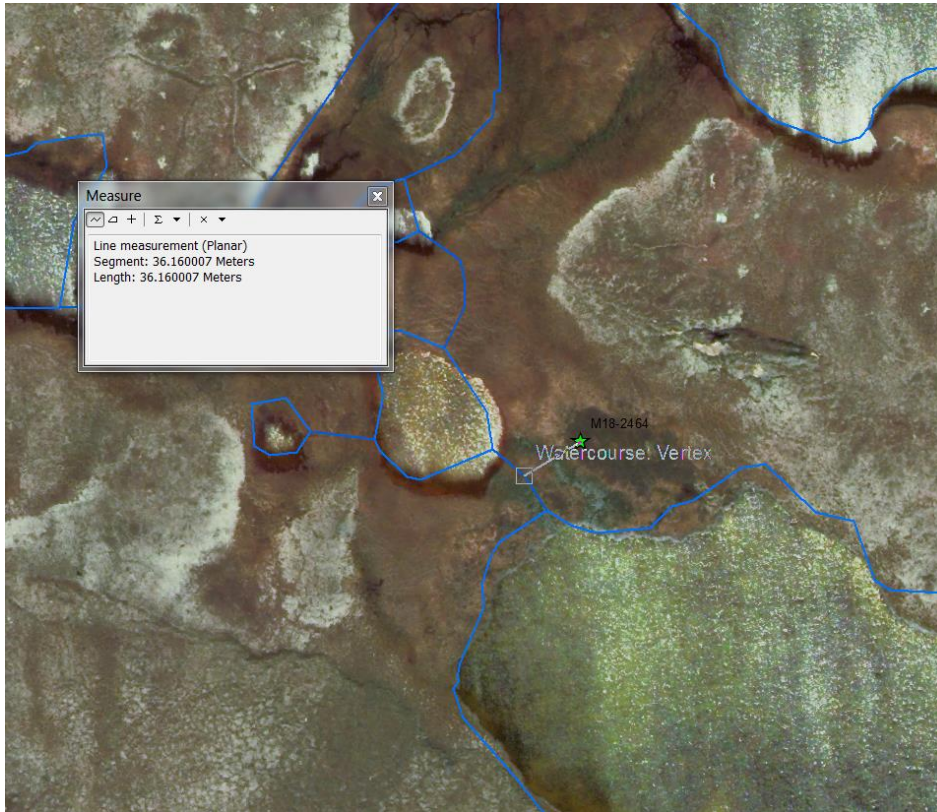
2. The drill site is located between two small water bodies, with the actual drill approximately 60ft from a flowing stream (Photo 1). The inspector is concerned that the proponent may have failed to meet the requirements of PART F item 1.

- As discussed above, we can see that when using the Canada water course shapefile, the hole M18-2464 was located at 36 meters from the creek, but due to the gap between the reality in the field and the tool, the hole was drilled nearer than planned. To reduce the risk in the future, the procedure EXP-ENV-001 has been updated and the protection buffer extended internally with respect to the planning tool we use and this, in order to avoid working within the thirty-one (31) meter from a water body, even during the winter period unless otherwise authorized to do so by the Nunavut Water Board.

Figure 7, Distance between hole M18-2464 and creek presumed location

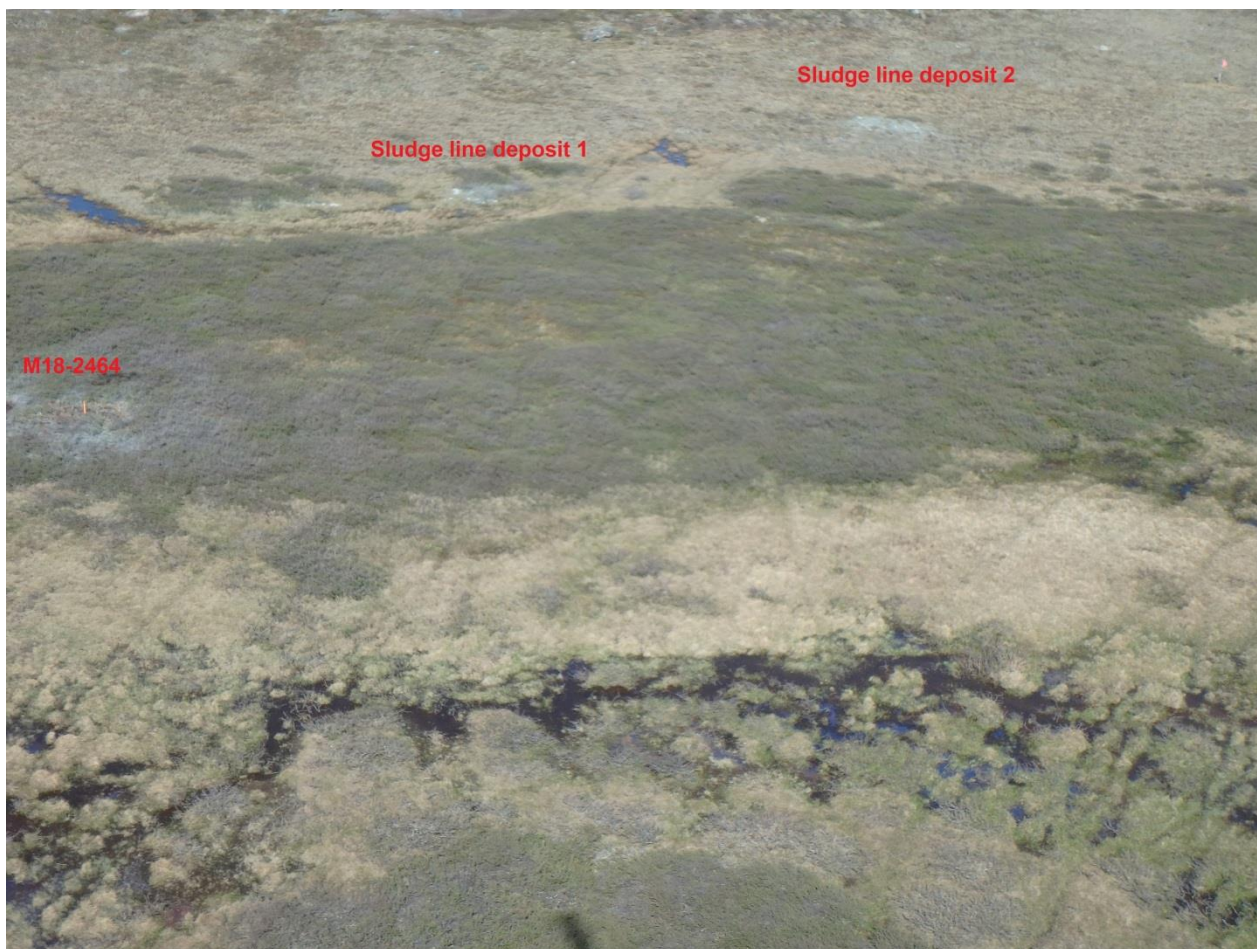
4. The cuttings line is located on the north east side of the drill rig. Though the location of the line appeared to be 31 meters from a water body, the cuttings waters would have connectivity with the nearby lake because of freshet. This activity fails to meet the requirements of PART F item 2.

- Observation 3, the cuttings disposed by the sludge line associated to hole M18-2464 were measured to be located at more than 31 meters from a water body. A visit of the area on July 3<sup>rd</sup> concluded that the cuttings disposed at the 2 cuttings deposits for hole M18-2464 had not migrated toward the ponds.

Figure 8, Location of the cuttings deposits

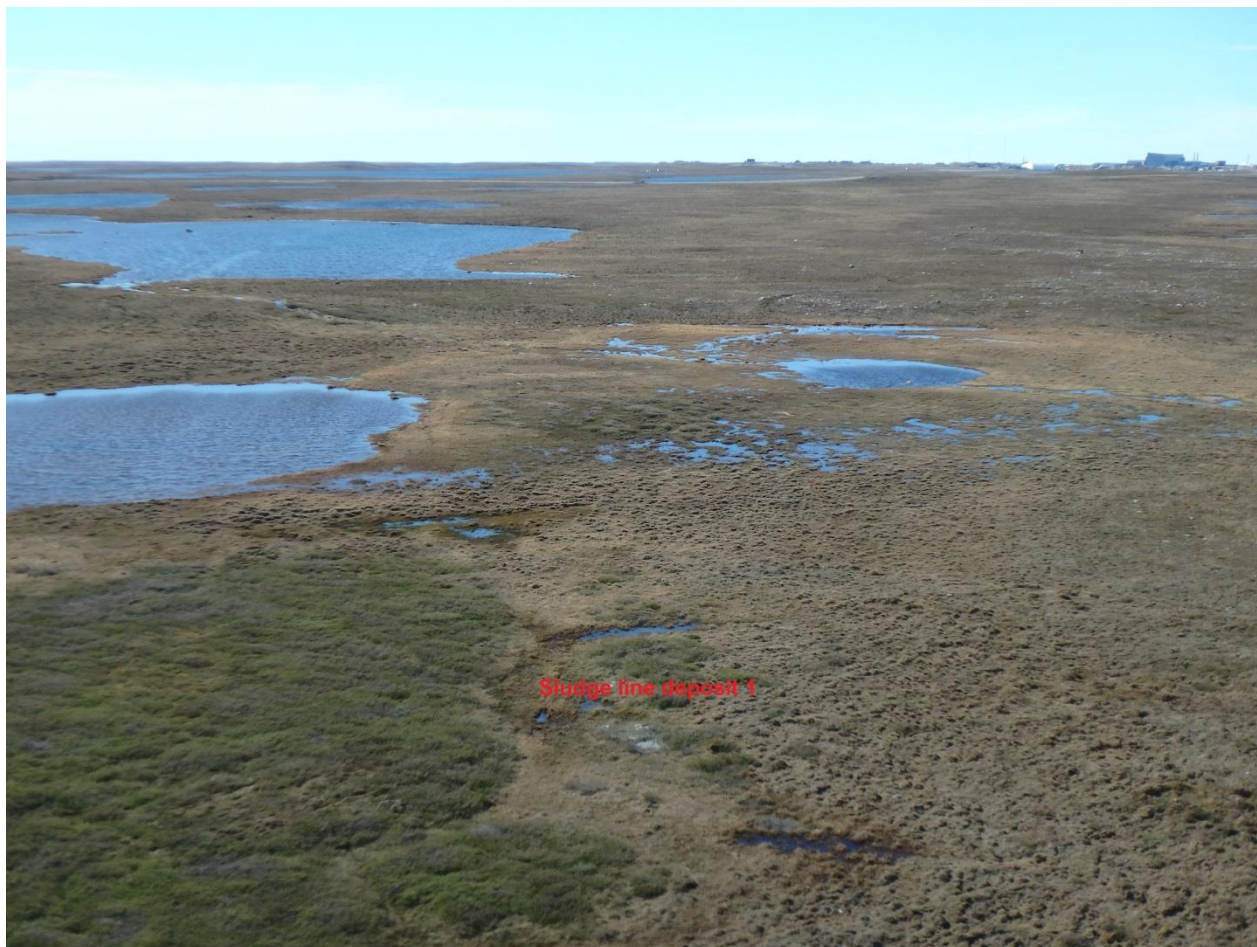
Figure 9, Cuttings deposit 1
