WATER LICENCE INSPECTION FORM

| Agnico-Eagle Mines Limited | Jennifer Brown |
| 2BB-MEL1424 / July 21 st 2024 | Environmental Coordinator |
| September 20 th to 21st 2018 | WRO T.Morton |

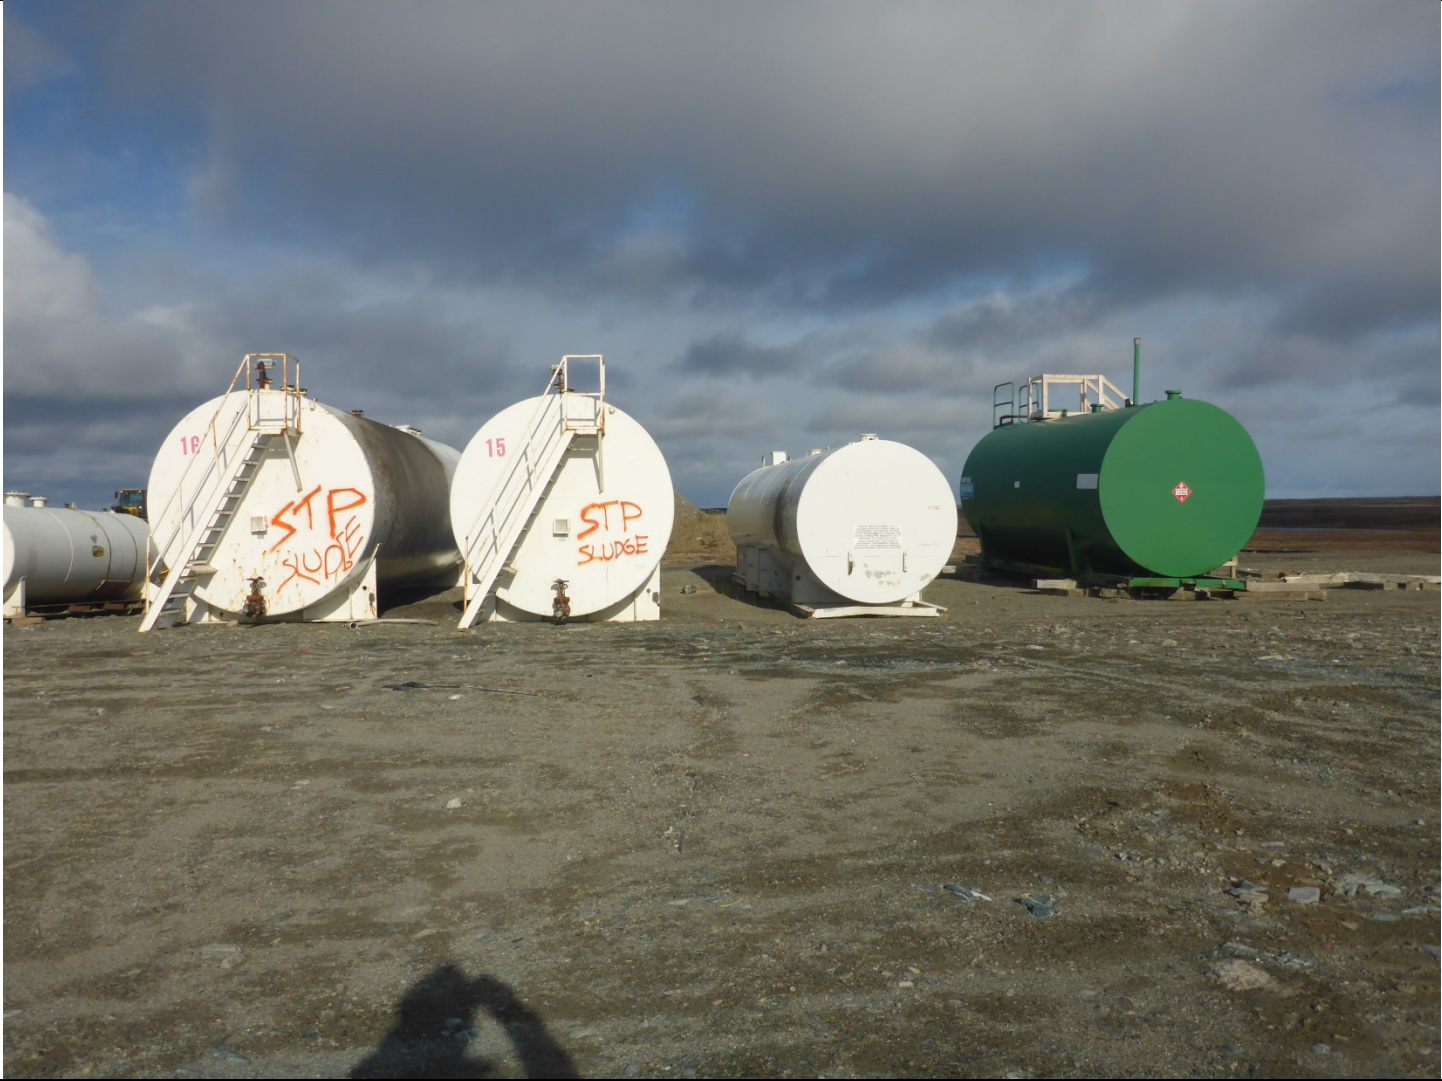
| Date: | Authorization Number: | Camera/Model: | Inspector |
|---|---|---|---|
| Photo 1 | | | |

| Description: |
|---|
| Overview of the old tank farm area. Note the tanks labeled “STP Sludge” |

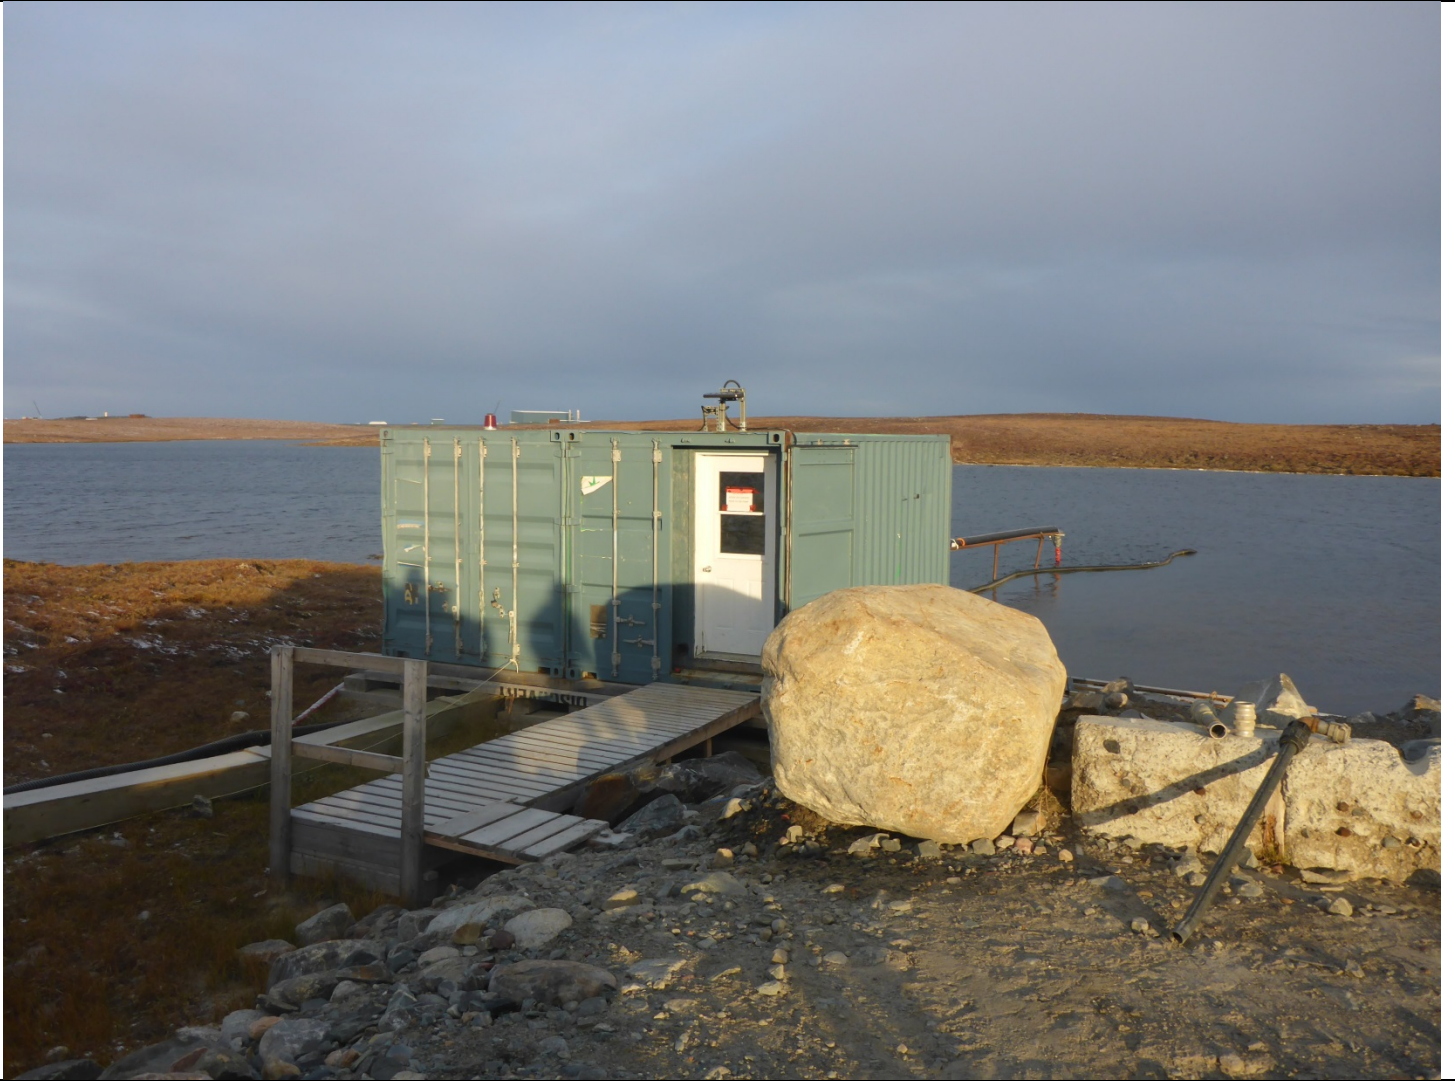
| Date: | Authorization Number: | Camera/Model: | Inspector |
|---|---|---|---|
| Photo 3 | | | |

| Description: |
|---|
| Overview of the water intake facility at the exploration camp. |

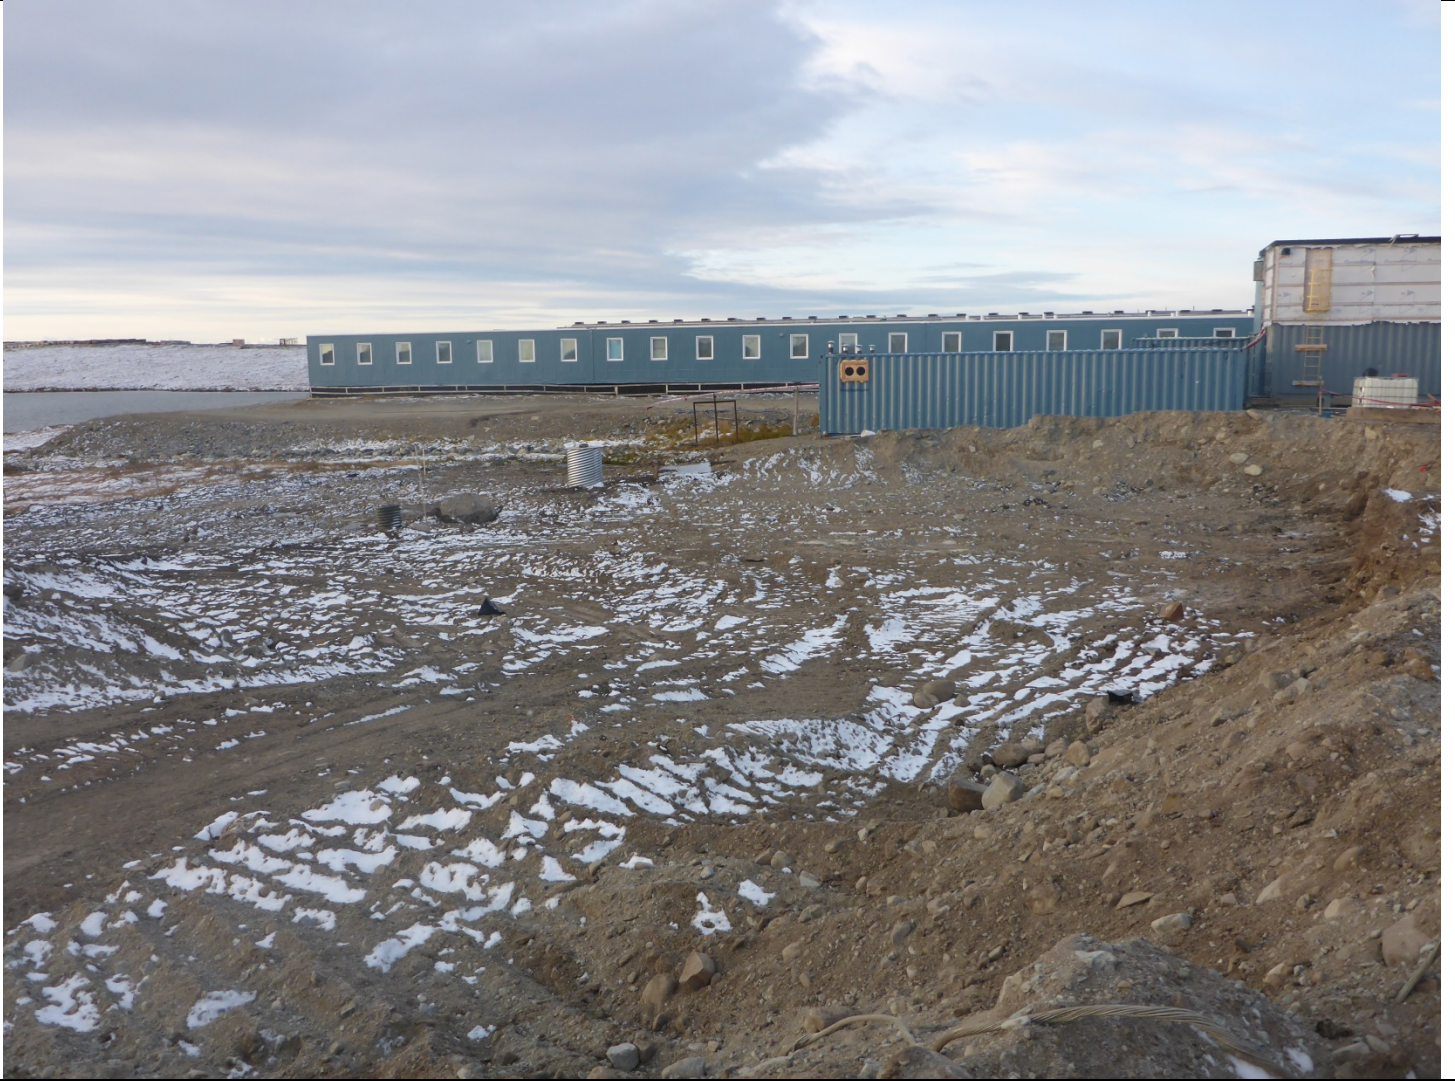
| Date: | Authorization Number: | Camera/Model: | Inspector |
|---|---|---|---|
| Photo 5 | | | |

| Description: |
|---|
| Overview of the genset spill area located between the camp and Meliadine Lake. |

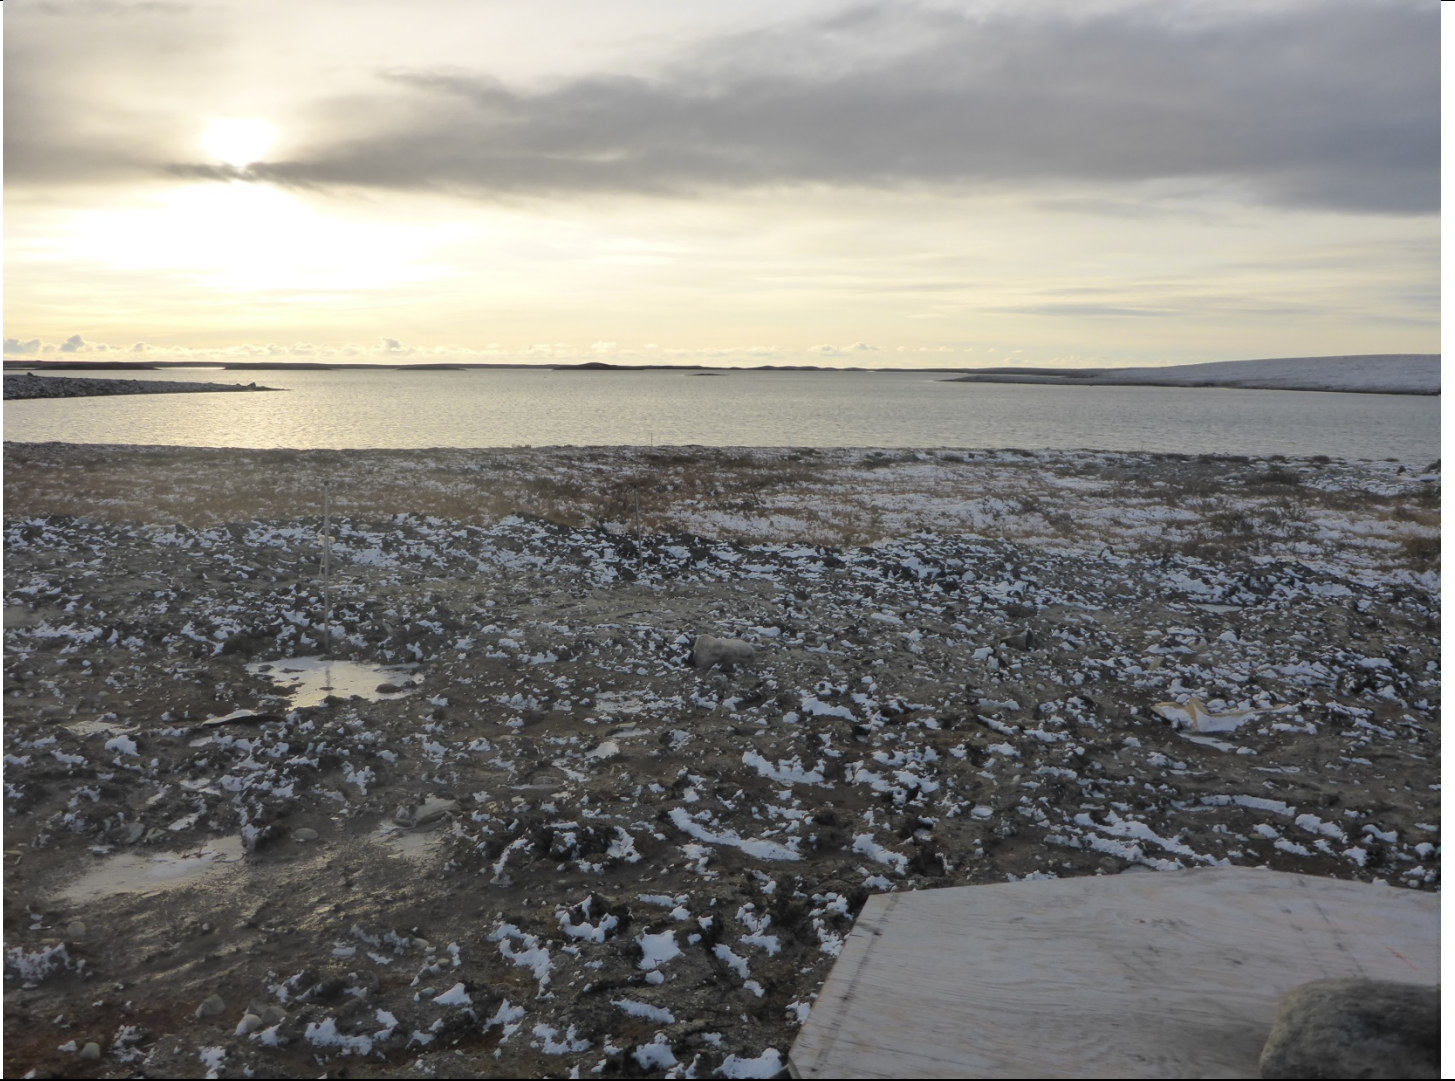
| Date: | Authorization Number: | Camera/Model: | Inspector |
|---|---|---|---|
| Photo 6 | | | |

| Description: |
|---|
| Genset spill location in relation to the shoreline of Meliadine Lake. |

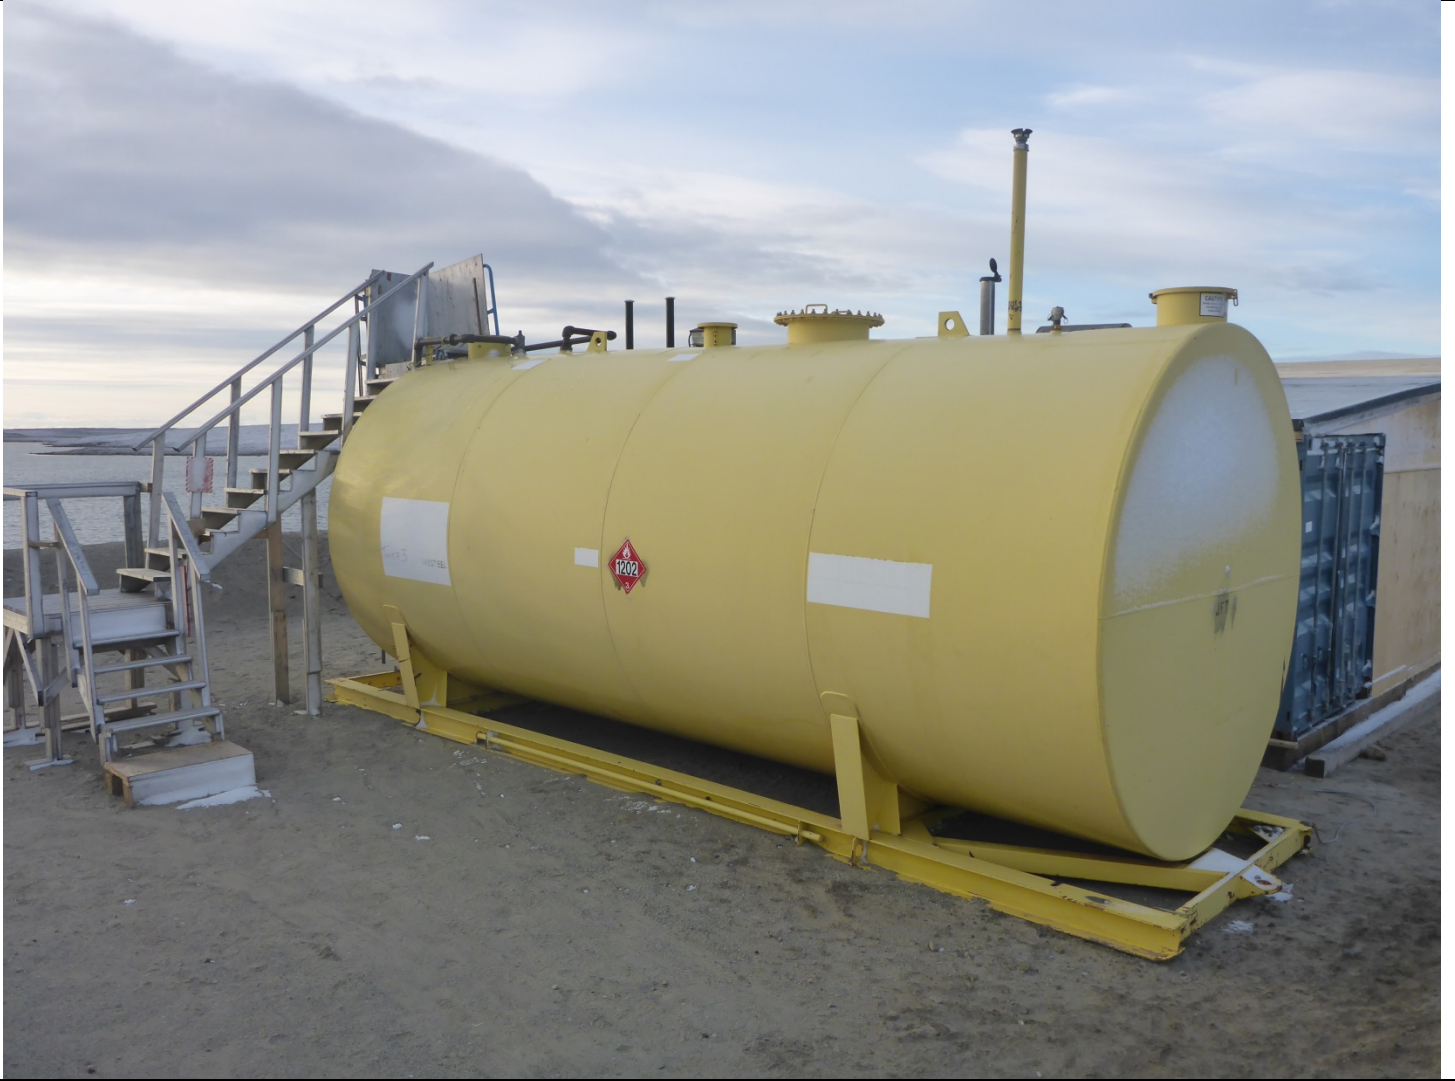
| Date: | Authorization Number: | Camera/Model: | Inspector |
|---|---|---|---|
| Photo 7 | | | |

| Description: |
|---|
| Fuel storage tank located near the exploration camp. |

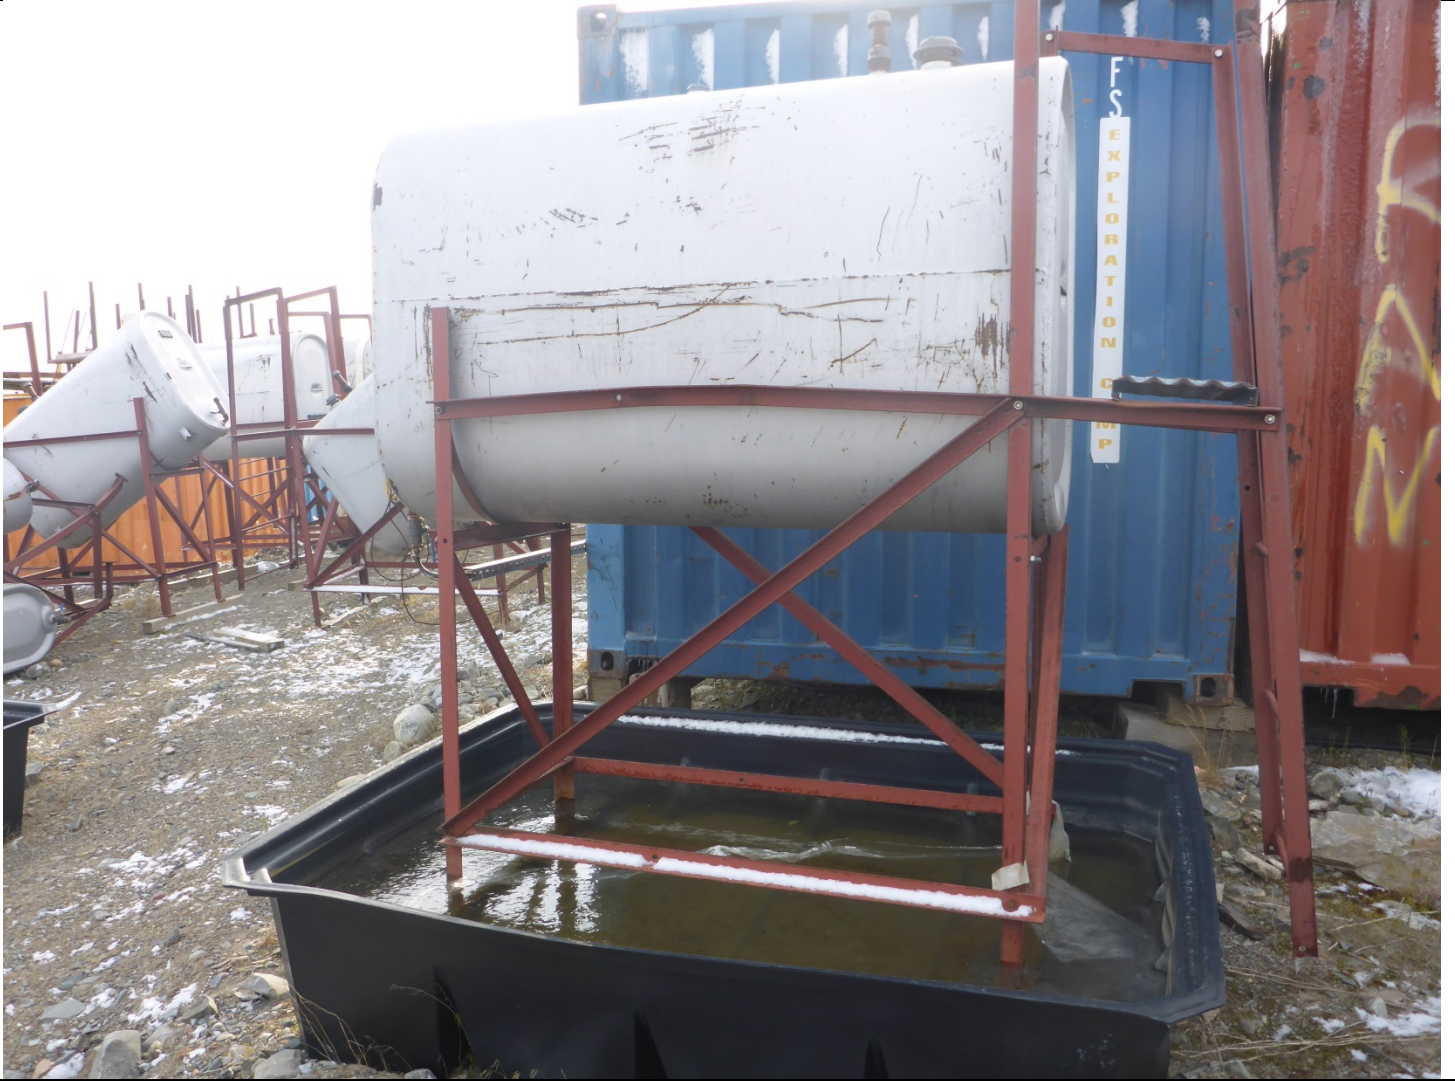
| Date: | Authorization Number: | Camera/Model: | Inspector |
|---|---|---|---|
| Photo 8 | | | |

| Description: |
|---|
| Small fuel tank with the secondary containment full of water and ice. |

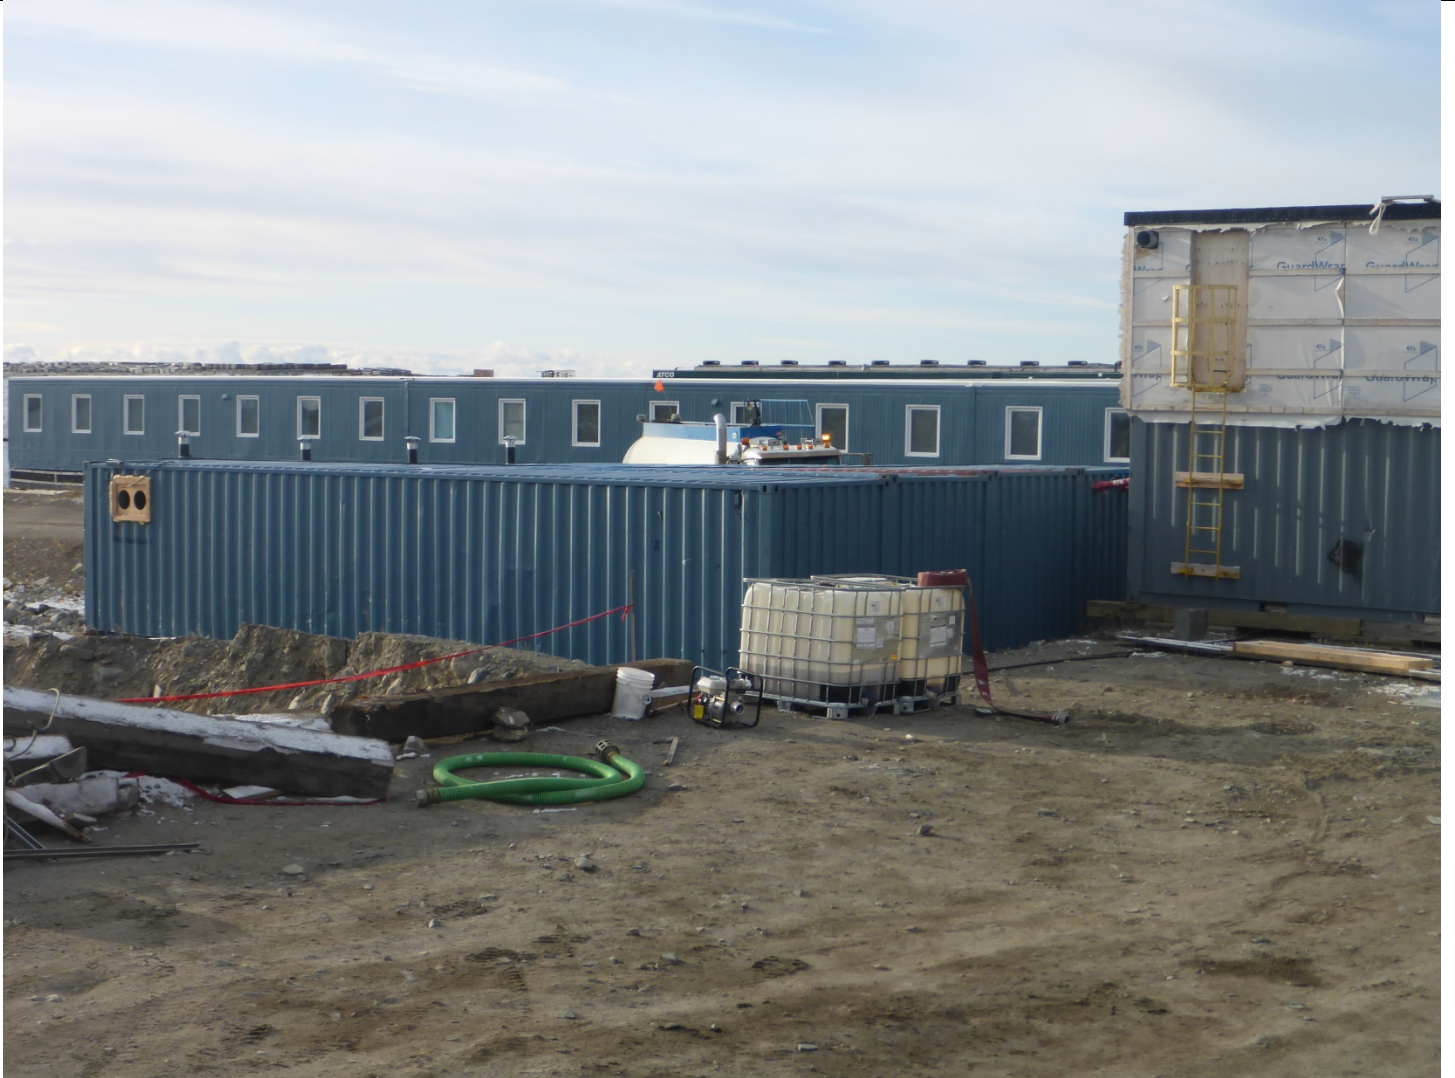
| Date: | Authorization Number: | Camera/Model: | Inspector |
|---|---|---|---|
| Photo 9 | | | |

| Description: |
|---|
| Overview of the camp sewage discharge location. |

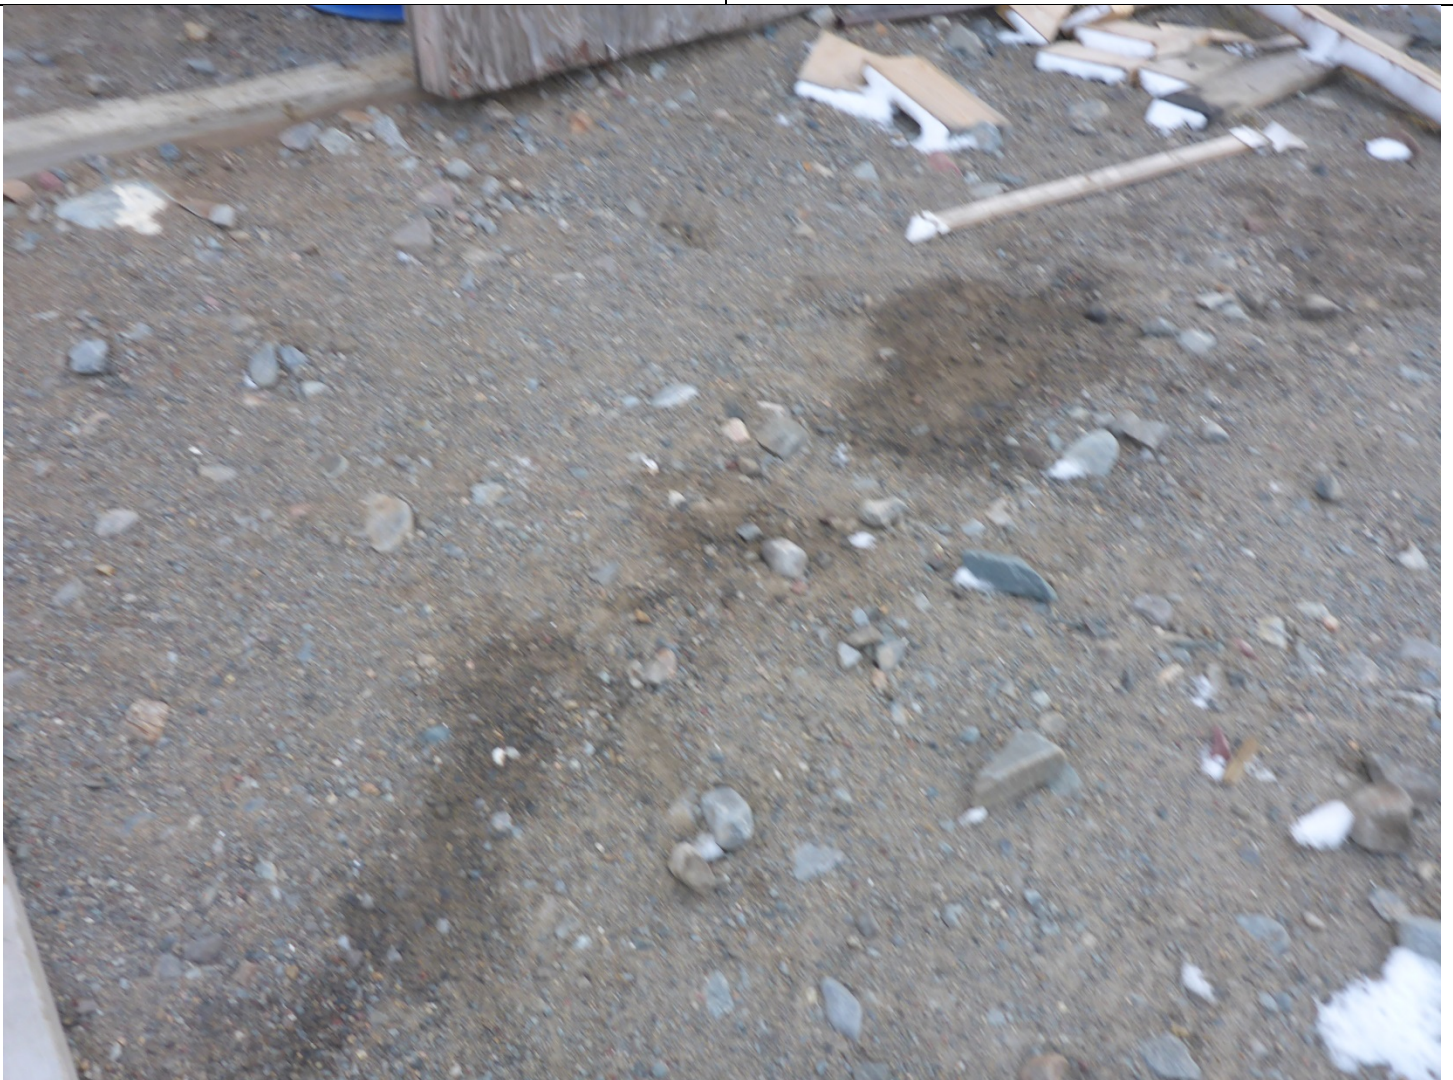
| Photo 10 | | | |

| Small hydrocabon stainting near the camps genset area. | | | |
