# Follow Up Report: #19-485

## December 16, 2019 Treated Sewage Water Spill

The following information refers to spill 19-485 reported by Agnico Eagle Mines Ltd. December 16th 2019, and is being provided in accordance with:

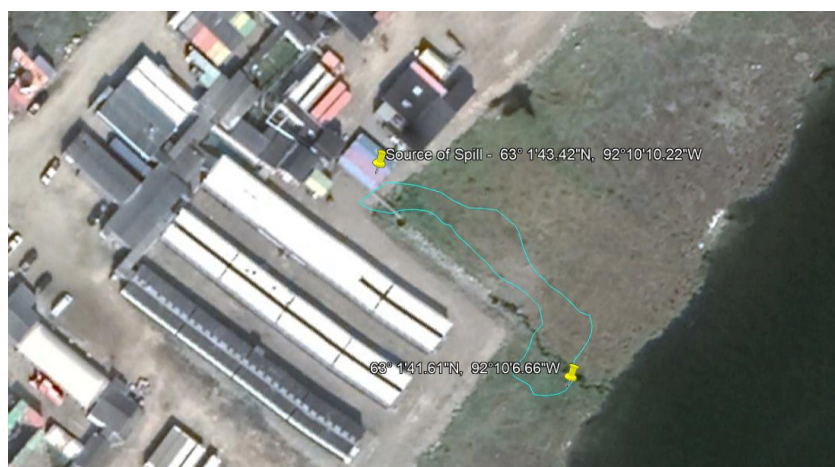
No water reached Meliadine Lake, however, it did freeze approximately 10 m from the shore. The retention tanks are located at 63° 1'43.42"N, 92°10'10.22"W. The extent that the frozen material migrated towards Meliadine Lake was 63° 1'41.61"N, 92°10'6.66"W (Figure 1).

**Figure 1:** Location and extent of spill area (blue line indicated area of frozen material).

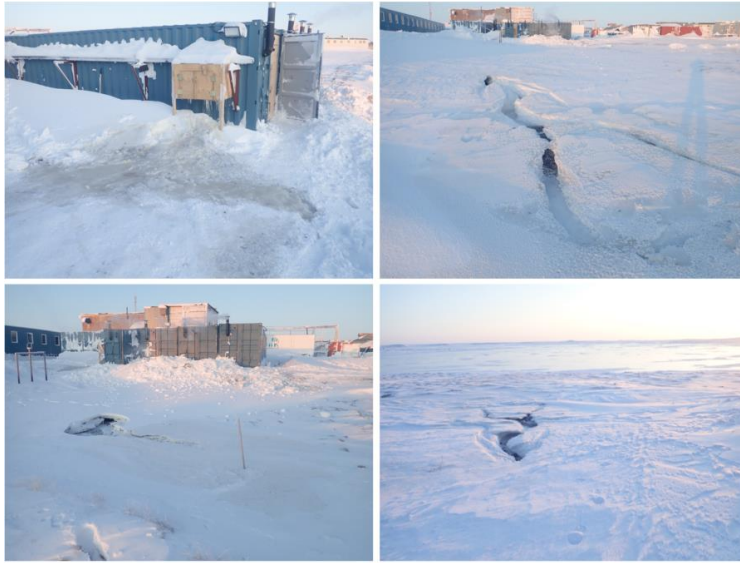
**Figure 2:** Spill area and proximity to Meliadine Lake.

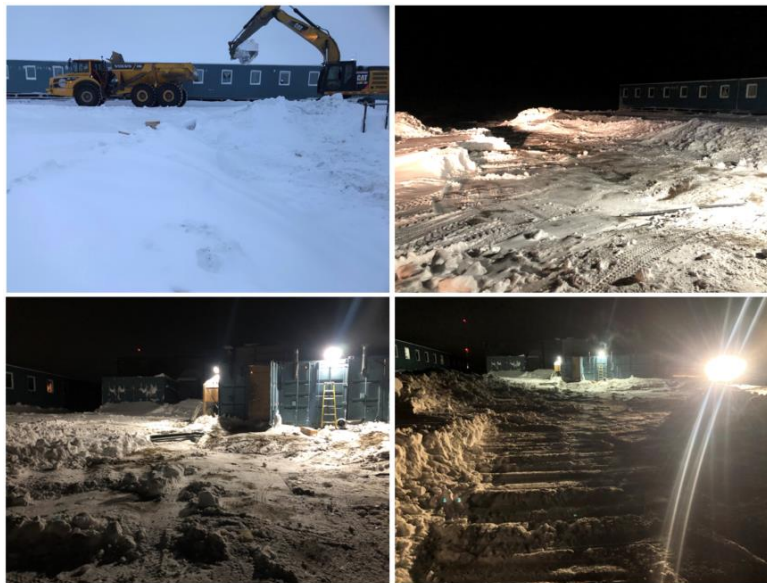
**Figure 3:** Spill location following clean-up.

A backhoe was used to remove as much contaminated snow and ice as possible without damaging the tundra (Figure 3). The material was loaded into a 40 tonne haul truck and trucked to the CP1 snow dump pile since this is the where the treated water is sent to normally (CP1). Nine full loads of material were removed and trucked to the snow dump.

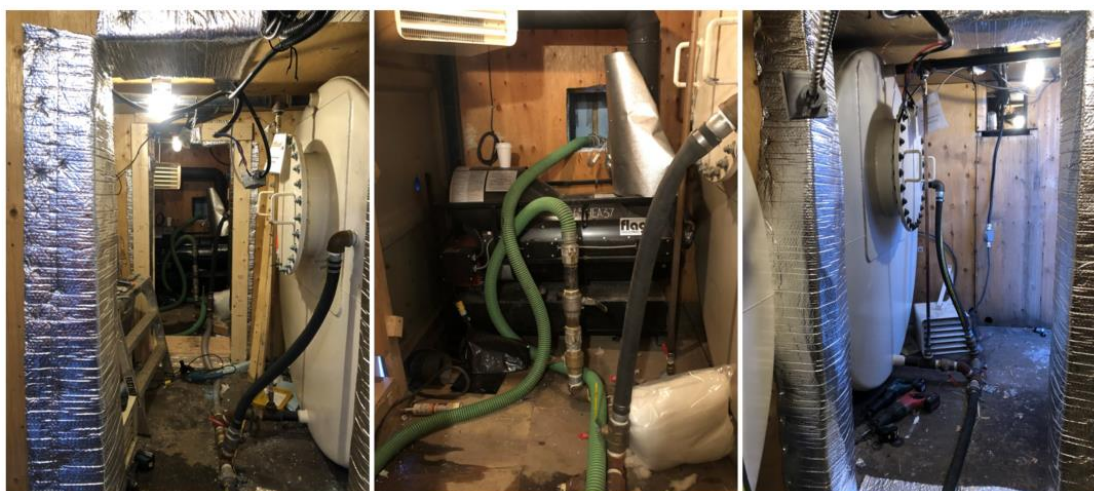
**Figure 4:** Improvements made to the interior of the retention tank storage containers. Four containers have been connected so that all lines running between tanks, are no longer exposed to external temperature. An additional heater was installed at ground level.

A major re-design of the storage containers, which house the retention tanks, has been completed. At the time of the incident, there were four retention tanks which sit inside individual sea-cans. The tanks were connected in series by pipes and small pumps which sit on the floor, and pass through the walls of each sea-can. This setup allowed for very small sections of the piping to be exposed to the cold, causing them to freeze. To mitigate this in the past, each sea-can is also outfitted with an industrial heater (frost-fighter) controlled by a thermostat, which was meant to prevent any piping from freezing.

The new setup (Figure 4) involves connecting each sea-can together from the inside so that no components need to be exposed to exterior temperatures. Large sections were cut from the wall of each sea-can so that they could be connected together, essentially creating one large container so that nothing is exposed to the outside. An improved heating setup has also been established which directs more heat to the floor where the temperatures are colder.
