# Follow Up Report:

## June 27, 2020, Jet-A / Waste Oil

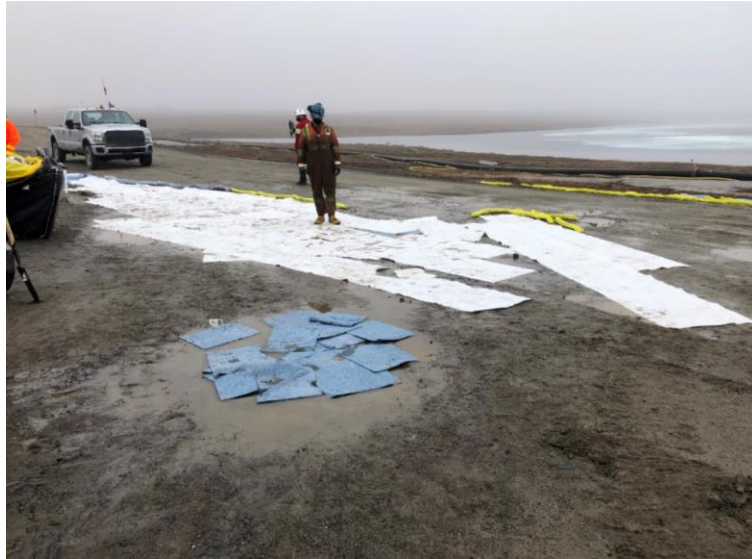
The spill occurred after a night of significant rainfall. The Jet-A fuel settled into a large puddle on the road, and spill pads and absorbent booms were used to contain the area (Figure 2). A sump was dug out using a back hoe so that a vacuum truck could be used to pump out the contaminated water from the puddle. This water was transported to the Landfarm A oil-water separator for treatment.

Figure 2: Initial Jet A spill initial containment.

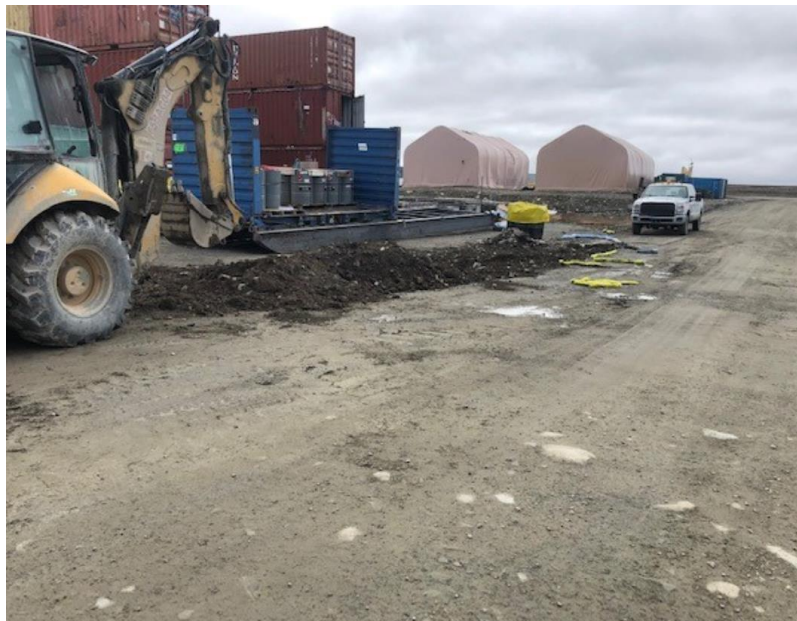
After the water was removed, the back hoe began clearing the contaminated gravel into piles, and a loader was used to transport all of this material to Landfarm A (Figure 3).

Figure 3: Contaminated gravel being removed from Jet A spill area.

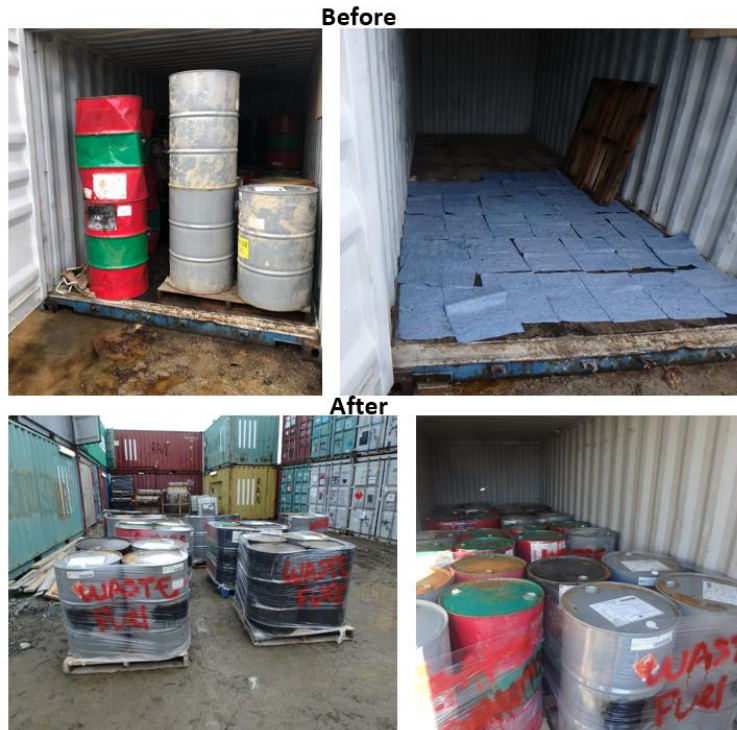
The area affected by the contaminated sea can was also excavated, and the sea can was removed to access the material underneath. The damaged drum was pumped into a new drum, the entire sea can was emptied, and the contents were repacked properly in order to avoid future spills (Figure 4).

Figure 4: Condition of the seacan before, and after decontaminating and repacking the drums.

The sea can was emptied and the drums were inspected and repacked properly. Several cubic meters of contaminated gravel was removed from the surface of this pad. An investigation was completed with all departments involved and the Environment Department has provided them with a list of corrective and preventative measures. These include ensuring that personnel use a mandatory spotter when moving hazardous materials with forked equipment, completing a full inventory of the remaining sea cans in that area, repacking any improperly stored sea cans, and ensuring that hazardous waste containers are shipped south each year.
