August 21, 2020

Subject: Presence of a Fuel Tank in Meliadine Lake | Action Plan update - Report 3

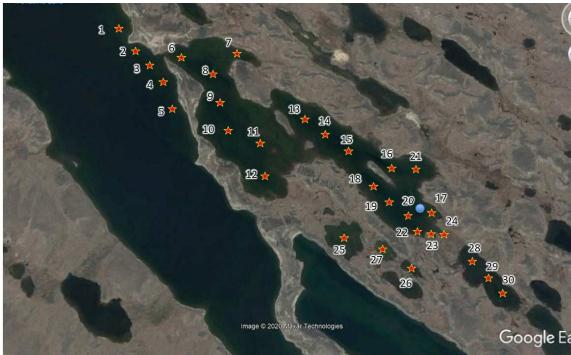
- Also, a plan of the water sampling points done earlier this week was developed (see Figure 1). It
 can be seen that many samples have been collected. Results of the analysis are expected to be
 available in about 1 week. Furthermore, all the available water samples in the area and at the
 fresh water supply of the mine are being collected and reviewed.

Figure 1 Sampling locations following the identification of the abandoned fuel tank on August 18 2020.
