Meliadine Exploration Project

**Fuel Tank in Meliadine Lake,
Closing Report**

September 17th, 2020

**Agnico Eagle Mines Limited,
Exploration Division**

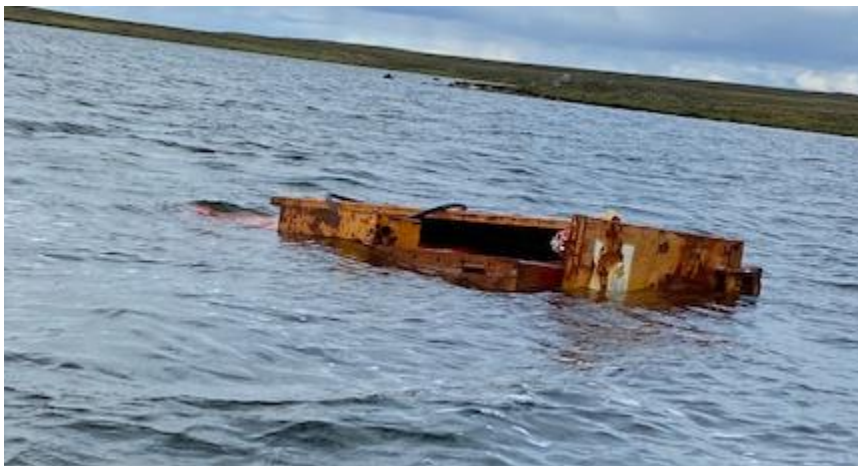
The initial assessment conducted by Agnico Eagle showed that it was located in a bay of Meliadine Lake, between the main camp and the Discovery Gold Deposit. The tank was a certified 4,640-litre double-walled fuel tank mounted on a steel sled used during winter drilling activities. It was inadvertently left behind on the ice surface by one of our drilling contractors after a 2019 winter drilling campaign and partly sank in the lake after freshet in 2019.

The tank was seen resting on its side, in shallow water. Given the fairly shallow water depth at this location, the fuel tank was partially submerged in the lake. The information received from our drilling contractor seems to suggest that this fuel tank was essentially empty after the drilling program when left at this location.

Figure 1. Fuel tank in the lake, August 19th, 2020

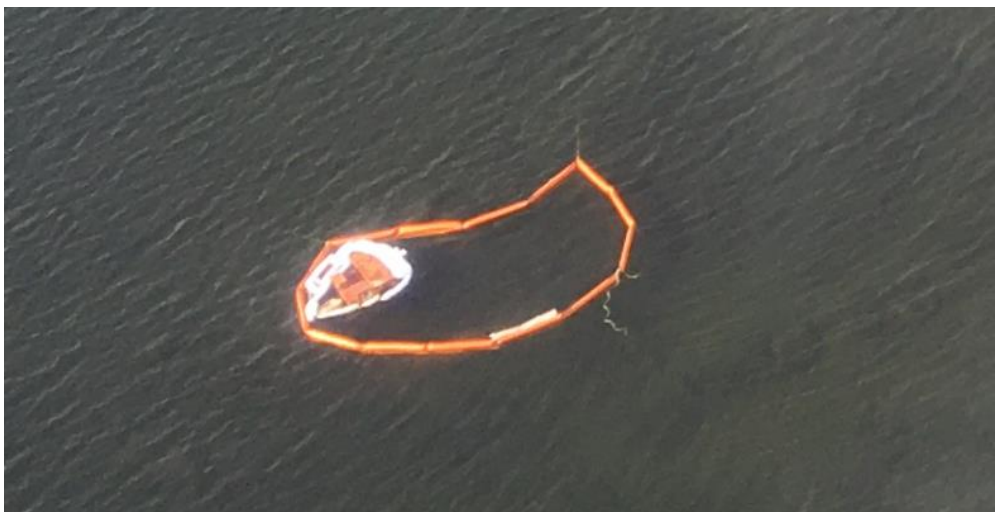
A visit of the area was conducted on August 19th by the Nunavut Environmental and the Geology departments. A marine containment barrier and absorbent booms (see Figure 3) were installed around the tank as a preventative measure, even if no visual evidence of a fuel (diesel) spill was seen on the water surface or on the shoreline. Several walks along the shore were conducted to verify if there were any evidence of a spill or contamination, none was observed.

Figure 3. Fuel tank inside containment barrier and absorbent booms

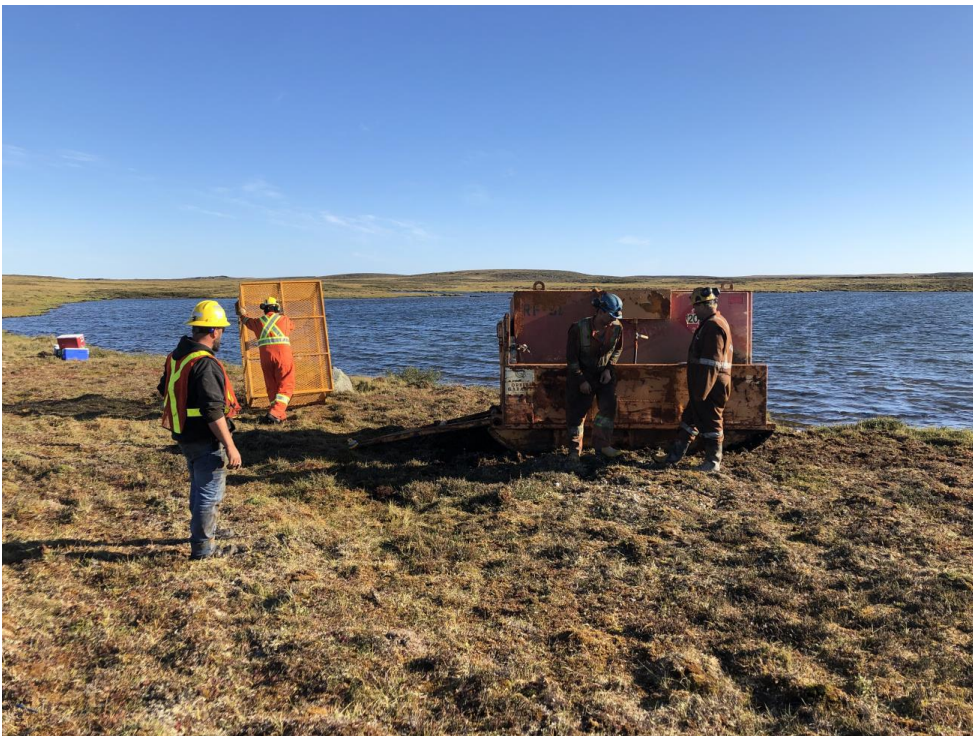
The 4 phases of the Action Plan (plan in Appendix B) were conducted on August 25th between 11AM CT and 6PM CT and resulted in a successful and safe tank extraction and according to plan. The tank was laid on the shore after being fully emptied and installed on two wood beams placed on a tarp on a flat surface. All the drums with the contaminated water pumped from the tank were transported to

Figure 6. Fuel tank being extracted from the lake

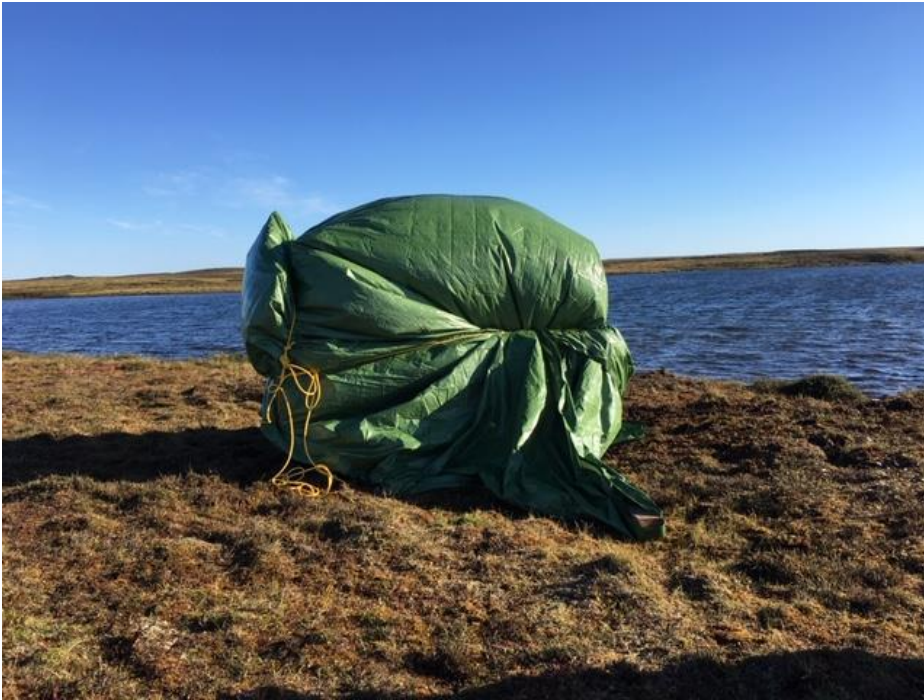
The tarp was flipped over the tank and secured with ropes to fully wrap it.

Figure 7. Fuel tank is on land and secured

A bulldozer will bring back the tank to the camp next winter to minimize damage to the tundra.

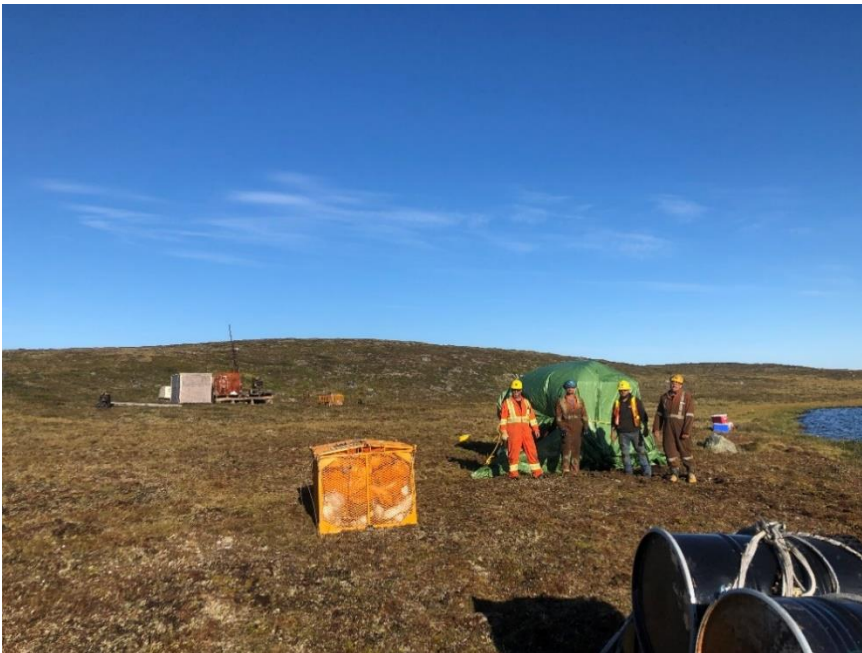
Figure 8. Fuel tank general location with drums ready to be transported

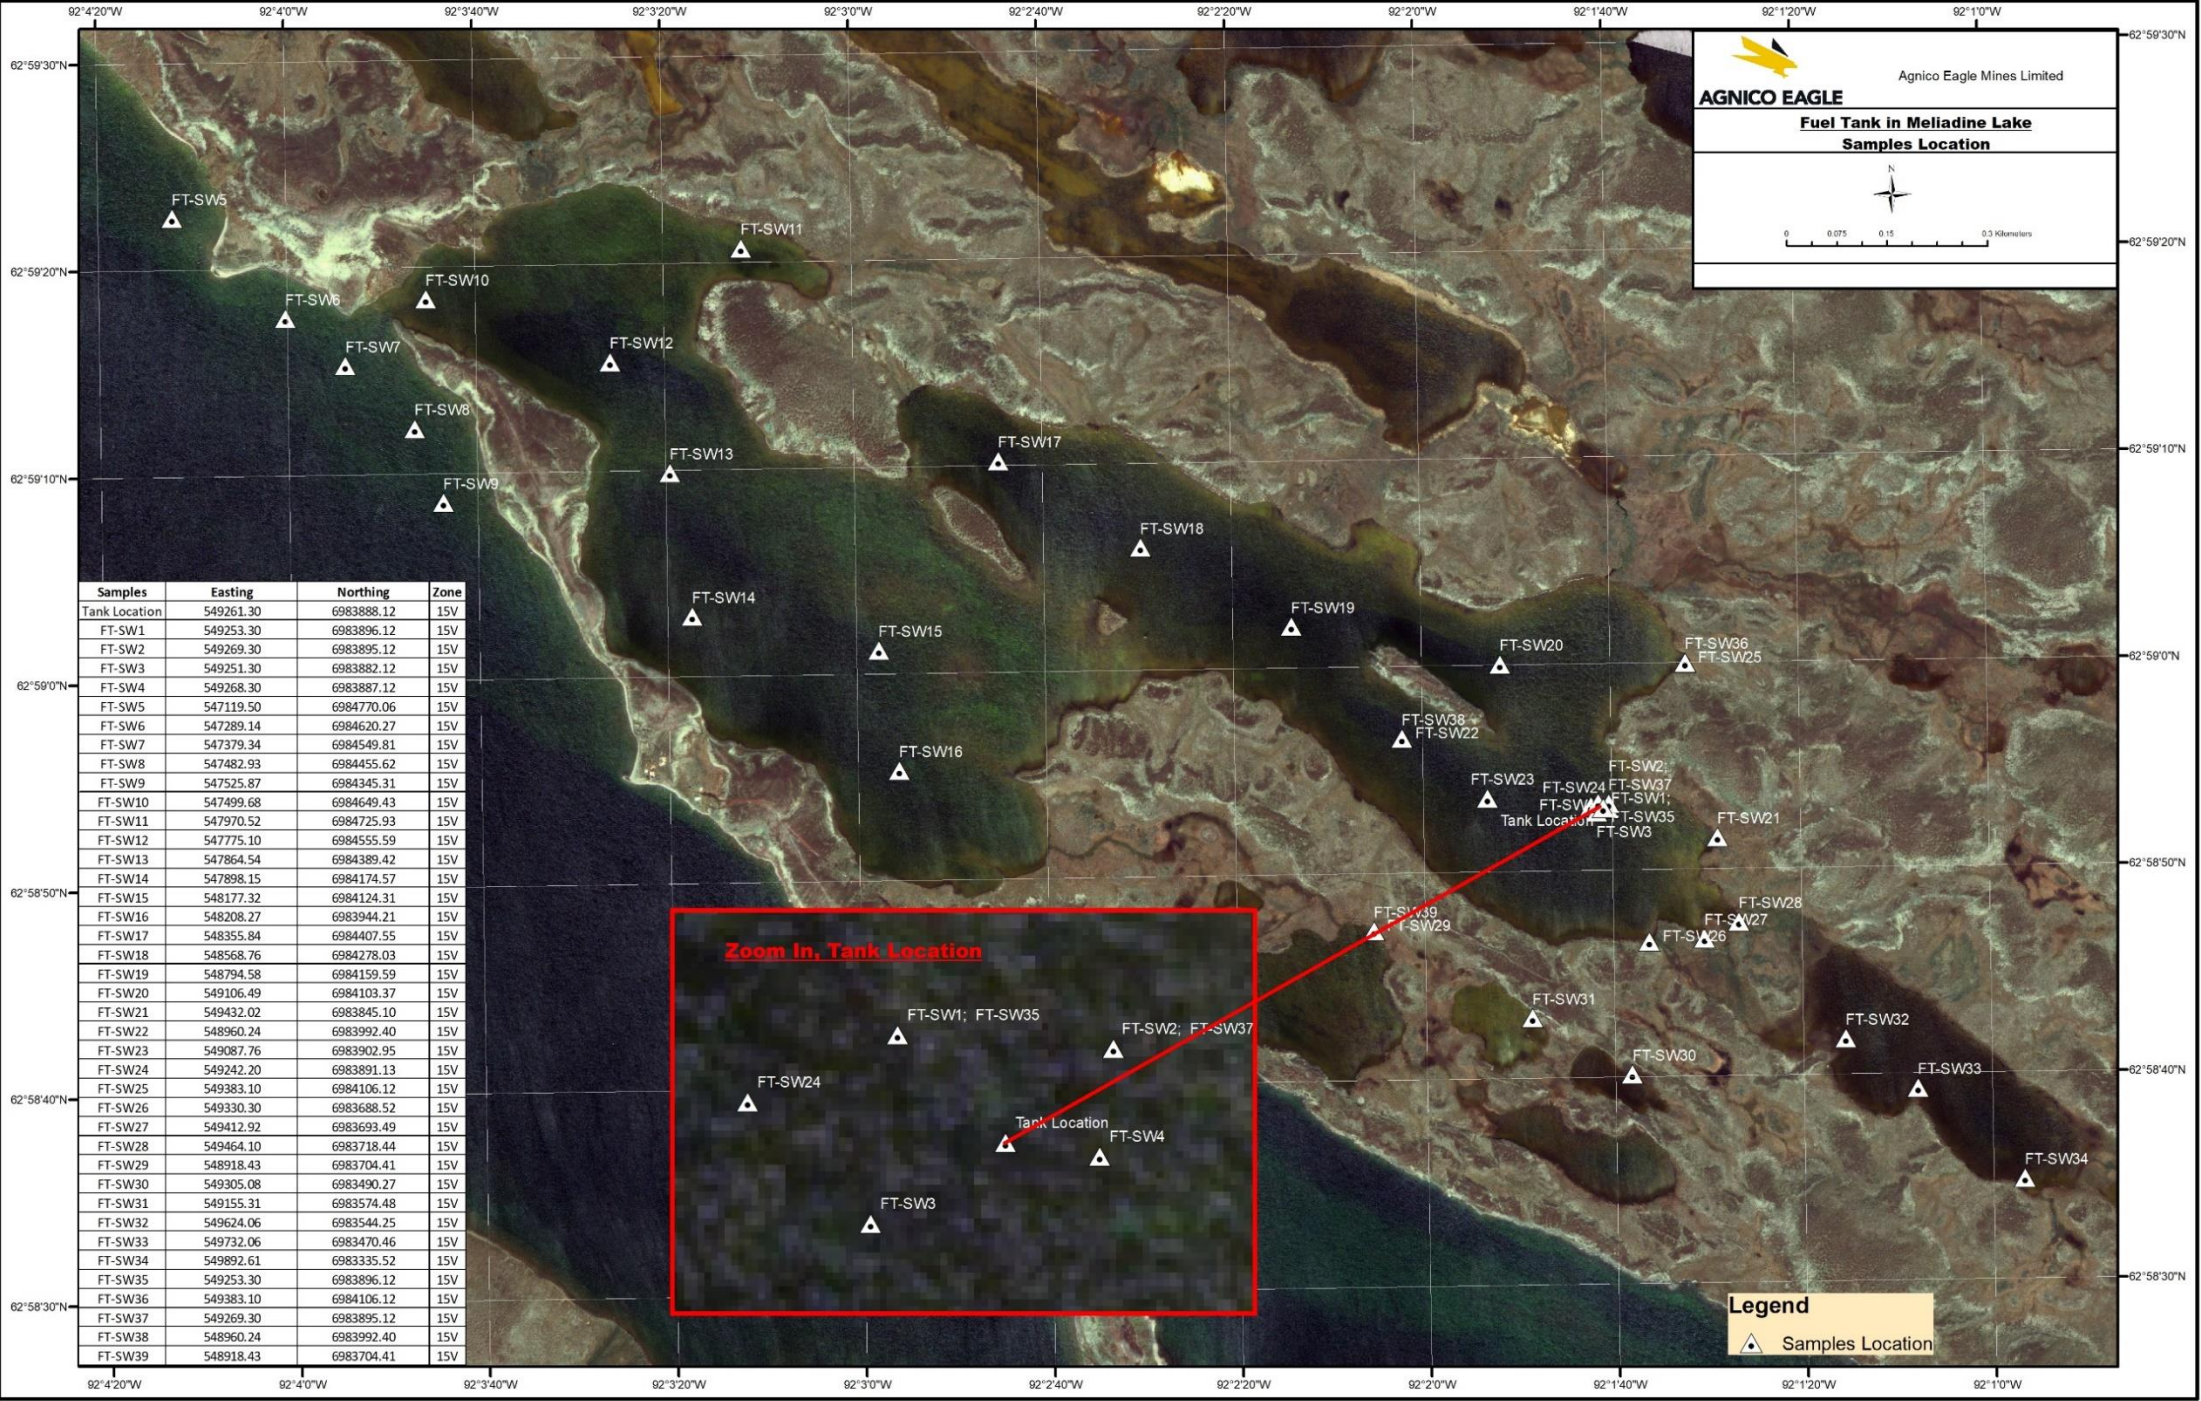
Figure 9, Water Sampling Locations

During the extraction activities conducted to transport the fuel tank to the shore, three water sampling campaigns were conducted. A first sampling campaign was conducted on August 18th when the tank was located. This first campaign was used to define the conditions prior to the extraction operation. The second sampling campaign was conducted on August 25th immediately after the extraction operation. The third sampling campaign was conducted on August 29th a few days after the extraction as a precautionary measure in case the second campaign would have revealed signs of contamination.

The first sampling campaign included 34 samples, the second campaign included 35 samples (a sample in the tank added) and the third campaign included 39 samples as field duplicate and blanks samples were added to ensure a quality control.
