Follow Up Report – September 25th 2017 MEL-07 Fecal Coliforms Exceedance

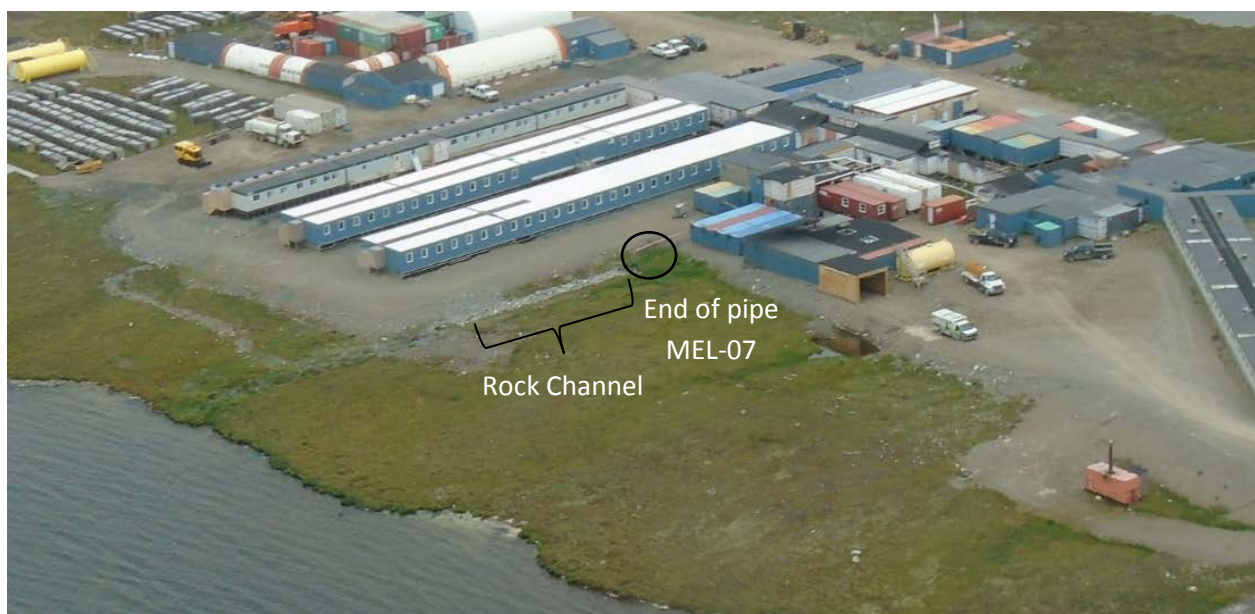
The MEL-07 effluent discharges to land at a location situated approximately 65 m from the ordinary high water mark of Meliadine Lake (see Figure 1). Once the effluent reaches the end of the pipe, it travels along a rock channel intended to reduce the flow and prevent erosion. The effluent will then follow the rock channel to Meliadine Lake.

Figure 1: View from above - MEL-07 discharge configuration with rock channel and flow path to Meliadine Lake
