Follow Up Report: #21-234

June 4, 2021 – 250 L Diesel Fuel Spill

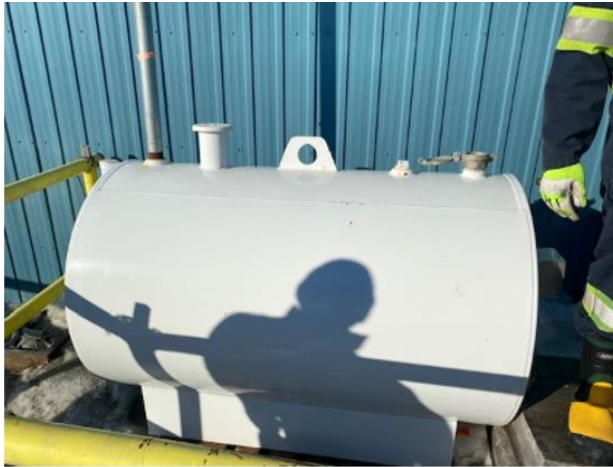
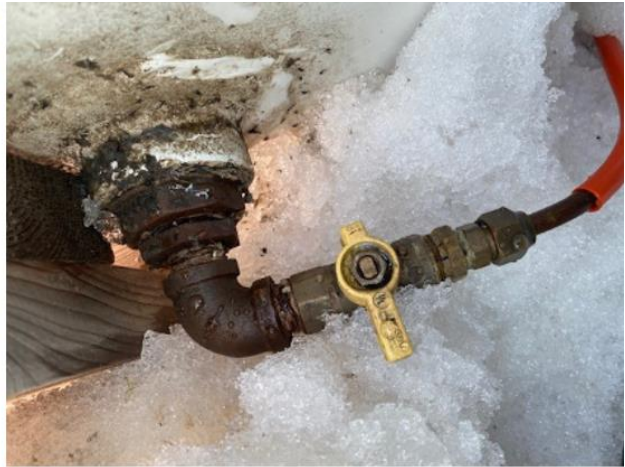
The supply copper line to a furnace located approximately 10 m away cracked, likely due to the cold conditions and the presence of water in the line.

Figure 2: The exterior fuel tank and damaged fuel line which led to the spill.

The remaining fuel in the tank was pumped out and the tank was disconnected from the building. An identical tank on an adjacent building was inspected to ensure the fuel line was in a safe condition. The contaminated wood was removed and disposed of as hazmat, and the water was treated through the oil/water separator.

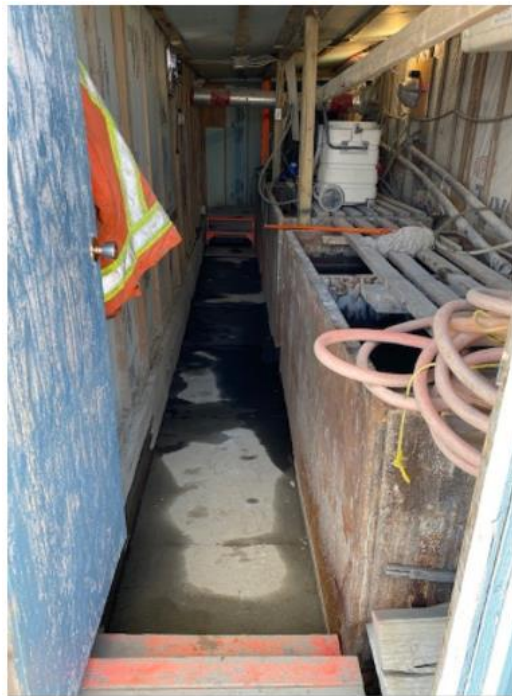
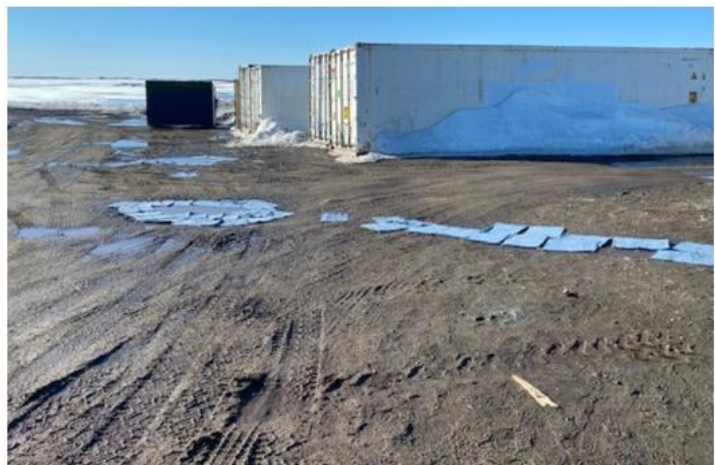
On the morning of June 4th, workers noticed the smell of fuel in the exploration camp core shack. A fuel line from an exterior above-ground heating fuel tank had cracked, releasing an estimated 250 L of fuel. Most the fuel migrated under the building, while some of it flowed away from the building onto the gravel driveway area.

Figure 3: Initial extent of the contaminated areas inside the decantation room, and into the parking area.

An estimated 20L of fuel began to migrate away from the building and into the parking area. Absorbent pads were used to collect the contaminated standing liquid and were disposed of into Quatrex hazmat bags. A trench was dug to mitigate further migration of the spill.

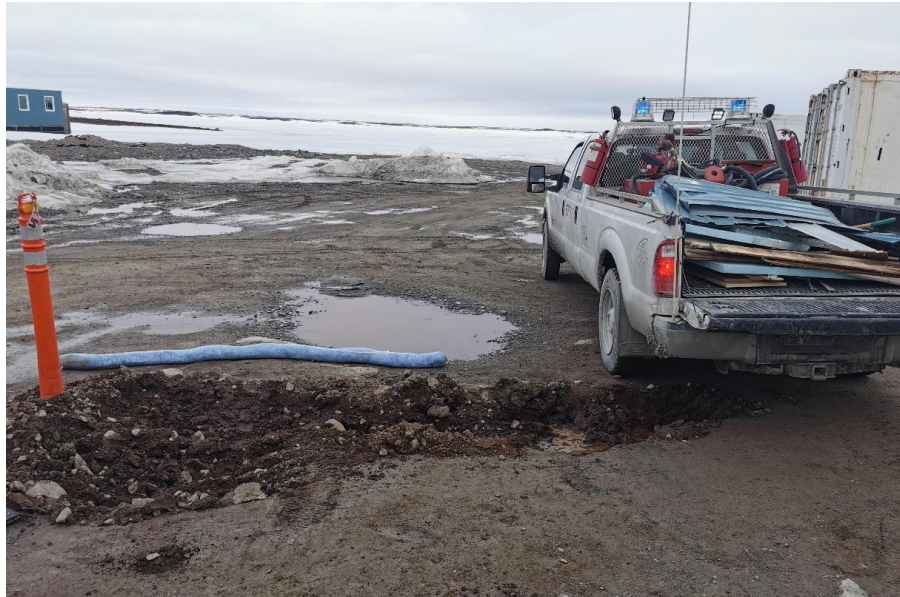
Figure 4: Trench dug to restrict potential flow further down slope.

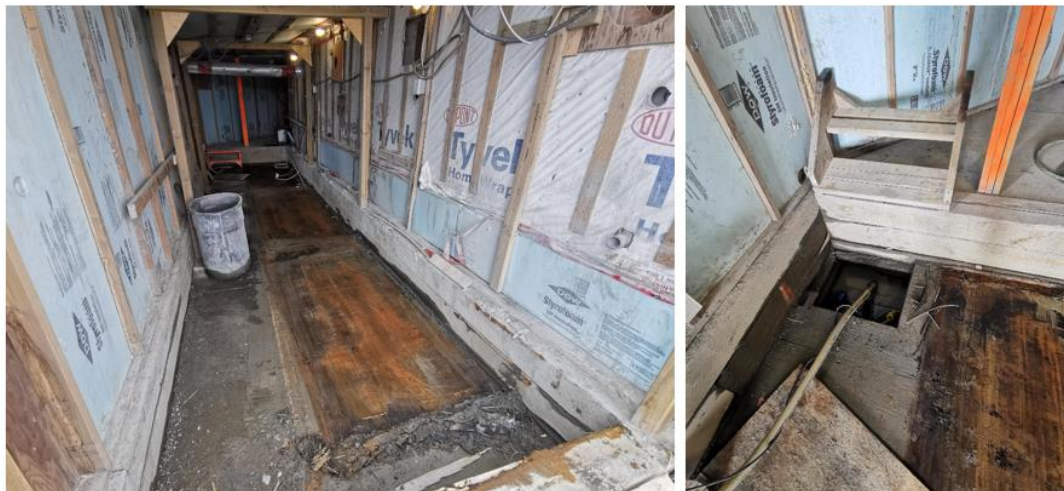
Figure 5: Decantation room cleared of all materials, and the down slope sump actively being pumped of standing diesel.

The decantation room inside the building contains a down slope sump, which began to fill with diesel. A submersible pump was used to periodically pump the diesel and contaminated water into a tote. The entire decantation room was dismantled and cleared of material so that the subfloor could be inspected more thoroughly.

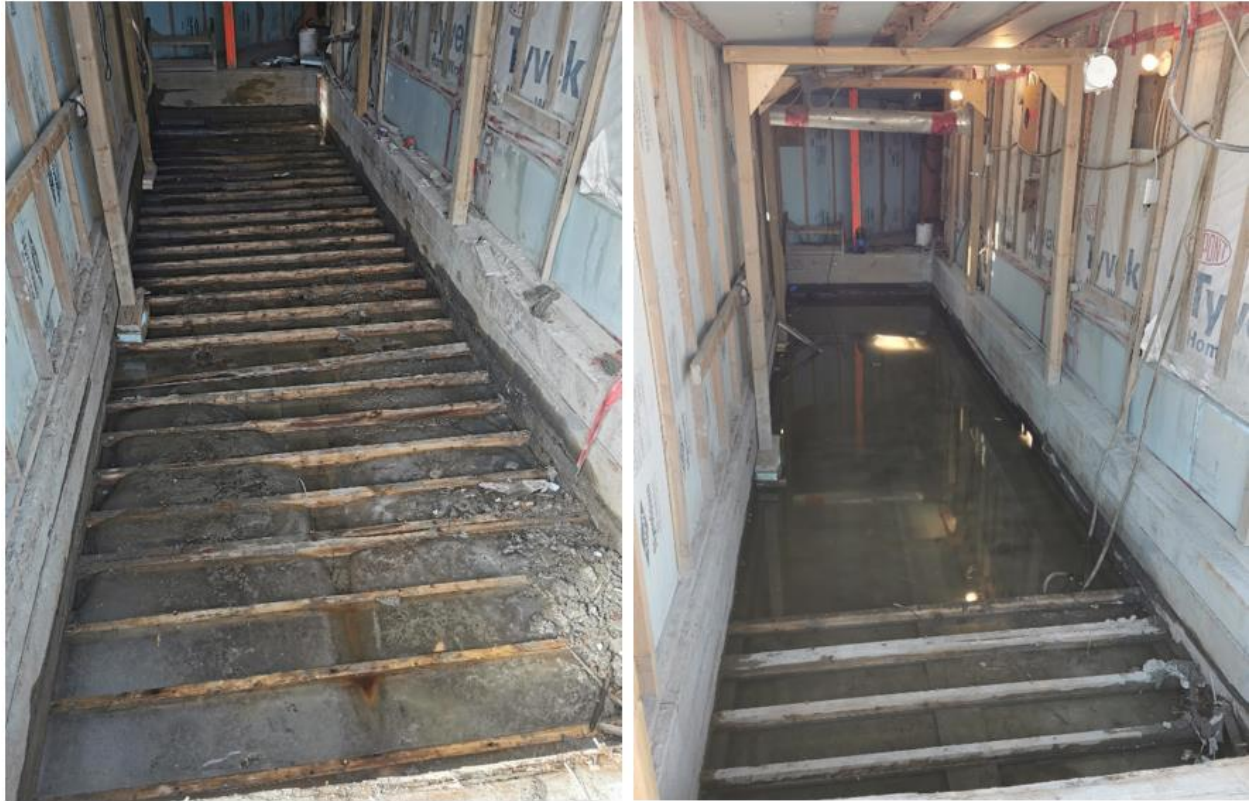
Floorboards were removed, revealing a significant amount of ice and diesel contaminated floor joists. A heater was used in order to speed up the melting process so that floor joints could be removed. The ice was left to melt and the contaminated water was pumped into totes which will be shipped south as hazmat.

Figure 6: Removal of floorboards, joists, and final recovery of contaminated liquid.
