Follow Up Report: #2022701

March 5, 2022,

10L Diesel Fuel on Water Body A8 – Drill Rig#10

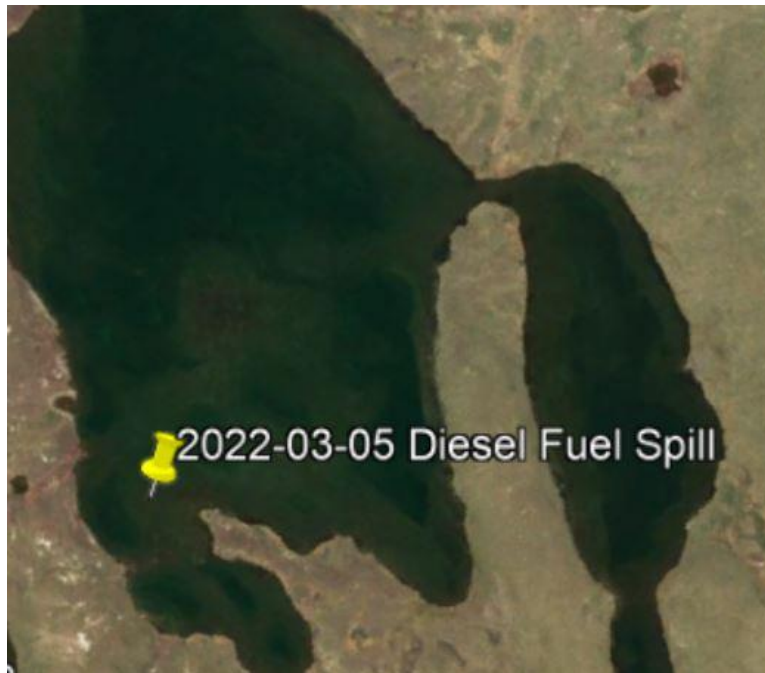
On March 5th, at approximately 9:00, Environment Technicians were conducting an inspection of the surface drill areas, operated by AEM's contractor Orbit Garant. During the inspection, a small amount of diesel fuel was observed by a 4000L overpack. The overpack released 10 L of diesel fuel on the surface of the lake ice. The coordinates of the spill are: 63° 0' 33" N, 92°12' 9"W, on the Water body A8, which is a lake. After further investigation it was determined that the spill occurred due to a combination of fuel expansion in the overpack due to drastic temperature changes and movement of the overpack itself. When the overpack was being moved, fuel was released out of the breather and contaminated snow located on the overpack. The snow then fell on the surface of the lake ice.

Figure 1: Incident Location- A8 Lake

Environment technicians notified the Orbit Garant supervisor and the overpack was moved forward to allow a loader to remove contaminated material. The cleanup was then finalized following the movement of the overpack. The Environment Department was present during this time to ensure environmental compliance with clean up methods as per section 6.4 of Spill Contingency Plan (spills on snow and ice).

As an immediate corrective action, overpacks will be given extra headspace to allow for expansion to occur. This has been communicated with fuel truck operators and supervisors have been asked to put a note on employee's health and safety work cards as a reminder.
