2022-03-05 WTP 20L Hydraulic Oil

GN reference #: 2022-066

Spill Description

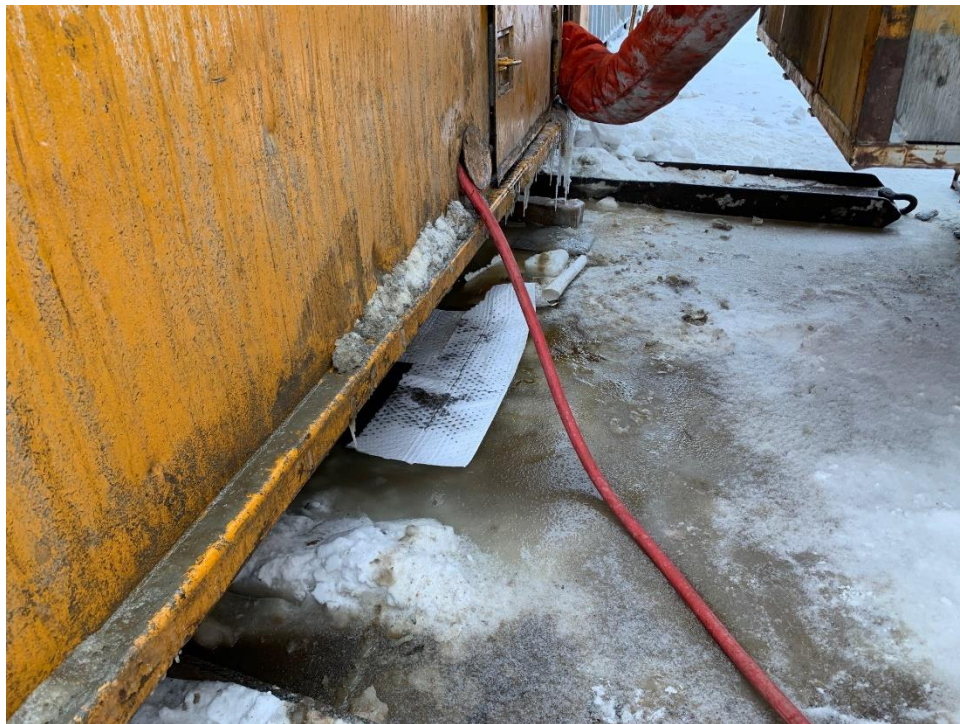
During operations at Whale Tail pit, operators of SH92 Drill noticed a puddle of hydraulic oil under the drill on Mammoth Lake.

A small pin hole was found in one of the hydraulic lines.
