Follow Up Report: #2022102

March 27th, 2022,

20 L Drilling Recirculation Water on Waterbody A8

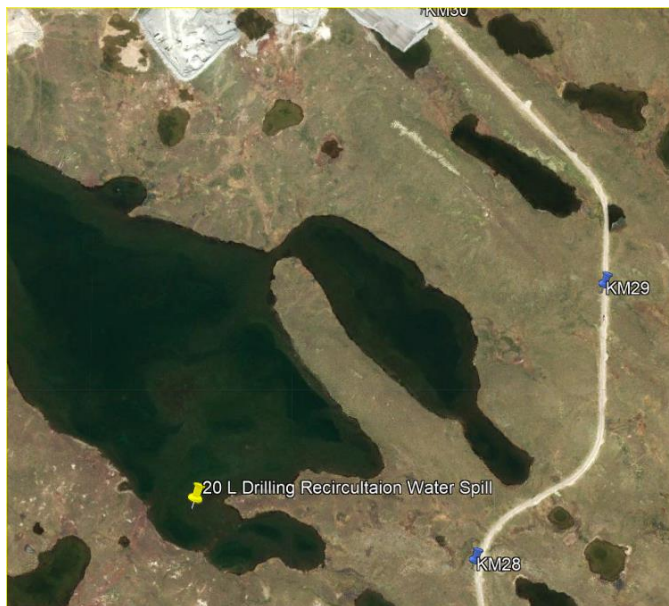
On March 27th, 2022 during an environmental inspection of the Orbit drill rigs located on waterbody A8, a worker identified a 20 L drilling recirculation water overflow from the drill recirculation water recovery tank to the surface of the ice. No drilling recirculation water entered the waterbody as it was contained on the surface of the ice cover.

Figure 1: Drilling recirculation water spill location

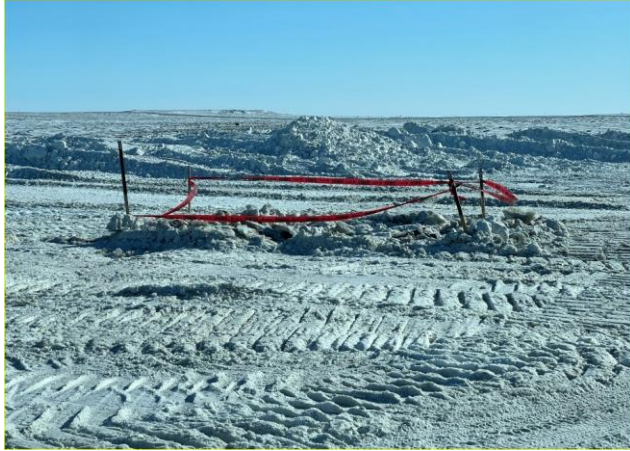
Figure 2: Spill Location- Post cleanup

The release was a result of an equipment failure as the drill recirculation recovery tank became tilted during the drilling process. Orbit Garant stopped the drilling process, realigned the drill recirculation recovery tank and attached it to the drill with chains to prevent movement of the drill recirculation recovery tank and future spills.

Orbit Garant stopped drilling operations which stopped the flow to the drill recirculation water recovery tank and allowed realignment of the drill recirculation recovery tank. Orbit Garant employees promptly started the spill cleanup using ice chippers and shovels. The impacted snow and ice was placed into the decantation tank to be reused in the drilling process.
