Follow Up Report: #2022111

April 3rd, 2022,

6 L Contaminated Water on Waterbody A8

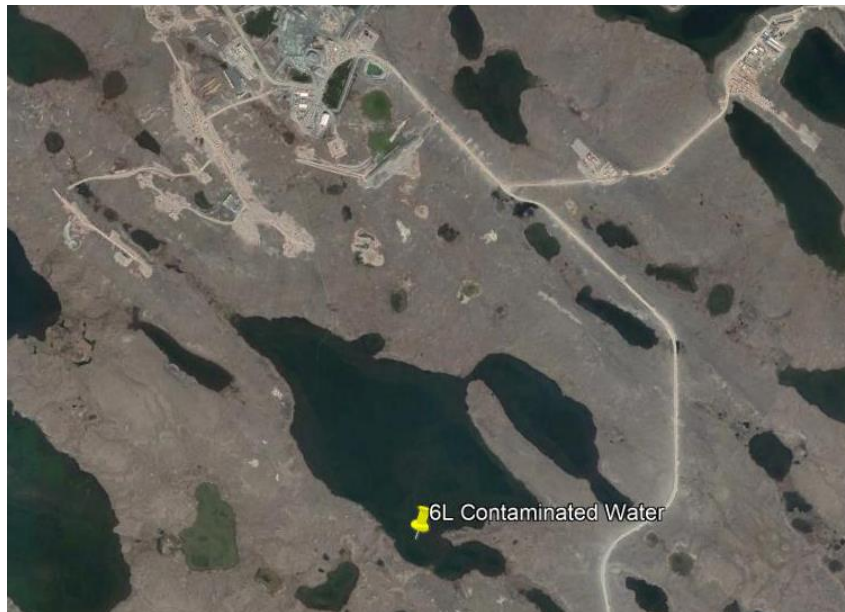
On April 3rd, 2022, during an environmental inspection of the Orbit drill rigs located on waterbody A8, a worker identified water leaking from the heating unit sea-can to the surface of the ice. Upon inspecting the heating unit sea-can, it was discovered that the water recirculation pump had failed, which resulted in 6 L of contaminated water to leak inside on the sea-can floor thus being released on the surface of the ice. It is suspected the water came in contact with the heating sea-can floor which contained traces of hydrocarbons, and therefore is treated as contaminated water spill. No contaminated water entered the waterbody as it was contained on the surface of the ice cover.

Figure 1: Contaminated water spill location

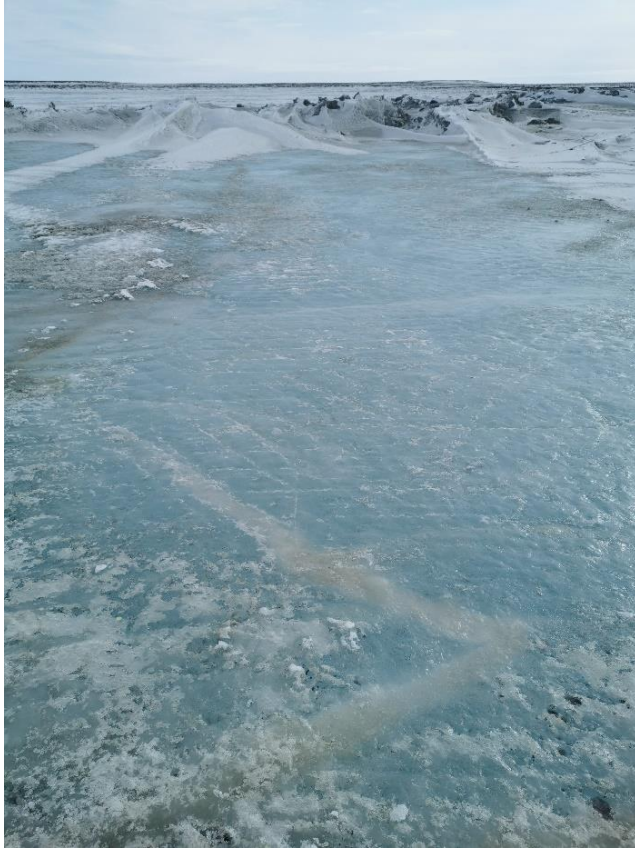
Figure 2: Spill Location- Post cleanup

Orbit Garant immediately stopped the recirculation water pump. The contaminated ice and water were shoveled and brought to the contaminated snow cell where it will be stored until snowmelt, at which point the contaminated water will be transferred to the Landfarm for treatment at the oil-water separator, with the other existing material accumulated during Winter, as per the Water Management Plan.

The release was a result of equipment failure as the pump recirculation pump failed. The pump was changed immediately to prevent another potential spill.

These pumps are inspected daily as per the normal pre-operations of the drill and during the April 3rd, 2022 visual inspection, no issues with the pump were visible and starting of the operations was normal. Orbit conducts mechanical verification on the pumps every two weeks – these verifications, alongside the daily pre-operation's inspections will continue to be conducted, reducing the likelihood of equipment malfunctions.
