Follow Up Report: #2022164

May 4th, 2022,

75 L Drilling Recirculation Water on Waterbody B38

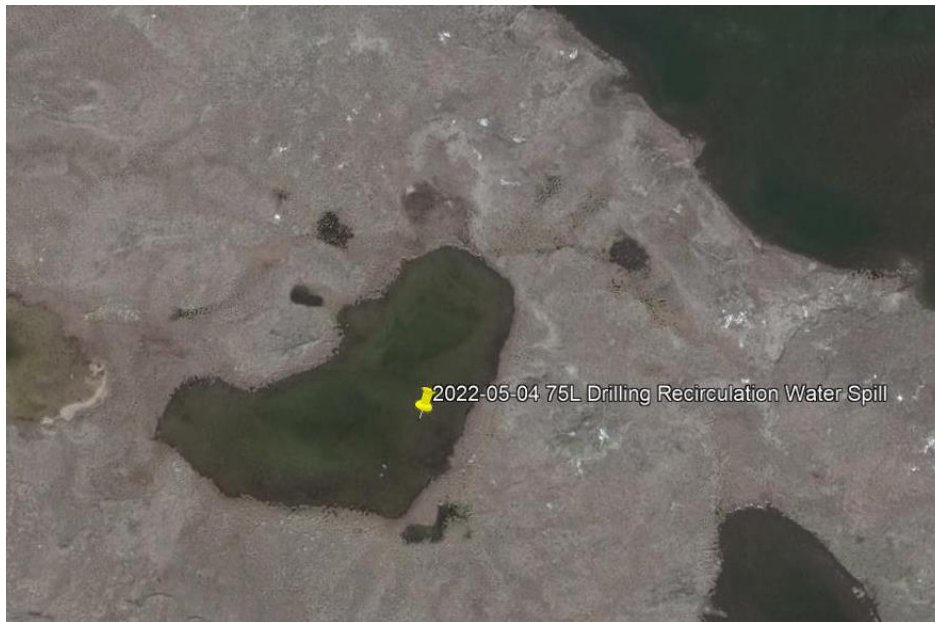
The coordinates of the spill are: 63° 0' 26" N, 92°12' 35"W, which is on waterbody B38.

Figure 1: Drilling recirculation water spill location

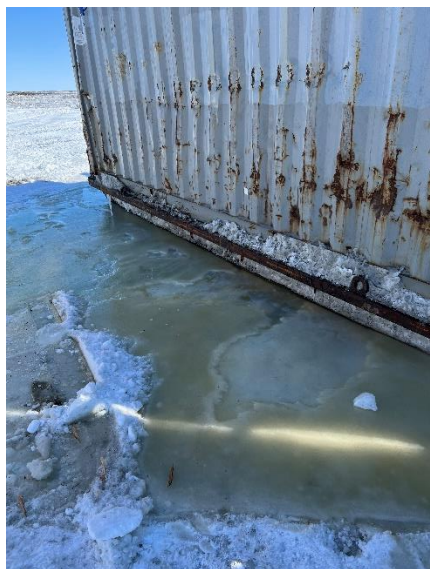
On May 4th, 2022, during an environmental inspection of the Orbit Garant drill rigs located on waterbody B38, a worker identified that 75 L of drilling recirculation water had overflowed from the decantation tank to the surface of the ice.

Figure 2: Spill location prior to clean-up. A post clean-up photo is not available. The corrective measures to follow to address this discrepancy are in the updated procedure EXP-ENV-001 as outlined below.

The release was a result of a natural cause as the borehole intersected a water vein, which caused an excess of water in the recirculation system (more water was coming out of the hole than being used for regular drilling operations). The decantation tank overflowed releasing recirculation water onto the surface of the ice. Orbit Garant stopped the flow of fresh water into the decantation tank immediately after the overflow was observed.

At the time of inspection, the decantation tank was no longer overflowing, and drilling recirculation water was no longer spilling onto the ice. The cleanup of the spill was completed as part of the final site cleanup as all drilling operations were complete at the site. During the drill site cleanup all impacted snow and ice was removed and sent to the drill cuttings disposal area with the remaining drill cuttings.

With respect to corrective measures, the procedure titled “**EXP-ENV-001 Brief summary for Environmental compliance during exploration activities**” has been updated to include further details on when and how the spring inspection and clean-up of previous drill sites and pump shack setups will be performed. Every inspection will be compiled in a folder accessible to Environment Department, with maps and pictures attached. The following reviews some key components of the updated procedure.
