MARY RIVER PROJECT - BULK SAMPLING PROGRAM			
EXISTING ROAD CONDITIONS			
 	P/A NO. NB102-00181/6	REF. 1	REV. 0
	FIGURE 2.13

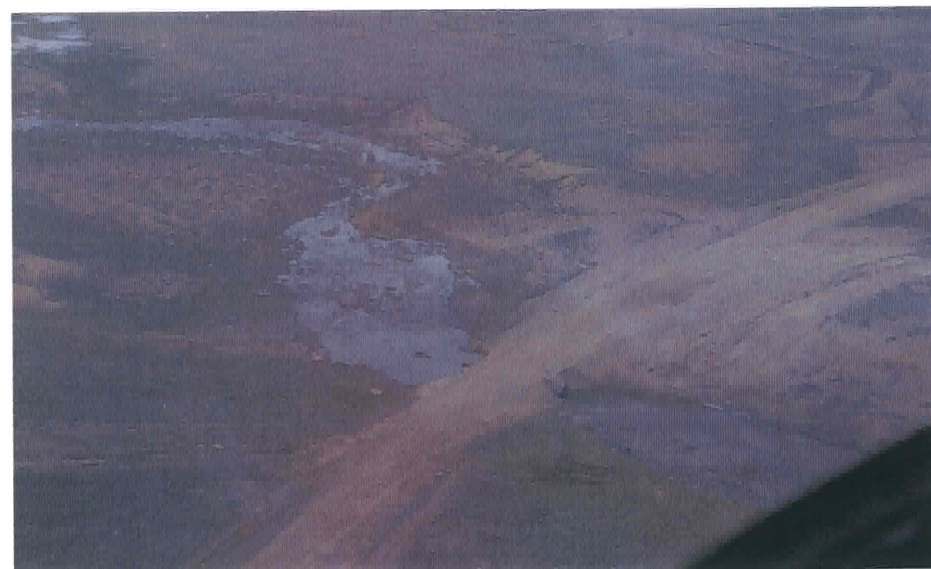
Photo 1 A functioning culvert crossing.

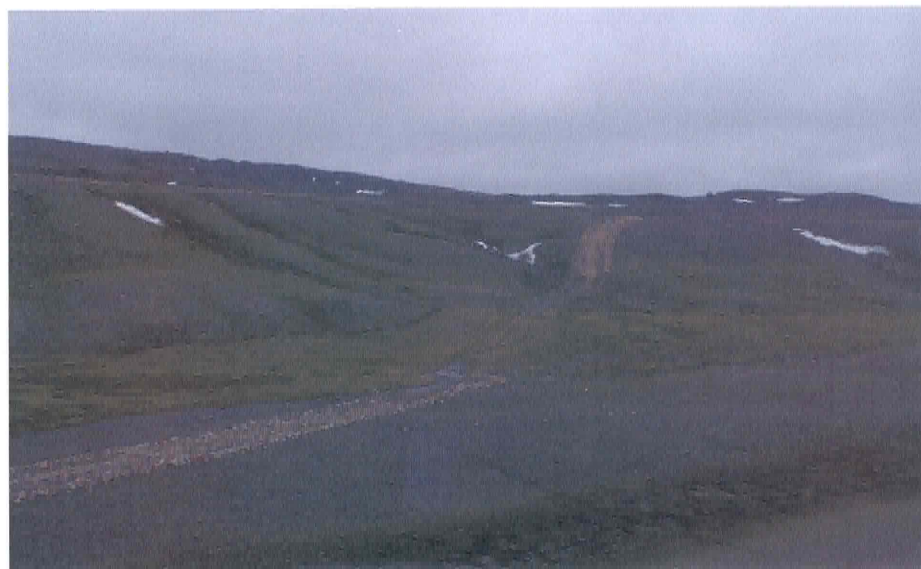
Photo 2 Typical roadbed conditions.

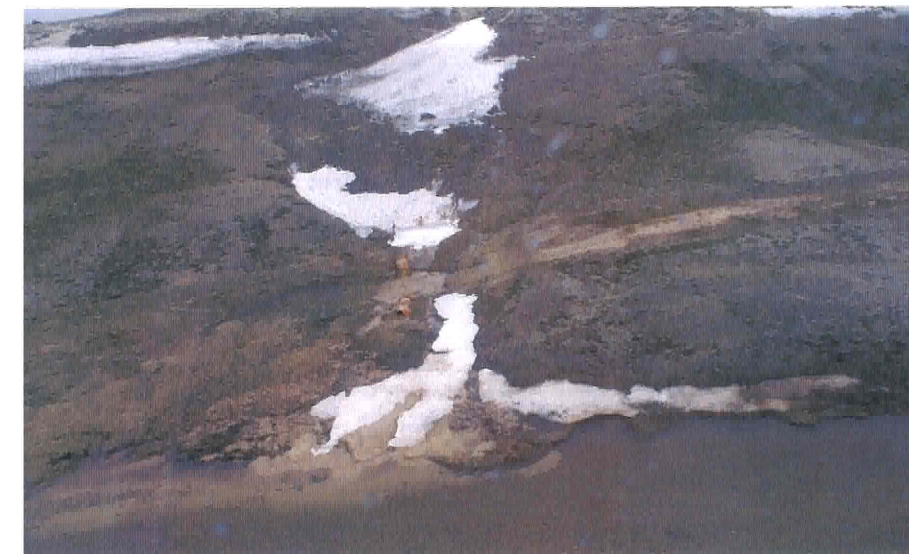
Photo 3 A washed out barrel culvert bypassed by a new channel.

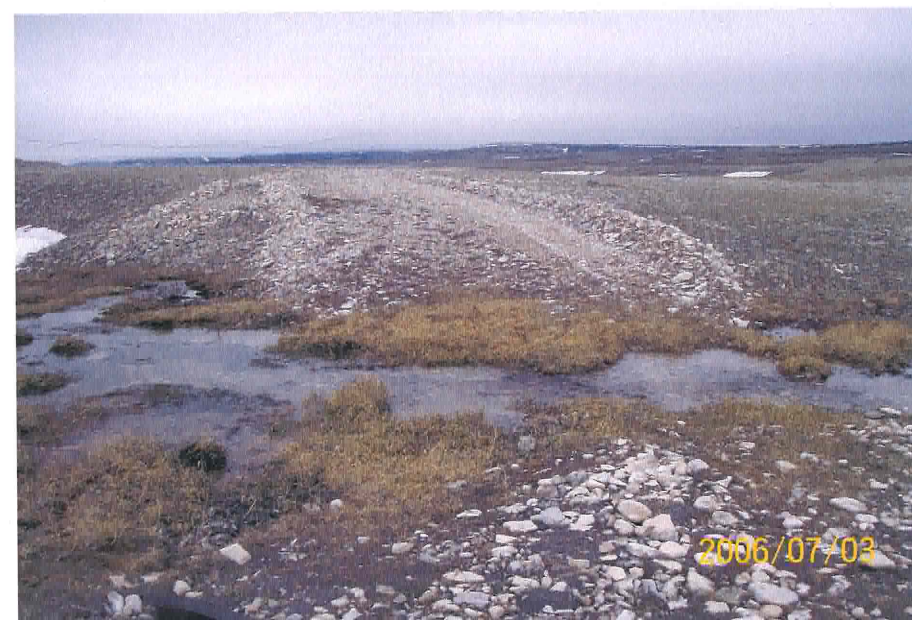
Photo 4 A typical small crossing.

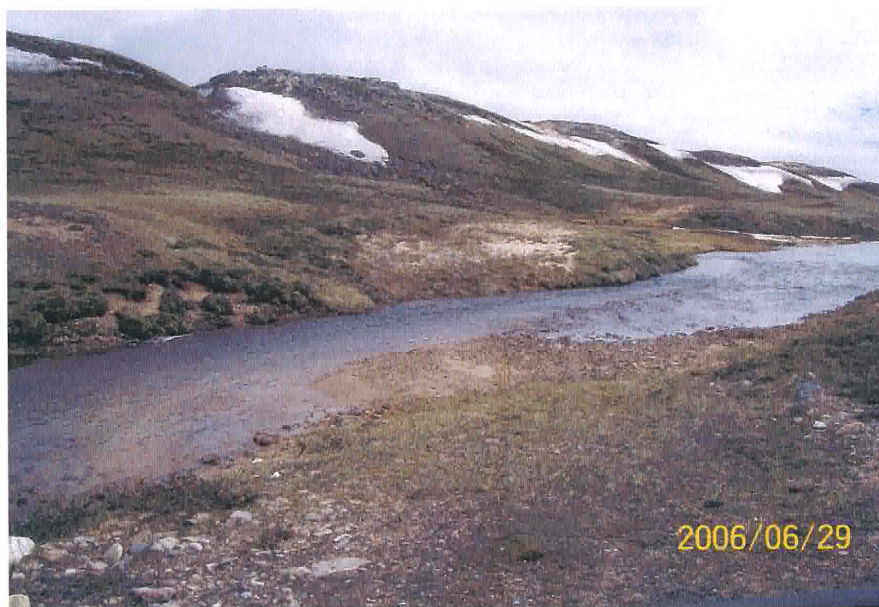
Photo 5 A typical medium sized crossing.

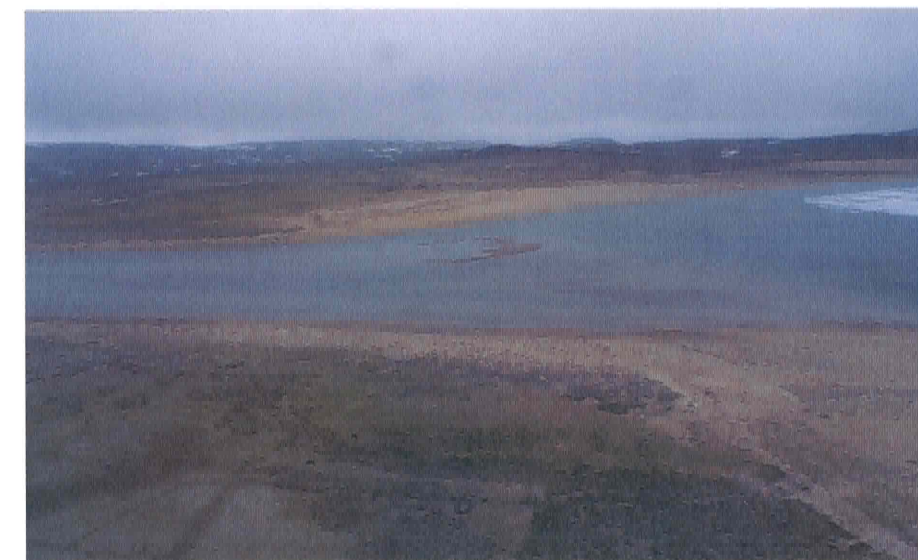
Photo 6 A major watercourse along the road.
