Re: Water License Inspection of Mary River Project July 14th, 2007-12-18

We thank you for your report dated on December 10th, 2007 for an inspection that occurred on July 14th, 2007. The purpose of this letter is to provide the information requested in the report and to respond to specific items of noted concern. Our letter is presented under the same headings as your inspection report.

Baffinland Iron Mines Corporation
Mary River Project - Deposit No.1,2,3
Table 1: 2007 Drill Holes Summary

SELECT PHOTOGRAPHS

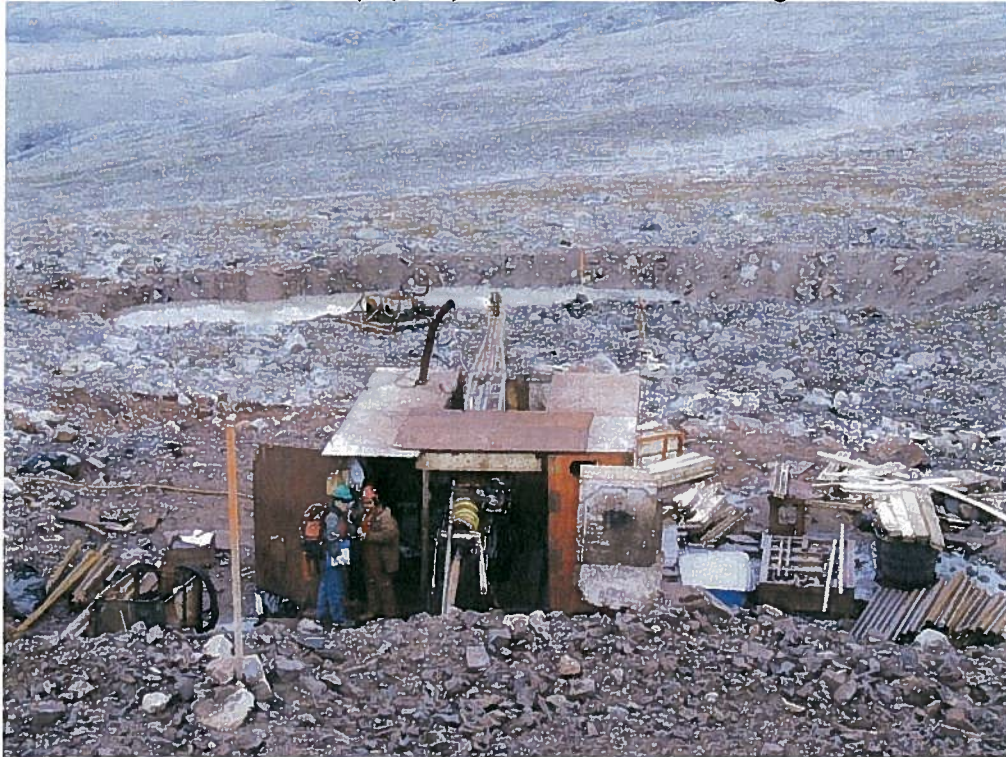
Photo 1: Sump (SU 2) at MR1-07-124 Looking NW

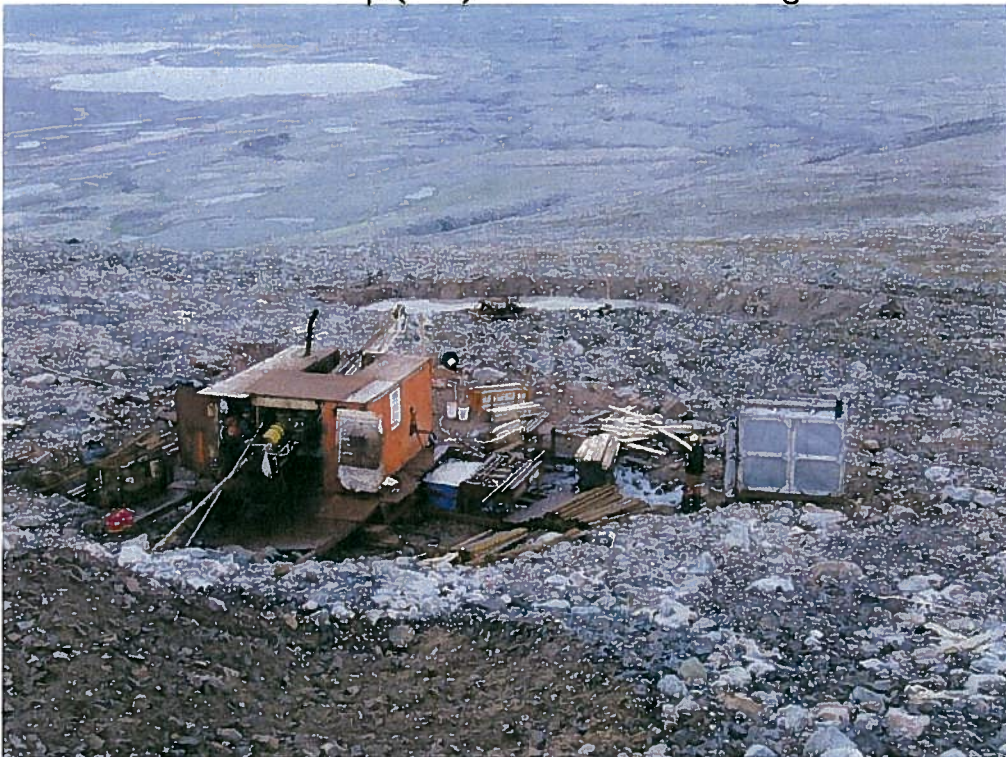
Photo 2: Sump (SU 2) at MR1-07-124 Looking W

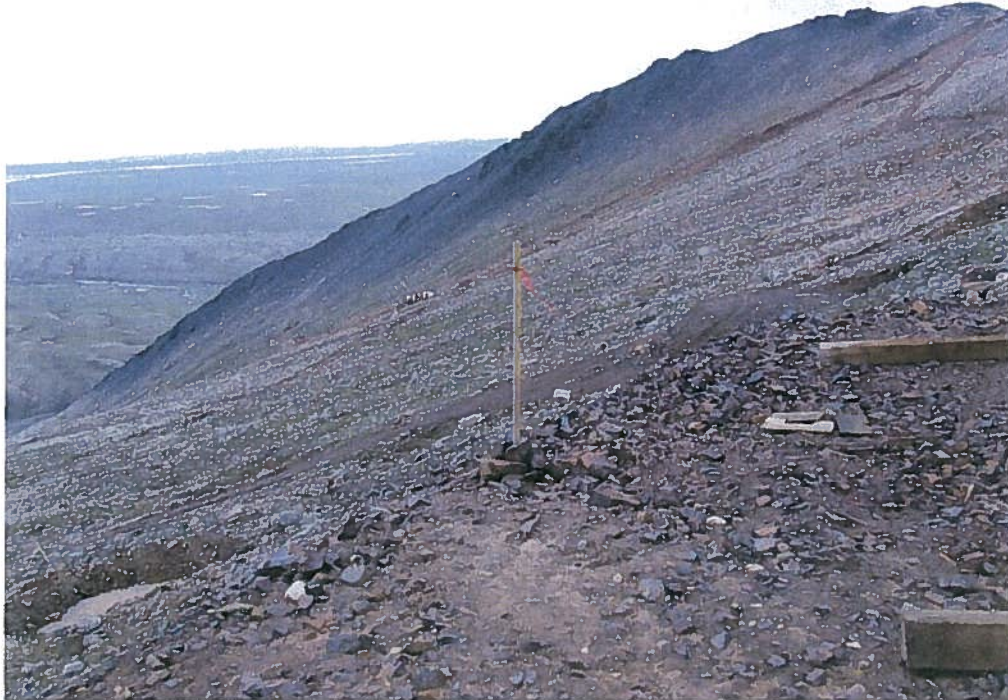
Photo 3: Sump (SU 3) below MR1-07-133 looking S

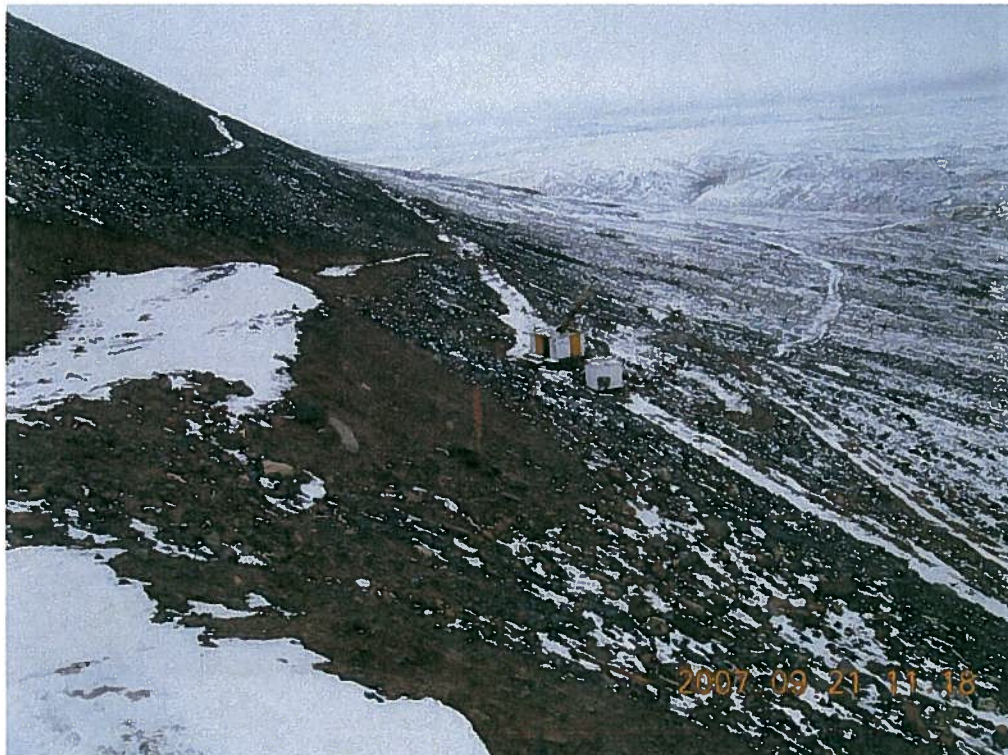
Photo 4: Sump 4 (SU 4) below MR1-07-136 looking NE

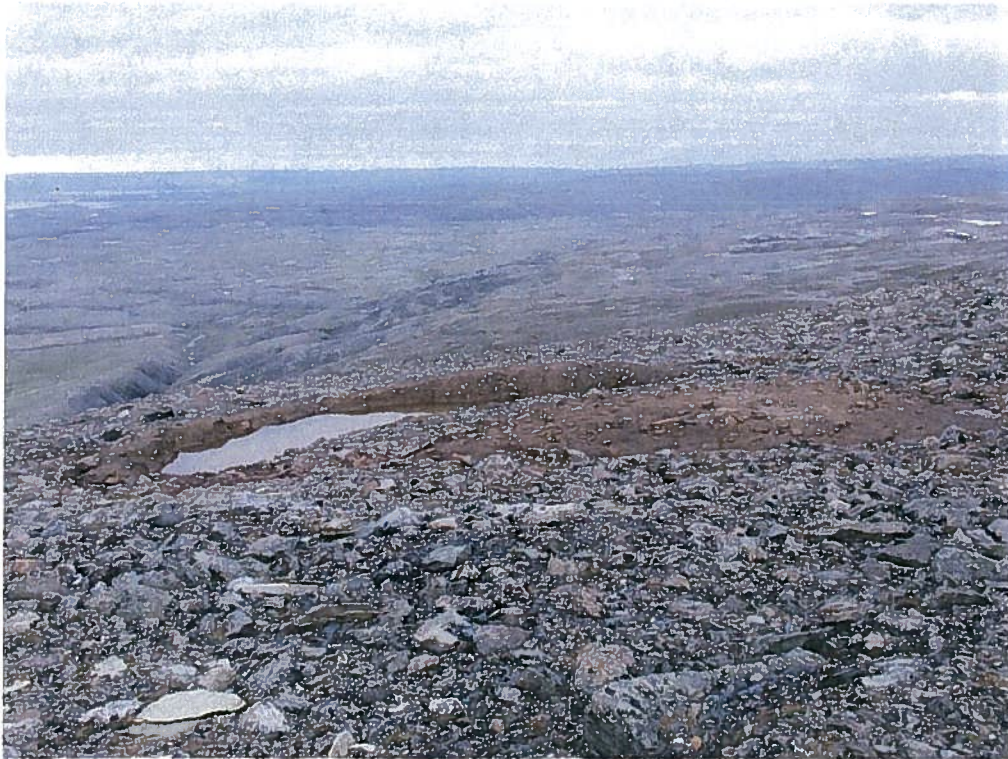
Photo 5: Sump (SU 5) at MR1-07-118 looking NNW

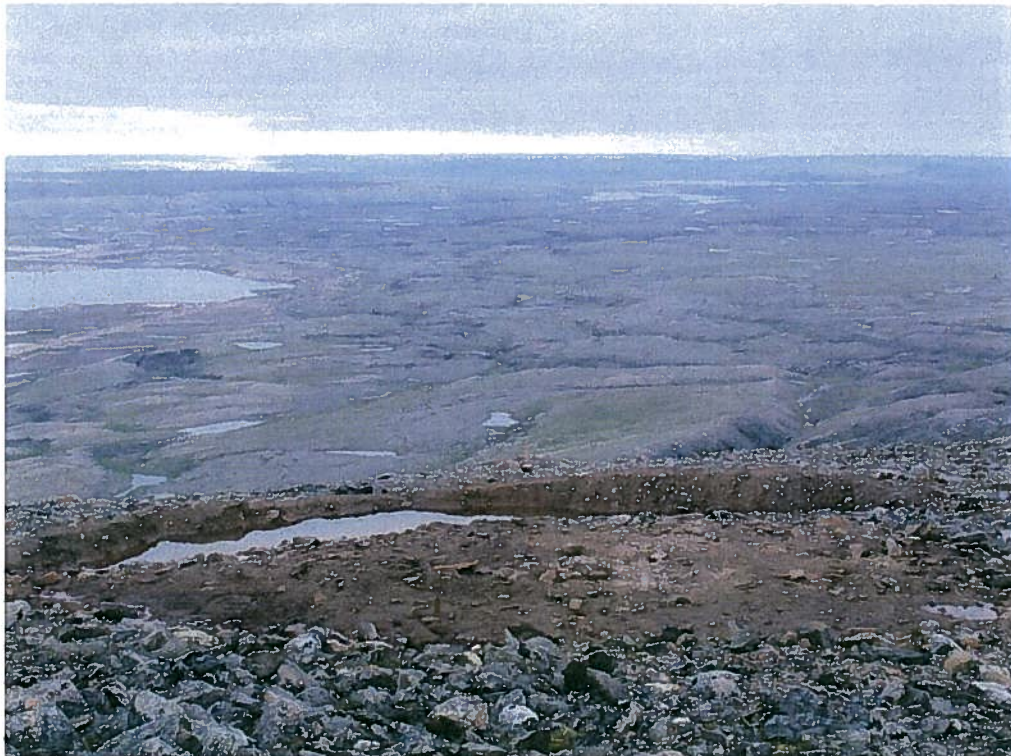
Photo 6: Sump (SU 5) at MR1-07-118 Looking NW

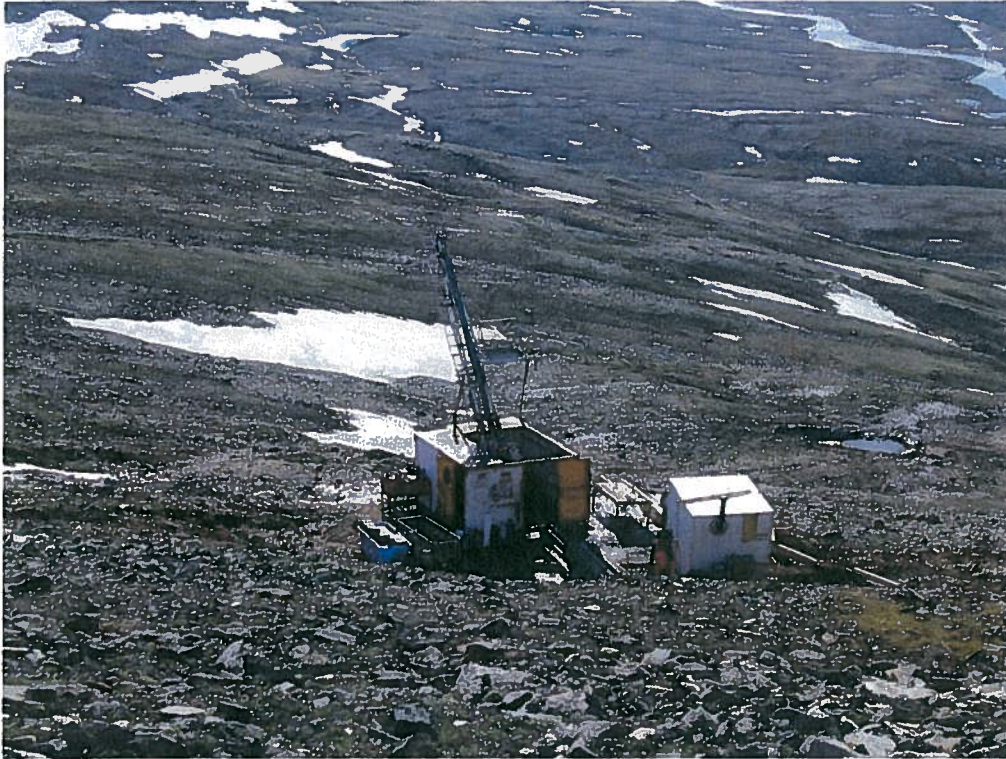
Photo 7: Axial Sump (SU 6) ESE of MR1-07-113 pad

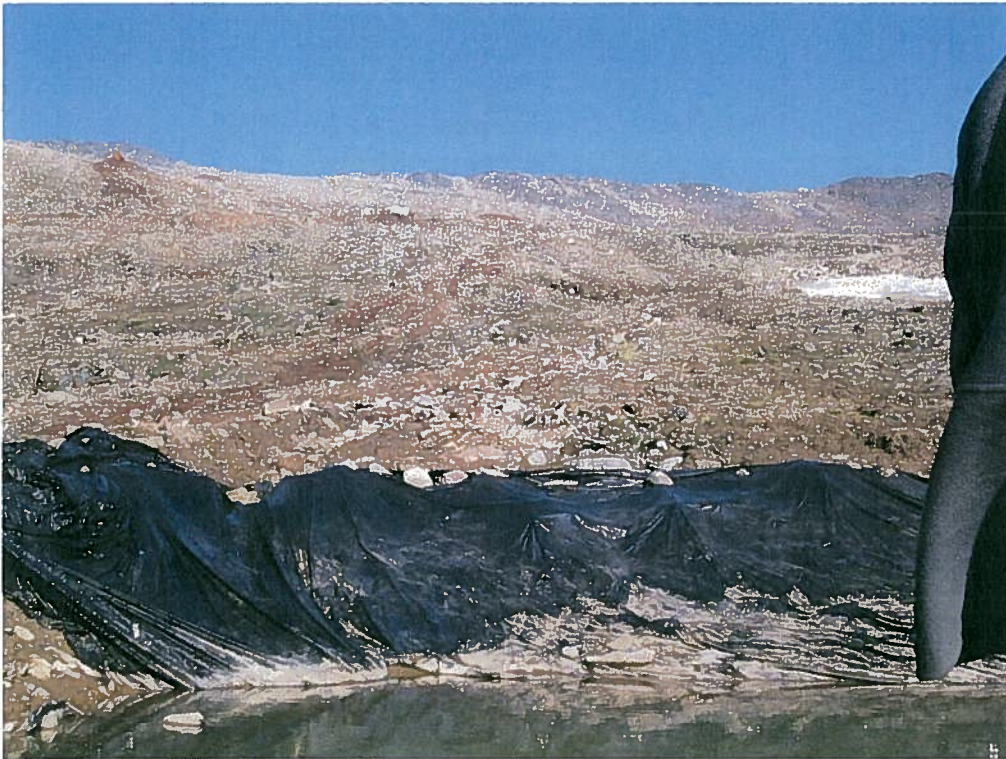
Photo 8: Axial sump (SU 6) for drainage from Lower and Upper fan pad sites (photo 1)

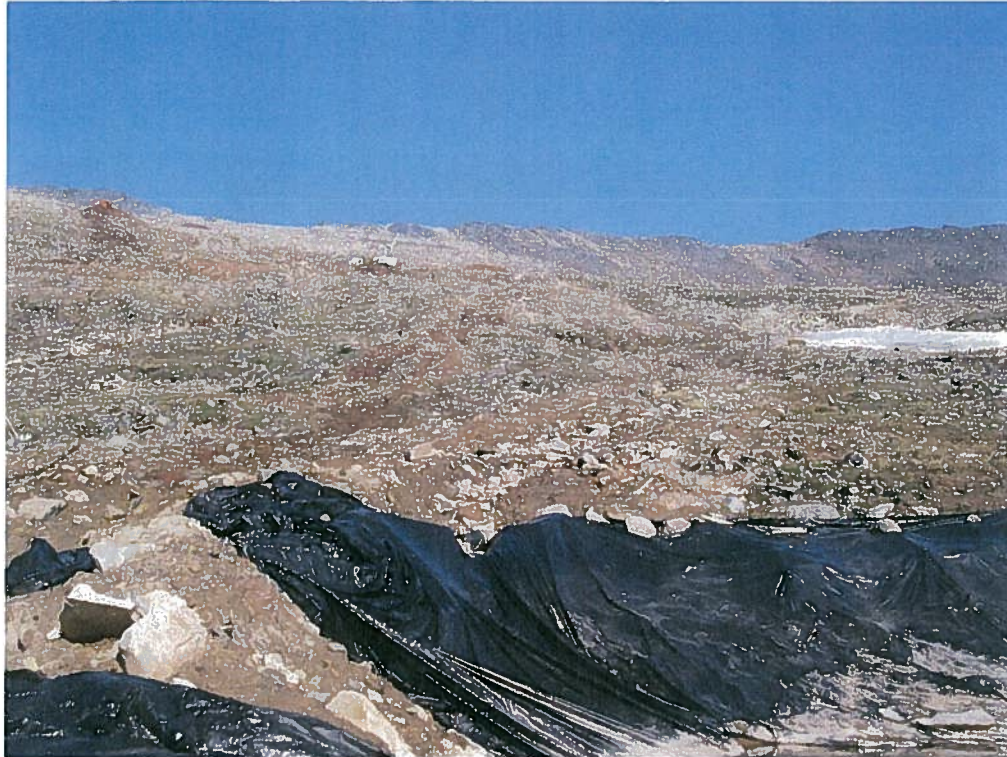
Photo 9: Axial sump (SU 6) for drainage from Lower and Upper fan pad sites (photo 2)

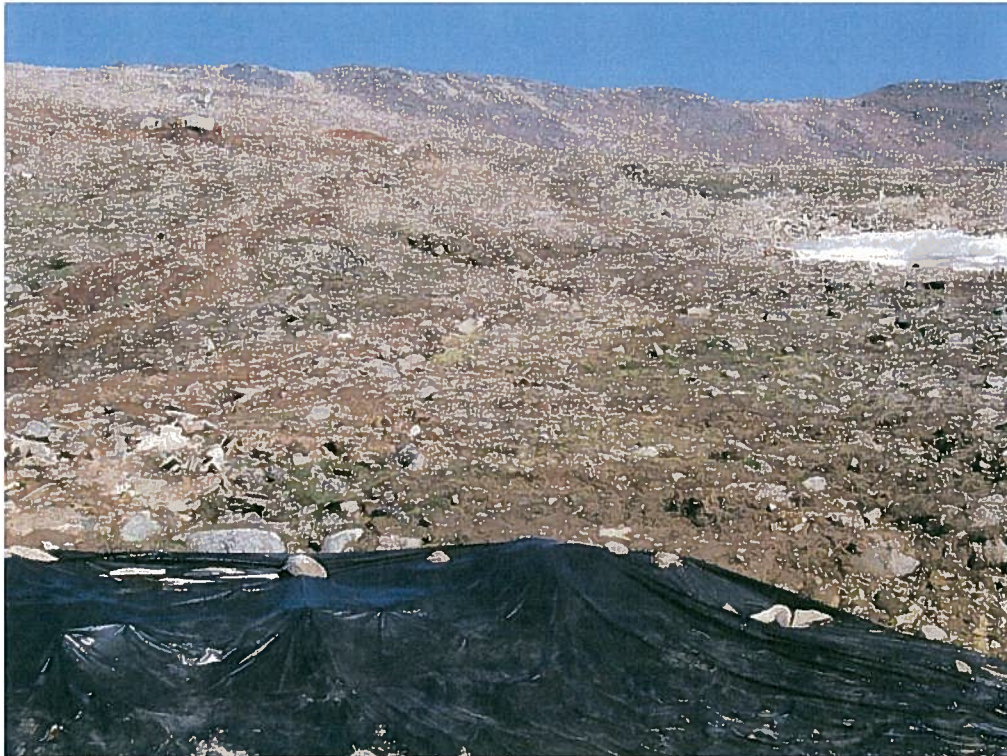
Photo 10: Axial sump (SU 6) for drainage from Lower and Upper fan pad sites (photo 3)

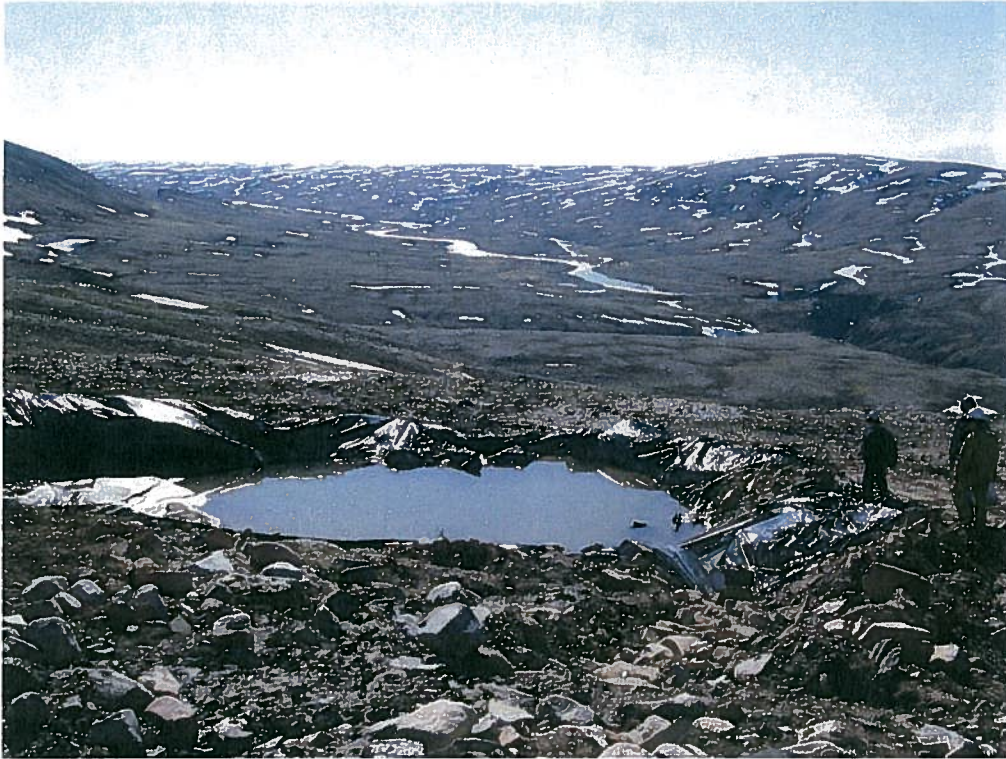
Photo 11: Axial sump (SU 6) with liner (photo 1)

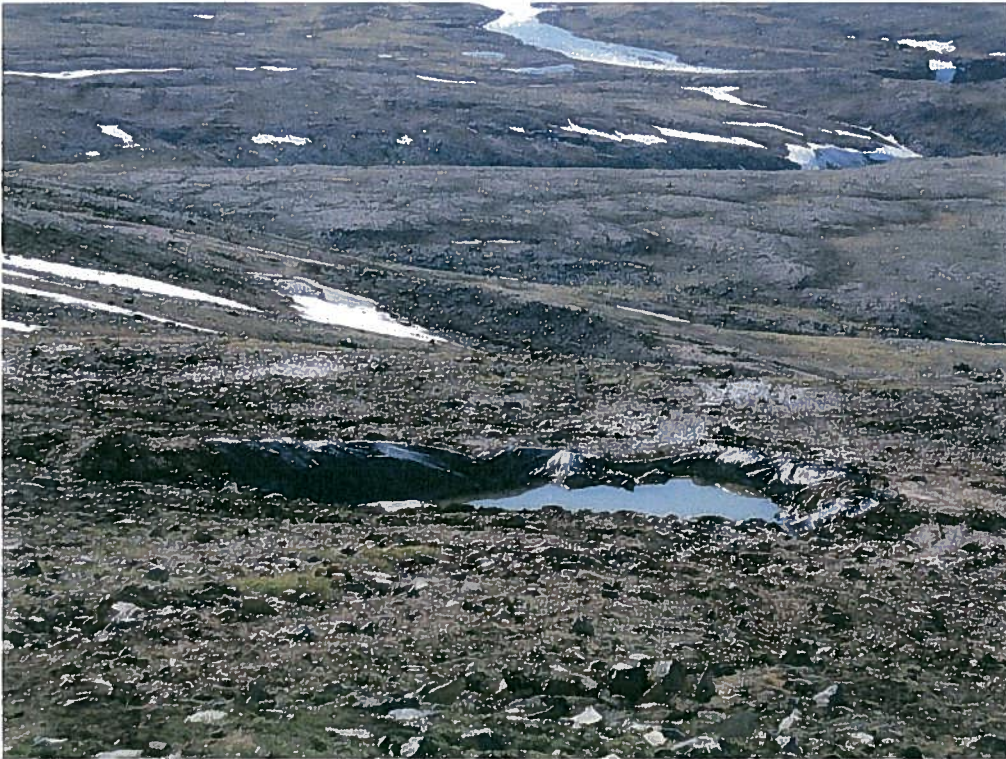
Photo 12: Axial sump (SU 6) with liner (photo 2)

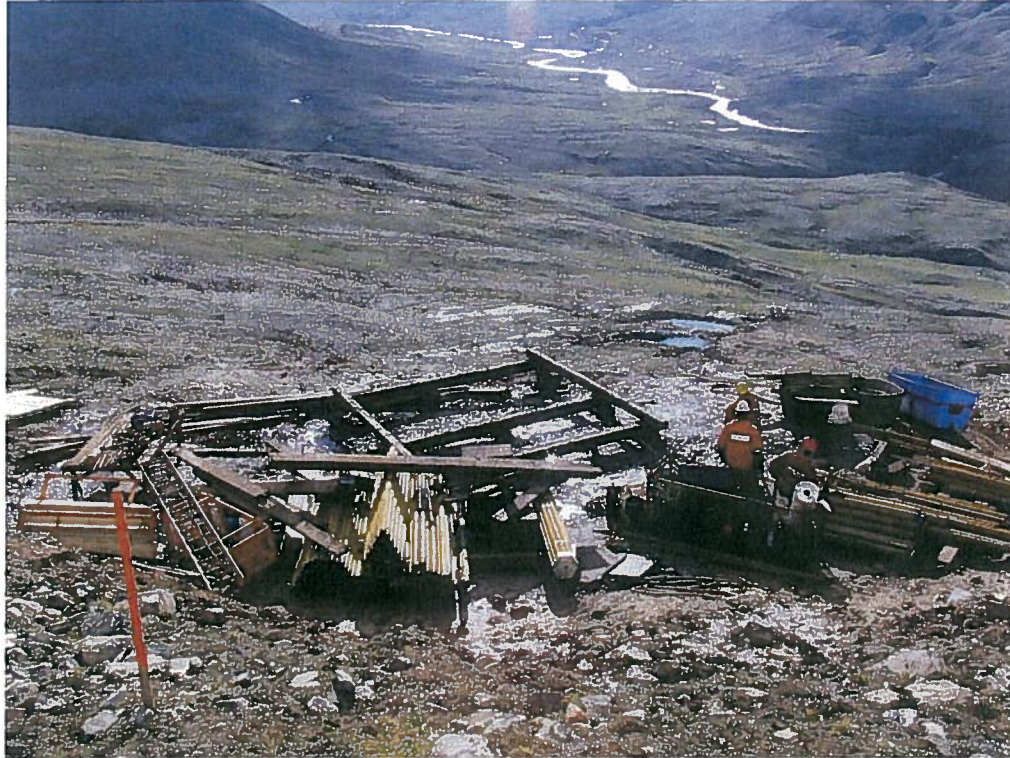
Photo 13: Axial sumps (SU 6+7) downslope from MR1-07-127 pad, looking SE

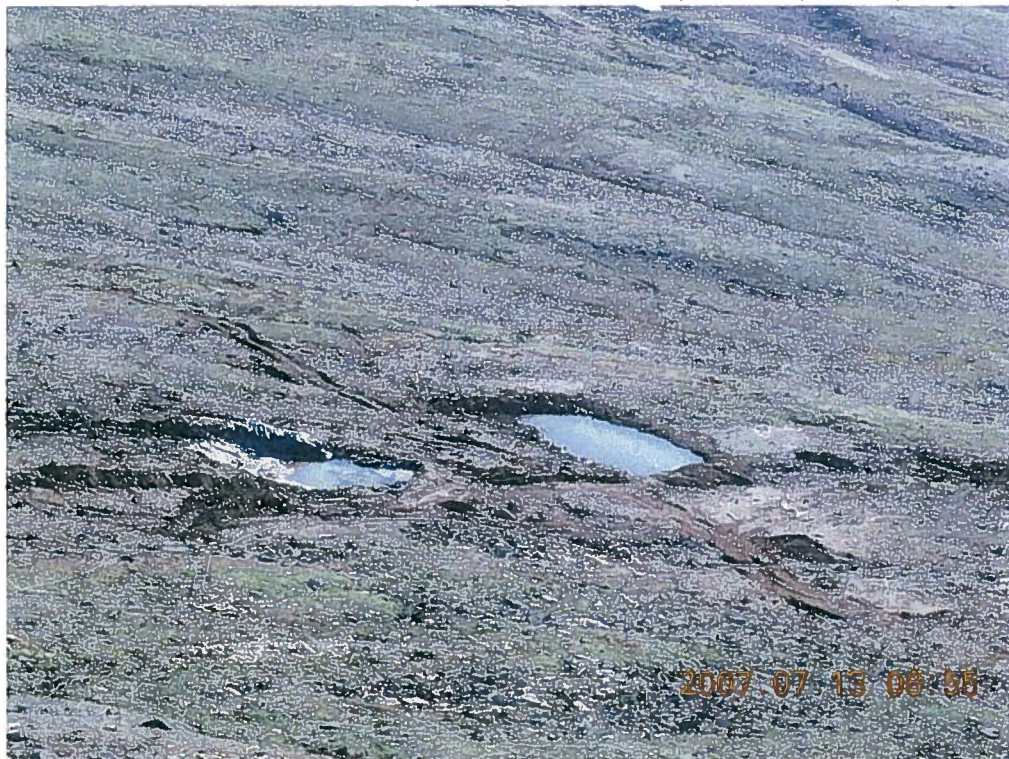
Photo 14: Silt fences (SF 1+2) below sumps 6 + 7 (SU 6+7)

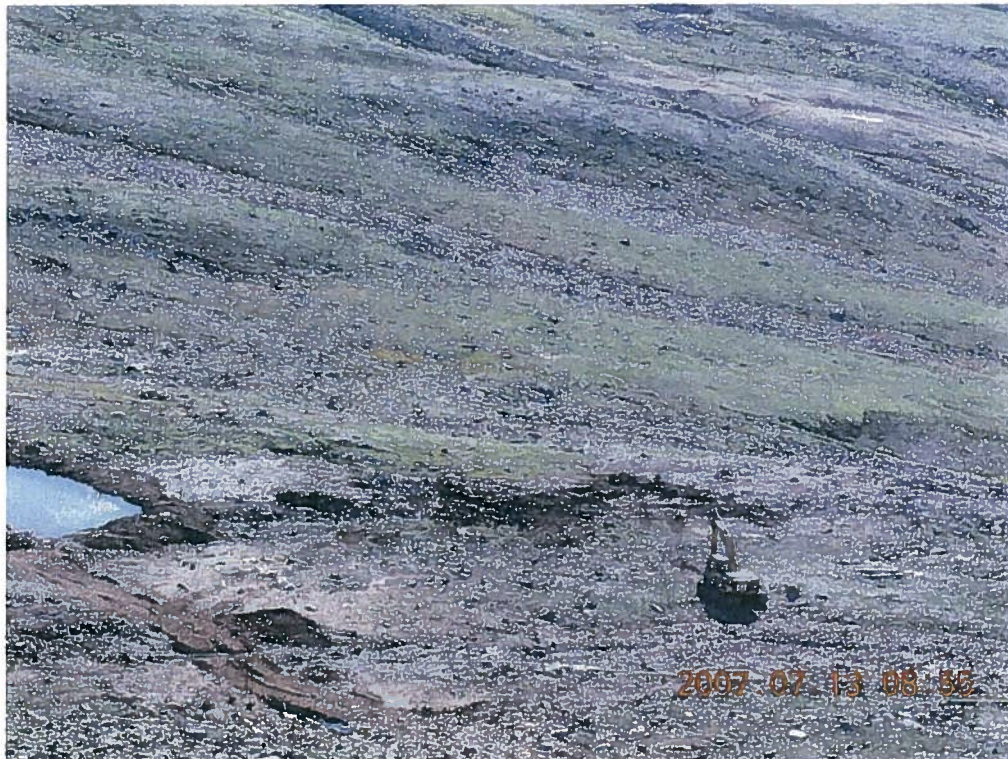
Photo 15: Silt fences (SF 1+2) below sump 7 (SU 7)

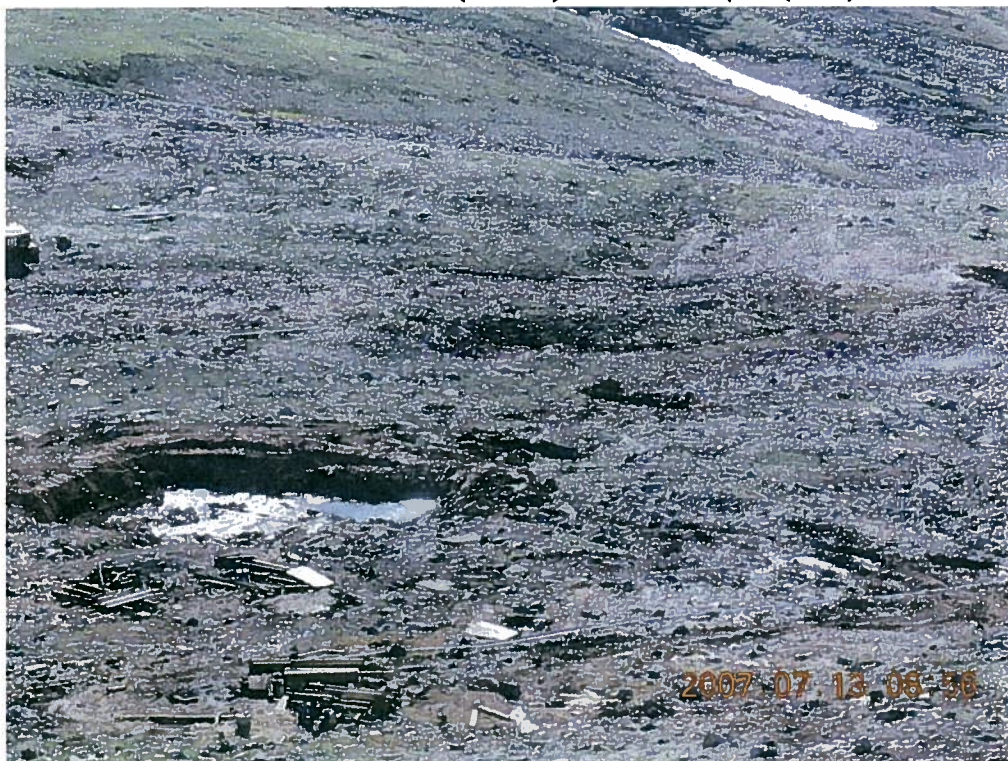
Photo 16: Silt fences (SF 3+4) below sump 8 (SU 8)

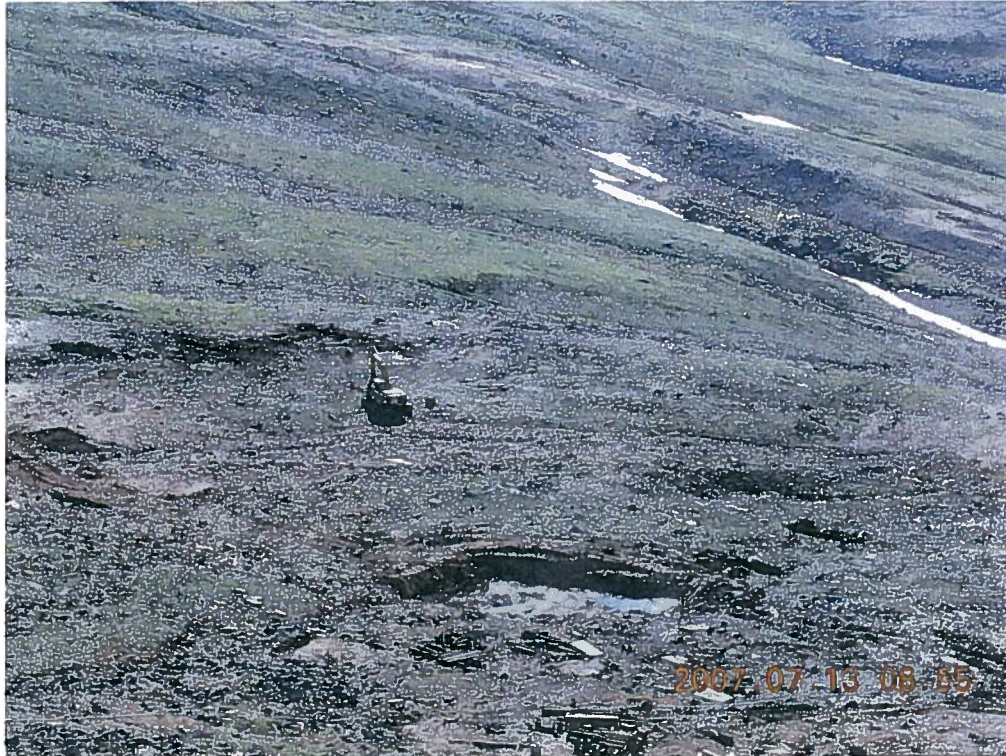
Photo 17: Silt fences (SF 3+4) below sump 8 (SU 8) looking ESE

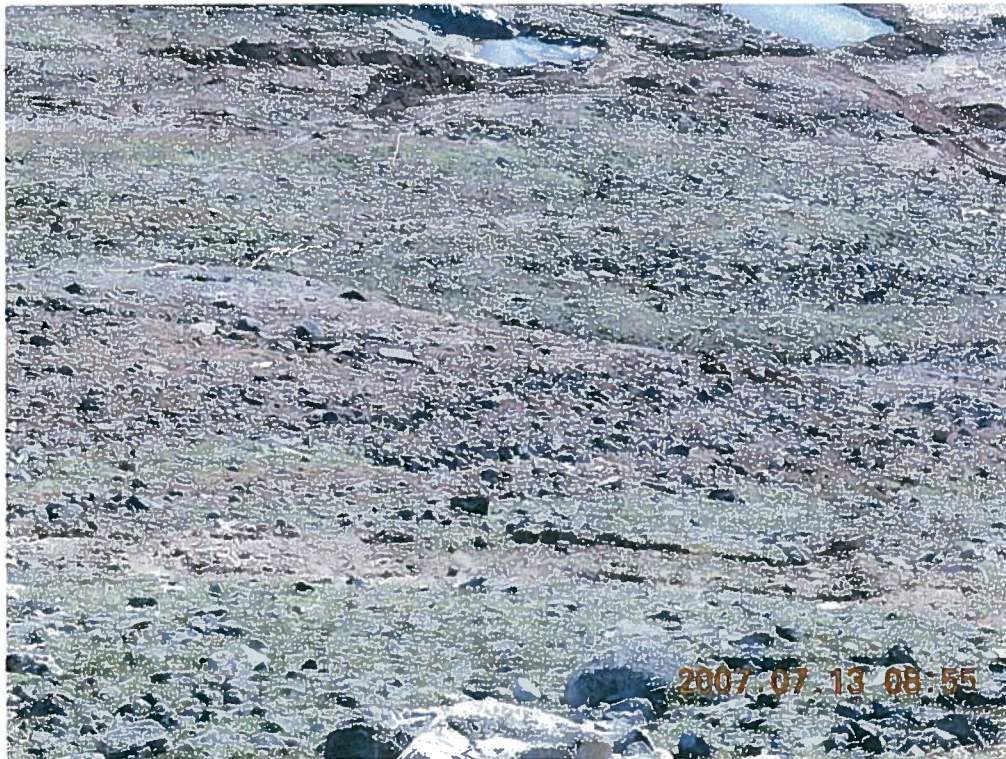
Photo 18: Waterline south of sumps 6 and 7 (SU 6+7)

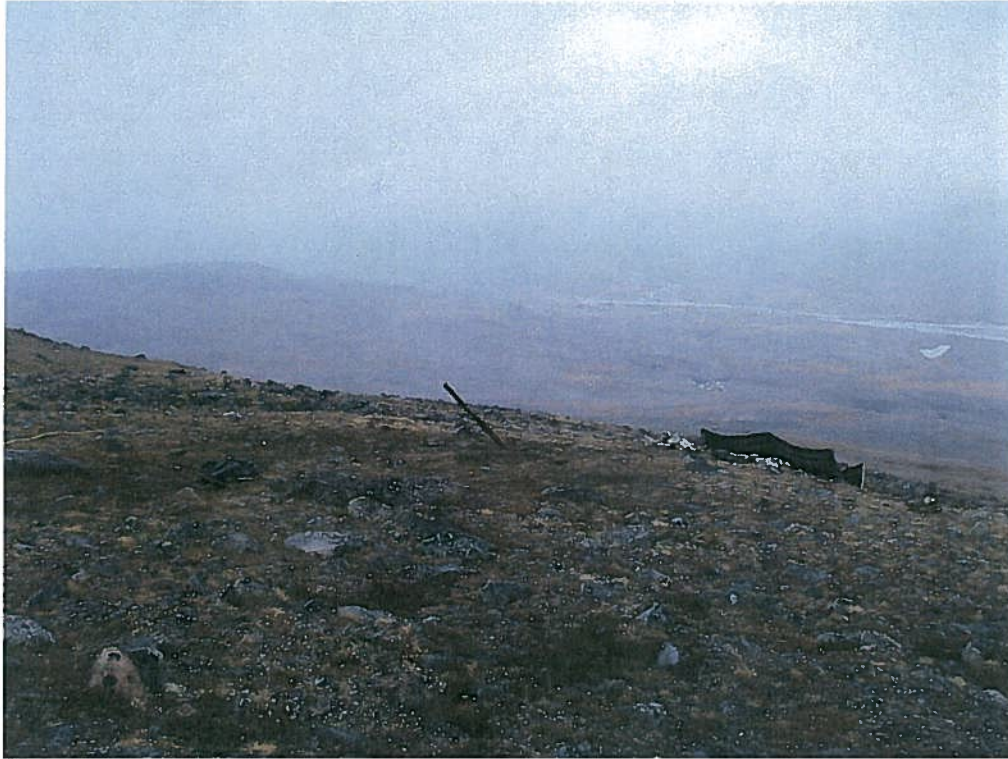
Photo 19: Silt fences (SF 5+6) and berms (B 1+2) at MR3-07-116 and 120

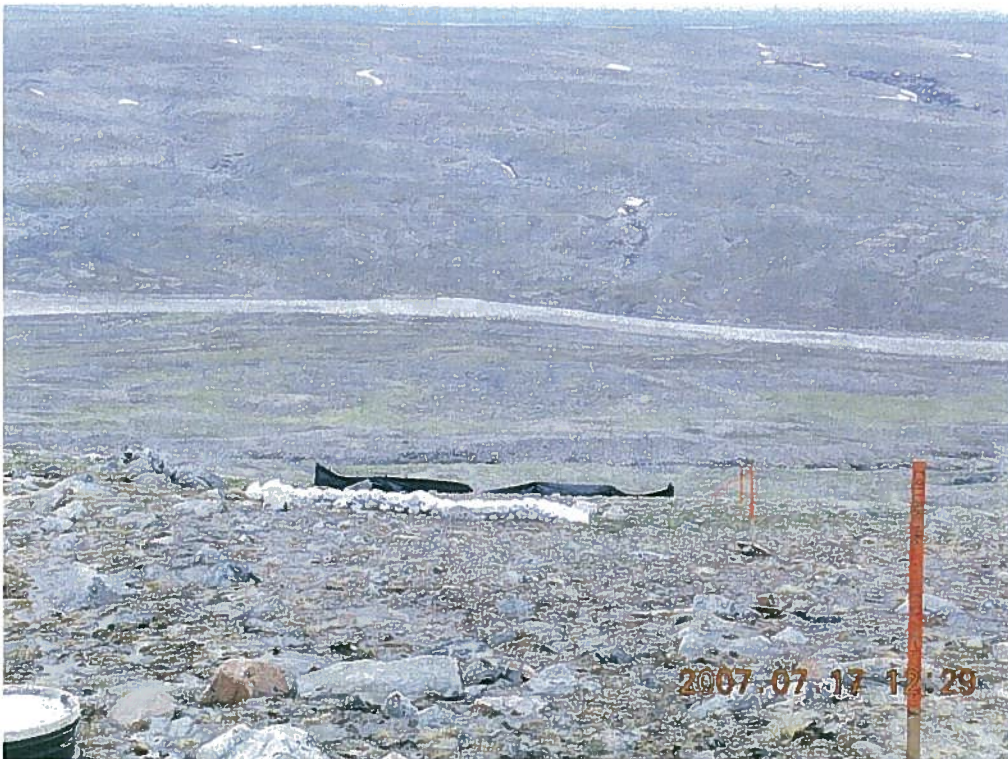
Photo 20: Silt fences (SF 5+6) and berms (B 1+2) at MR3-07-116 and MR3-07-120

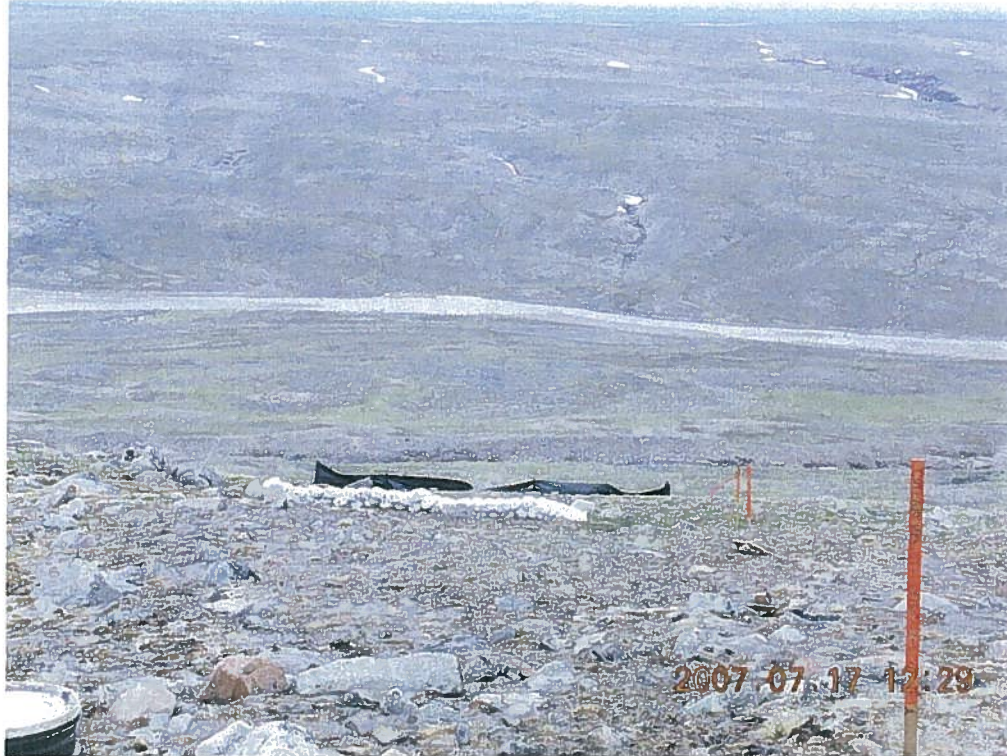
Photo 21: Silt fences (SF 5+6) and berms (B 1+2) at MR3-07-116 looking SSE

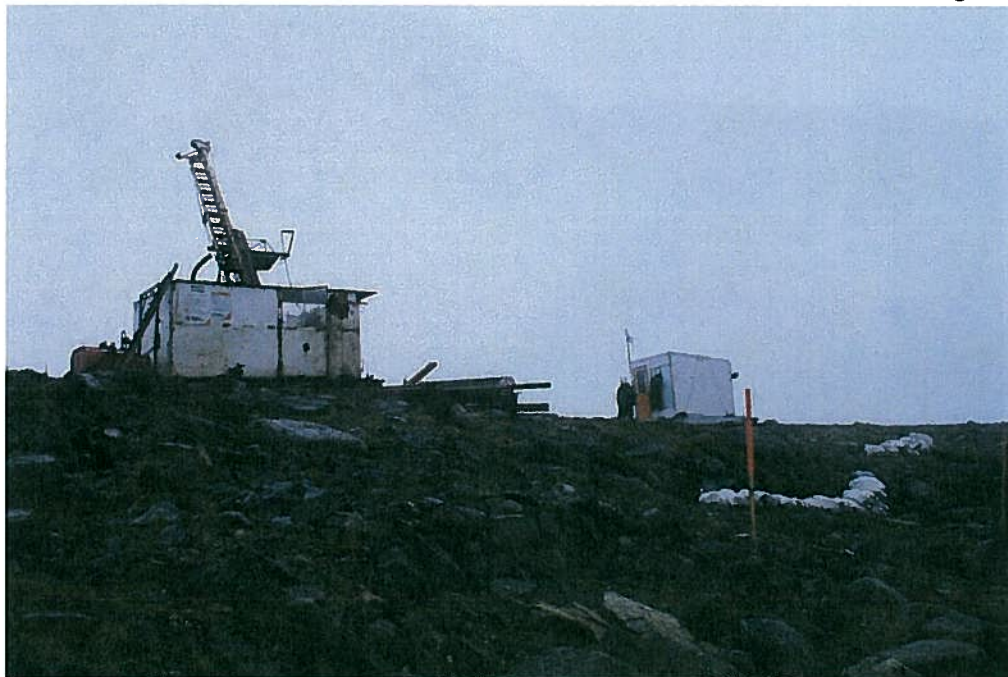
Photo 22: Silt fences (SF 7+8) and berms (B 3+4) at MR3-07-122 looking NNE

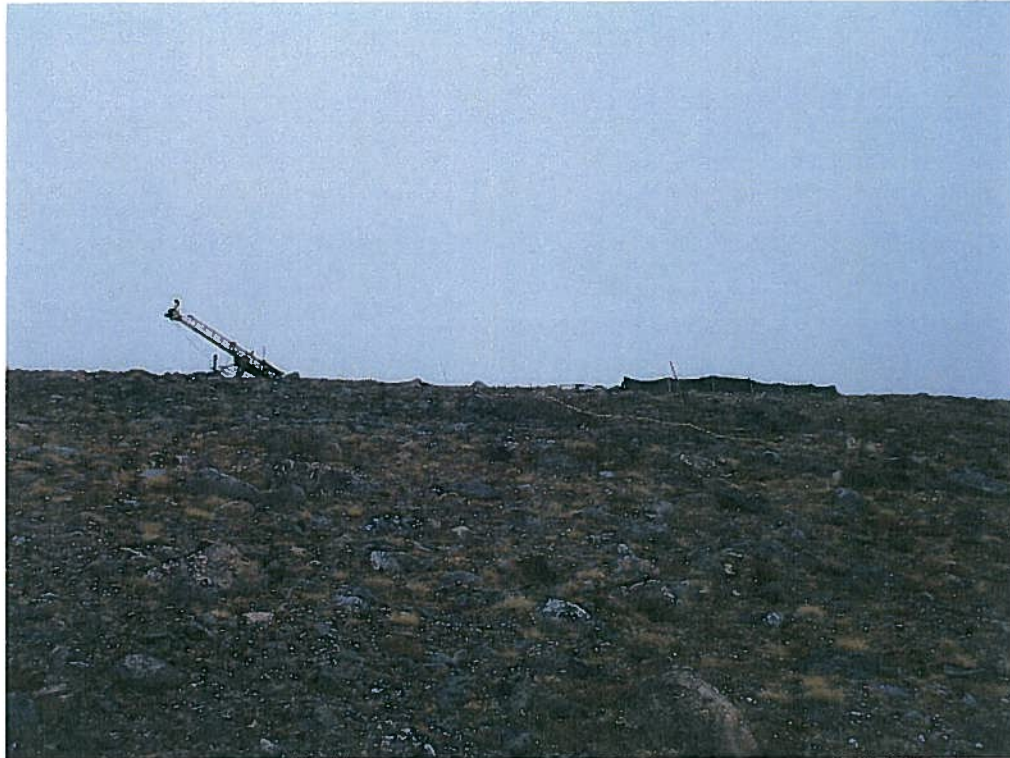
Photo 23: Silt fences at MR3-07-122 looking NNE (SF 7+8)
