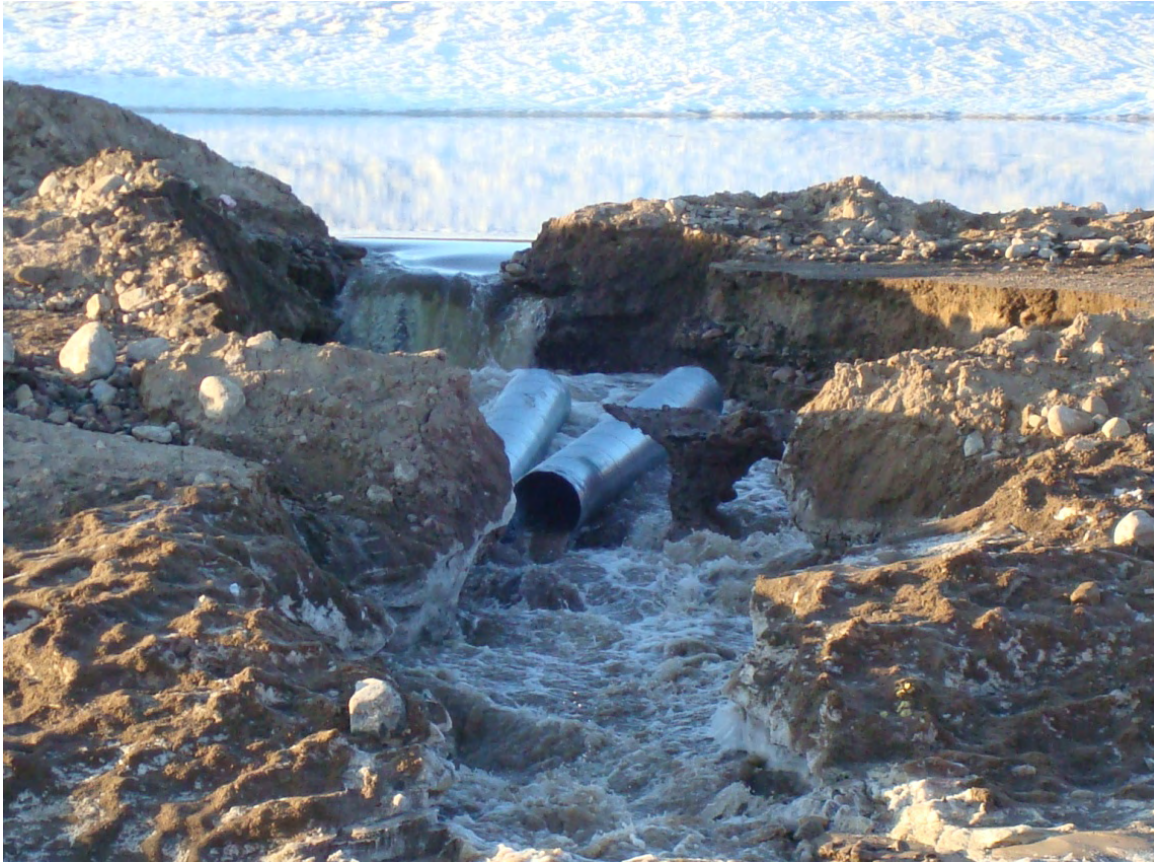
Photo 1: May 15, approximately 9 PM - View upstream showing washed out area of road and upstream pond.

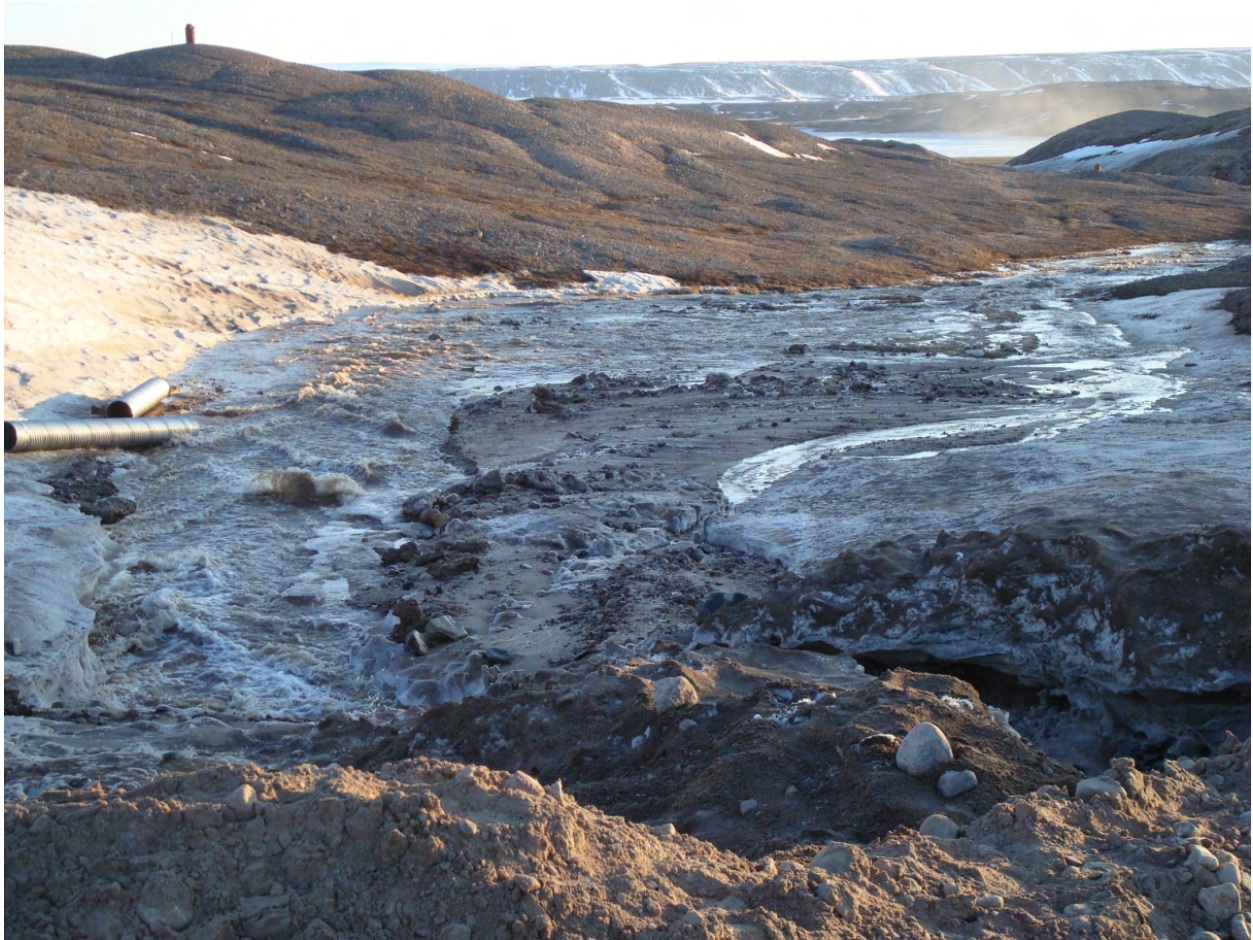
Photo 2: May 15, approximately 9:00 PM – View downstream showing high flows resulting from road wash, flows subsided within 2 hrs. Note two temporary culverts that were washed downstream during attempt to mitigate.

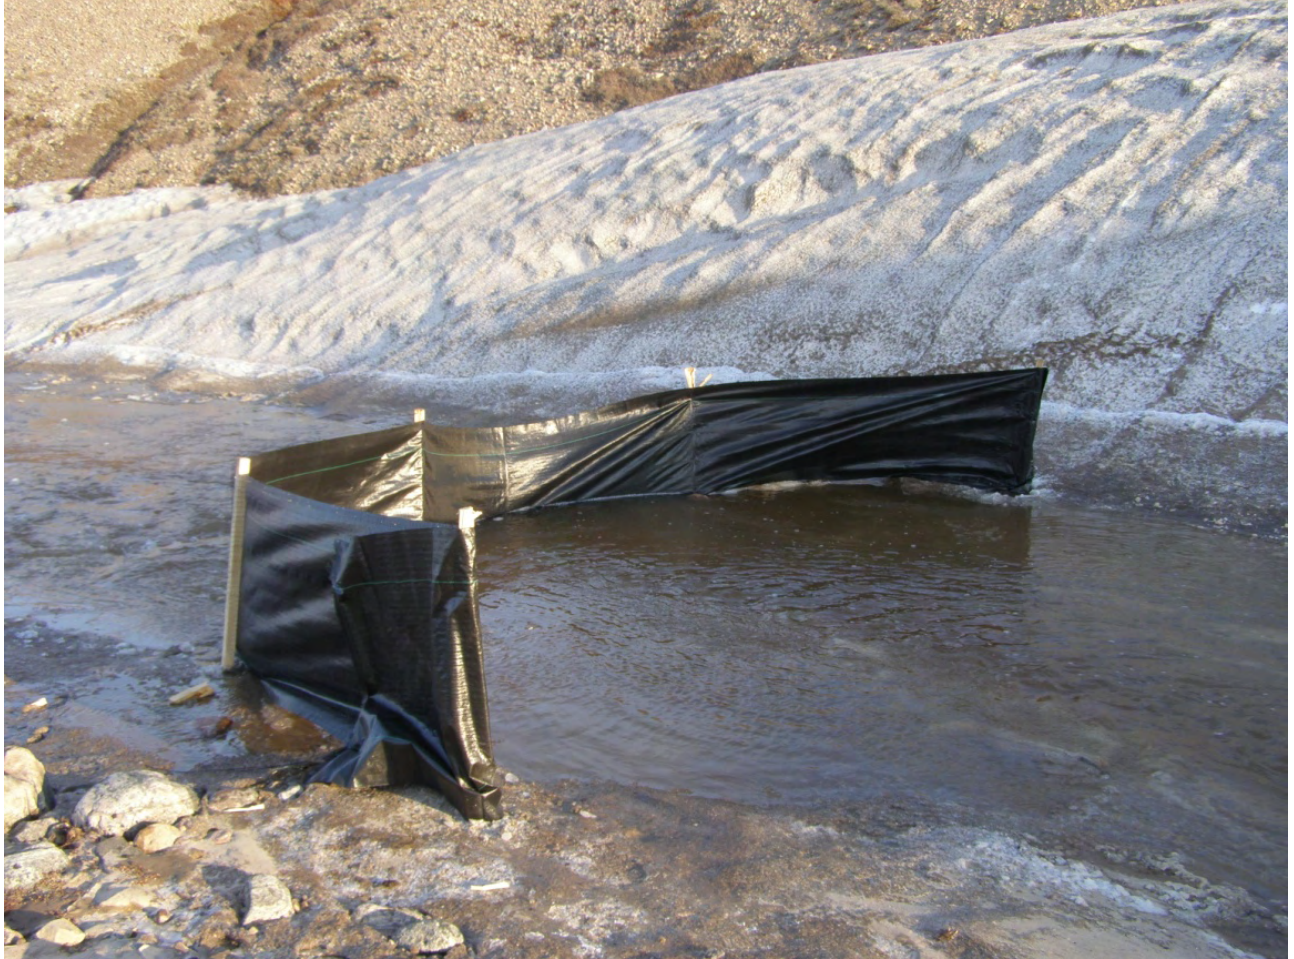
Photo 3: May 16 approximately 2 AM – View downstream - close-up silt fence installation

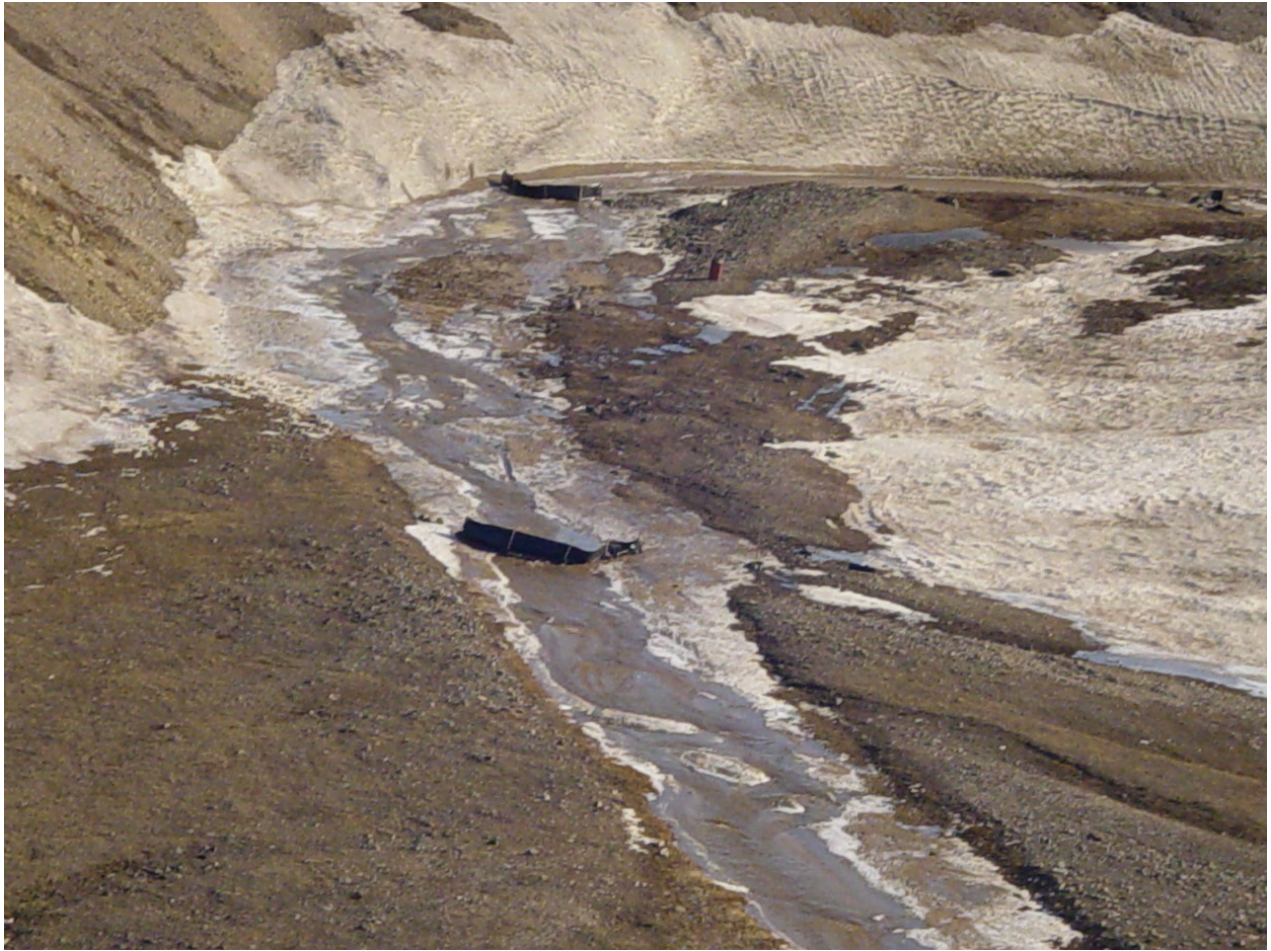
Photo 4: May 16, approximately 11 AM – Aerial view upstream –silt fence installation.

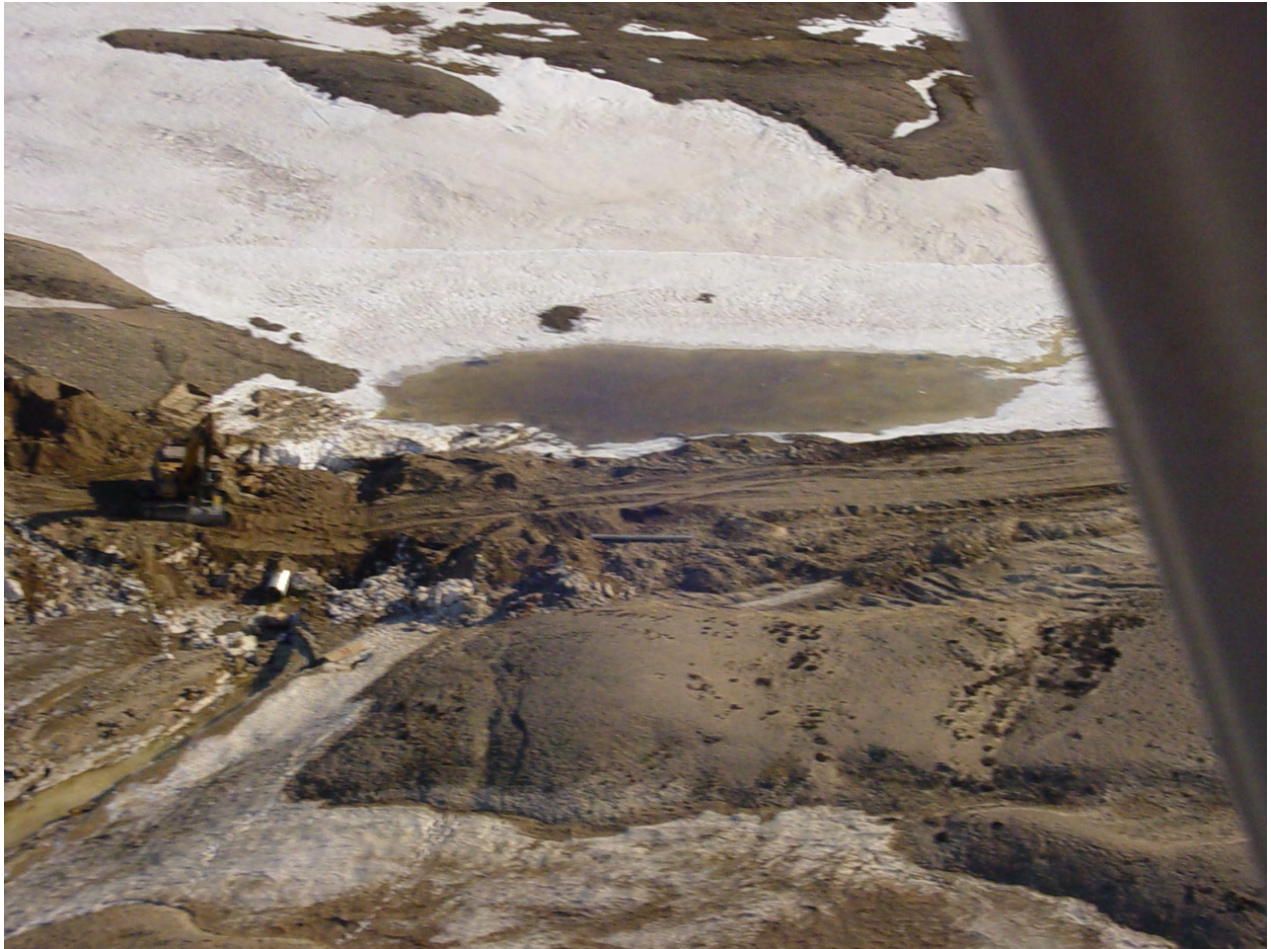
Photo 5: May 16, approximately 11 AM – Aerial view upstream showing auxiliary 1.0 m diam culvert, existing 1.0 m diam culvert (not washed out) is located below new installation (not visible in this photo).

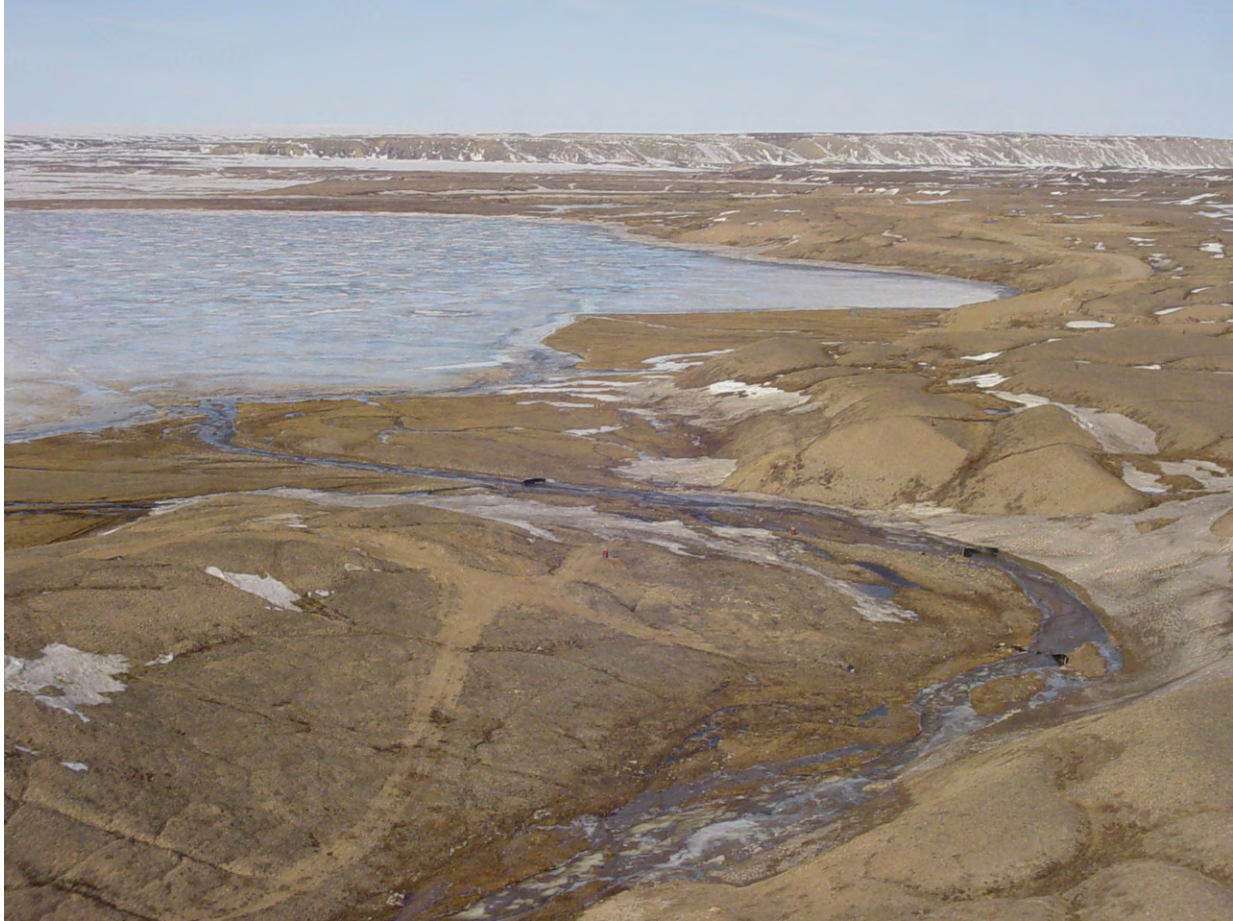
Photo 6: May 16, approximately 11 AM - Aerial view downstream of stream and Camp Lake, note three silt fence installations.

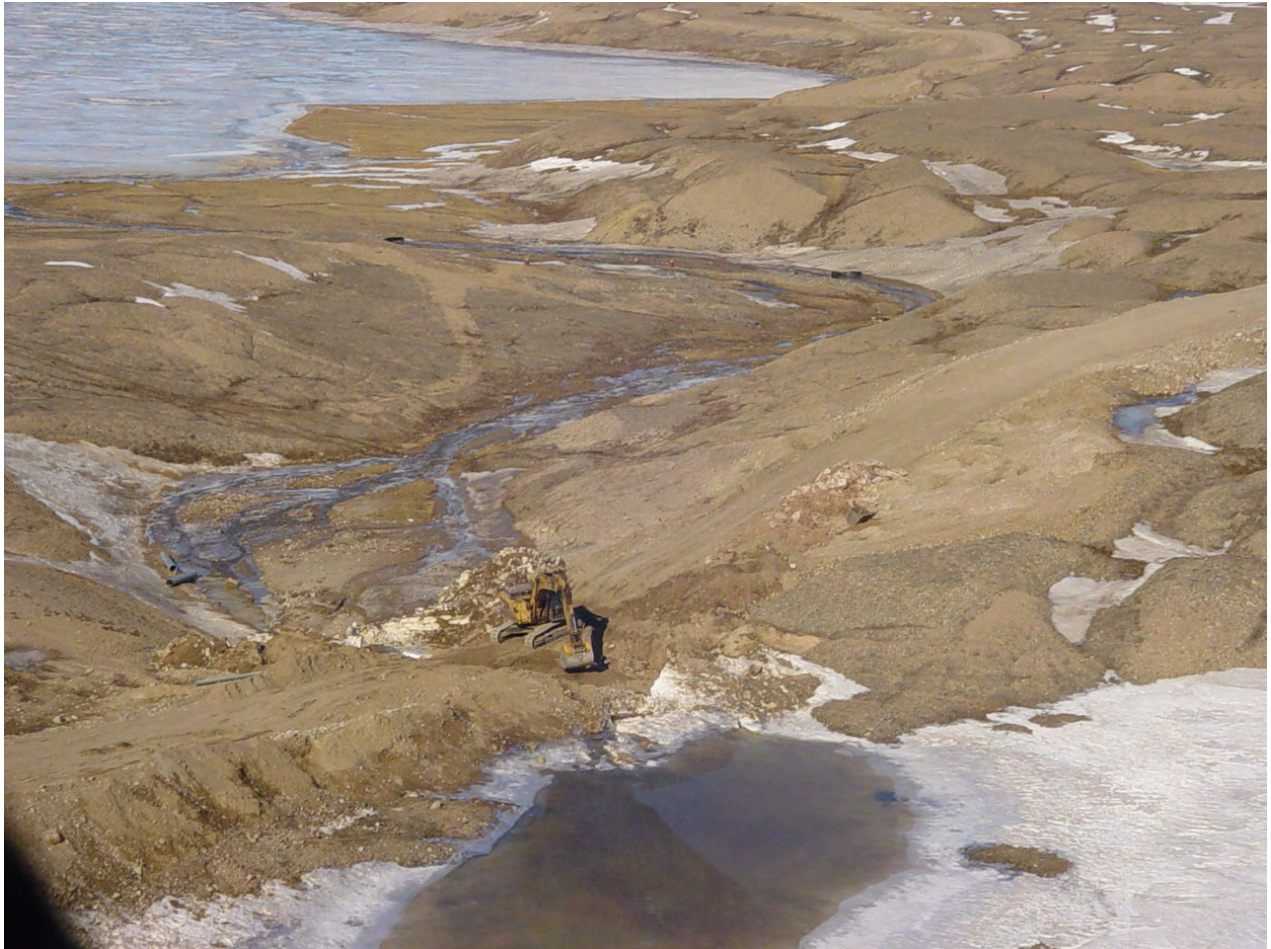
Photo 7: May 16, approximately 11 AM - Aerial view downstream from remnant of upstream pond, showing installation of auxiliary culvert.

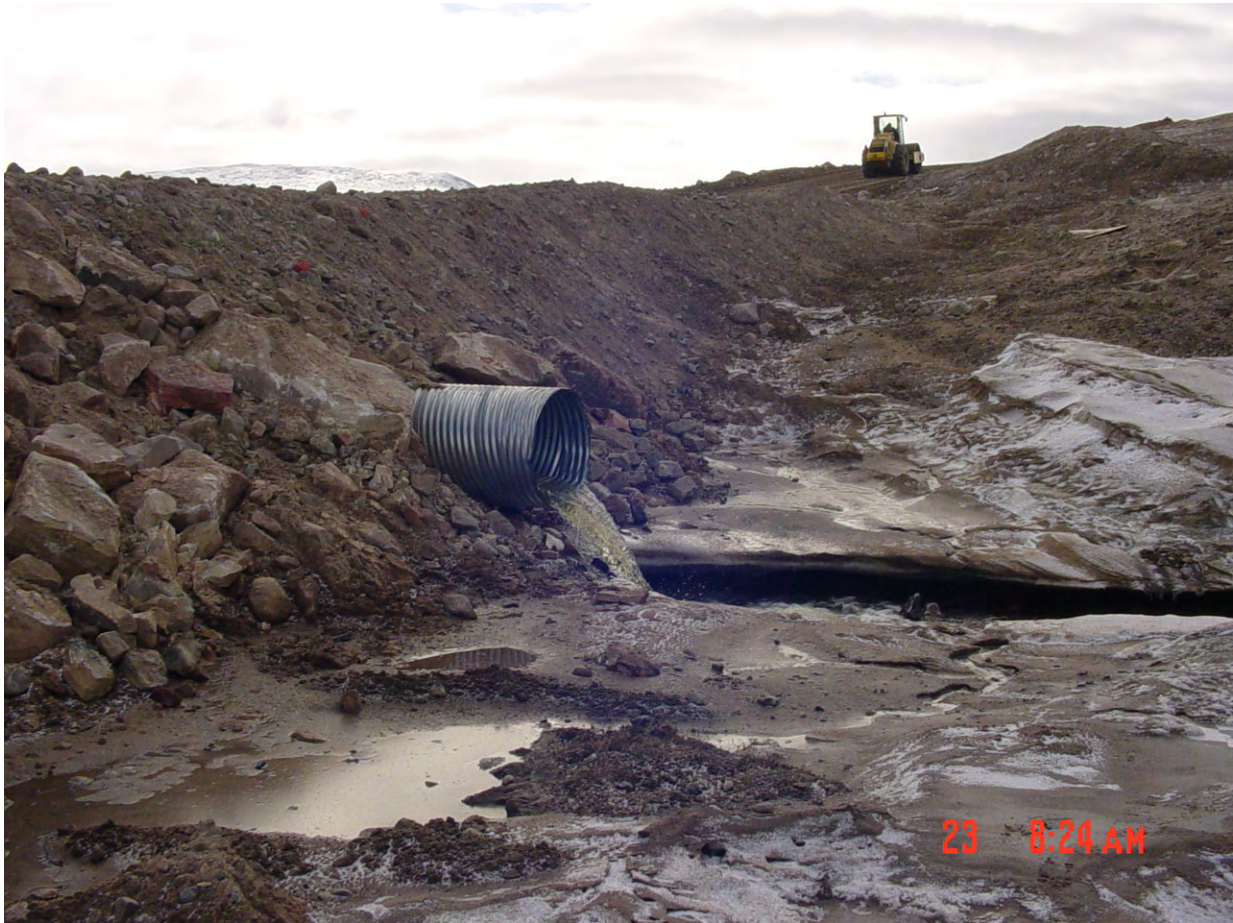
Photo 8: May 23 stream walk over - Perched downstream 'auxiliary' culvert. Original installed culvert is below, and not currently visible or open.

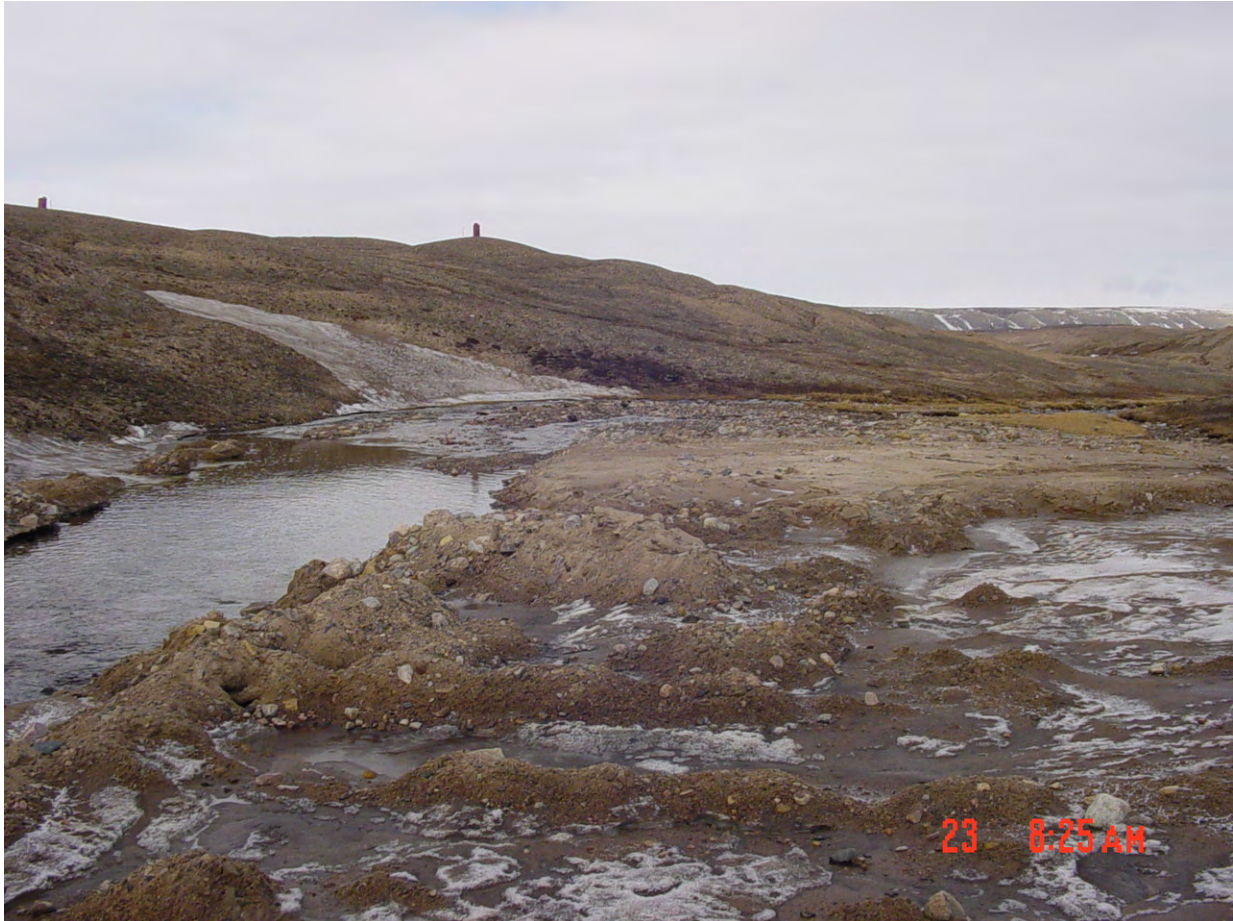
Photo 9: May 23 stream walk over - Road material, mainly cobbles and sand, deposited to west of main stream bed, immediately downstream of road. This material averages around 10 cm in depth, thinning in a downstream direction.

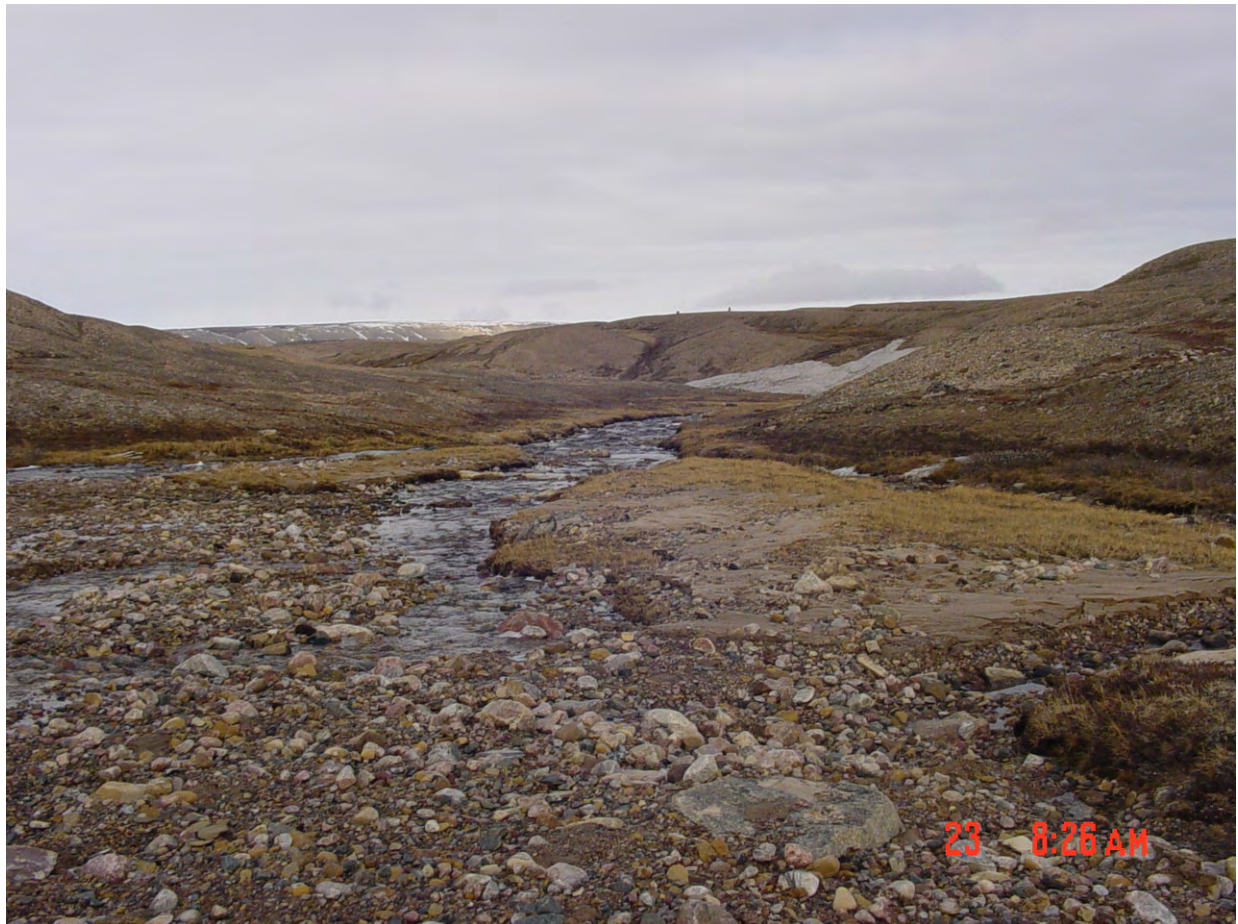
Photo 9: May 23 stream walk over - Approximately 80 m downstream. Material in foreground is thought to be natural material. Material in midground is several cm thick sand material from road bed, this material is found in patchy sections to within 80-100 m of Camp Lake shore.

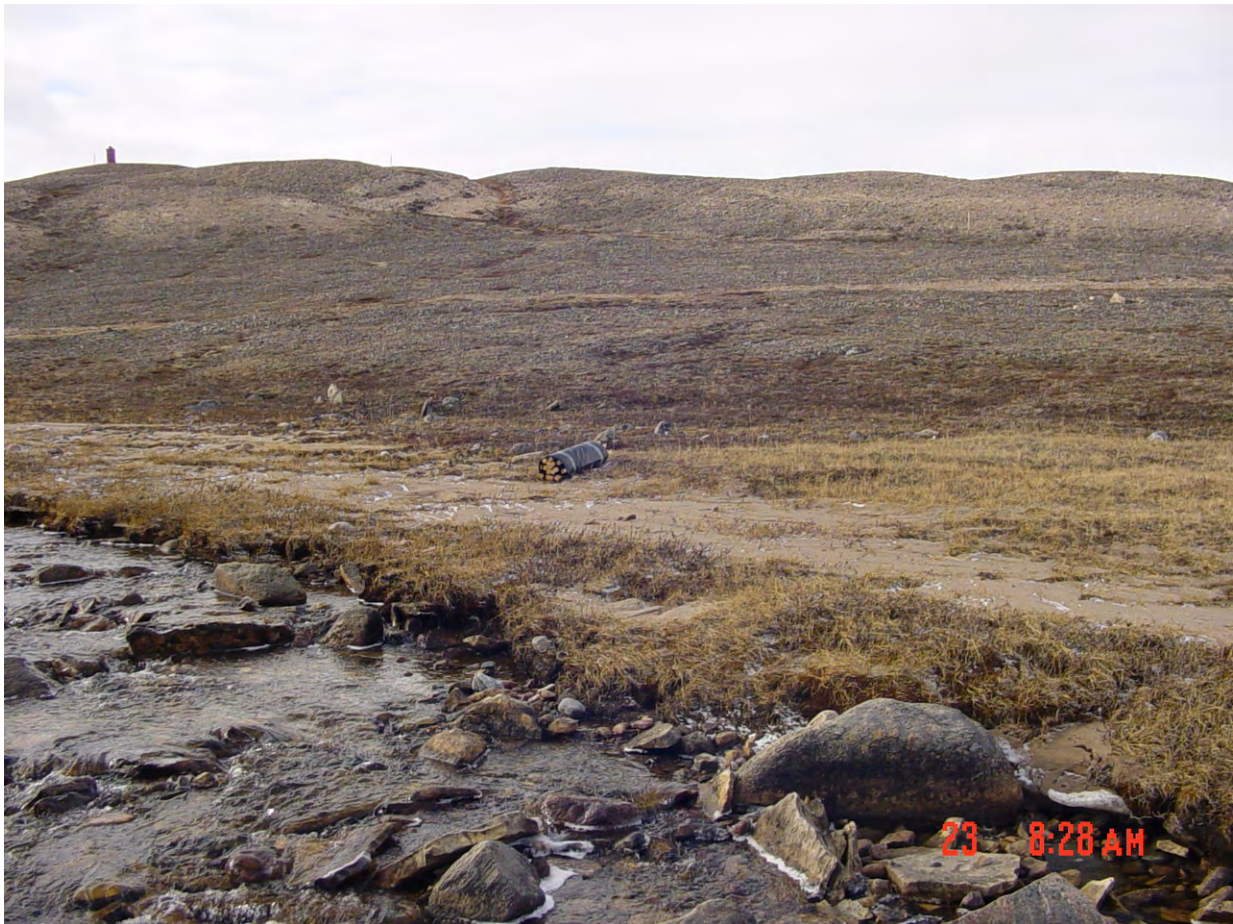
Photo 10: May 23 stream walk over - Further downstream. Patchy cm thick sand deposited on stream bank.

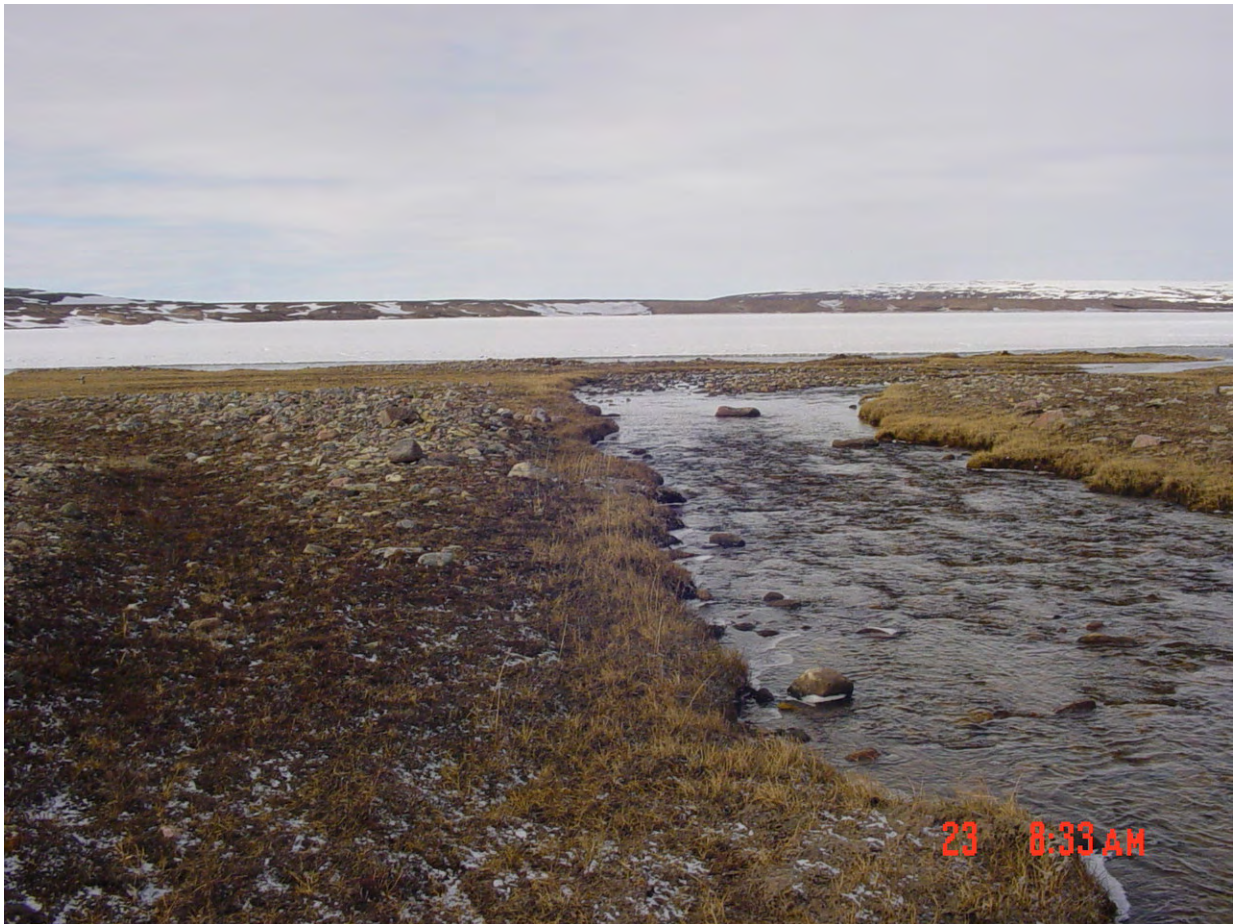
Photo 11: May 23 stream walk over – last 60-80 m of stream banks are free of road bed material.

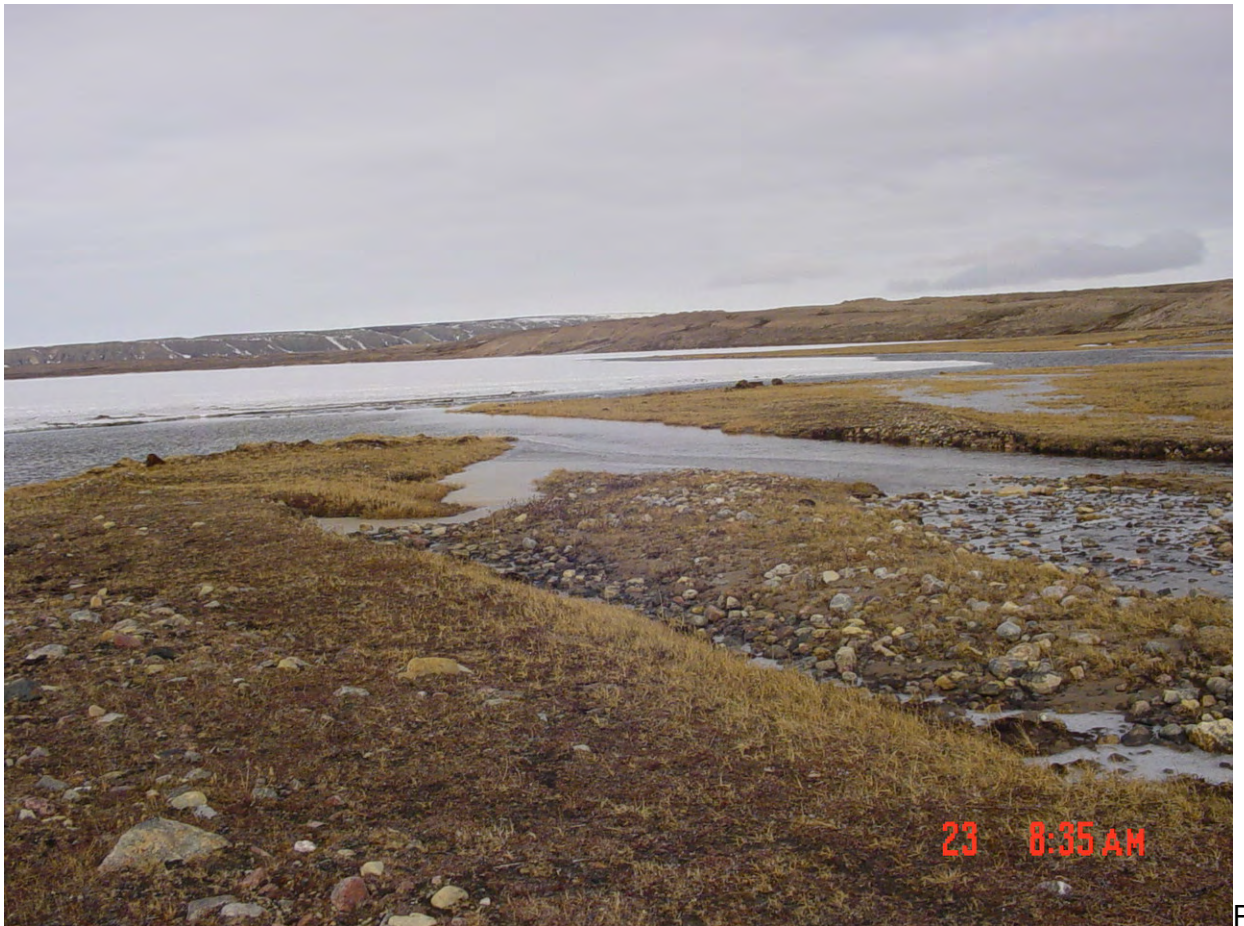
hoto 12: May 23 stream walkover - Outlet of stream to Camp Lake.
