**Baffinland Iron Mines Corporation**

**BORROW SITE RECLAMATION OVERVIEW  
MILNE POINT ACCESS ROAD, MARY RIVER PROJECT  
BAFFIN ISLAND, NU**

**E14101074**

**December 2009**

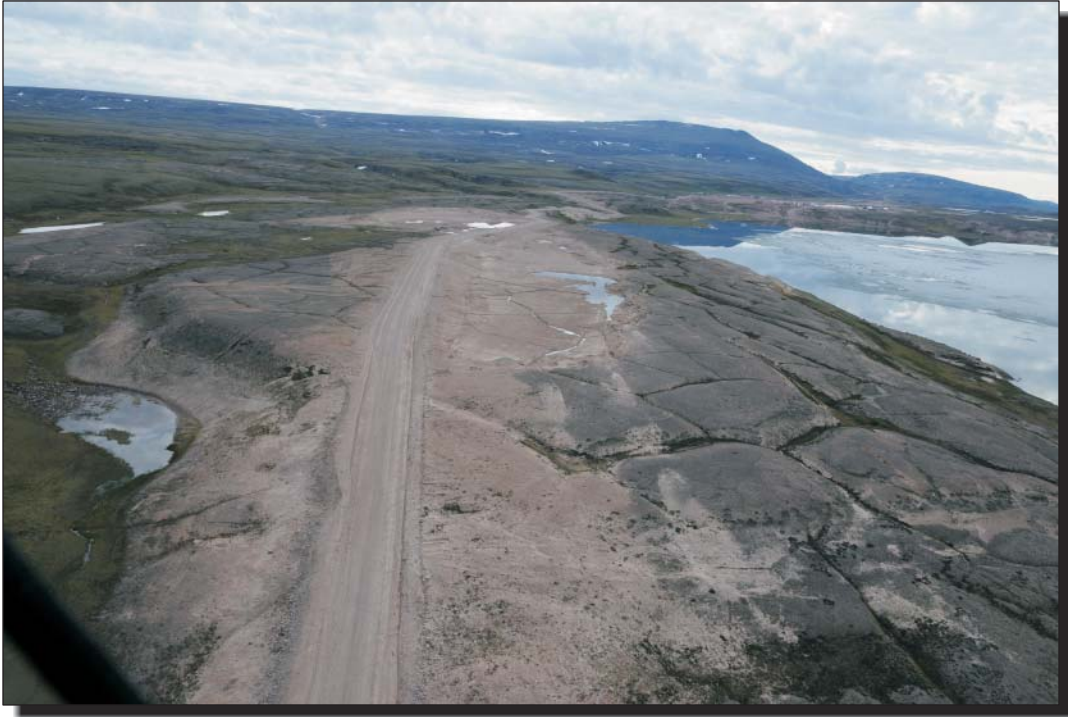
**Photo 1**

The wedge ice is the most striking feature in the region of naturally well-drained granular uplands. These show up in aerial oblique photos, such as Photo 1,<sup>1</sup> as polygonal patterned ground comprising a series of orthogonal cracks that are the surface expression of ice wedges that occur to depths up to 3 m into the permafrost. These ice wedge features formed over a period of 8,000 or so following deglaciation by perennial rapid thermal contraction followed by water infiltration and frost heave expansion. They can be up to 1 m wide at the top of permafrost and taper with depth in a carrot-like shape. They are a common feature of granular permafrost soils as these frozen soils behave in a brittle fashion when subjected to rapid drop in air temperature leading up to winter.

Priority B pit at km 97.9 (WP 9) just north of Mary River Camp lies on a gravel terrace with well established Ice Wedge polygons. Melt out within the pit has initiated thaw and ponding.

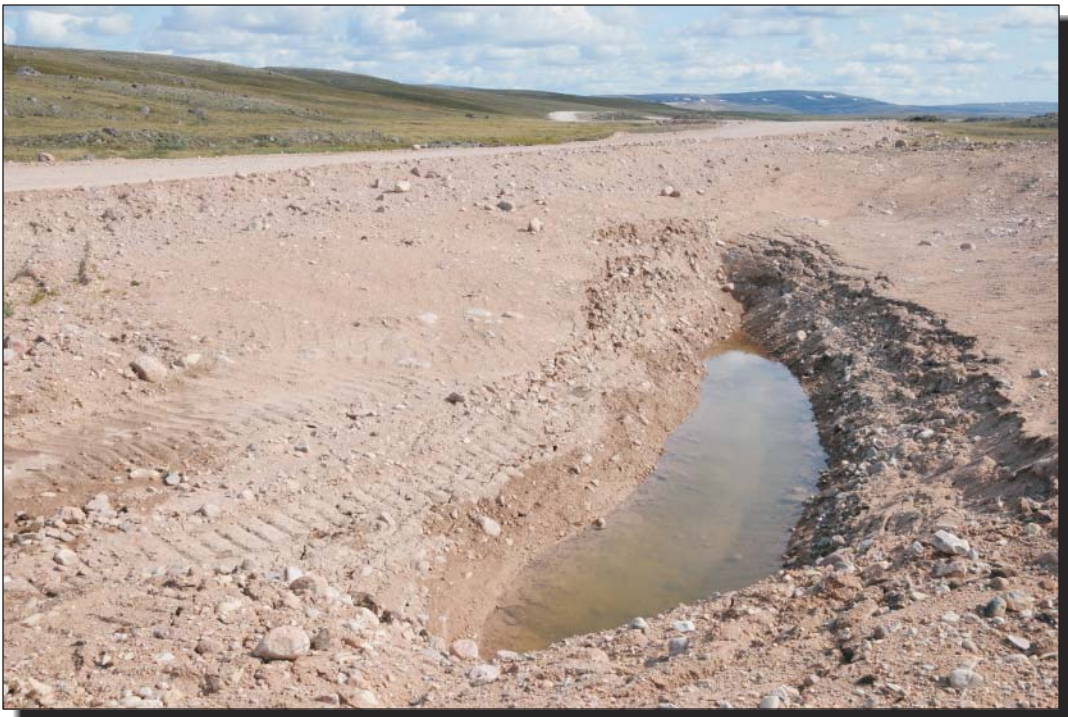
**Photo 2**

Pit at km 22.3 (WP 68) linear sinkhole from thaw of wedge ice about to affect road shoulder.

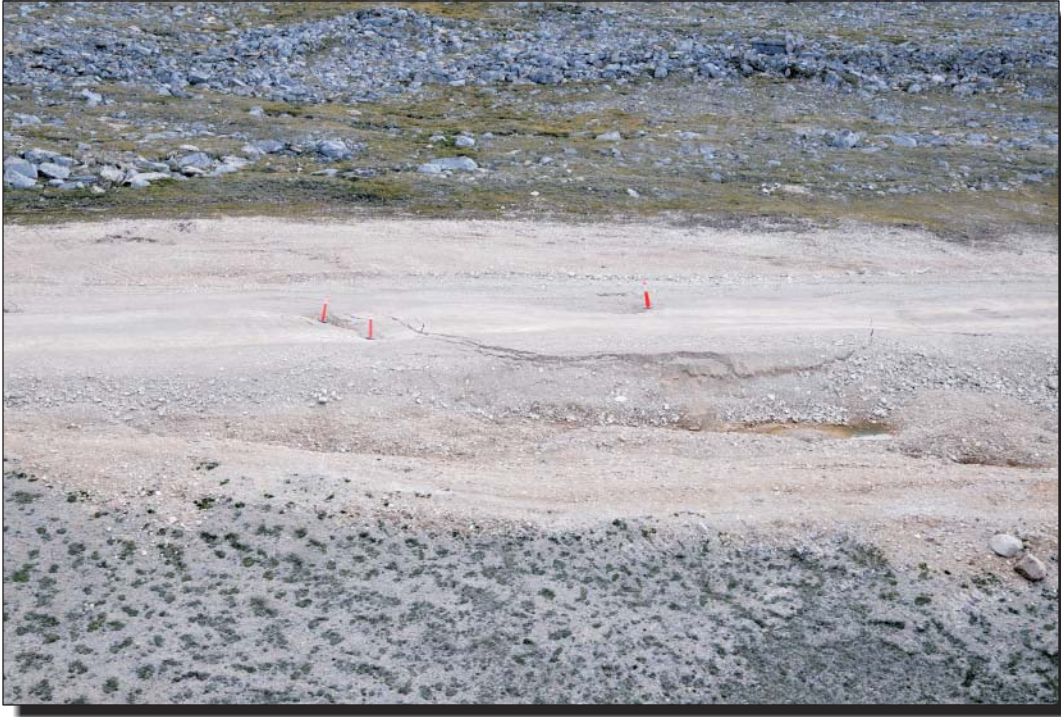
**Photo 3**

Road collapse at km 55.4 (WP 35) initiated by thermal erosion from water running through ice wedge exposed in adjacent pit.

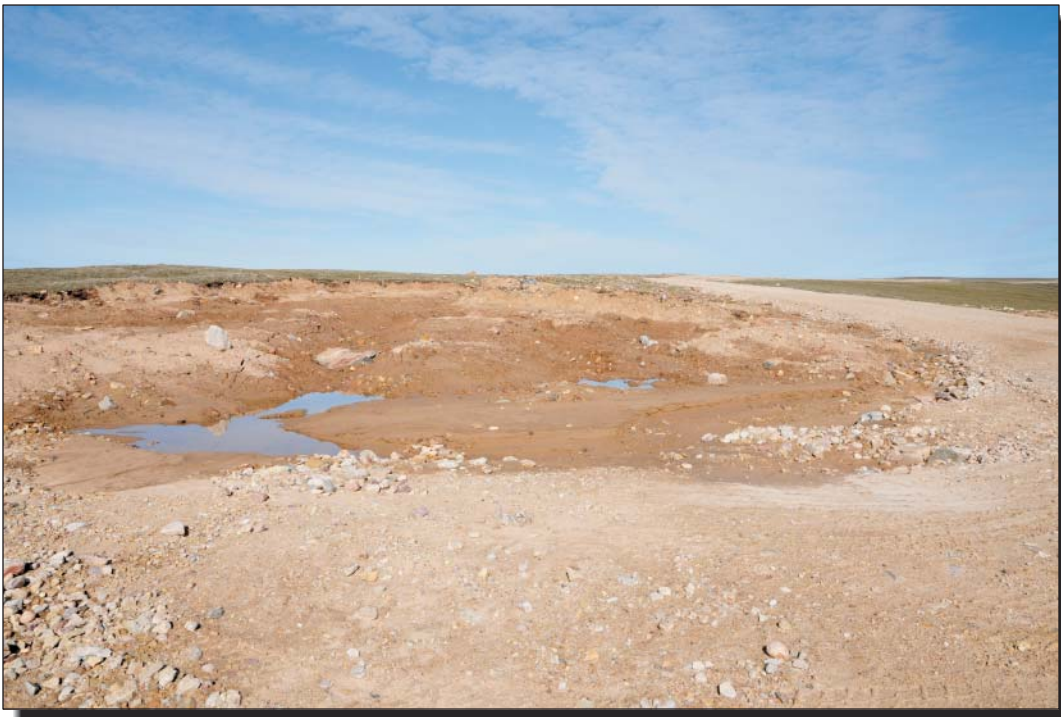
**Photo 4**

Pit at km 71.8 (WP 23) typical sinkholes in pit bottom from thaw of segregated ice common in fine-grained lacustrine soils

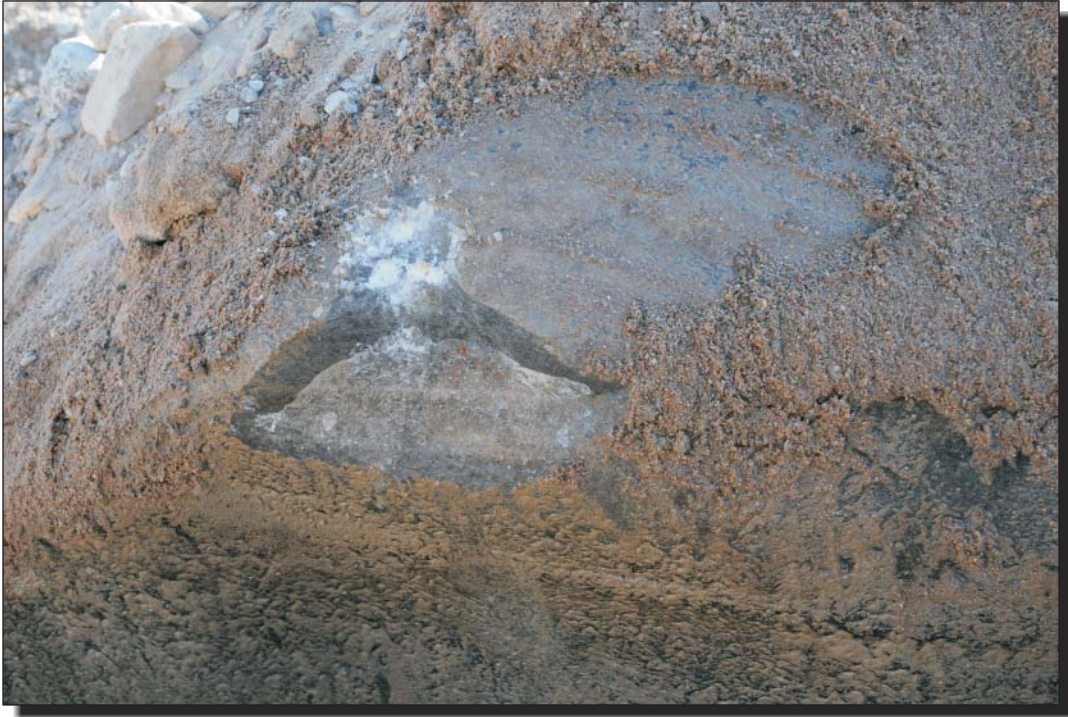
**Photo 5**

29	63.7			Severe	Massive ground oce observed in pit. Wedge ice under road.	Unstable, extensive thaw	Rebuild road grade	A	693, 694, 695, 696, 697, 698	587	This is the most ice rich site noted. Remnants of massive ice were found in large thaw depression on south side of road. Ice wedges are actively melting under road sideslope Cracks and depressions extend to the shoulder. To reduce risk of road collapse, the grade should be raised at least 1 m through this area and berms a minimum 3 m wide constructed on the south sideslope. Final reclamation of this site will require further assessment of the best method for ensuring drainage from the sink hole without risking siltation of the creek valley immediately to the south.
30	63.1		Dry	Low	Not apparent	Stable	Regrade	C	703	593, 653	River terrace. Active layer gravel removed over a large area. Site is dry and naturally well drained. Regrade surface for reclamation.

Pit at km 63.7 (WP 29) exposure of massive ice remaining in pit wall.

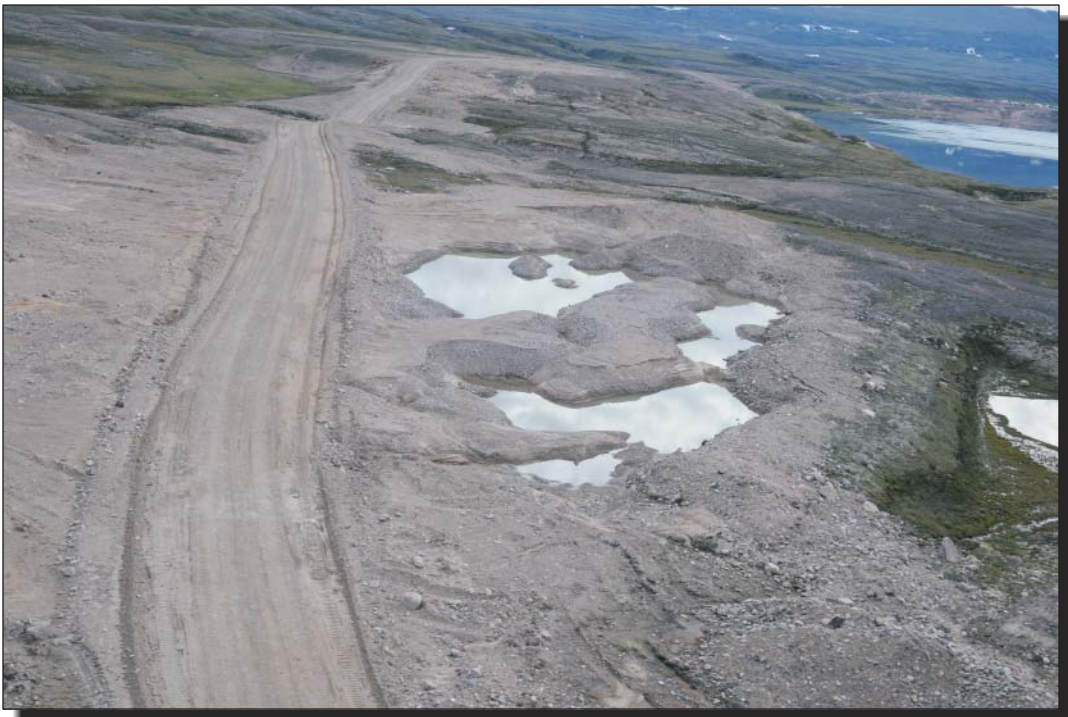
**Photo 6**

Pit at km 97.5 (WP 10) typical sinkhole formation from thaw of massive ice.
