**APPENDIX D**  
**AS BUILT REPORTS**

**APPENDIX D.2**  
**GEOTECHNICAL INSPECTION**

**Re: Baffinland Iron Mines Corporation (BIMC) - Submission of 2013 Annual Geotechnical Inspection, Water Licences Type 'A' No. 2AM-MRY1325 and Type 'B' 2BB-MRY1114**

**ANNUAL GEOTECHNICAL INSPECTION**  
**Baffinland Iron Mines Corporation**  
**Mary River Project**

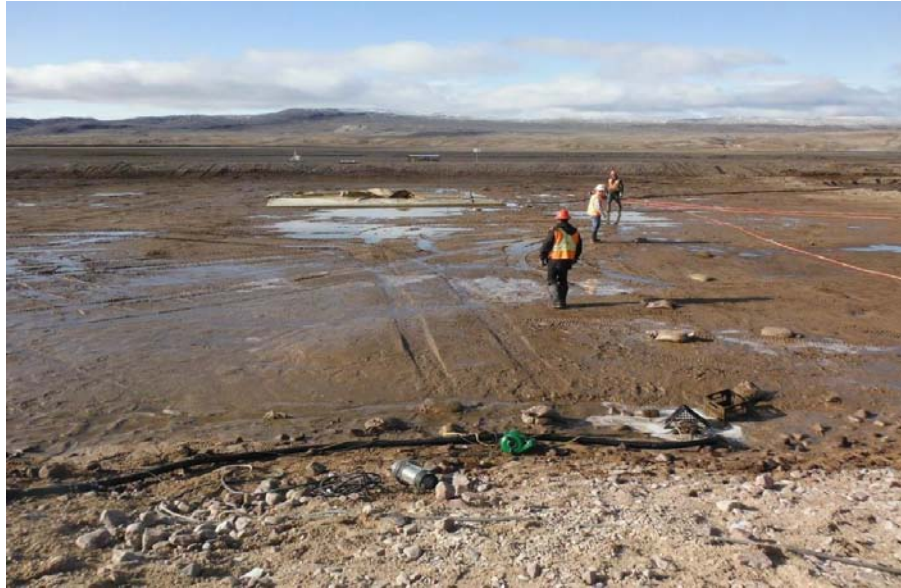
**PHOTO 21** Sump pump in Bulk Fuel Bladder Farm during Decommissioning September 2013

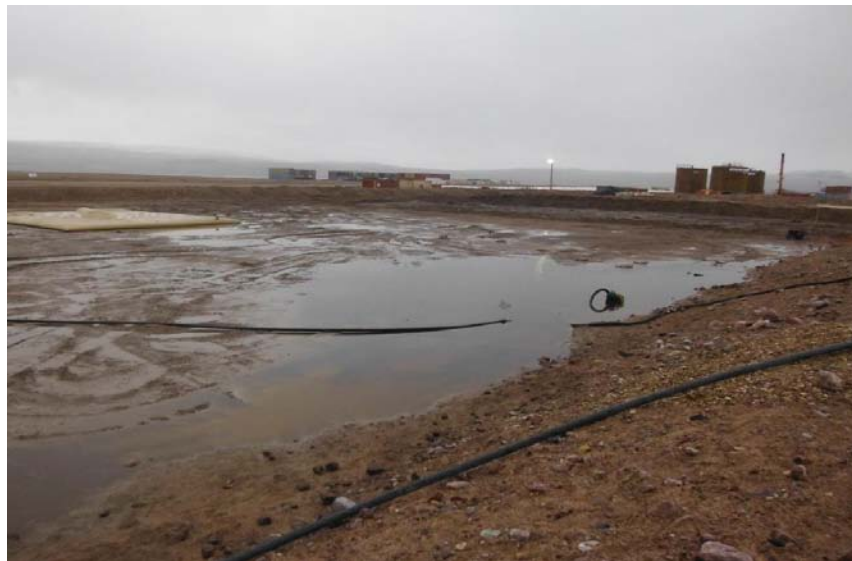
**PHOTO 22** North west view of sump pump in Milne Port Fuel Bladder farm during decommissioning September 2013
