November 19, 2008

Baffinland Iron Mines Corporation  
Suite 1016, 120 Adelaide Street West  
Toronto, ON M5T 1T1

**RE: ANNUAL GEOTECHNICAL INSPECTION 2008  
BAFFINLAND IRON MINES CORPORATION  
OUR REFERENCE NO. 07-039**

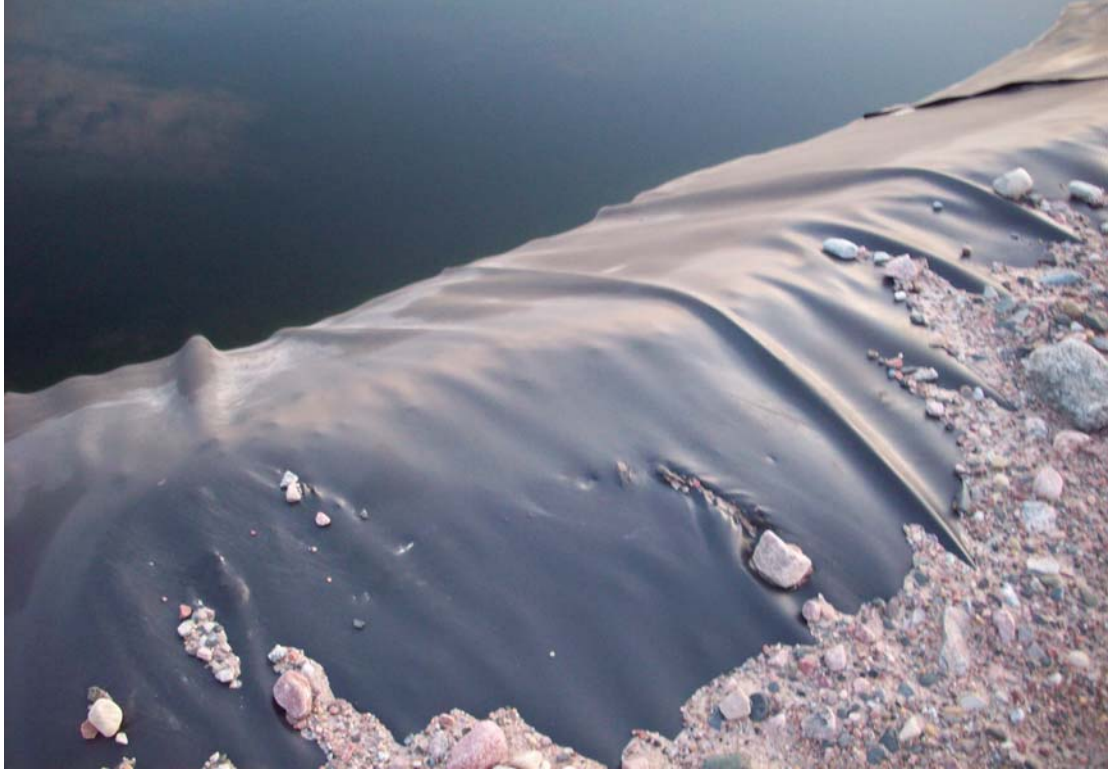
A review of the exposed liner on the upper edge of the dyke showed a number of tears in the upper edge of the liner caused by vehicular traffic on the top of the dyke and generally within a distance of 30 m of the ramp access to the top of the dyke.

Typical damaged membrane PWSP #1.

- It is recommended that the exterior slopes on the dykes be built out to a 4:1 slope if the effluent level exceeds the levels measured on September 4, 2008 (175.90).
- In consideration of the potential for the thawing of permafrost regime under the PWSP, it is recommended that monitoring points be established on the dyke structure and an elevation monitoring program be implemented to measure any potential settlement. It is recommended that a monthly monitoring be implemented from May through October 2009.
- The liner rips should be repaired as soon as practicable.

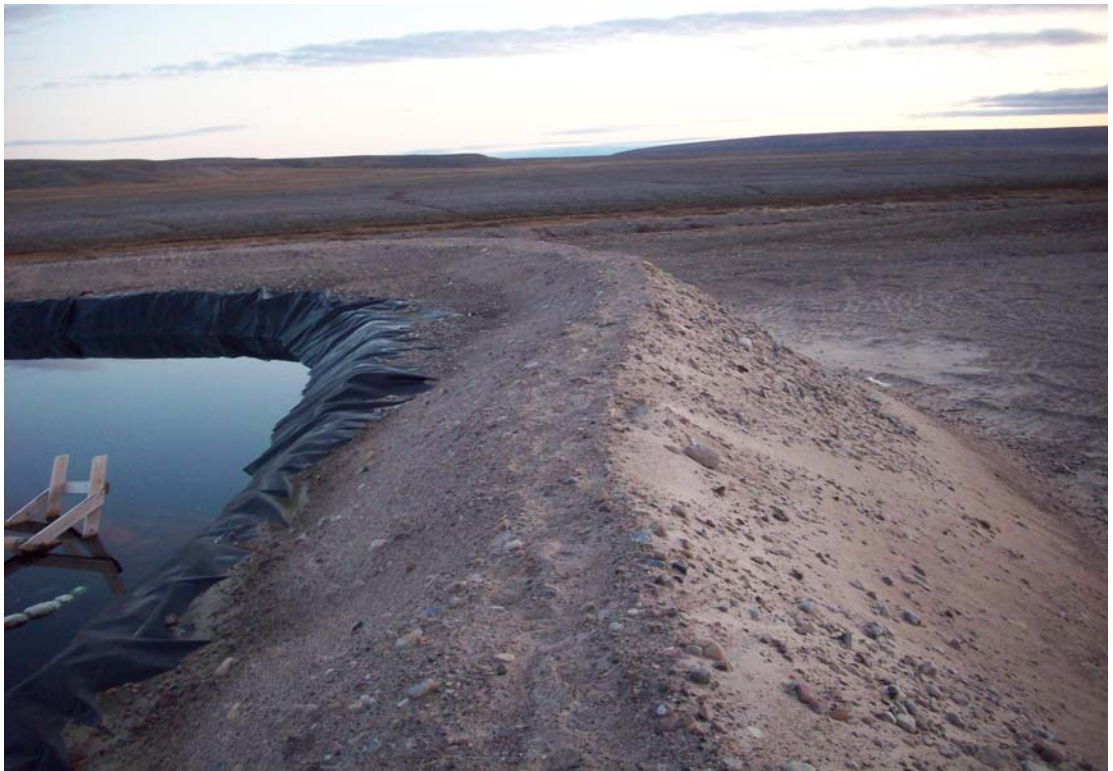
PWSP #1

Our inspection of the area around the pond at the base of the slopes showed no signs of water (treated sewage effluent) and hence we conclude that there are probably no tears or ruptures in the membrane below the water table.

A review of the exterior and top of the dykes showed no indication of settlement or cracking which would be indicative of overstress on the structure.

The structure is considered to be stable in its present condition.

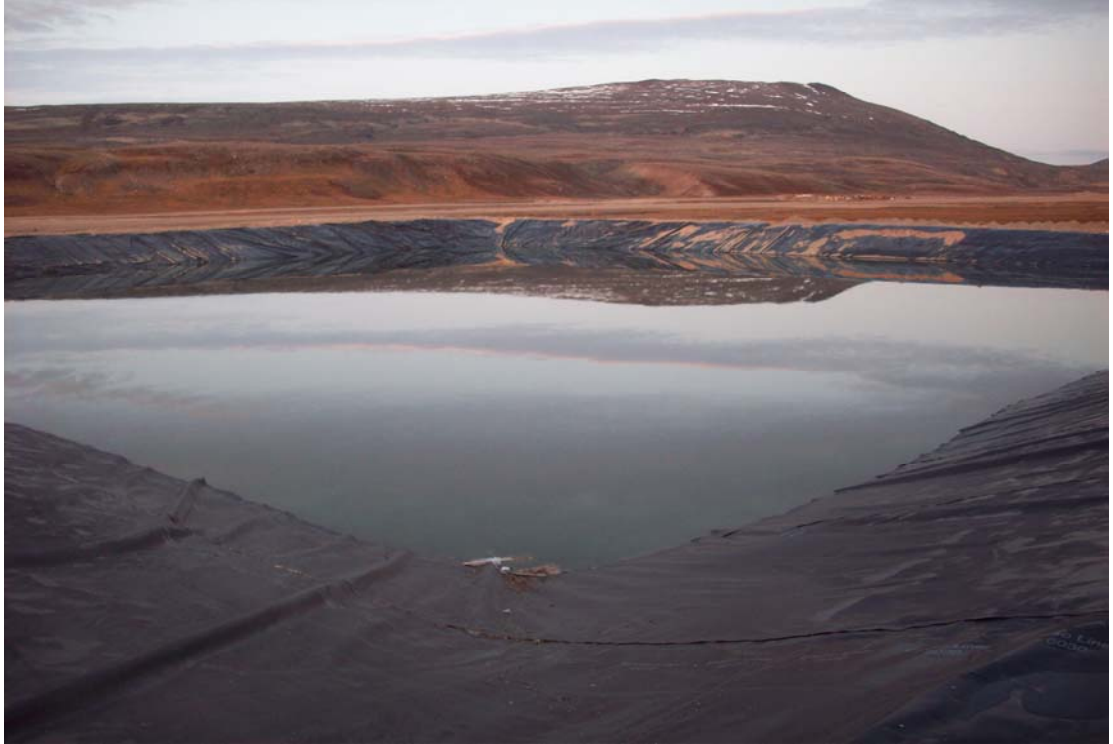
PWSP #2

Our review of the area around the pond at the base of the slopes showed no signs of water (sewage) and hence we conclude that the liner has been effective in containing the sewage and there are no tears or ruptures in the membrane.

A review of the exterior and top of the dykes showed no indication of settlement, seepage, or cracking which are signs of overstress on the structure. The structure is considered to be stable at its present condition.

- Based on the current 4:1 backslope the level of sewage in the cell shall not exceed a height of 1.8 m.
- In consideration of the potential for the thawing of permafrost regime under the PWSP, it is recommended that monitoring points be established on the dyke structure and an elevation monitoring program be implemented to measure any potential settlement. It is recommended that monthly monitoring be implemented from May to October 2009.

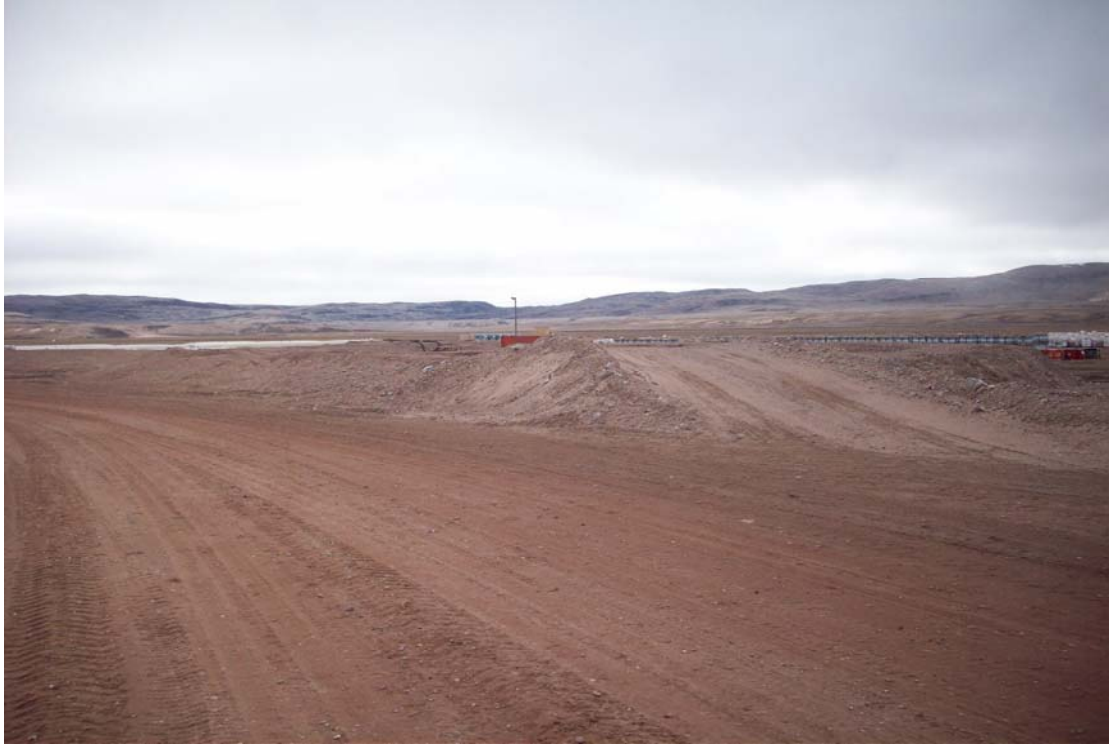
Milne Inlet PWSP

The exterior slopes of the dykes were observed to be at 4:1. The interior slope of the dykes could not be directly observed on September 7, 2008, due to the high level of treated effluent.

Currently, the Milne PWSP structure conforms to the design basis of the facility with the exception of the high levels of treated effluent in the pond.

Based on the observed 4:1 dyke exterior slopes, the structure appears stable at current conditions which involve treated effluent near or at the top of the liner. It should be noted that despite the high treated effluent levels, there was no sign of effluent break-out or seepage at any location along the bottom of the dyke. However, as noted in the recommendations, the facility should not be operated at this effluent height for any extended period of time.

- The treated effluent level should be decanted to a depth 600 mm below the top of the liner. The effluent can be transported to the PWSP at Mary River via tanker truck for disposal. The long term use of this structure for the storage of effluent is acceptable so long as effluent levels are kept to the aforementioned design levels.
- In consideration of the potential for the thawing of permafrost regime under the PWSP, it is recommended that monitoring points be established on the dyke structure and an elevation monitoring program be implemented to measure any potential settlement. It is recommended that monthly monitoring be implemented from May through to October 2009.

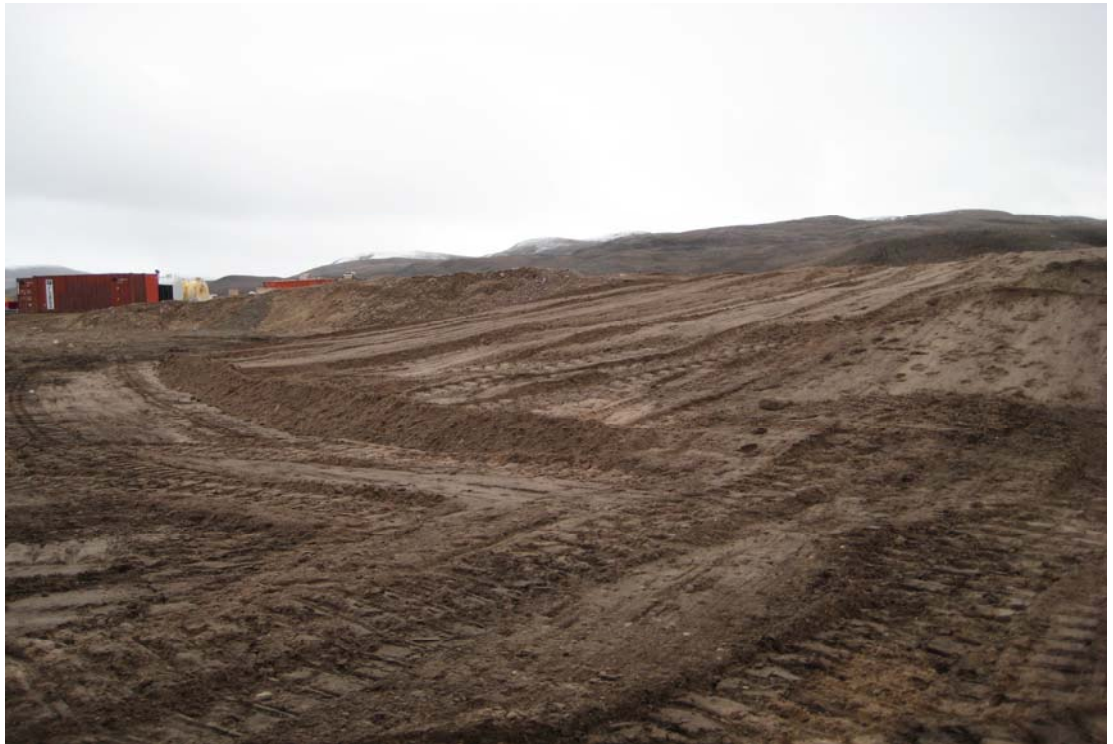
Milne Inlet PWSP north dike exterior.

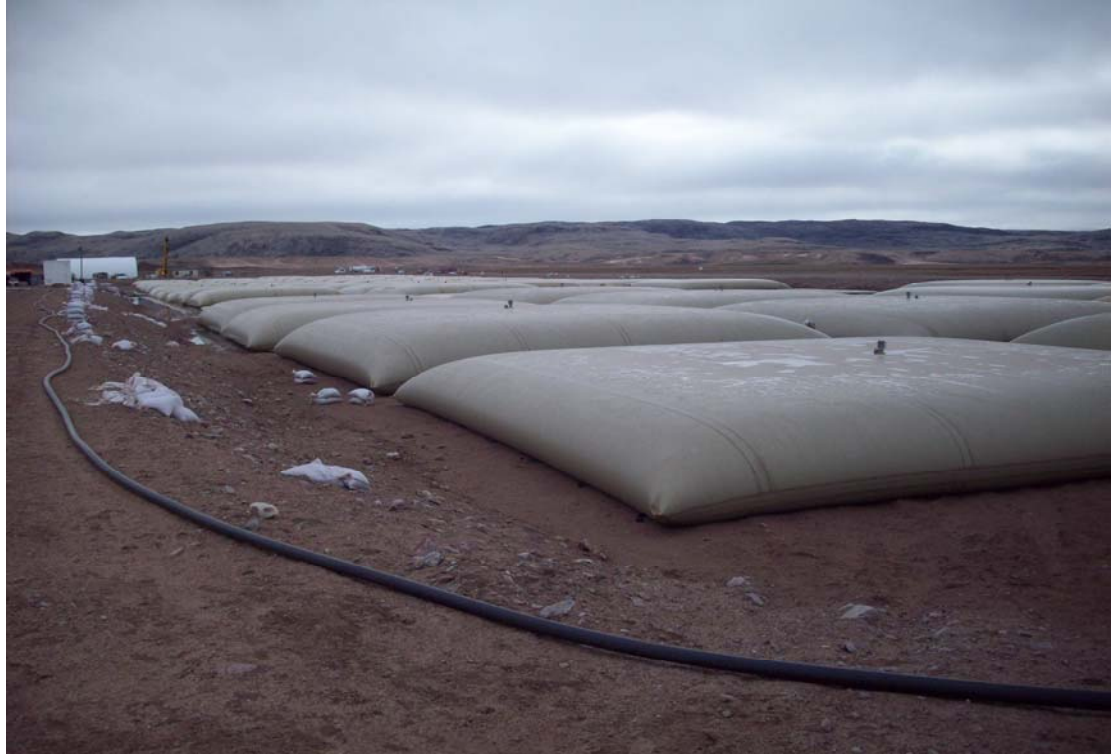
Milne Inlet Fuel Containment Facility

The structure around the fuel farm currently conforms to the design basis of the facility. A review of the interior of the dyke indicated a water depth averaging approximately 300 mm depth in the central portion of the facility. Water treatment and discharge utilizing an oil/water separation/filtration/batch process was underway. The ponding of water helps to confirm the integrity of the liner.

Our review of the area around the pond at the base of the slopes showed no signs of water or oil/water mixture and hence we conclude that the integrity of the liner has been maintained. Tears or ruptures in the membrane were not observed.

There was no indication of any settlements, seepage, or cracking at the soil structures forming the dykes.

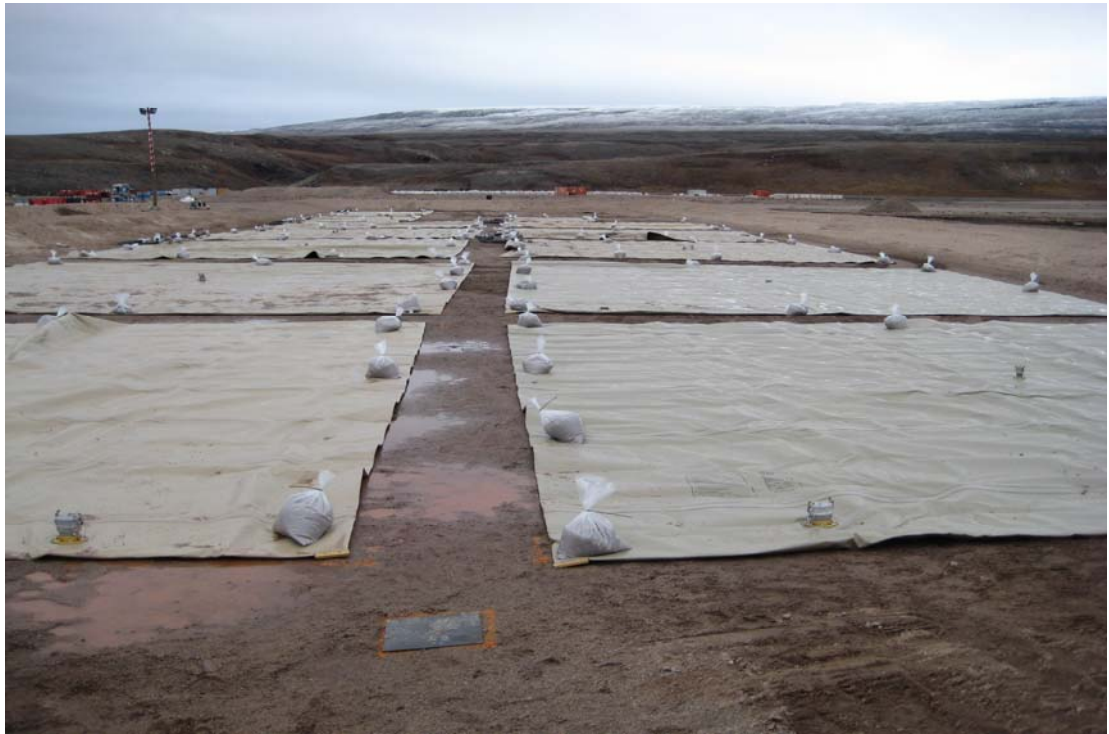
At the time of the inspection of the bulk fuel storage facility, the containment structure was completed; however, the piping and dispensing modules/fuel handling facilities had yet to be constructed.

Mary River Fuel Containment Facility  
(during bladder installation)

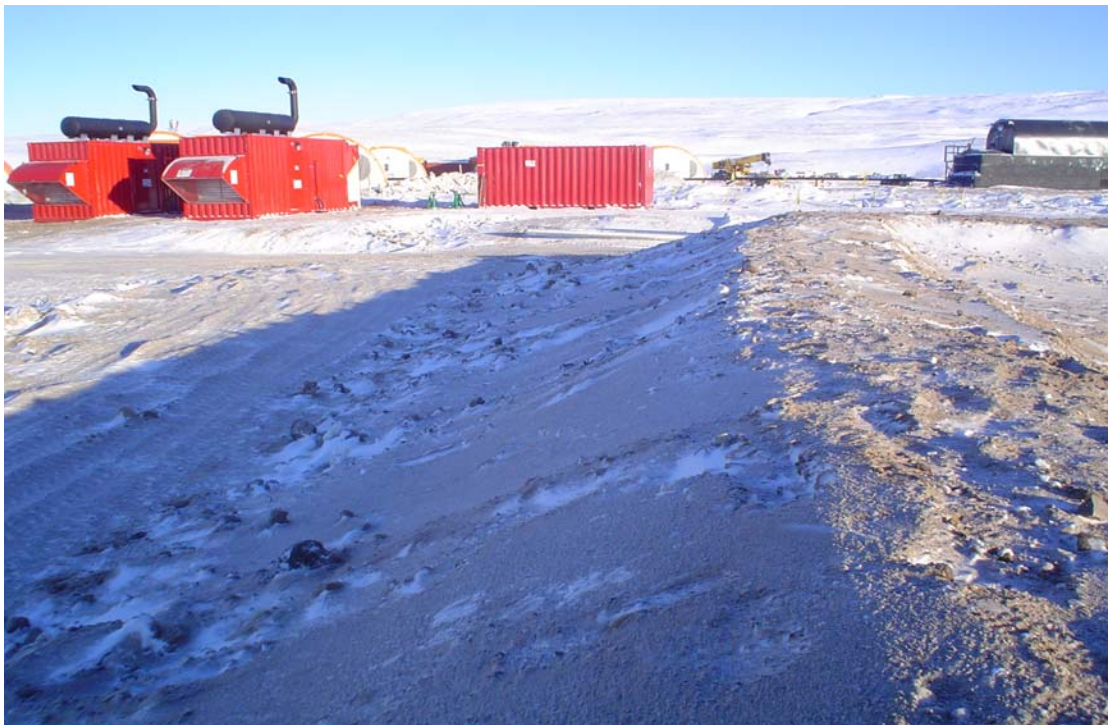
Mary River Fuel Containment dyke

The entire structure was visually inspected for any signs of cracking or subsidence. There was no indication of any settlements, seepage or cracking in the soil structures that formed the dykes. Also, there was no indication of seepage at the base of the soil structure dyke around the exterior. The soil containment structure is considered to be stable in its present condition and is in conformance with the design basis for the facility.

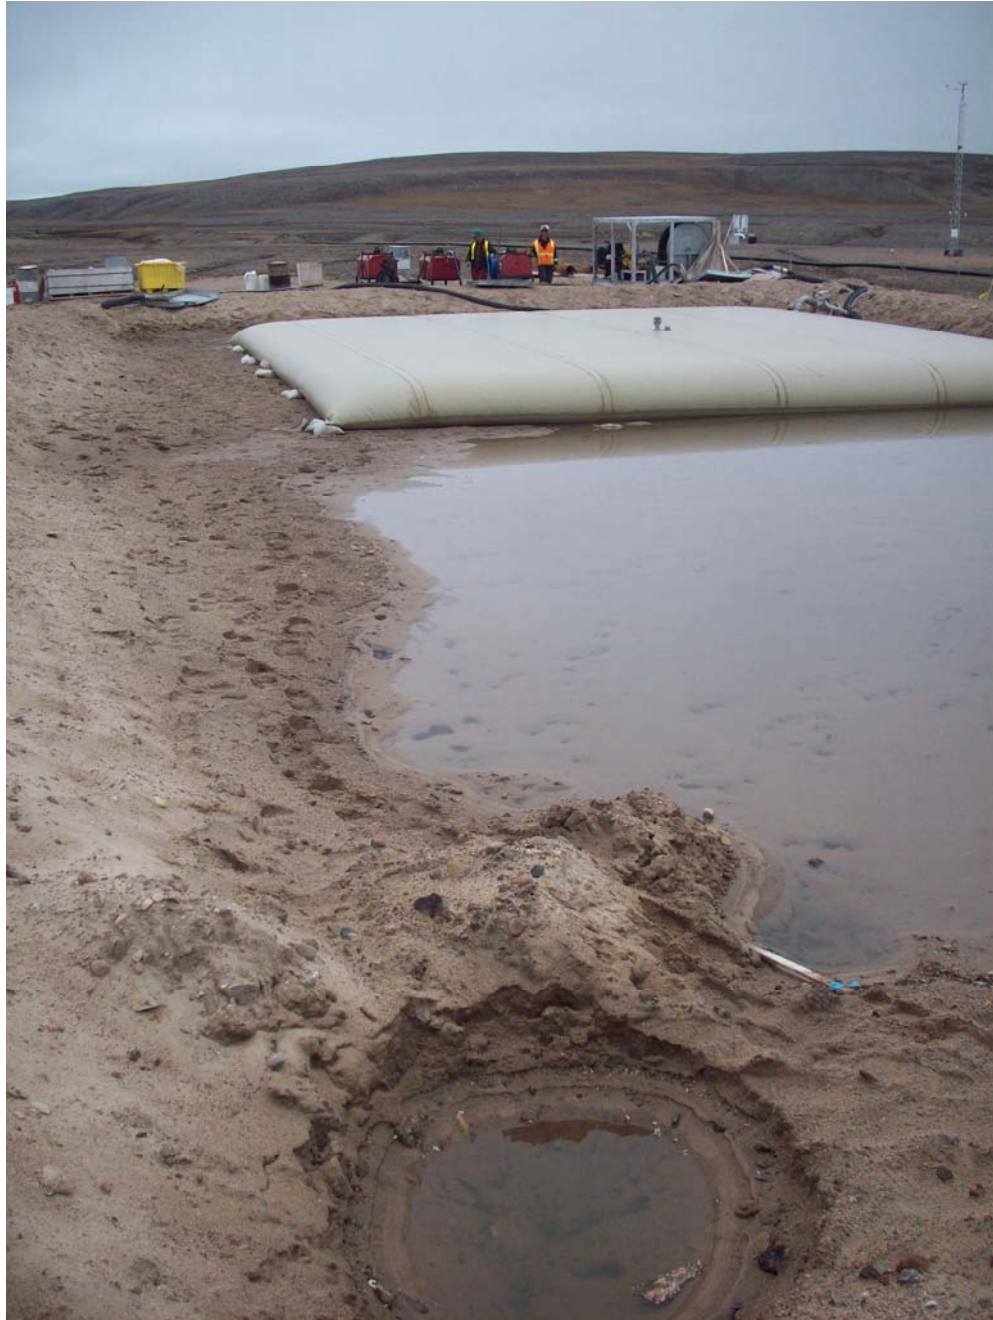
An as constructed review was carried out on this structure with respect to the height of cover over the base and minimum height of membrane in the dyke.

Generator Fuel Containment Cell  
(shows test pit to establish membrane elevation)

- Based on the need to contain 110 % of the bladder volume in the event of a fuel spill, the maximum volume of fuel permitted to be stored in the bladder in this facility as it is constructed, is 77,376 litres.
