**Re: Baffinland Iron Mines Corporation (BIM) - Submission of an Annual Geotechnical Inspection, NWB File: 2BB-MRY0710**

**RE: ANNUAL GEOTECHNICAL INSPECTION 2009  
BAFFINLAND IRON MINES CORPORATION  
OUR REFERENCE NO. 09-190**

GENIVAR Consultants completed the 2<sup>nd</sup> annual water license geotechnical inspection of the on-site containment structures at Baffinland Iron Mines Corporation (BIM) Mary River Project. The containment structures for the operation are located at two main camp sites known as the Mary River Camp and Milne Inlet Camp.

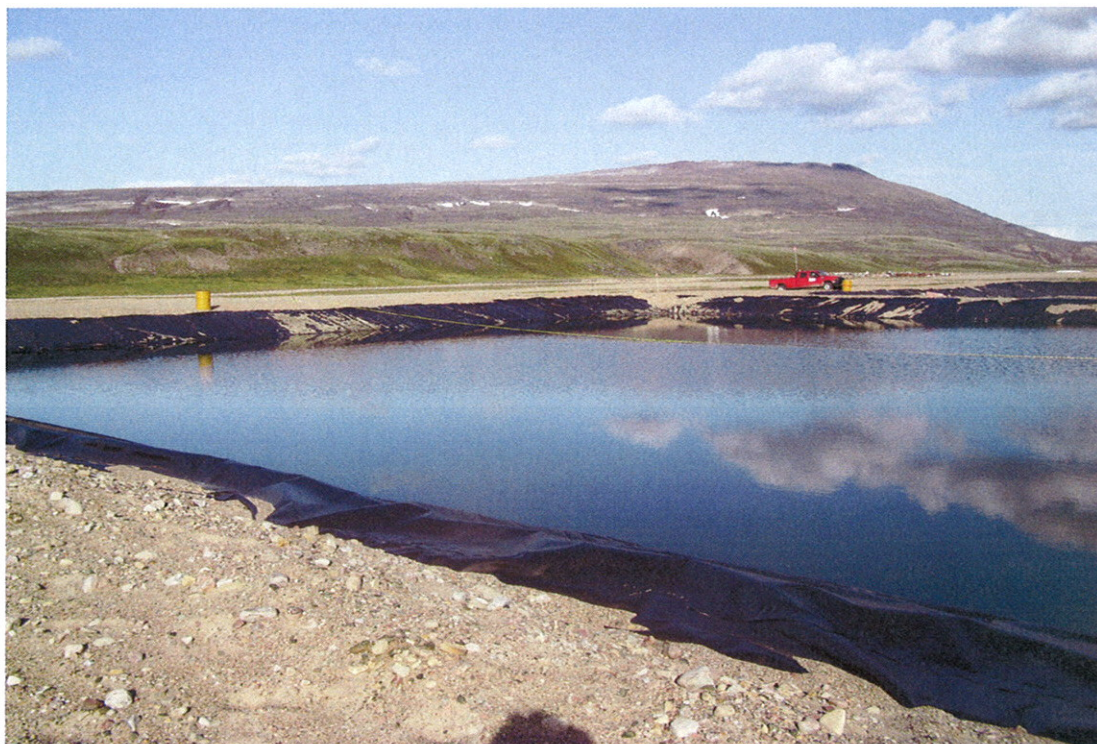
There were minor longitudinal cracks under the west berm of PWSP #3 near to the base of the exterior 4:1 slope. These cracks are minor in nature and are not due to ice lensing in permafrost. The structure is to be considered stable in its present condition.

PWSP #2 with PWSP #3 in background on right- Mary River

- Based on the current 4:1 backslope the level of sewage in the cell should not exceed a height of 1.8 m.
- In consideration of the potential for the thawing of permafrost regime under the PWSP, it was recommended that monitoring which started in June, be continued on the dyke structure and that the elevation monitoring program be to measure any potential settlement.  
This was done between June and September. Minor settlements in the order of 1 to 8 cm were found. This variation would include settlements within the dykes and in the soils beneath them.

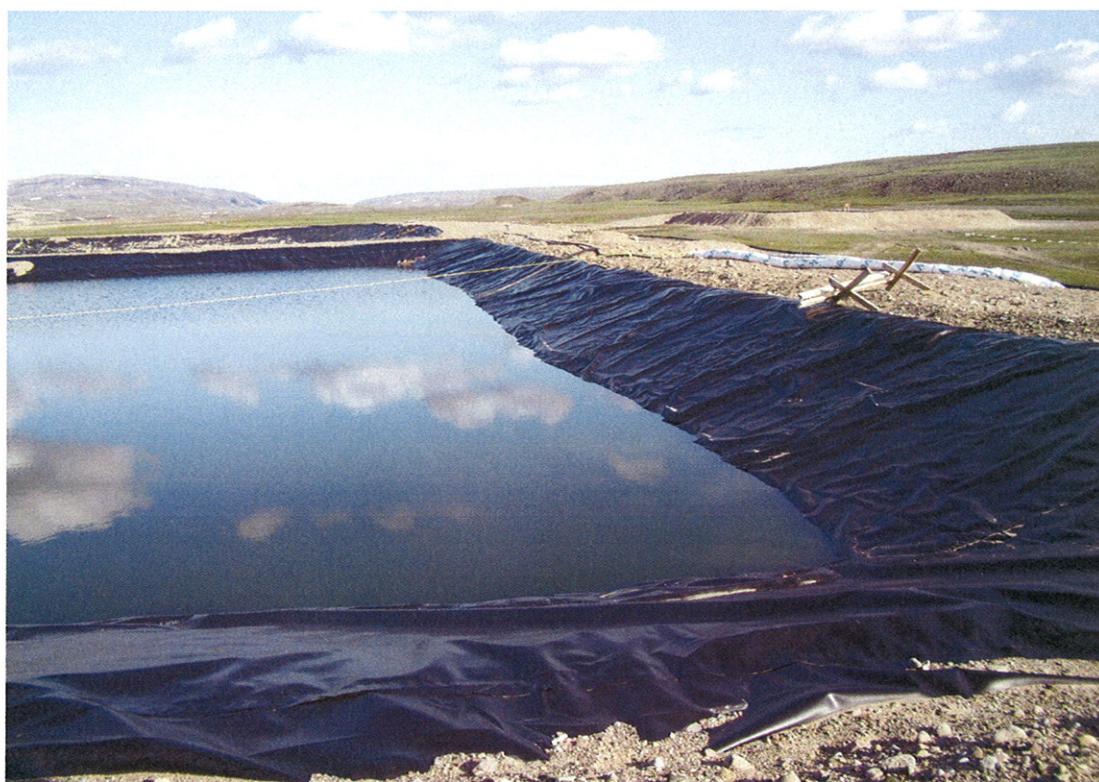
PWSP #2 with PWSP #3 in background – Mary River

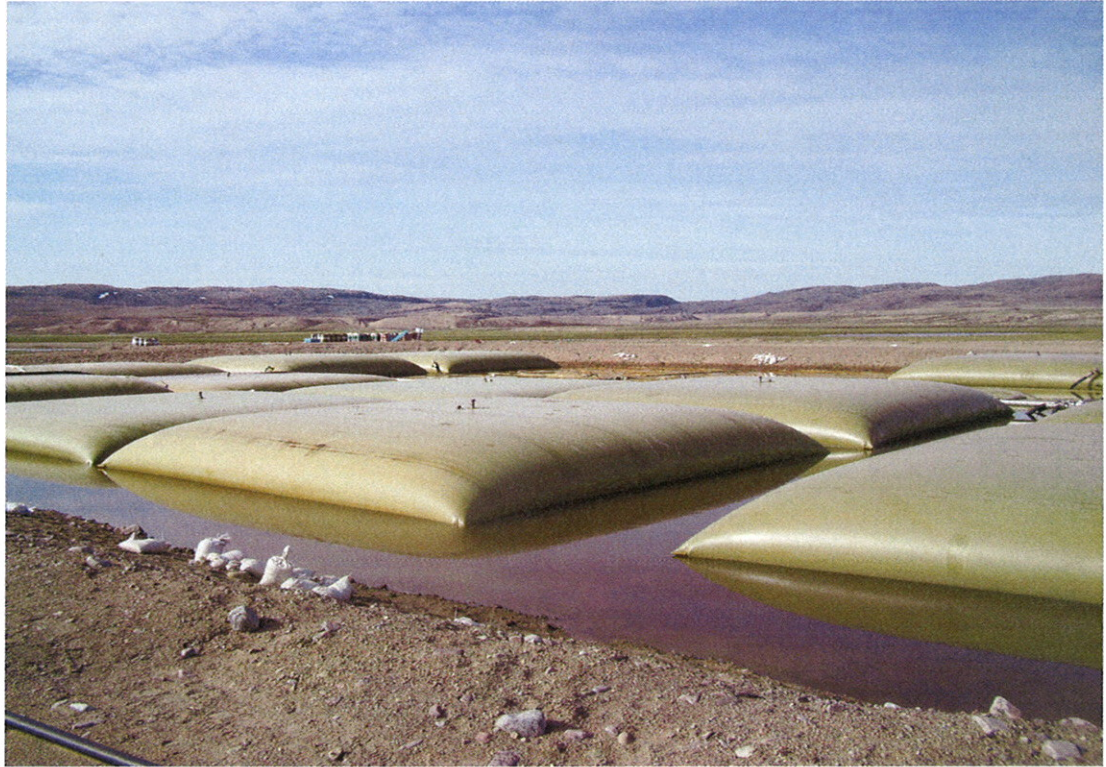
The structure around the fuel farm currently conforms to the design basis of the facility. A review of the interior of the dyke indicated a water depth averaging approximately 300 mm depth in the central portion of the facility. This depth is the same as last year. Water treatment and discharge utilizing an oil/water separation/filtration/batch process was underway. The ponding of water helps to confirm the integrity of the liner.

Our review of the area around the pond at the base of the slopes showed no signs of water or oil/water mixture and hence we conclude that the integrity of the liner has been maintained. Tears or ruptures in the membrane were not observed.

There was no indication of any settlements, seepage, or cracking at the soil structures forming the dykes.

Bulk fuel storage facility – Milne Inlet

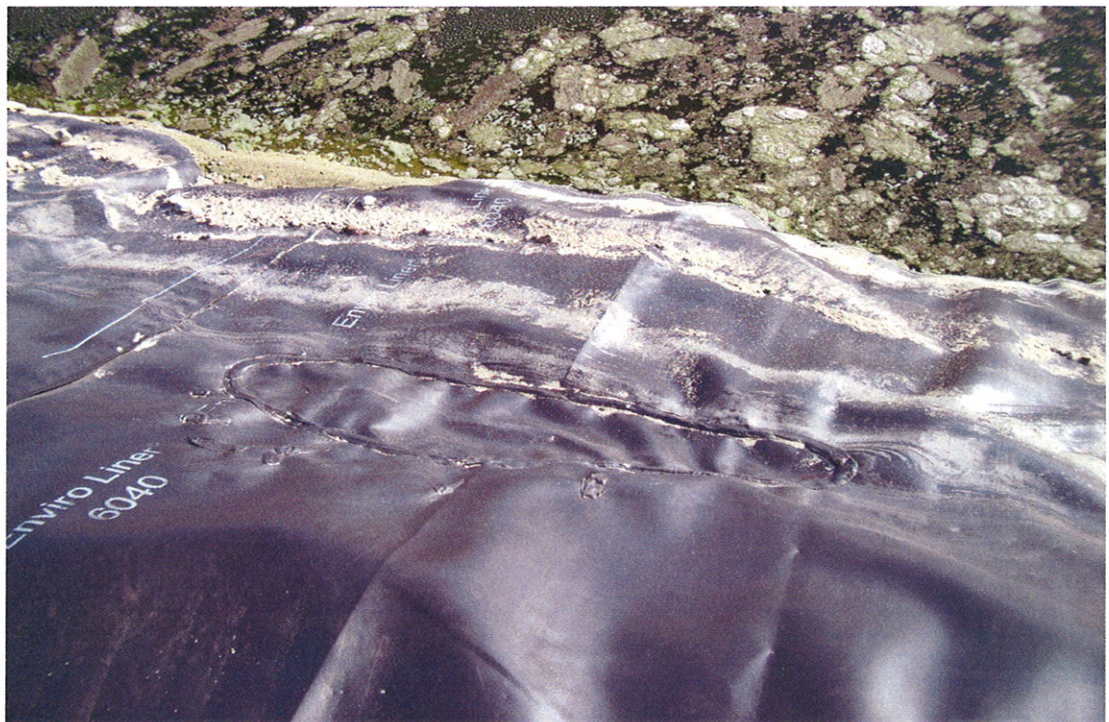
A review of the exposed liner on the upper edge of the dyke showed a number of tears in the upper edge of the liner caused by vehicular traffic on the top of the dyke and generally

within a distance of 30 m of the ramp access to the top of the dyke. These tears have been repaired since our last review in 2008.

Repairs made to liner at PWSP #1 – Mary River

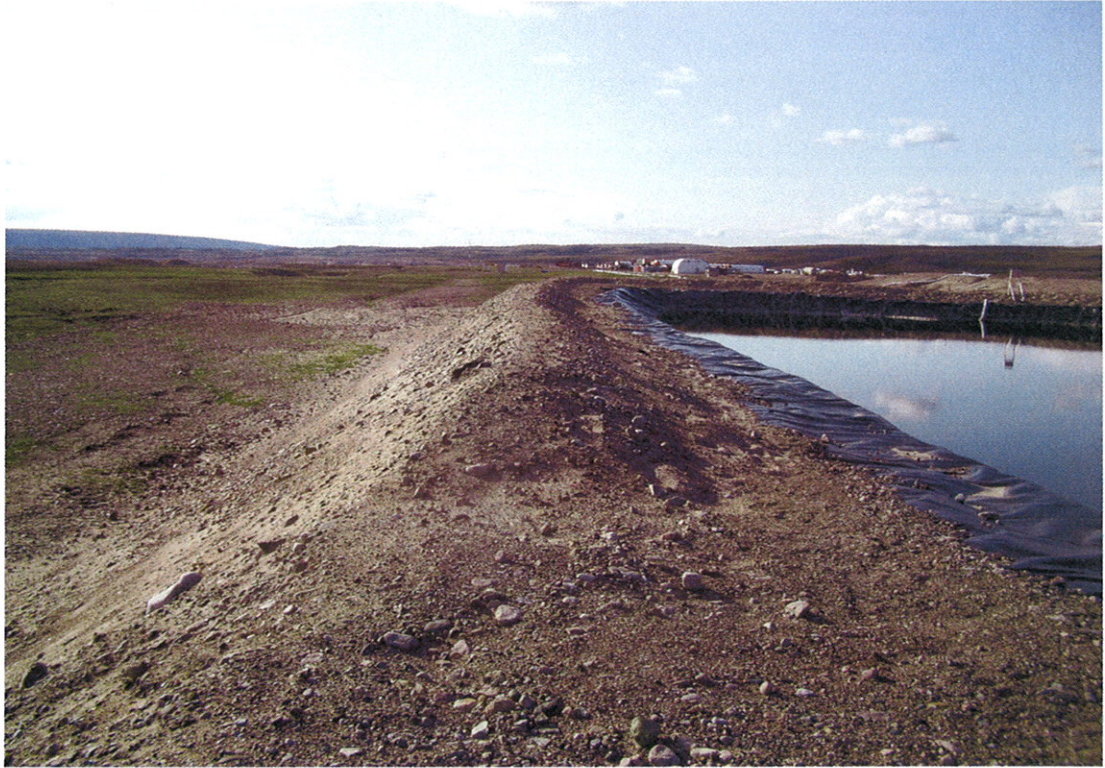
Monitoring points have been established on the berm and monitoring has commenced, to monitor settlement, in June 2009. This monitoring was done between June and September. Minor settlements in the order of 3 to 8 cm were found. This variation would include settlements within the dykes and within the soils beneath them.

PWSP #1 – Mary River

- It is recommended that the exterior slopes on the dykes be built out to a 4:1 slope if the effluent level exceeds the levels measured on September 4, 2008 (175.90). GENIVAR representative reviewed the conditions and repairs to the exterior berms were completed in accordance with the recommendations
- In consideration of the potential for the thawing of permafrost regime under the PWSP, it is recommended that monitoring points be established on the dyke structure and an elevation monitoring program be implemented to measure any potential settlement. It is recommended that a monthly monitoring be implemented from May through October 2009.

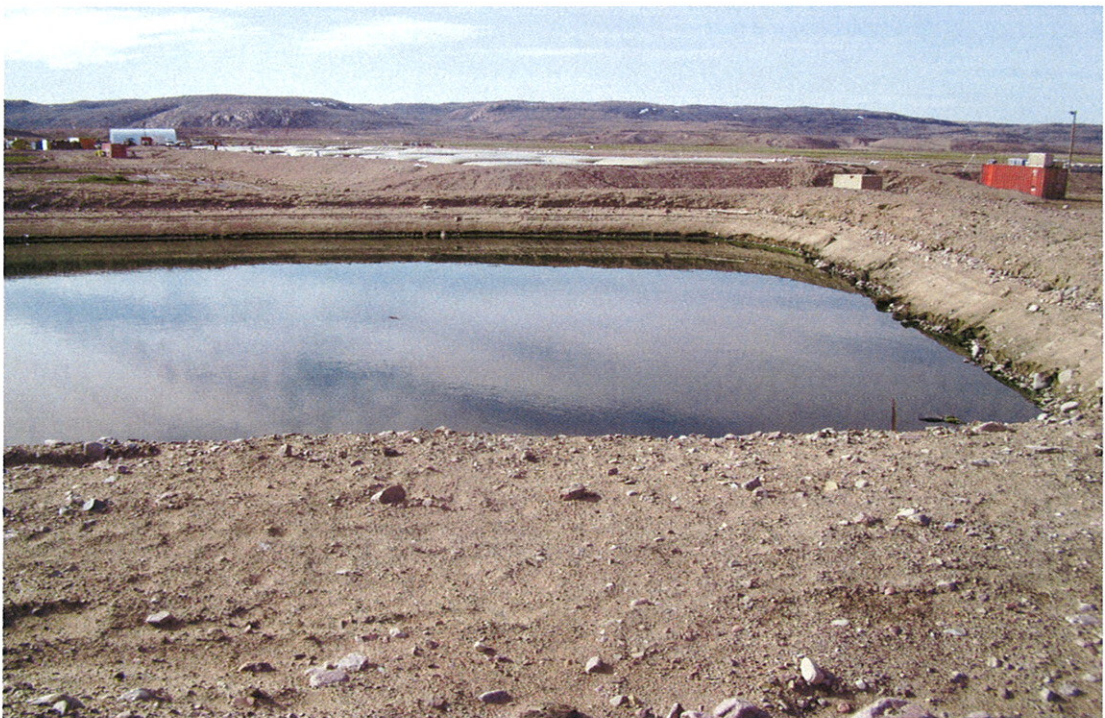
Based on the observed 4:1 dyke exterior slopes, the structure appears stable at current conditions. There was no sign of effluent break-out or seepage at any location along the bottom of the dyke. The high effluent levels which levels which were observed at the time of the 2008 visit had been lowered to less than design criteria.

Milne Inlet PWSP
