Re: Baffinland Iron Mines Corporation (BIM) - Submission of an Annual Geotechnical Inspection, NWB File: 2BB-MRY0710

Annual Geotechnical Report Baffinland Iron Mines

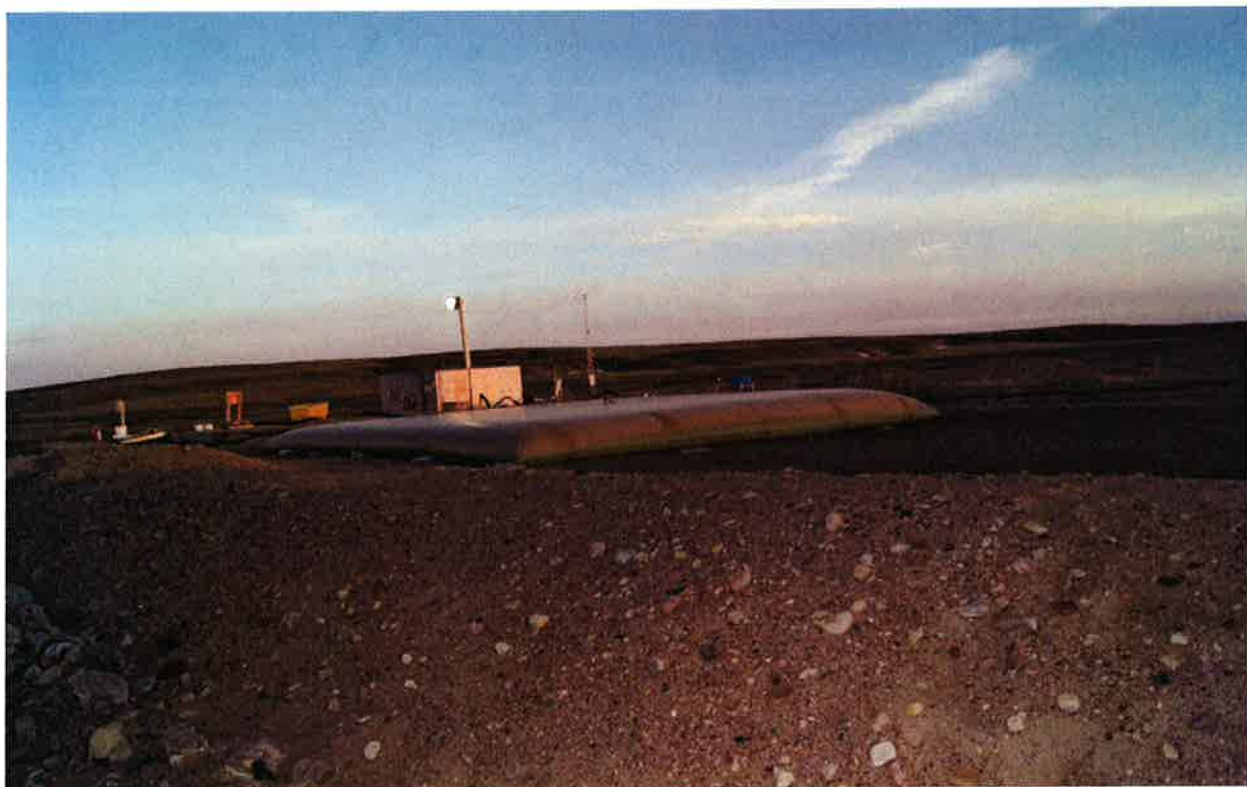
Generator Fuel Storage Facility – Mary River.

There is currently one bladder in this containment facility that has a capacity when full of 120,000 litres. This particular bladder contains 77,376 litres of fuel when the bladder is 32" high. The guideline for BIM is to fill this bladder to no more than 76 cm (30") which represents 70,097 litres of fuel.

At the time of our visit, the bladder height was measured at 29" representing approximately 68,000 litres of fuel.

The structure was visually inspected for any signs of cracking or subsidence. There was no indication of settlements, seepage or cracking in the structure. Also, there was no sign of seepage at the base of the structure. The soil structure is considered to be stable in its present condition and is in conformance with our design principles.

We recommend that BIM continue to control the amount of fuel in the bladder at 70,097 litres as per their present policy.

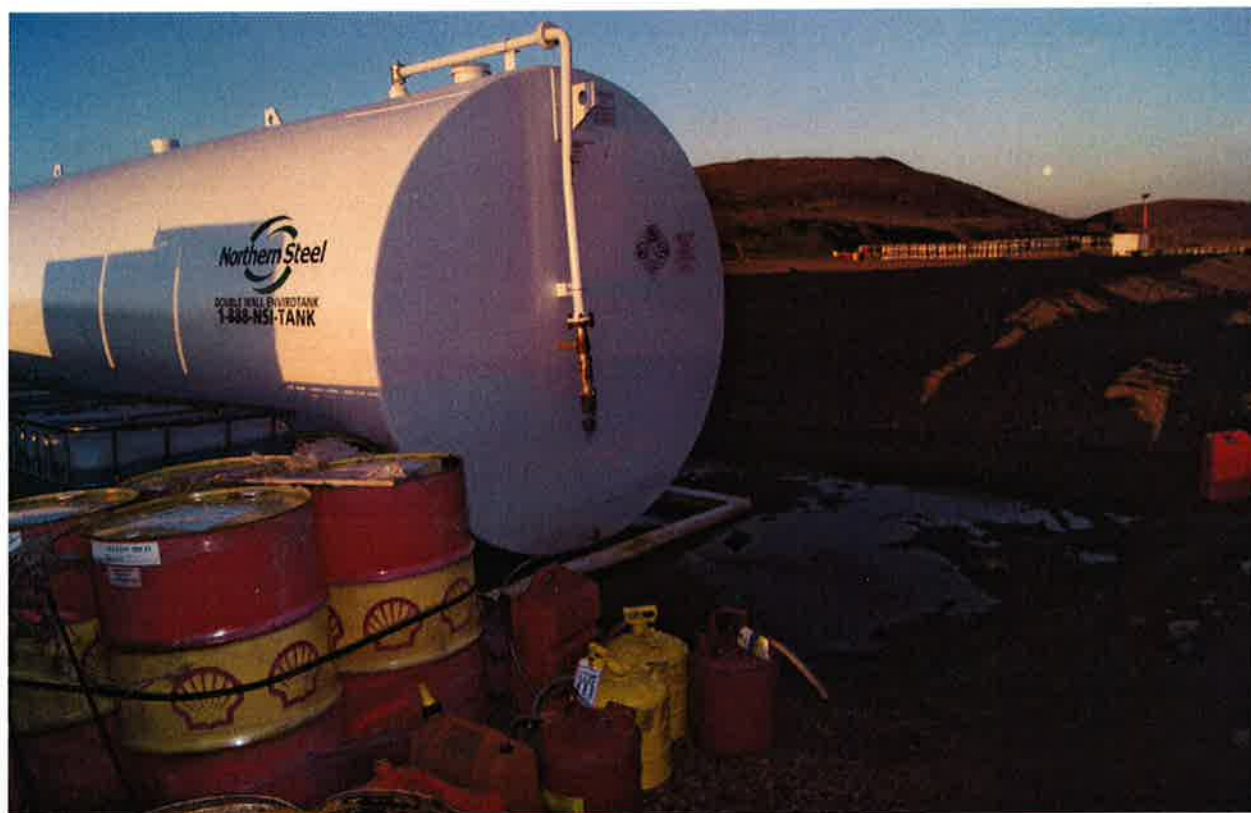
Environ tank Storage – Mary River

Our review of the area around this cell at the base of the slopes showed no sign of seepage. Water here has also ponded just above the gravel over the membrane liner in this cell.

This indicates no sign of tears or rupture in the membrane.

The structure is stable in its present conditions.

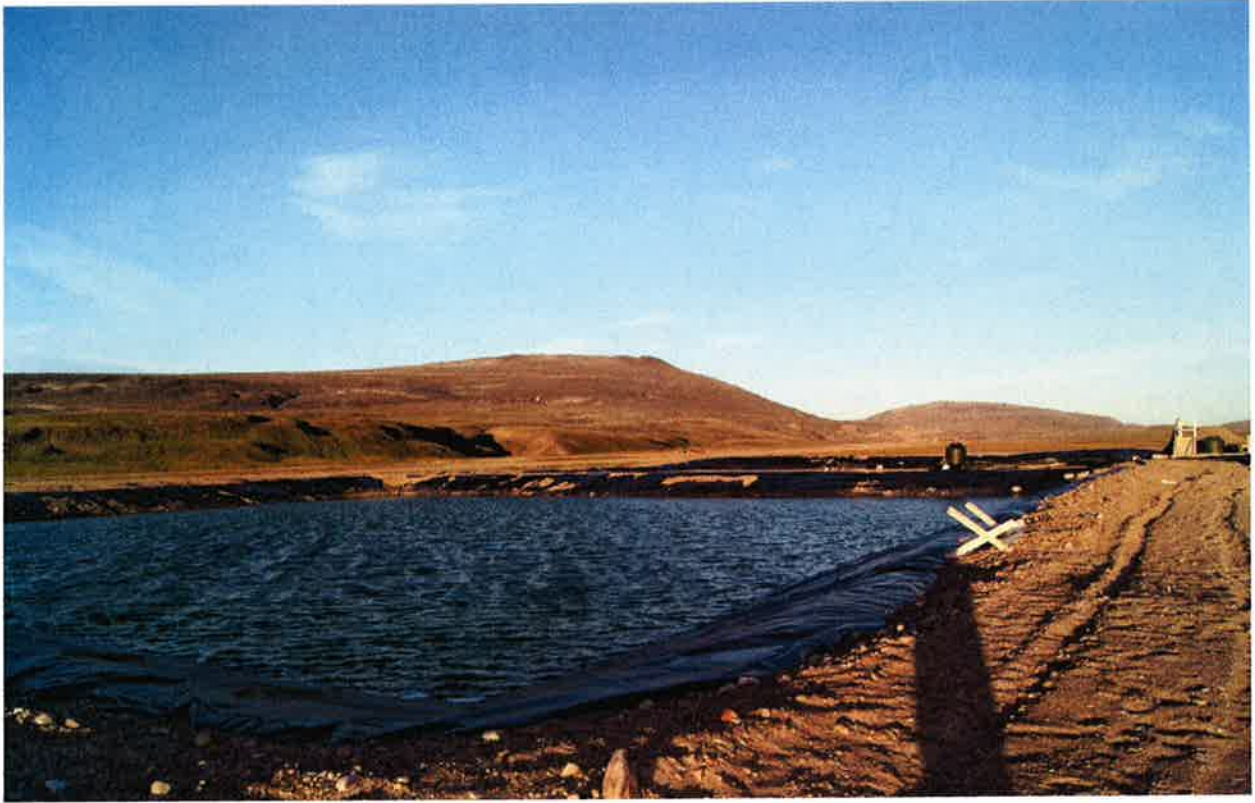
Polishing Ponds #2 and #3 – Mary River.

Our review of the area around the pond at the base of the slopes showed no sign of seepage and hence we conclude that the liner has been effective in containing the sewage and here are no tears or ruptures in the membrane.

Minor longitudinal cracks under the west berm of PWSP #3 that were noted during our last inspection in 2009 have not reoccurred this season. The structure is considered to be stable in its present condition.

Monitoring points have been set up on top of the berm and monitoring of the elevation of these points on top of the berm has been done since that time. Settlements in the order of 6 to 9 cm have occurred since this time. These settlements have not led to any stress cracks in the structure.

The structure is considered to be stable in the present condition.

We recommend that the monitoring of the elevations of the top of the berms continue for the remainder of 2010 and through the May to October season in 2011.

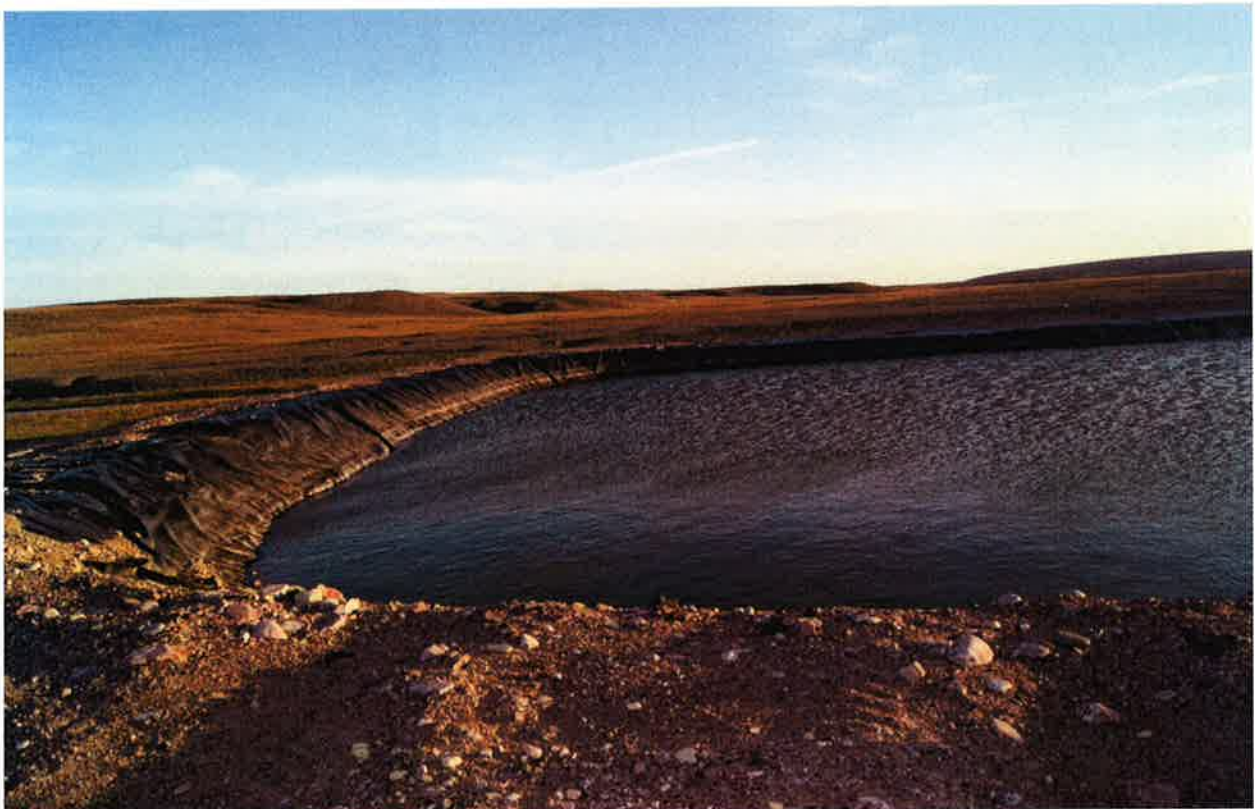
Polishing Pond #1 – Mary River.

Our inspection of the area around the pond at the base of the slopes showed no sign of seepage and hence we conclude that there are no tears or ruptures in the membrane.

A review of the exterior and the top of the dykes showed no indication of cracking or settlement which would indicate stresses within the structure.

Tears that had occurred in the top of the berm have been patched (between 2008 and 2009) and the patches are holding well.

Monitoring points have been set up and the berm and monitoring of the elevation of the top of the berm has been done since June 2009. Settlements in the order of 5 cm to 9 cm have occurred since this time. These settlements have not led to any stress cracks in the structure.

The structure is considered to be stable in the present condition.

We recommend that the monitoring of the top of the berms continue for the remainder of 2010 and through the May to October season in 2011.

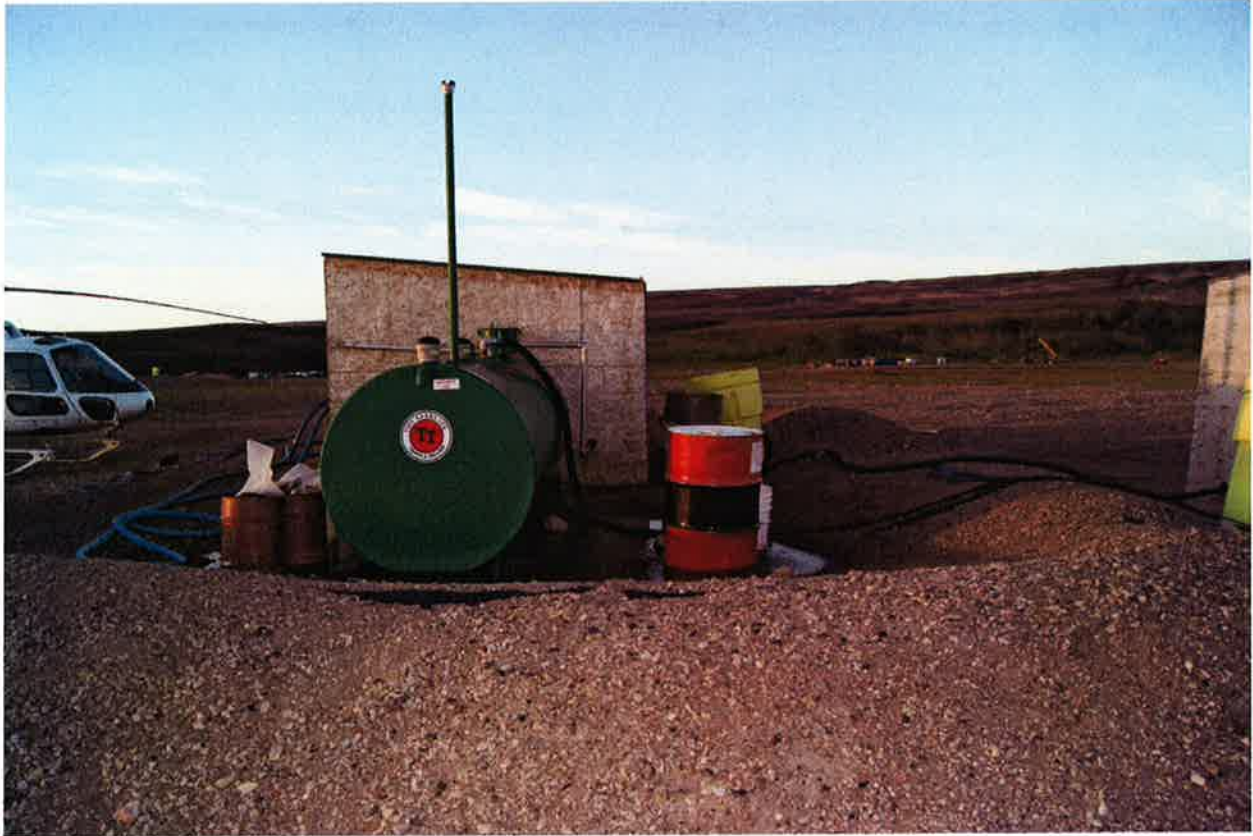
Helicopter Fuel Tank Containment – Mary River

Our review of the area around the pond at the base of the slopes showed no sign of seepage. Water has ponded just slightly higher than the gravel liner over the membrane liner.

This indicates that there are no tears or ruptures in the membrane liner.

A review of the exterior and the top of the berms showed no indication of cracking or settlement which would indicate stress within the structure.

The structure is considered to be stable in its present conditions.

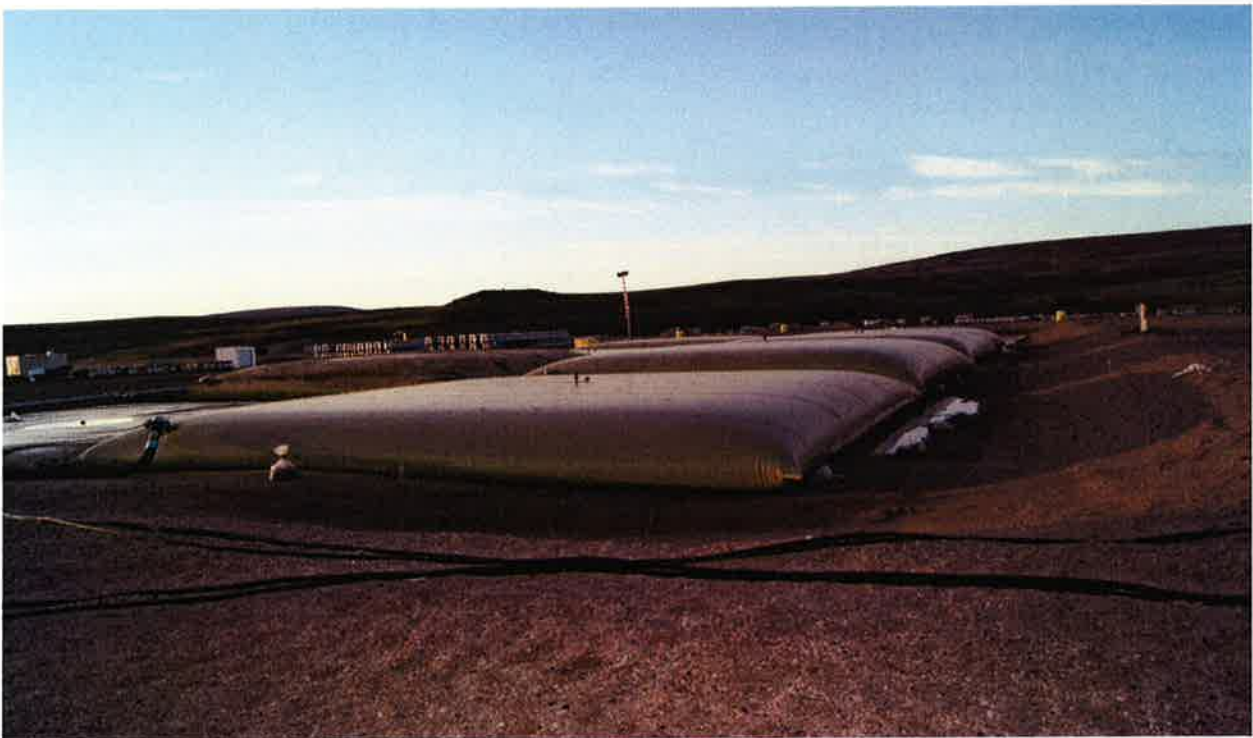
Bulk Fuel Storage Facility Containment – Mary River

At the time of our review, there were localized shallow areas of water within the containment structure that originated from recent rain and earlier snow melt.

The localized ponds are an indication of membrane integrity.

The structure was visually inspected for any signs of cracking or subsidence. There was no indication of any settlements, seepage or cracking in the soil structures that formed the dykes. As well, there was no indication of seepage at the base of the structure around the exterior. The soil structure is considered to be stable in the present condition and is in conformance with the design basis for the facility.

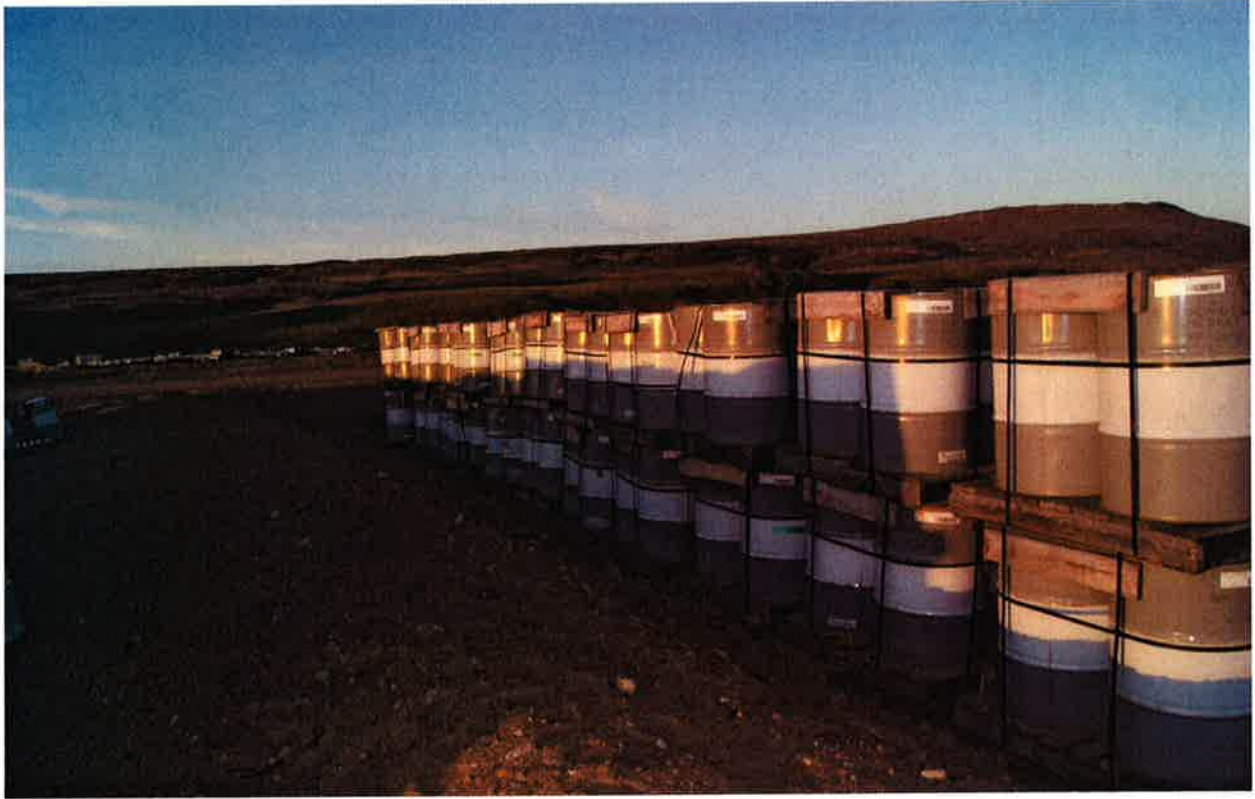
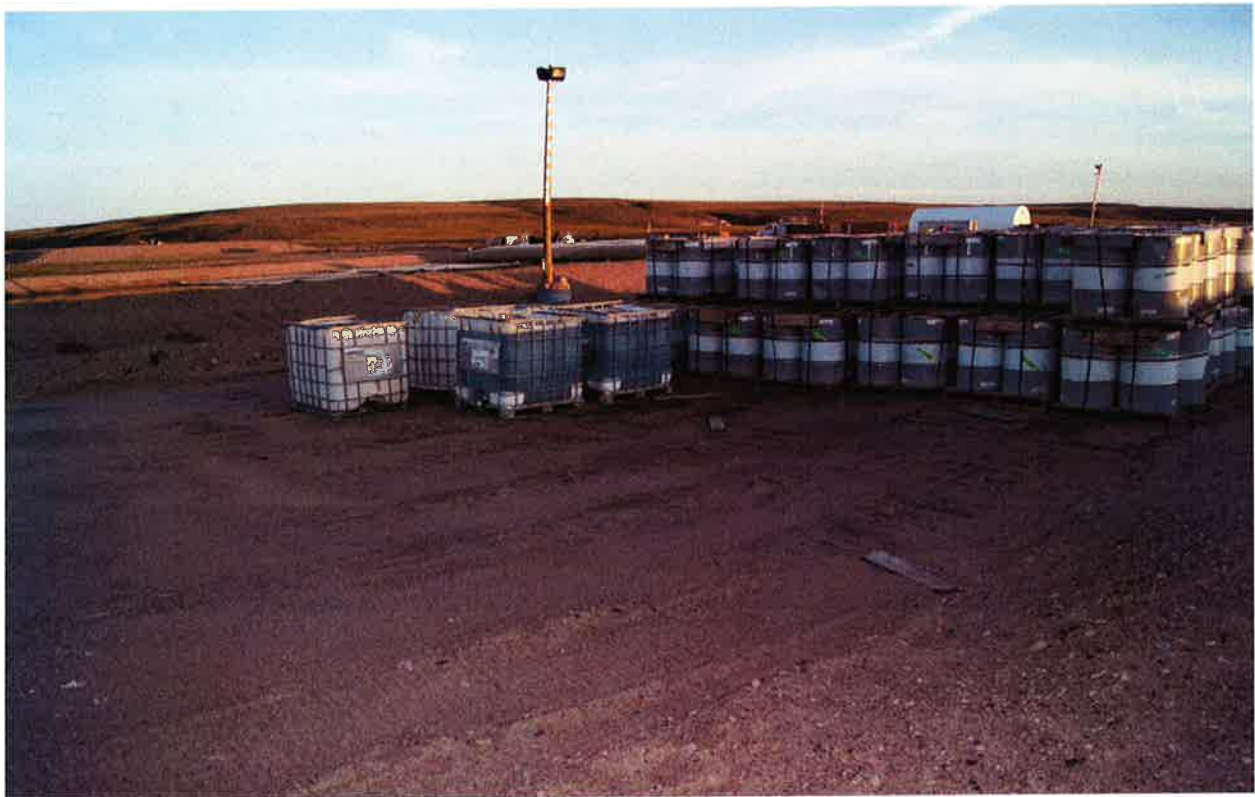
Barrel Fuel Containment – Mary River

A lack of ponding of water in the cells over the gravel liner as with other fuel containment cells was investigated. It was found that due to the fact that the cells were filled with 45 gallon drums, there was not the collection of winter snow that led to snow melt as there was in other cells.

Our review of the area around this containment structure showed no sign of seepage. This shows that there is little chance of tearing or rupture of the membrane.

A review of the exterior and top of the berms showed no sign of cracking or settlement which would indicate stresses within the structure.

The structure is considered to be stable in its present condition.

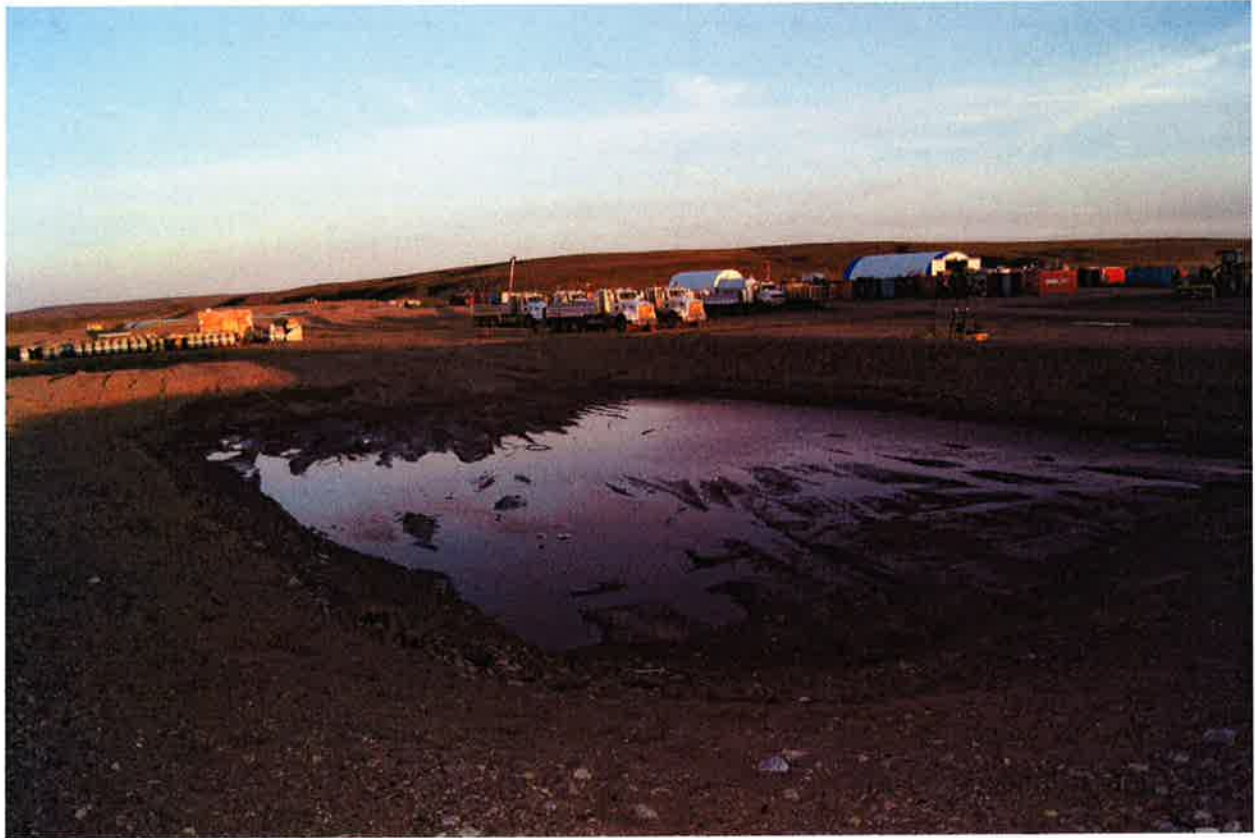
Hazardous Waste Storage – Mary River

Our review of the area around this cell at the base of the slopes showed no sign of seepage. Water has ponded just slightly higher then the gravel liner over the membrane liner.

This indicates no sign of tears or rupture in the membrane.

The structure is stable in its present condition.

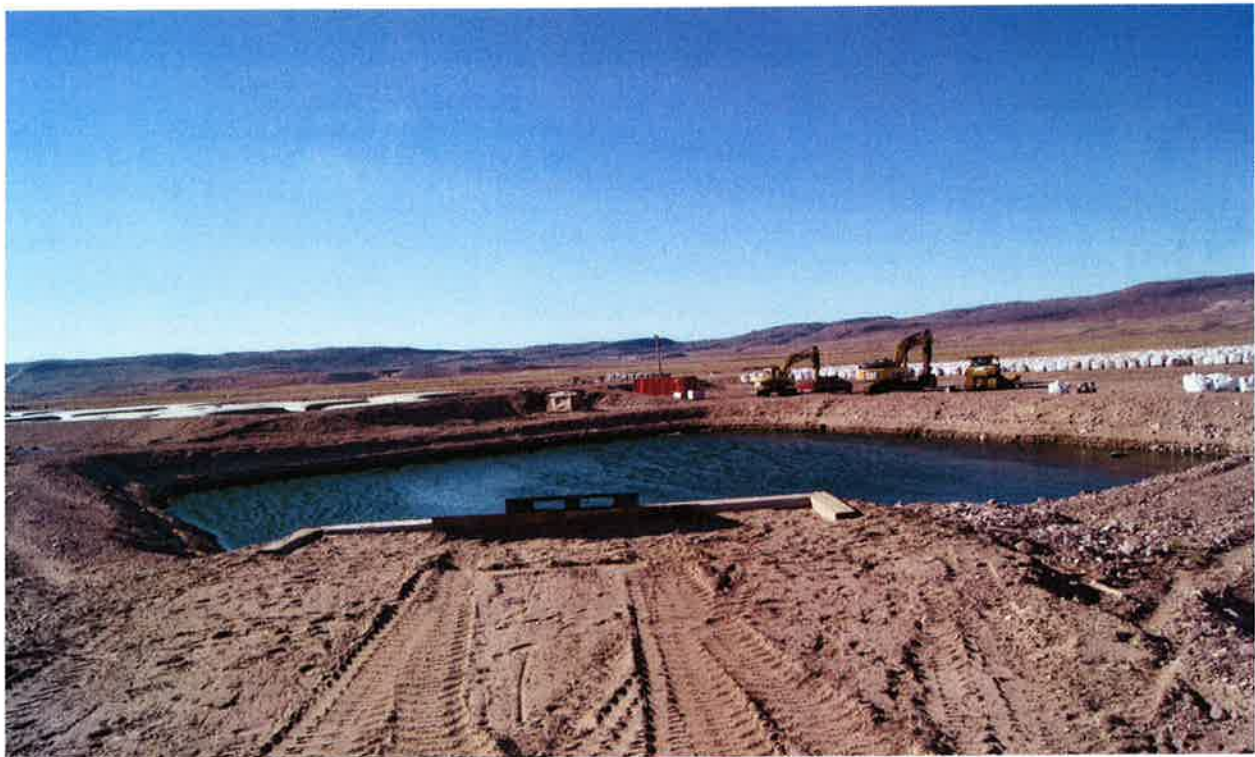
Polishing/Waste Stabilization Pond – Milne Inlet.

The water in the structure was approximately 3 to 4' below the top of the berm.

The exterior slopes of the dykes were observed to be at 4:1. The interior slope of the dykes appeared to be 2:1.

With the interior slope at 2:1 and the exterior slope at 4:1 we find the dykes to be stable for long term use.

Based on the observed 4:1 dyke exterior slopes, the structure appears stable at current condition. There was no sign of effluent break-out or seepage at any location along the bottom of the dyke. The high effluent levels which were observed at the time of the 2008 visits had been lowered to less than design criteria.

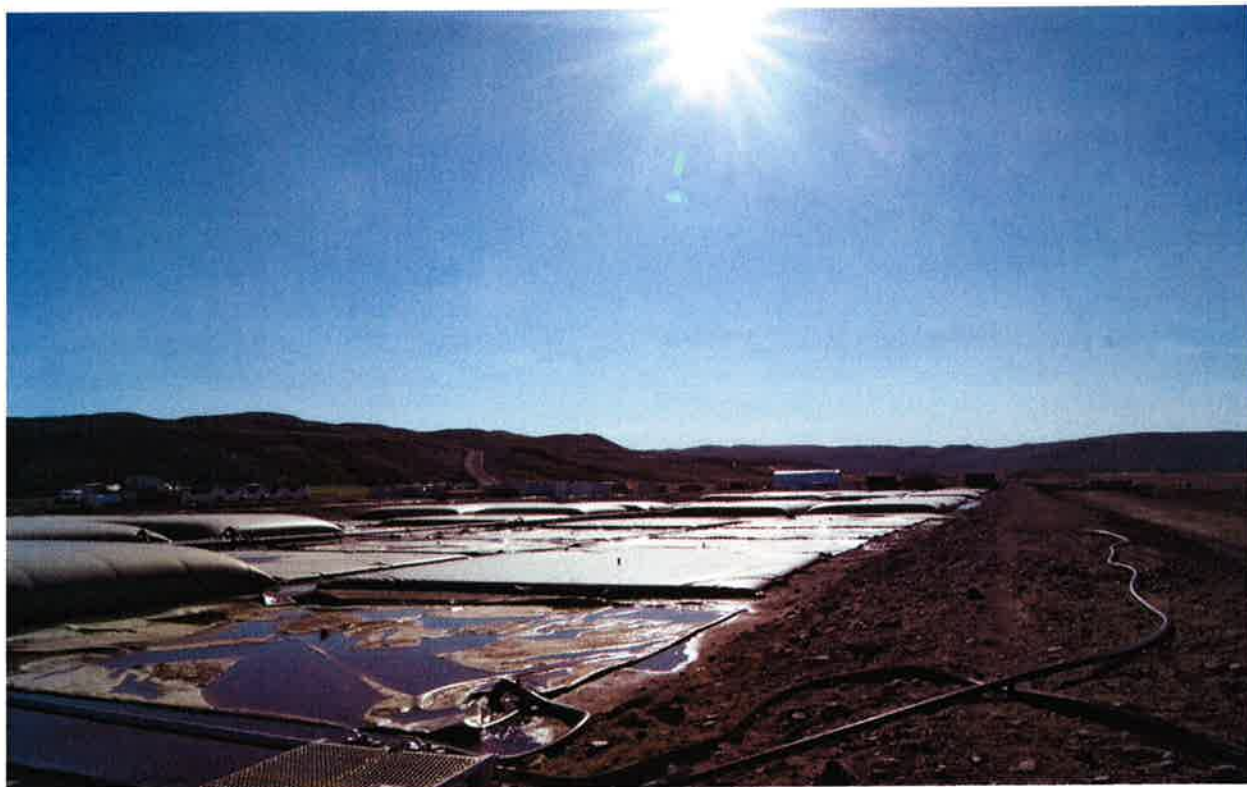
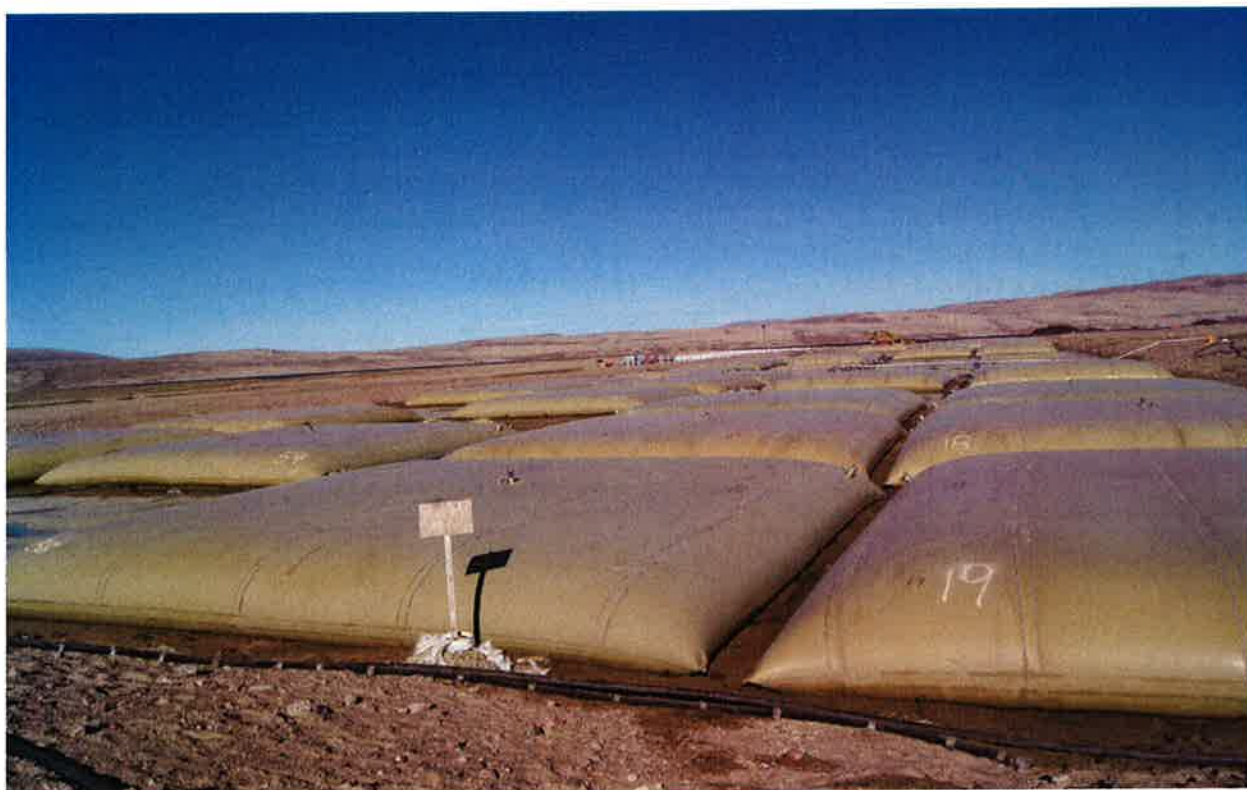
Bulk Fuel Storage Facility – Milne Inlet.

The structure around the fuel farm currently conforms to the design basis of the facility. A review of the interior of the dyke indicated that the water that existed on the interior of the dyke as viewed during the annual review last year was essentially gone and the treatment facility used to treat water that was removed was still in place. The ponding of water continues to confirm the integrity of the liner.

Our review of the area around the ponds at the base of the slopes showed no signs of oil, water or oil water mixtures and hence we conclude that the integrity of the liner has been maintained. Tears or ruptures in the membrane were not observed.

There was no indication of any settlements, seepage, or cracking at the soil structures forming the dykes.

The structure is considered to be stable in its present condition.

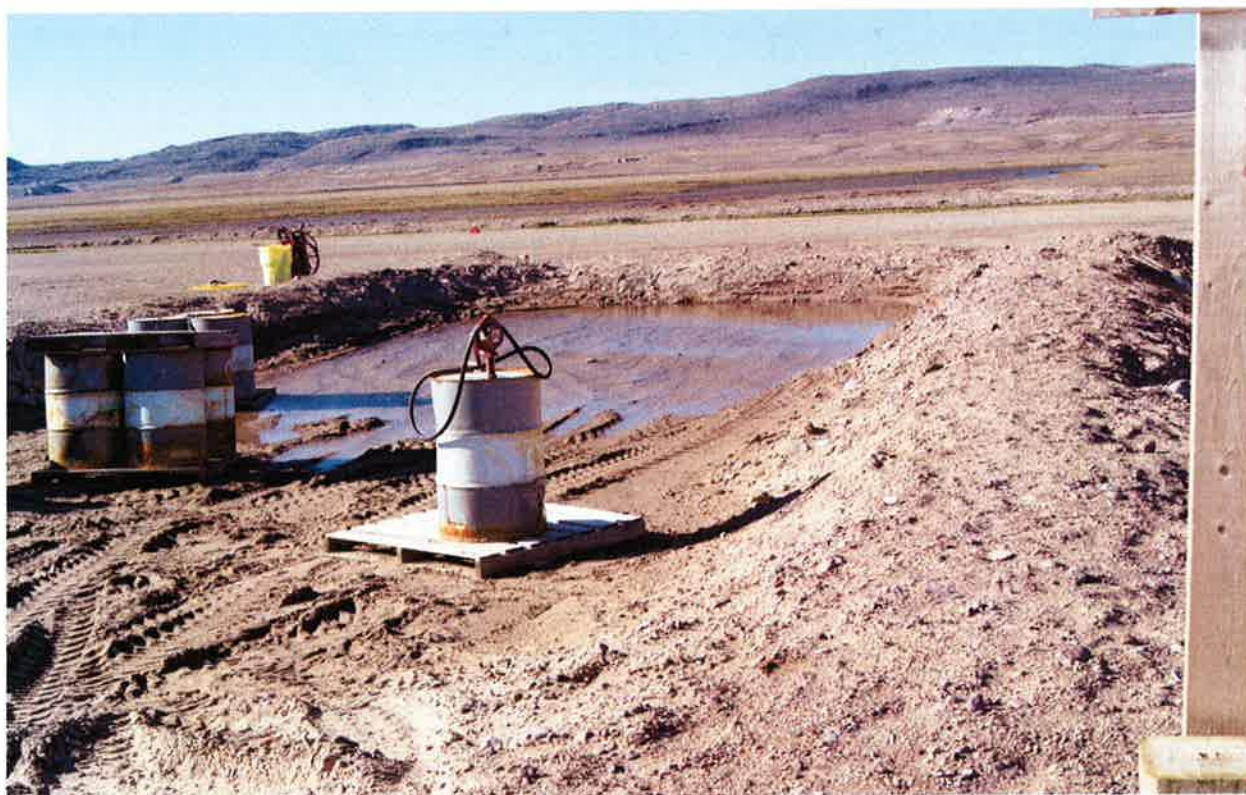
Barrel Fuel storage – Milne Inlet

A review of the interior of the dyke indicates that water is ponding slightly above the gravel liner over the membrane liner.

The ponding of water confirms the integrity of the liner.

Our review of the area around the ponds at the base of the slopes showed no signs of seepage.

A review of the dykes showed no sign of cracks or settlements.

The structures are considered stable in their present condition.

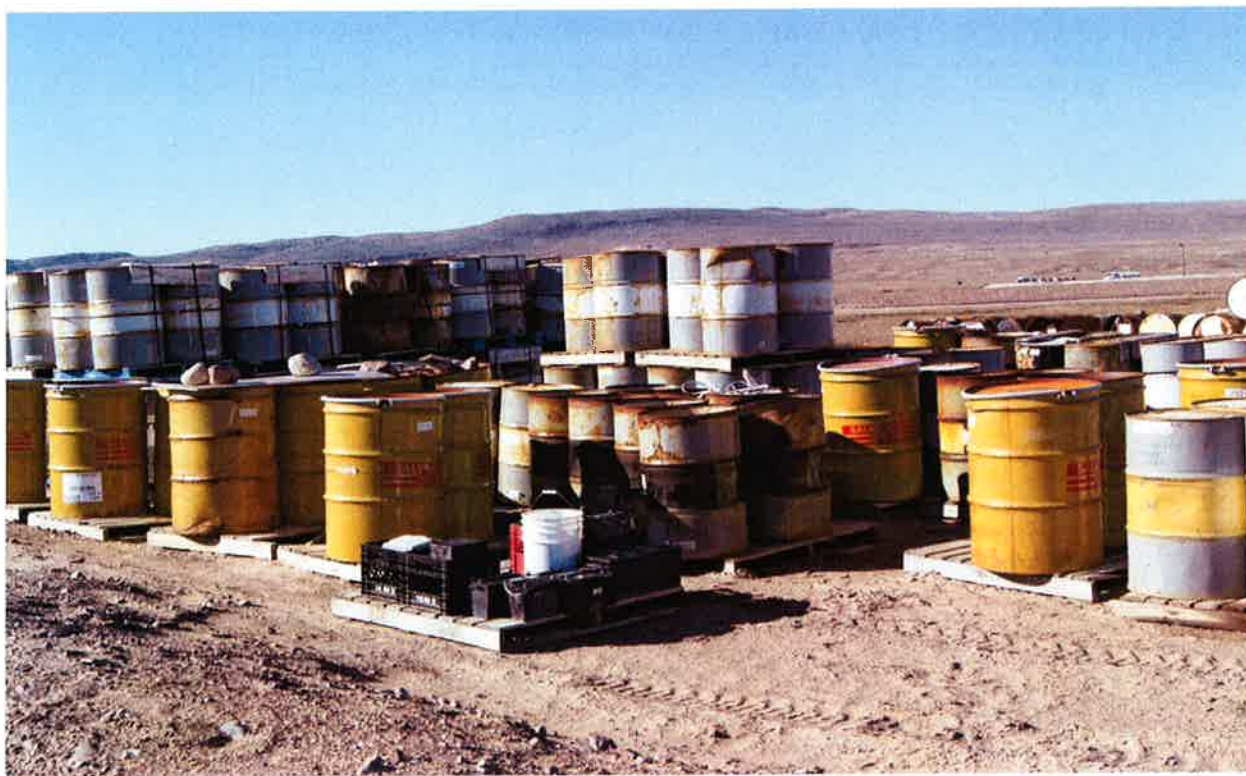
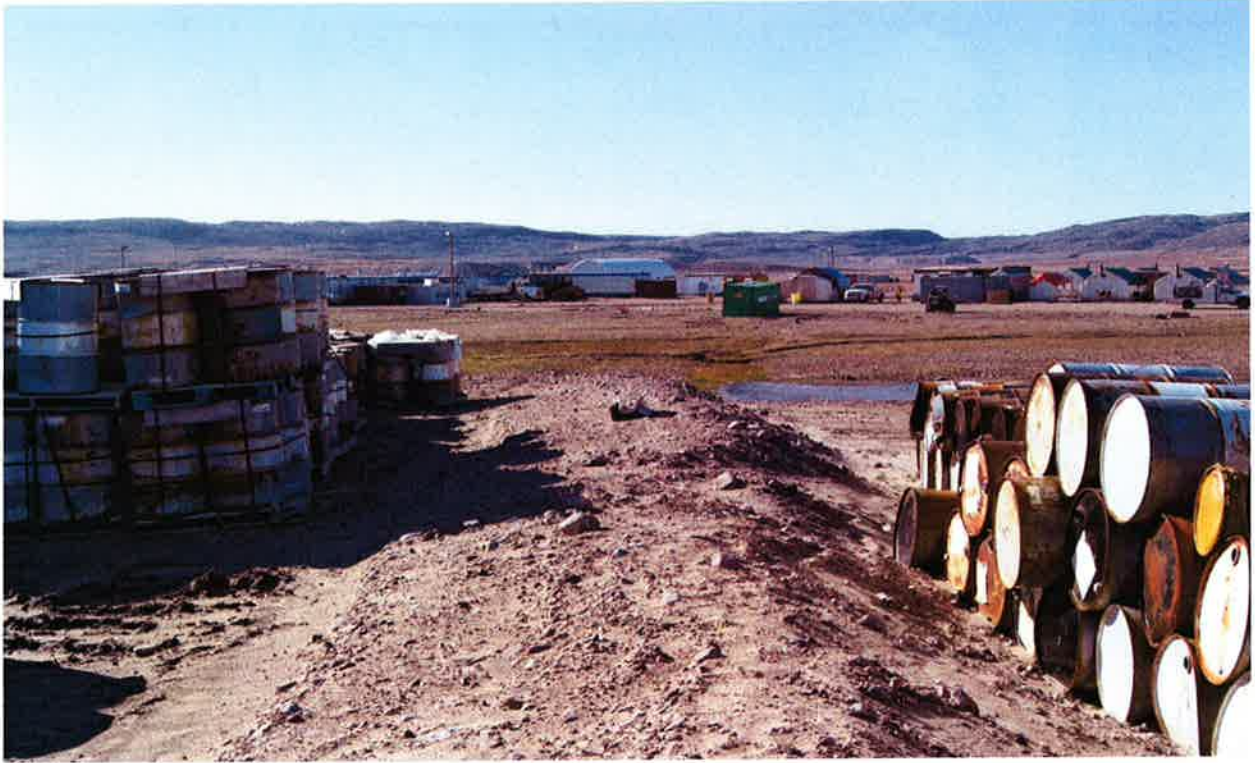
Hazardous Waste Storage – Milne Inlet

A review of the interior of the dyke indicates that water is ponding slightly above the gravel liner over the membrane liner.

The ponding of water confirms the integrity of the liner.

Our review of the area around the ponds at the base of the slopes showed no signs of seepage.

A review of the dykes showed no sign of cracks or settlements.

The structures are considered stable in their present condition.
