October 20, 2011

Re: Baffinland Iron Mines Corporation (BIM) - Submission of an Annual Geotechnical Inspection, NWB File: 2BB-MRY1114

October 5, 2011

RE: ANNUAL GEOTECHNICAL INSPECTION 2011-08-16
BAFFINLAND IRON MINES CORPORATION
OUR REFERENCE #10-098

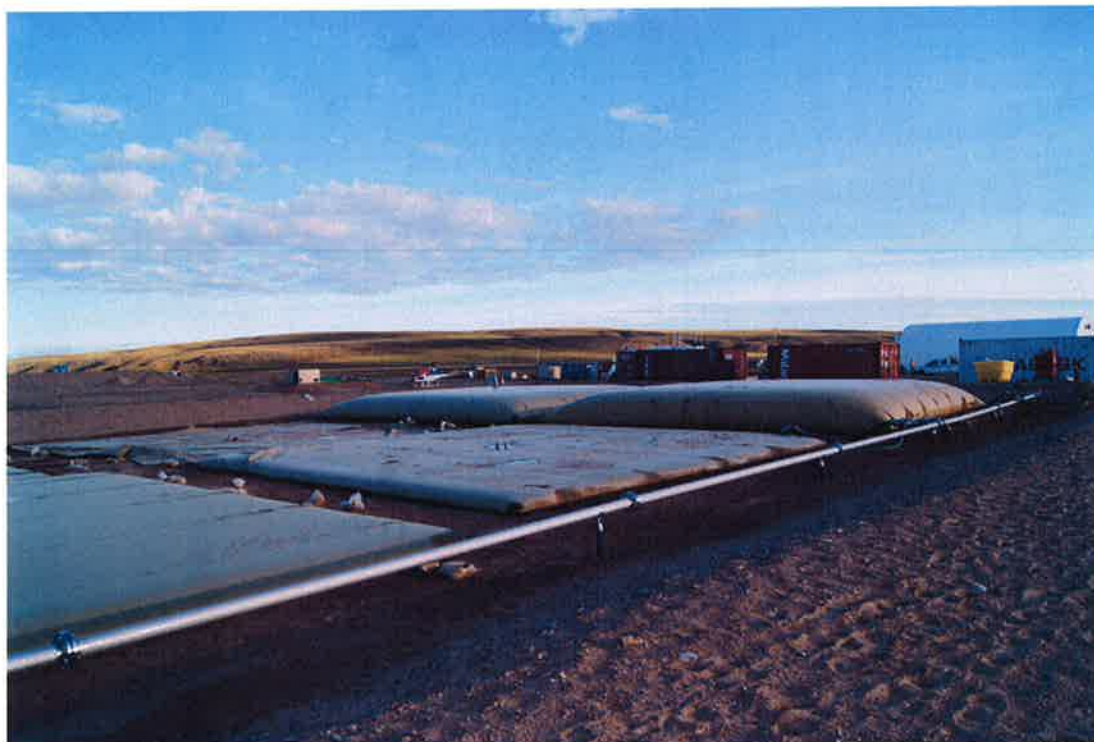
Mary River Bulk Fuel Containment

At the time of our review the water had recently been removed from the containment and treated for release. There was a small amount of water ponding in a depression or sump in the gravel from which water was removed.

The structure was visually inspected for any signs of cracking or subsidence. There was no indication of any settlements, seepage, or cracking in the soil structures that formed the dykes. As well, there was no indication of seepage at the base of the structure around the exterior. The soil structure is considered to be stable in the present condition and is in conformance with the design basis for the facility.

There are no recommendations to be made at this time.

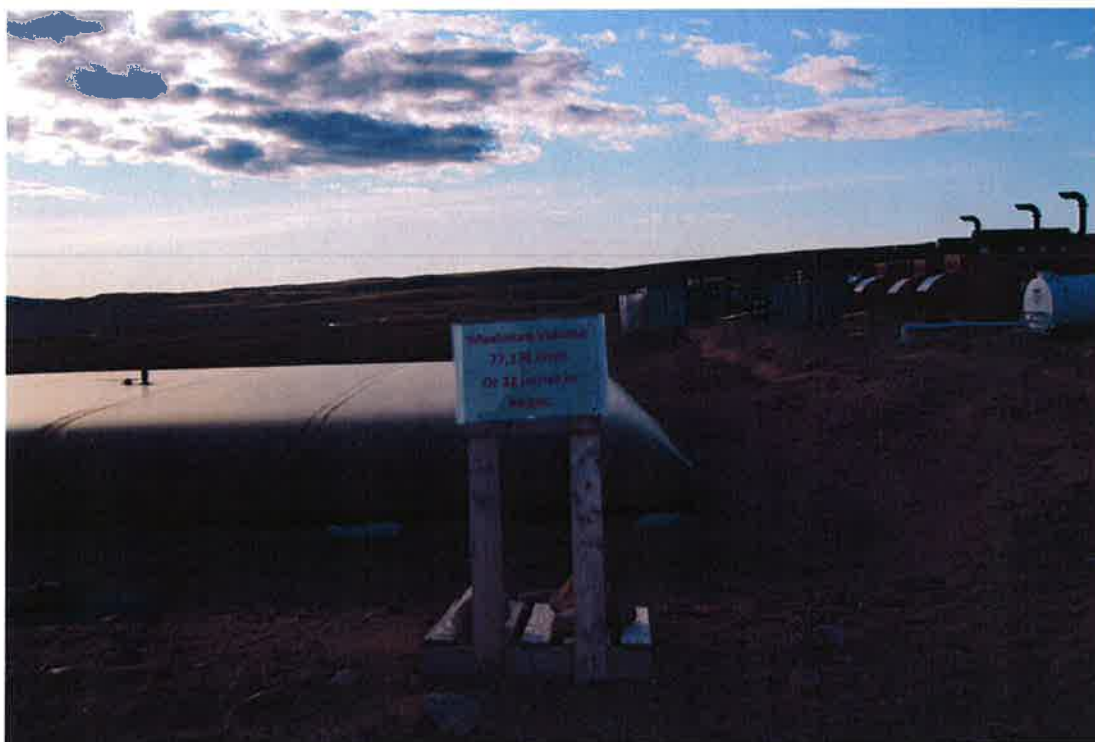
Generator Fuel Storage Facility – Mary River

There is currently one bladder in this containment facility that has a capacity when full of 120,000 litres. This particular bladder contains 77,376 litres when the bladder is 32" high. The guideline for BIM is to fill this bladder to no more than 76 cm (30") which represents 70,097 litres.

A sign is posted to limit the bladder height at 30".

At the time of our visit on August 12, 2011, the bladder height was measured at 30" (recently filled).

The structure was visually inspected for any signs of subsidence or cracking. There was no sign of seepage at the base of the structure noted. The soil structure is considered to be stable in its present condition and is in conformance with our design principles.

We recommend that BIM control the fuel in the bladder at 70,097 litres (30" high).

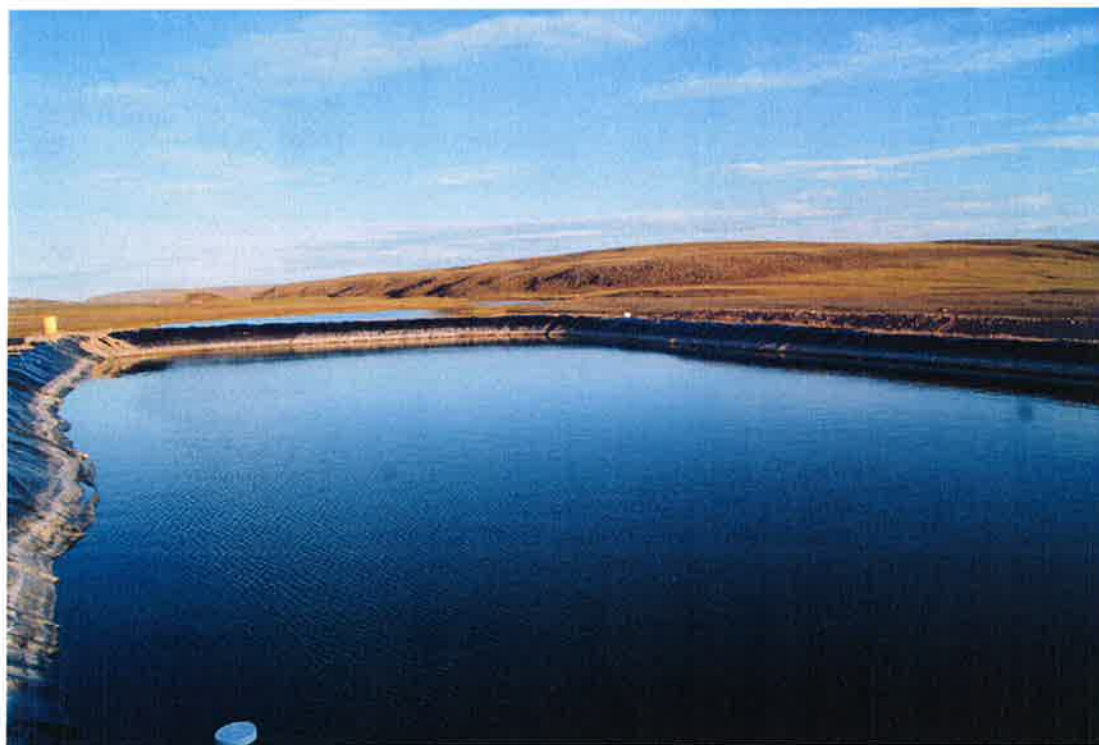
PWSP #1 – Mary River

At the time of our visit there was considerable freeboard to accommodate further sewage and the structure readily conforms to its design intent.

Our review of the area around the pond at the base of the slopes showed no sign of seepage and hence we conclude that the liner has been effective in containing sewage and there are no tears or ruptures in the membrane.

Tears that had occurred in the liner on the top of the dyke and have been patched during the period between reviews in 2008 and 2009 are holding well. As well there are no signs of weather related deterioration of the liner where it is exposed.

Monitoring points have been set up on the top of the dyke and have been monitored since 2009. Settlements of up to 17 cm have occurred since that time. These settlements have not led to any stress cracks in the structure.

We recommend that monitoring of the top of the berm continue on an annual basis through 2012. With the excellent condition of the dyke construction, we see no reason to complete this function other than annually prior to the next inspection.

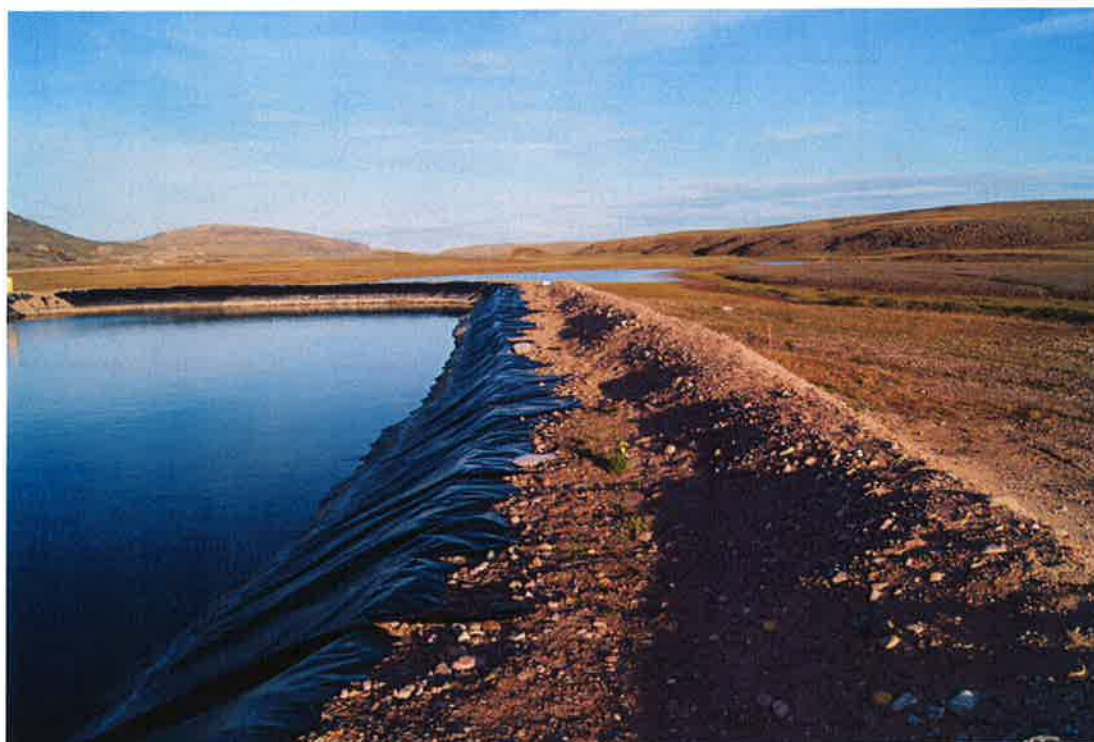
Typical dyke PWSP #1 – Mary River

A review of the top of the dyke showed no indication of cracking or settlement which would indicate stresses within the structure.

There appears to be no sign of erosion of the dykes. This phenomena appears to be due to the minimal precipitation in this area of the island.

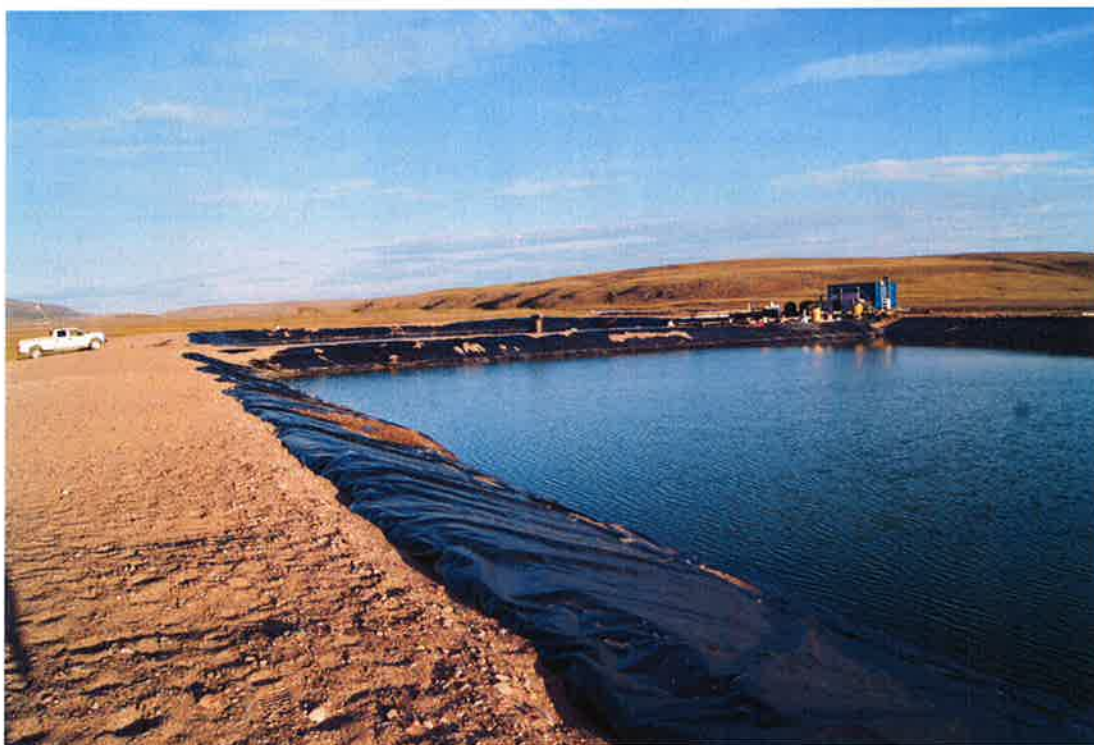
PWSP #2 – Mary River

At the time of our visit there was considerable freeboard to accommodate further sewage and the structure readily conforms to its design intent.

Our review of the area around the pond at the base of the slopes showed no sign of seepage and hence we conclude that the liner has been effective in containing the sewage and there are no tears or ruptures in the membrane.

We recommend that monitoring of the top of the dyke continue on an annual basis through 2012. With the excellent condition of the dyke construction we see no reason to complete this function other than annually prior to the next inspection.

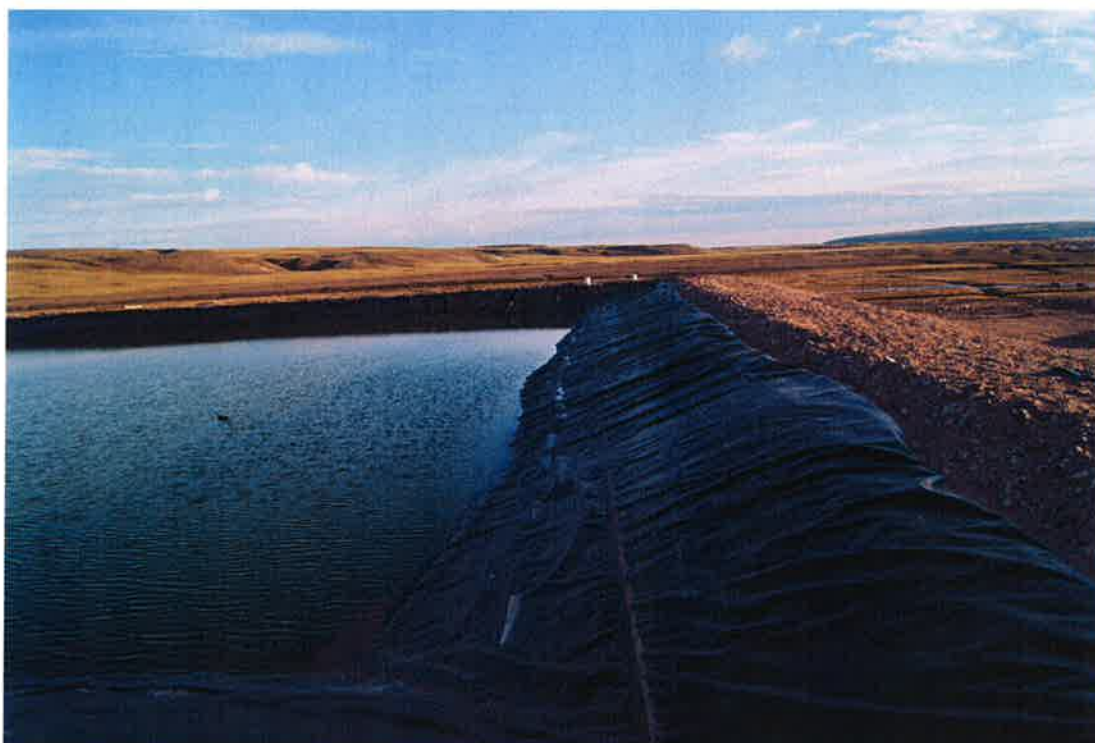
Typical dyke structure PWSP #2 – Mary River

Monitoring points have been set upon the top of the dyke and have been monitored since 2009. Settlements in the order of up to 9cm have occurred since that time. These settlements have not led to any stress cracks in the structure.

There appears to be no sign of erosion of the dykes and plants are only just now beginning to seed themselves on the dykes.

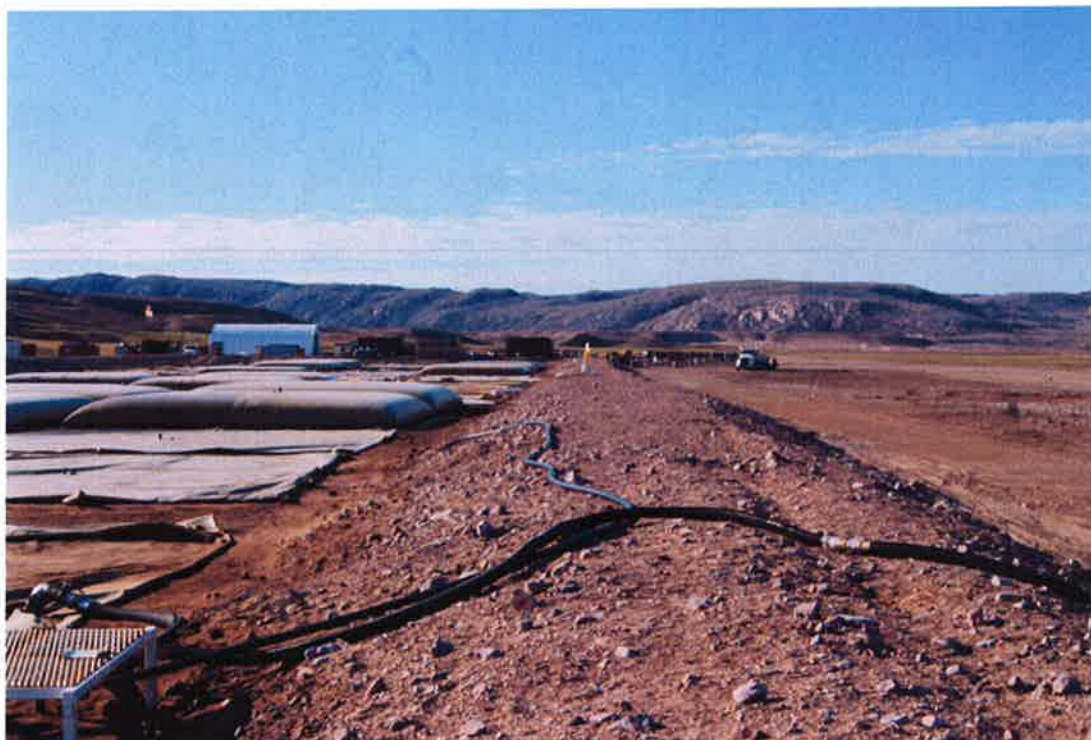
Typical dyke Milne Inlet Bulk Fuel Containment

The structure around the fuel farm currently conforms to the design of the facility. A review of the interior of the dyke showed only minor ponding of water although the oil stains on the interior sand layer indicates that the water on the interior of the dyke has been higher in the past as viewed during our review in 2009.

The ponding of water, although minor, continues to confirm the integrity of the liner.

Our review of the area around the ponds at the base of the slopes showed no signs of oil, water or oil/water mixtures and hence we conclude that the integrity of the liner has been maintained. Tears or ruptures in the liner were not observed.

There was no sign of any settlements, seepage, or cracking at the soil structures forming the dykes.

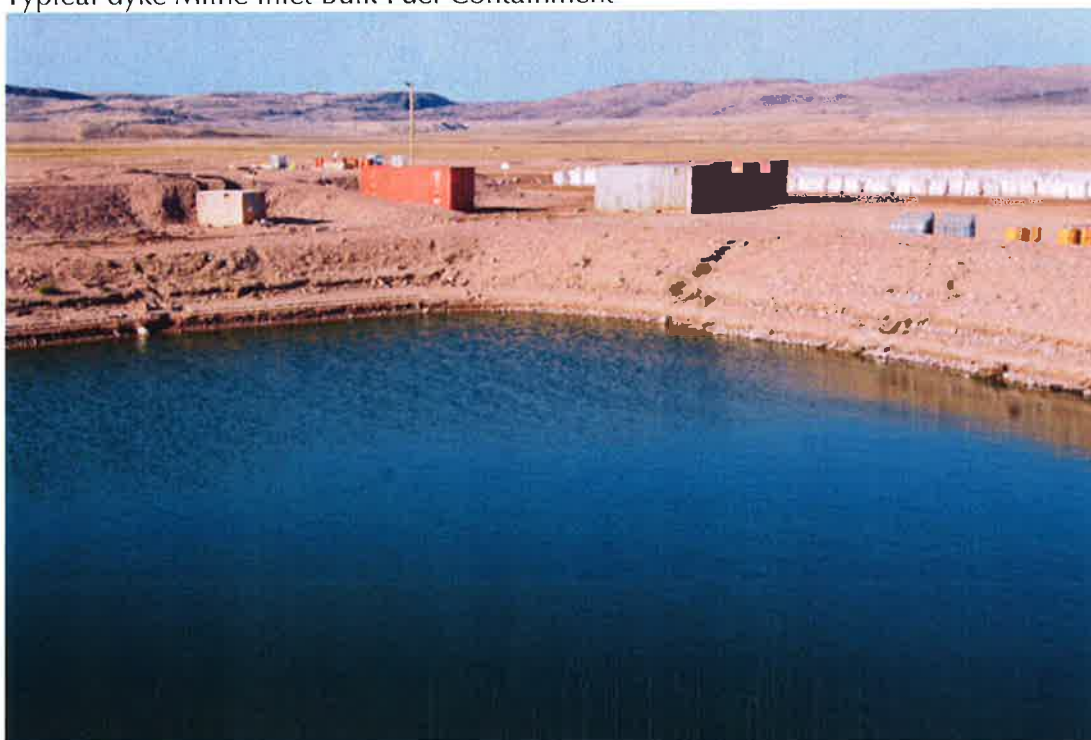
Milne Inlet PWSP

With the PWSP constructed as it is, the structure is considered stable for long term use.

There was no sign of seepage at the bottom of the dyke. There was no sign of settlement or cracking which are signs of stress in the structure.

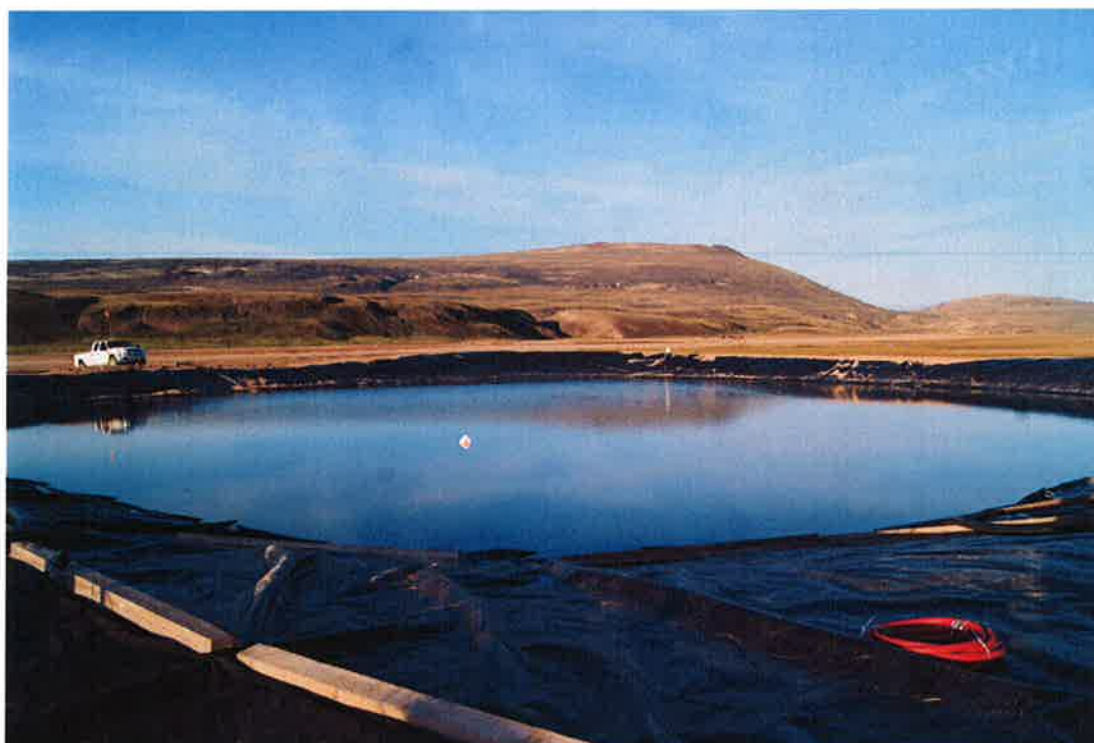
PWSP #3 – Mary River

Longitudinal cracking which appeared in the dykes of PWSP#3 due to the melt of permafrost wedges in 2009 have not reoccurred and we consider this structure to be stable in its present condition.

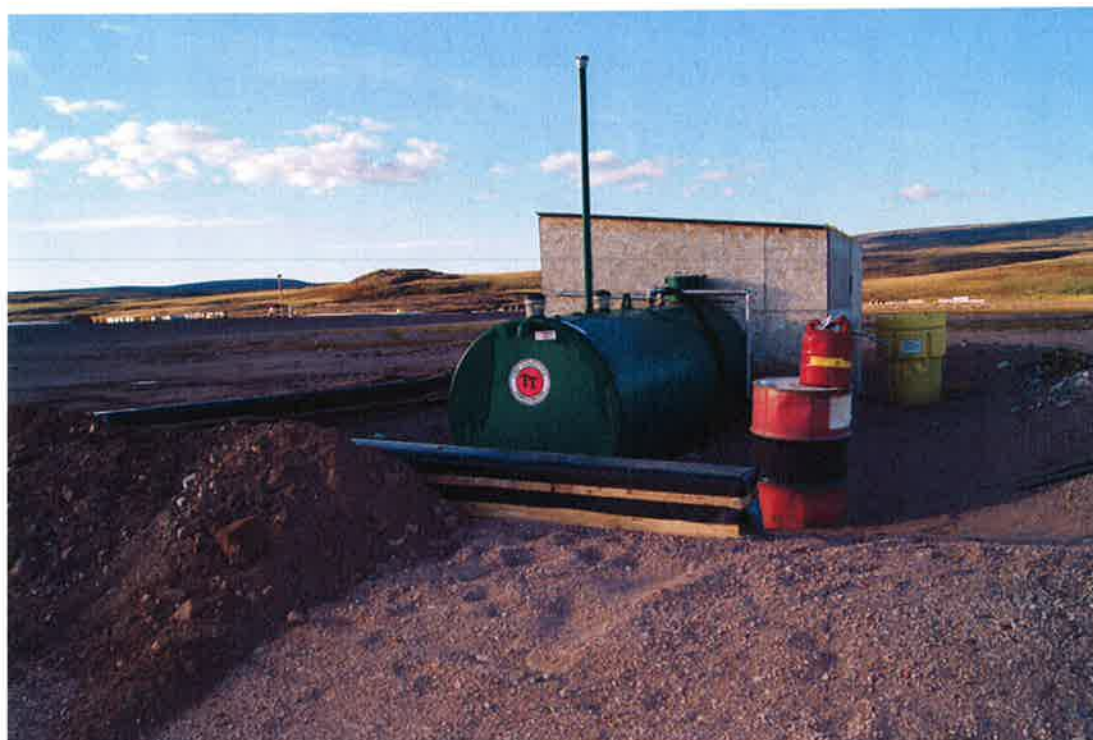
Recently a liner clad wood curb has been added to the top of the berm to prevent the erosion of gravel off the berm, caused by pulling the fuelling hose from within the dyke out to the helicopters to provide them with fuel.

Our review of the area around the pond at the base of the slopes showed no sign of seepage. Water that was ponding in this containment during our 2010 review is no longer present as there has been little or no precipitation this summer season.

A review of the exterior and the top of the berms showed no sign of cracking or settlement which would indicate stress within the structure.

Helicopter Fuel Cell Containment – curb sits above dyke – Mary River

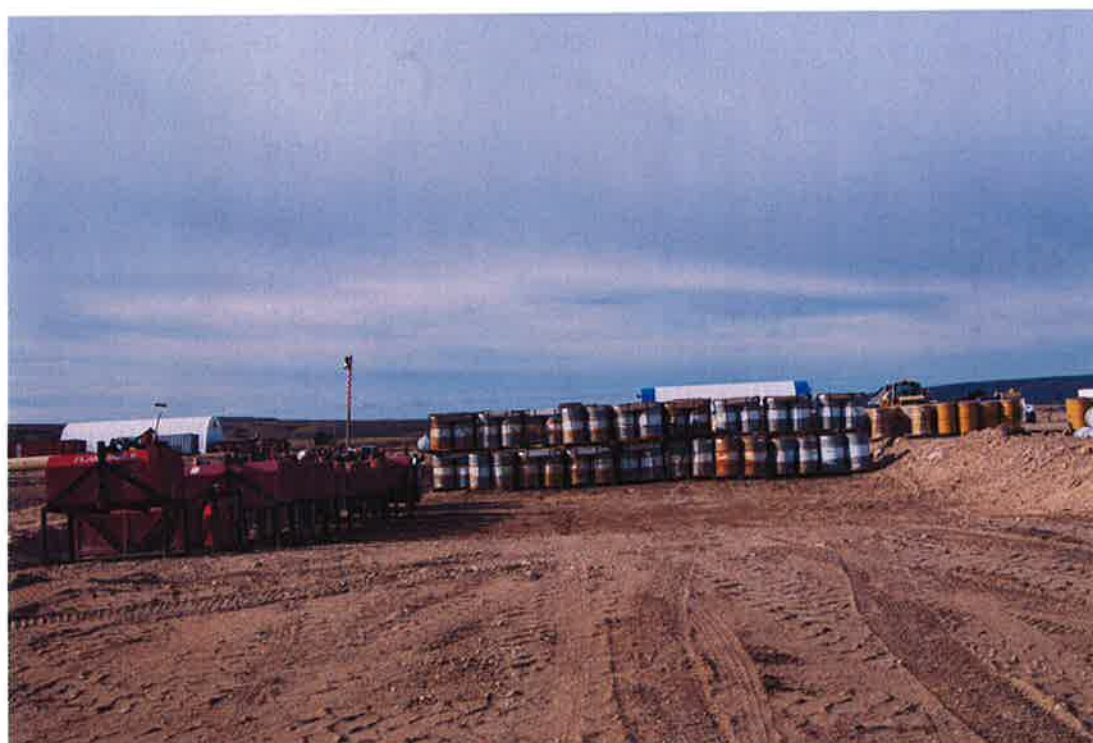
Barrel Fuel Containment cell #1 – Mary River

This particular structure which we called “Barrel Fuel Containment” in our 2010 inspection report is a two cell structure which is currently used to accommodate barrels of Jet A fuel in one cell including a number of fuel dispensing tanks and a number of stove fuel barrels on skids and a large number of empty drums in the other cell.

Our review of the area around this containment structure showed no sign of seepage. This shows that there is reasonably little chance of tearing or rupture of the membrane.

A review of the exterior and top of the dyke showed no sign of cracking or settlement which would indicate stresses within the structure.

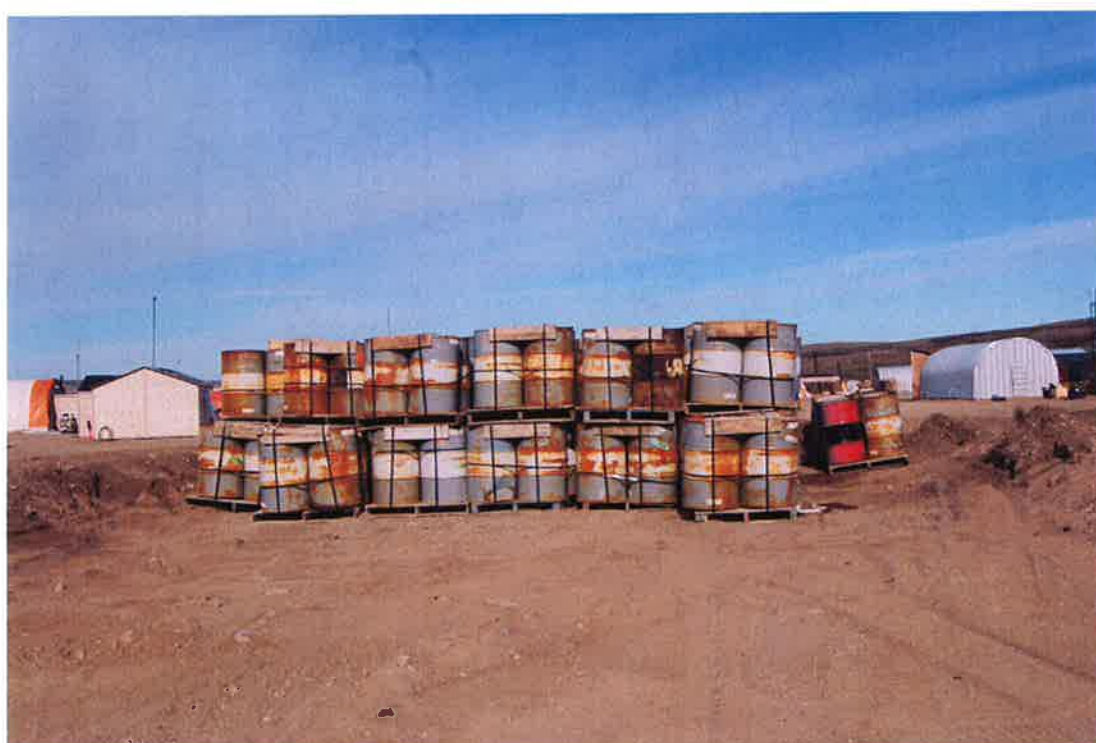
Stove Oil Storage – Mary River

Our review of the area around the containment structure shows no signs of seepage. This shows that there is reasonably little chance of tearing or rupture of the membrane.

A review of the exterior and top of the dyke showed no sign of cracking or settlement which would indicate stresses with the structure.

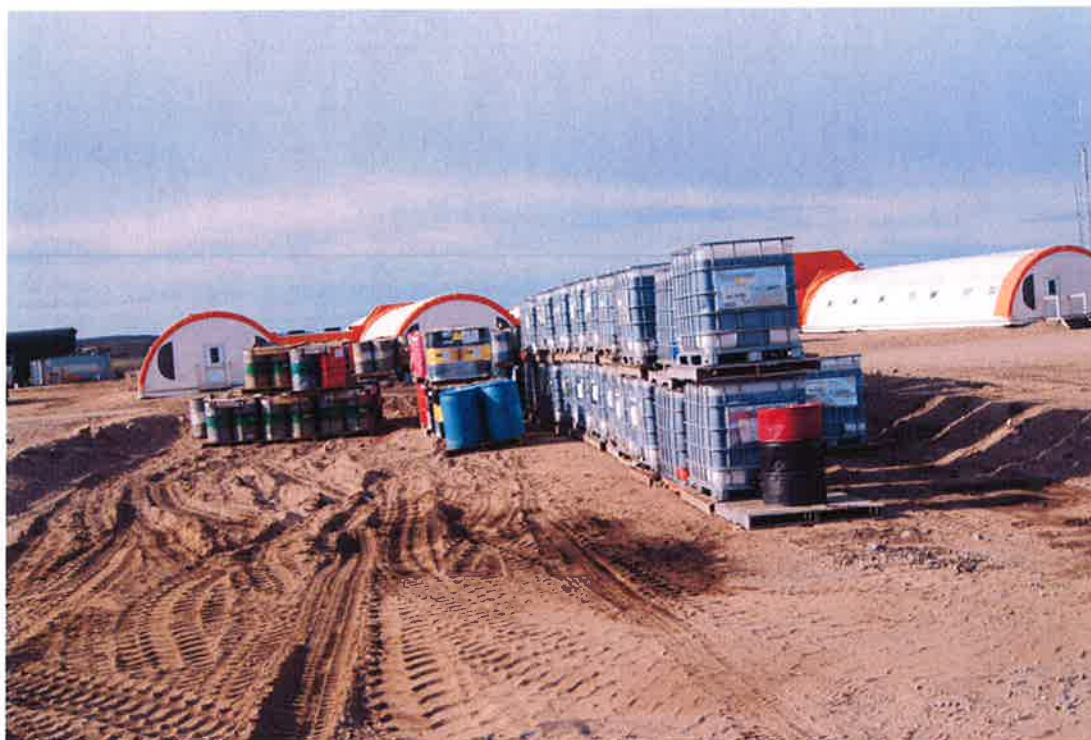
Enviro Tank Storage Containment – Mary River

This particular structure is constructed contiguous with the Hazardous Waste Storage constructed in 2010. It originally contained a fuel tank but now contains lubricants and antifreeze.

Our review of the area around this cell at the base of the slopes showed no sign of seepage.

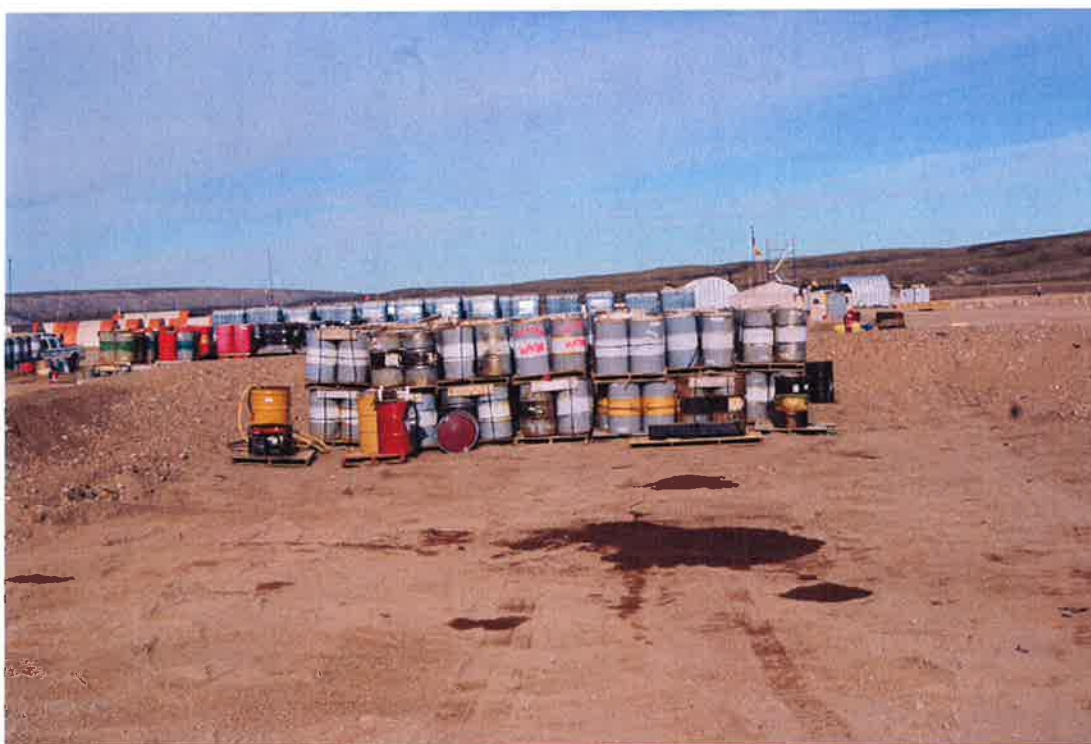
Hazardous Waste Storage – Mary River

This structure was empty during our review in 2010 but now is used as a containment for skids of barrels containing stove fuel.

Our review of the area around this cell at the base of the slopes, showed no sign of seepage.

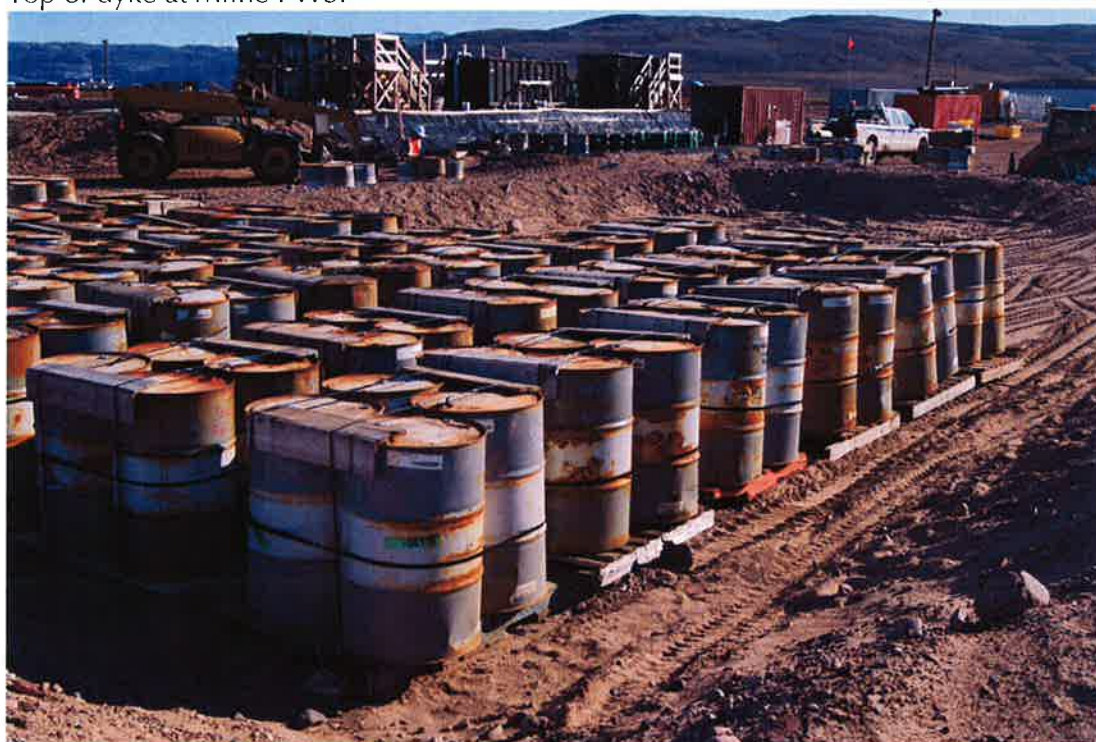
Barrel Fuel Storage Containment cell #1 – Milne Inlet

Our review of the area around the ponds at the base of the slopes showed no signs of seepage.

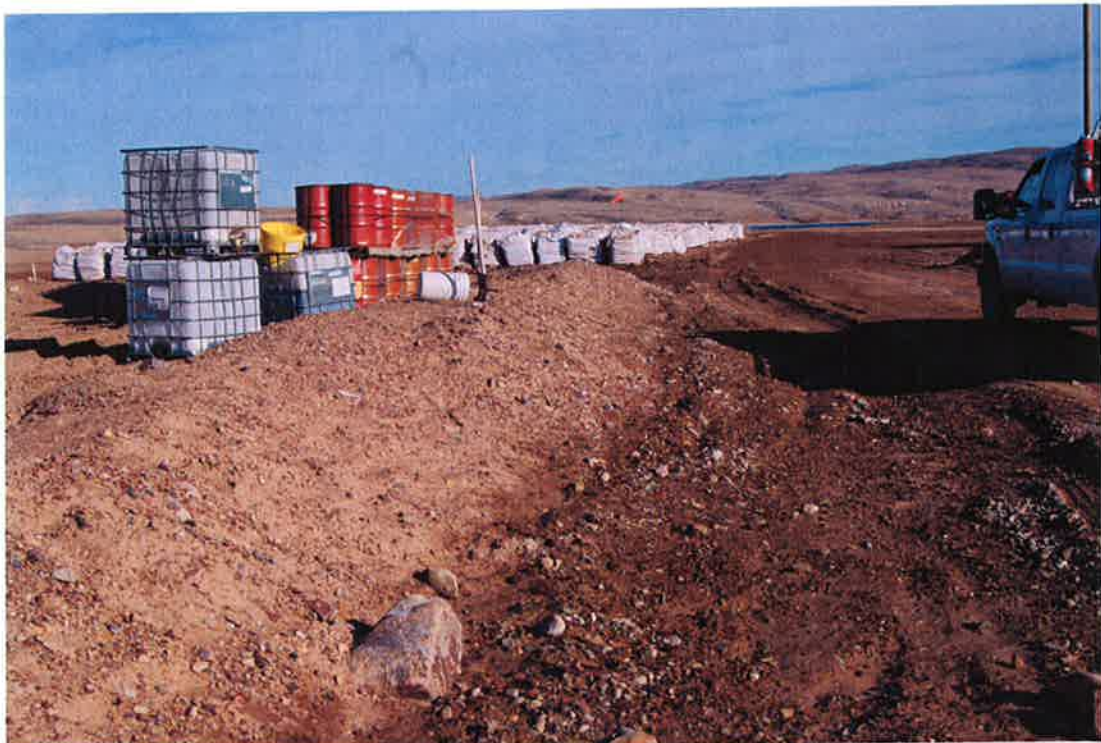
Oil and Antifreeze Containment – Milne Inlet

There is no cracking or settlement observed in the dyke structures which are signs of stress in the structure.

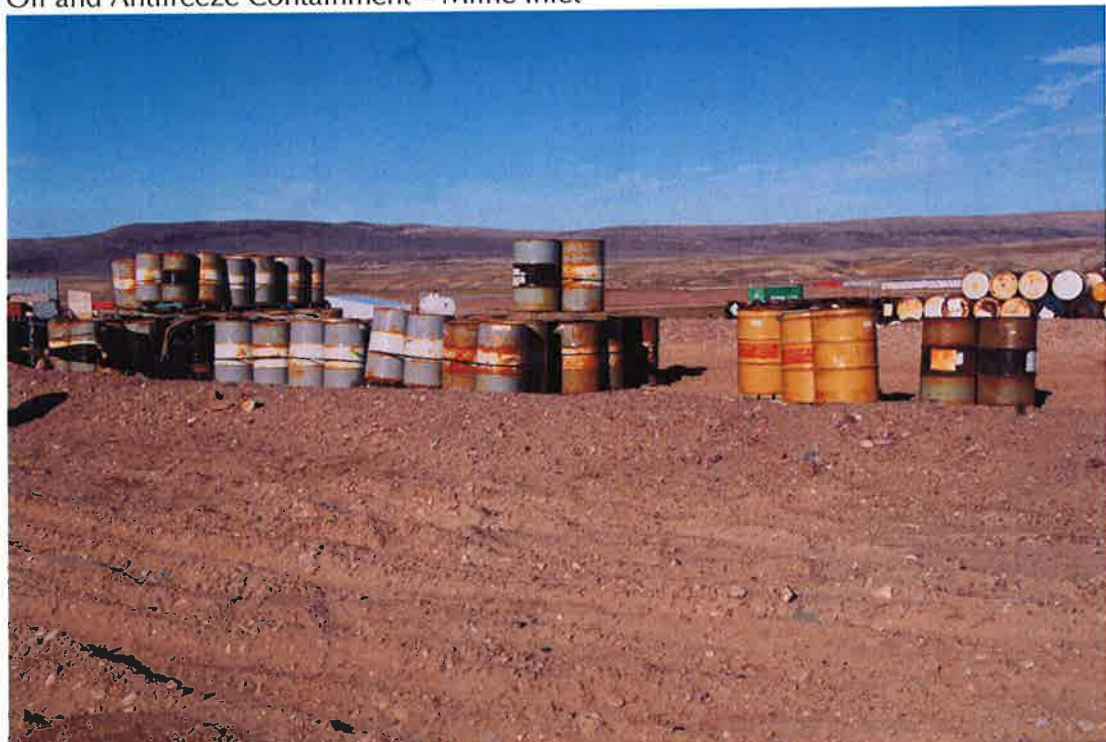
Hazardous Waste Storage – Milne Inlet

I note that during our inspection there were two tears noted in the liner on one cell. This was brought to the attention of administration.

Repairs to these two minor tears were subsequently made, prior to issuing of this report in final format, by replacing the liner in one cell.

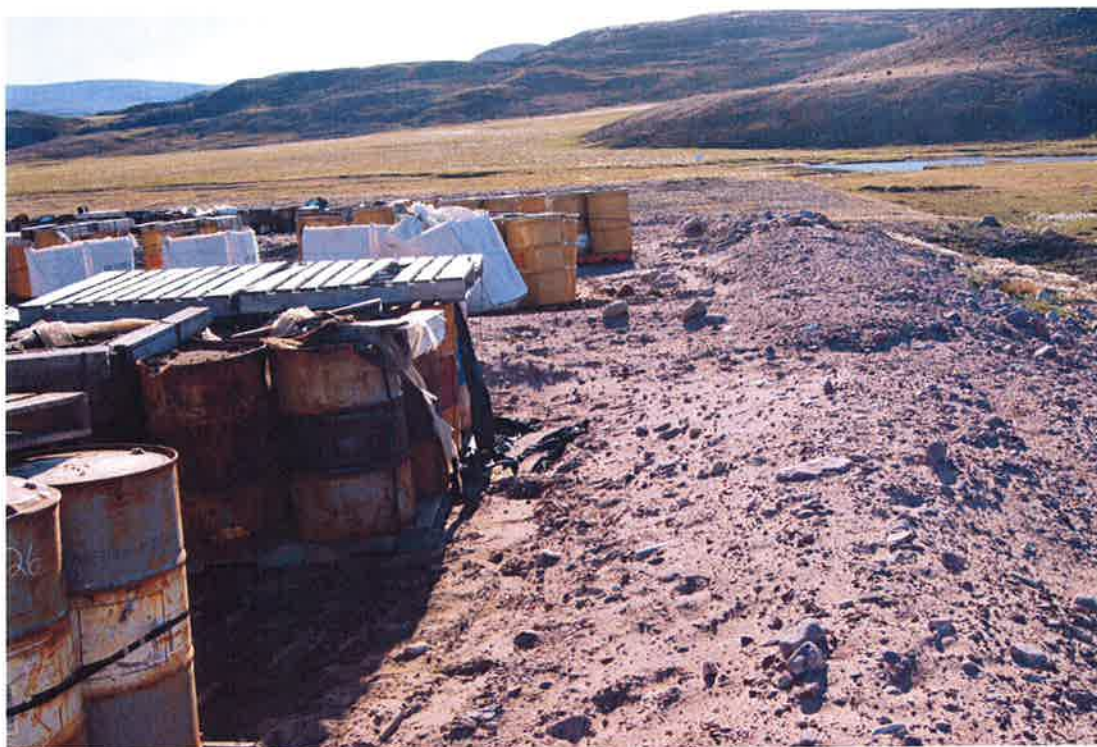
Dyke at Hazardous waste storage

Our review of the area around the dykes at the base of the slopes showed no signs of seepage. There were no signs of settlement or cracking which are signs of stress in the structure.
