October 25, 2012

Baffinland Iron Mines Corporation
120 Adelaide Street West, Suite 1016
Toronto, Ontario M5T 1T1

**RE: ANNUAL GEOTECHNICAL INSPECTION 2012-08-16
BAFFINLAND IRON MINES CORPORATION
OUR REFERENCE #10-098 (101-15104-01)**

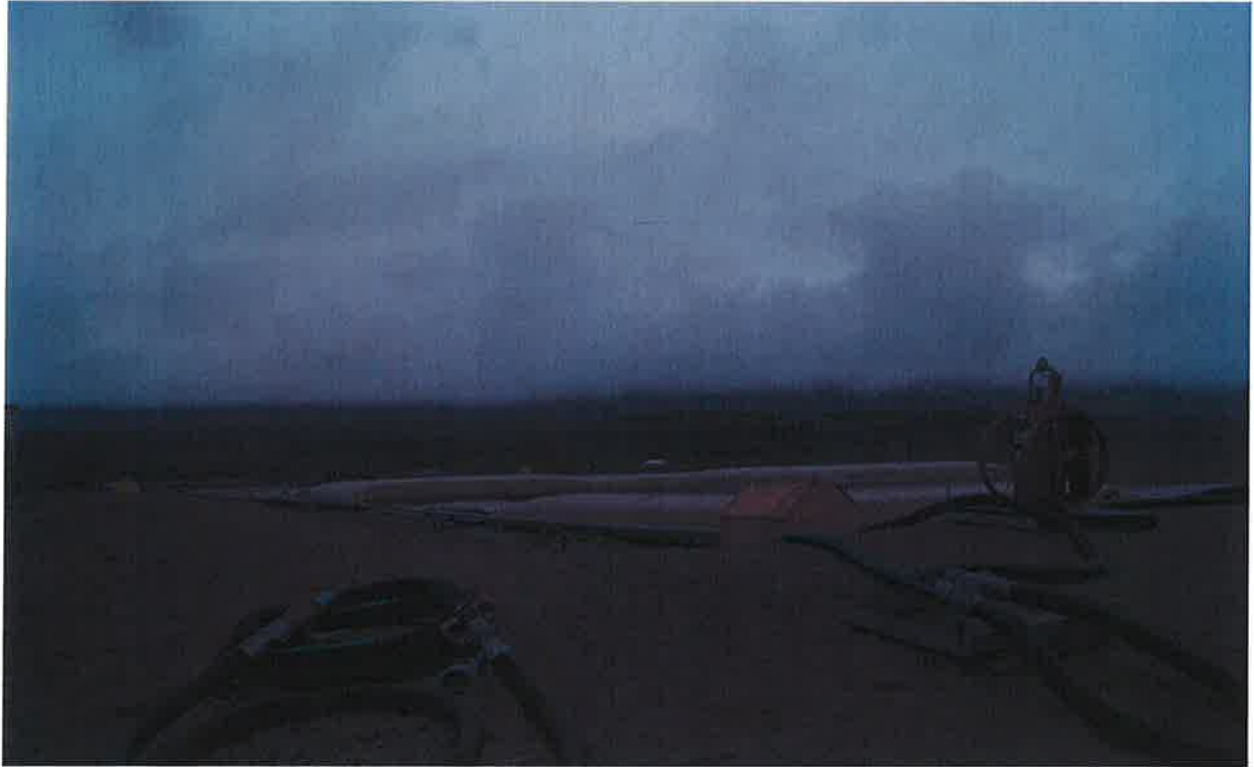
The structure was visually inspected for any signs of cracking or subsidence. There was no indication of any settlements, seepage, or cracking in the soil structures that formed the dykes. As well, there was no indication of seepage at the base of the structure around the exterior. The soil structure is considered to be stable in the present condition and is in conformance with the design basis for the facility.

Bulk Fuel Storage Facility Containment.

There are no recommendations to be made at this time other than to continue the pumping and treatment procedure currently undertaken.

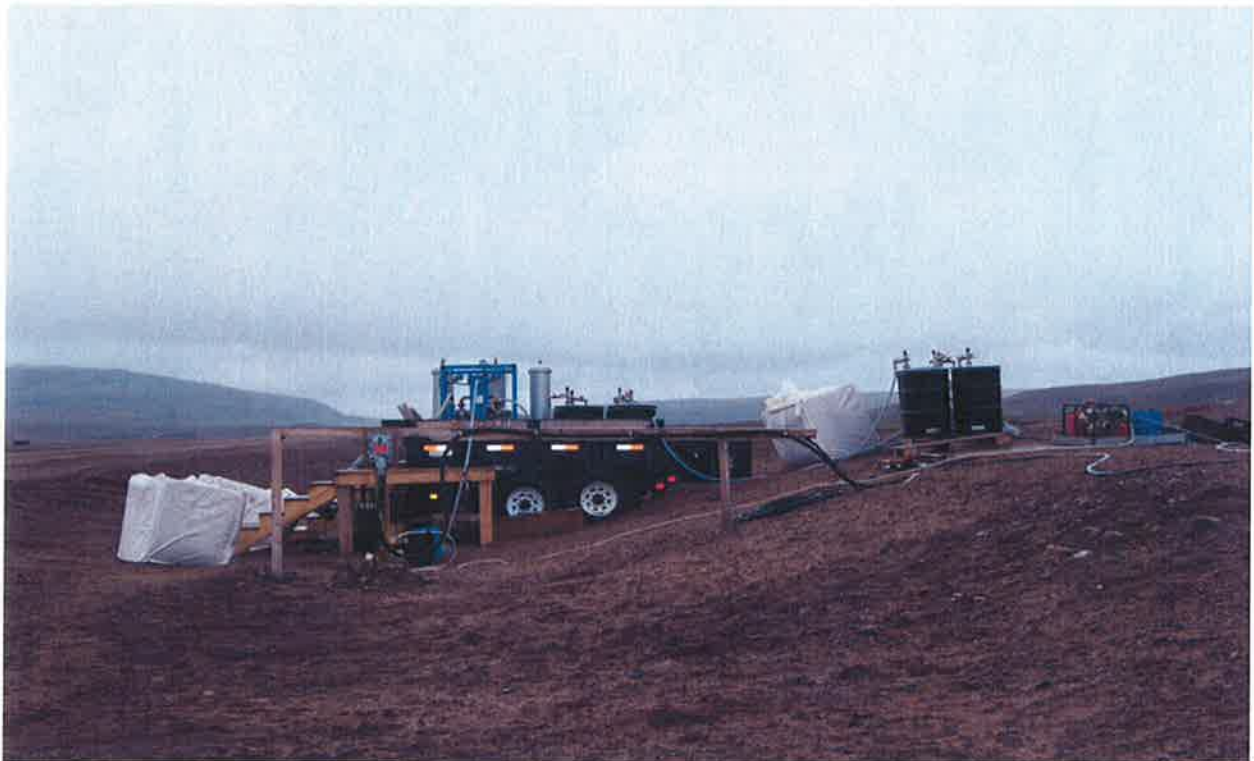
At the time of our review the water had recently been removed (3 days earlier) from the containment and treated for release. There was a small amount of water ponding in a depression or sump in the gravel from which water was removed.

Treatment operation at the Bulk Fuel Storage Facility Containment.

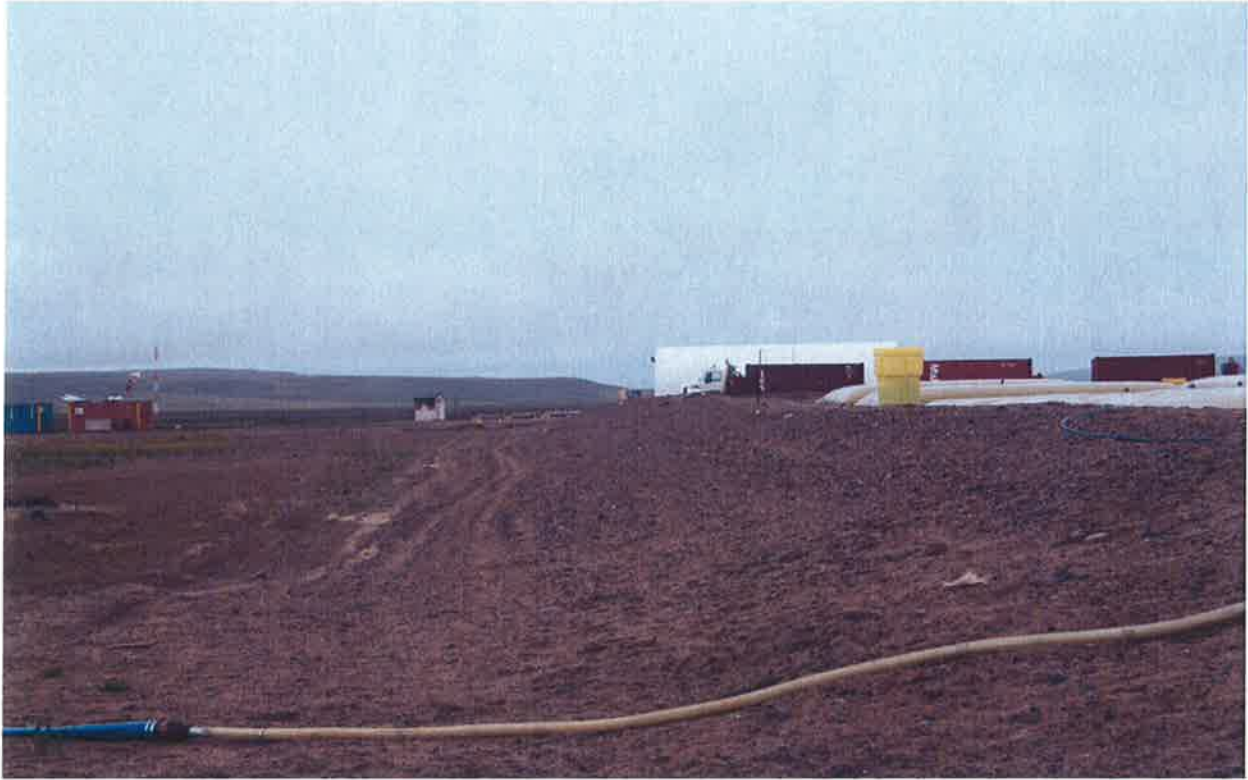
Outside slope of dyke at the Bulk Fuel Storage Facility containment.

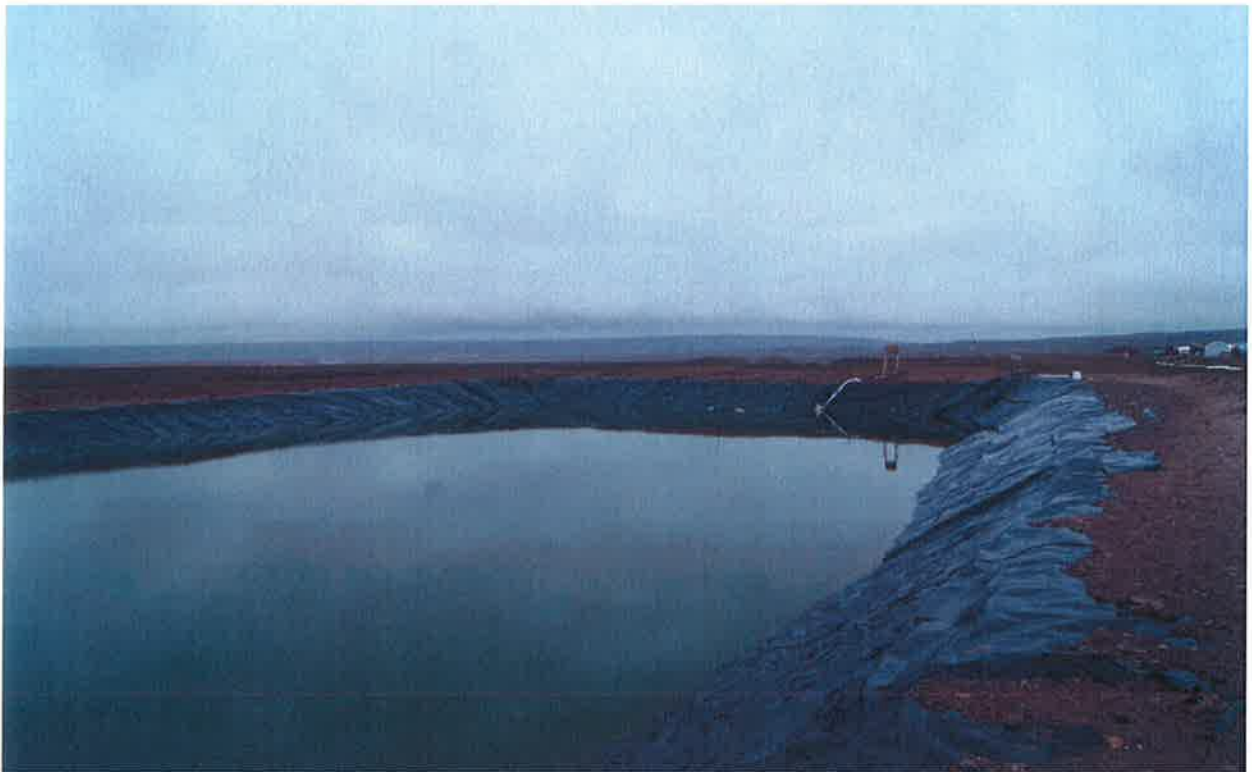
Our review of the area around the pond at the base of the slopes showed no sign of seepage and hence we conclude that the liner has been effective in containing sewage and there are no tears or ruptures in the membrane, excepting some minor tears from past activity at the top of the dyke wall above the allowable effluent level in the structure.

A review of the top of the dyke showed no indication of cracking or settlement which would indicate stresses within the structure.

Most tears that had occurred in the liner on the top of the dyke and have been patched during the period between reviews in 2008 and 2009 are holding well. As well there are no signs of weather related deterioration of the liner where it is exposed. Monitoring points have been set up on the top of the dyke and have been monitored since 2009. Settlements of approximately 10 cm have occurred since that time. These settlements have not led to any stress cracks in the structure.

Polishing/Waste Stabilization Pond No. 1

We recommend that monitoring of the top of the berm continue on an annual basis through 2013. With the excellent condition of the dyke construction, we see no reason to complete this function other than annually prior to the next inspection.

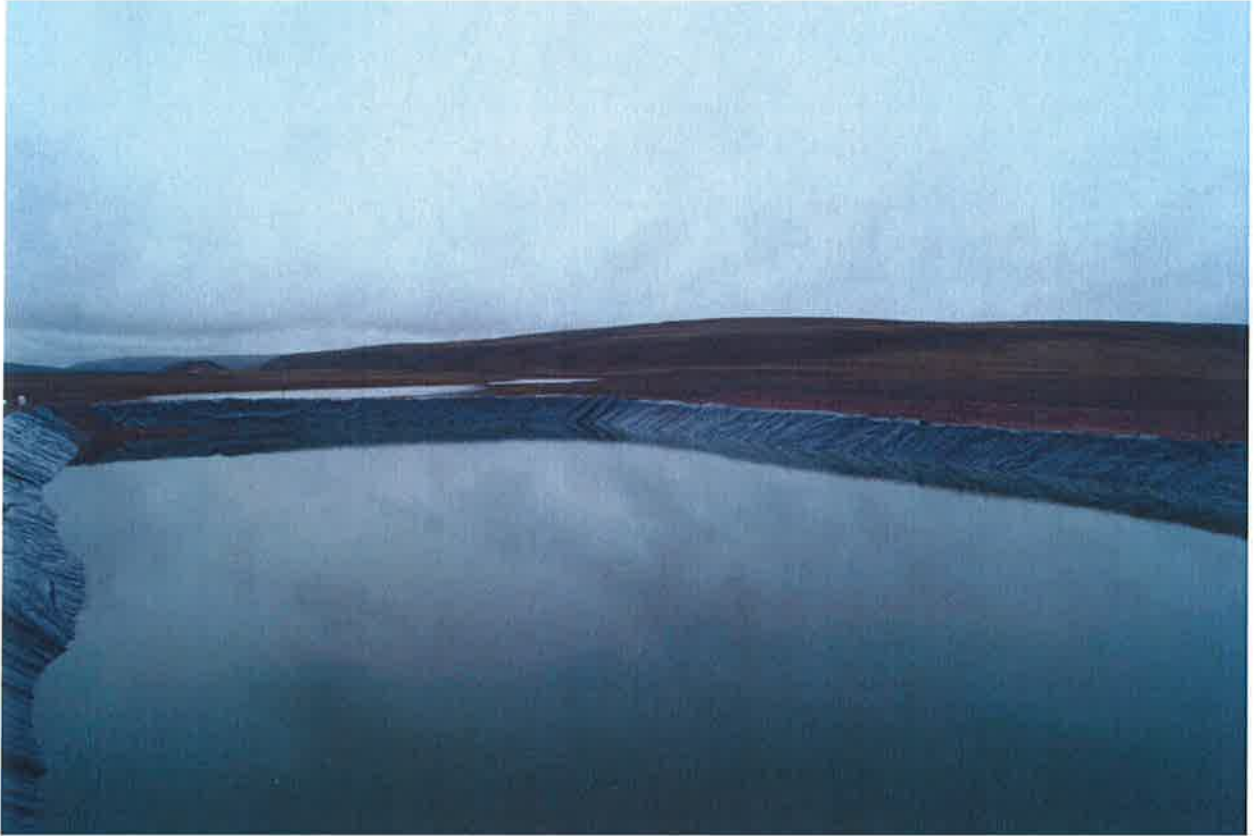
Longitudinal cracking which appeared in the dykes of PWSP#3 due to the melt of permafrost wedges in 2009 has not reoccurred and we consider this structure to be stable in its present condition.

Monitoring points have been set upon the top of the dyke and have been monitored since 2009. Settlements in the order of up to 10 cm have occurred since that time. These settlements have not led to any stress cracks in the structure.

Polishing/Waste Stabilization Pond No. 3.

We recommend that monitoring of the top of the dyke continue on an annual basis through 2012. With the excellent condition of the dyke construction we see no reason to complete this function other than annually prior to the next inspection.

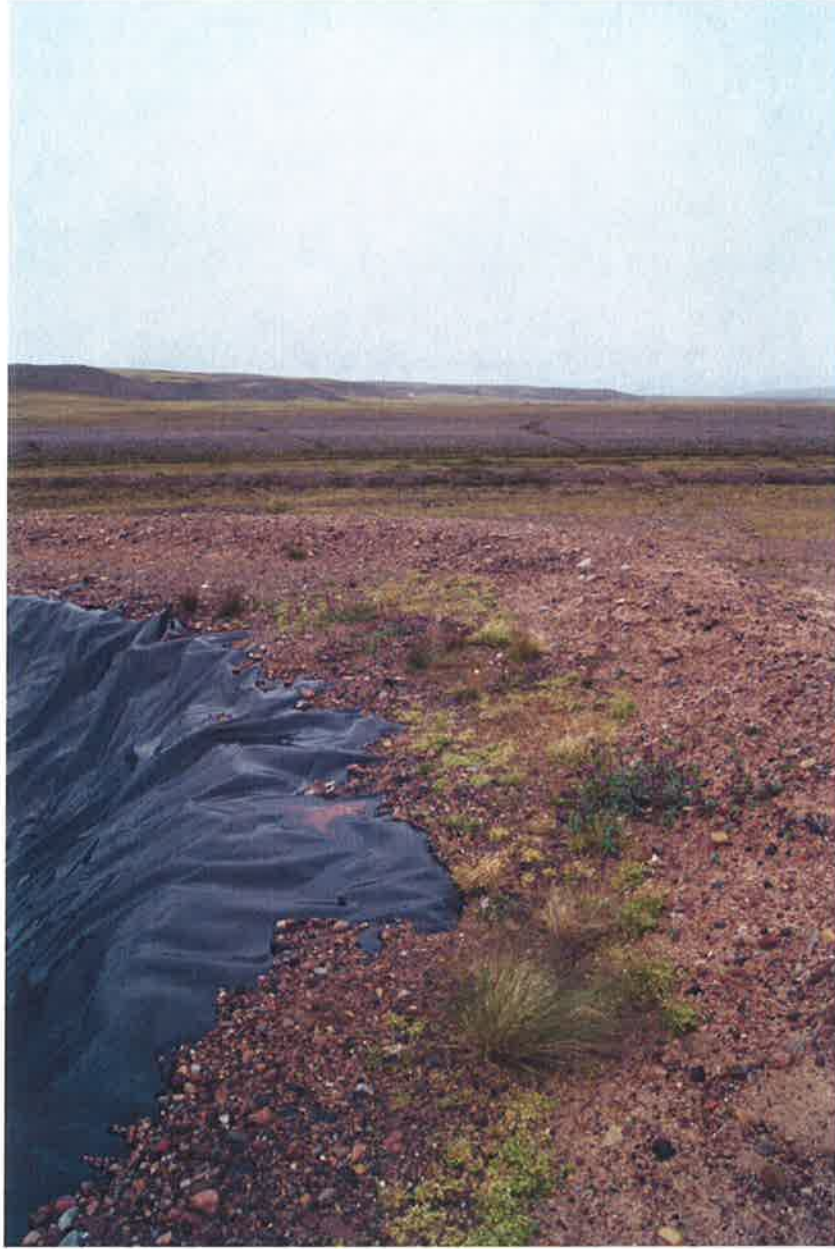
There appears to be no sign of erosion of the dykes and plants are continuing to seed themselves on the dykes. This growth is minimal however.

Vegetation Starting to grow on top of dyke only on PWSP #2.

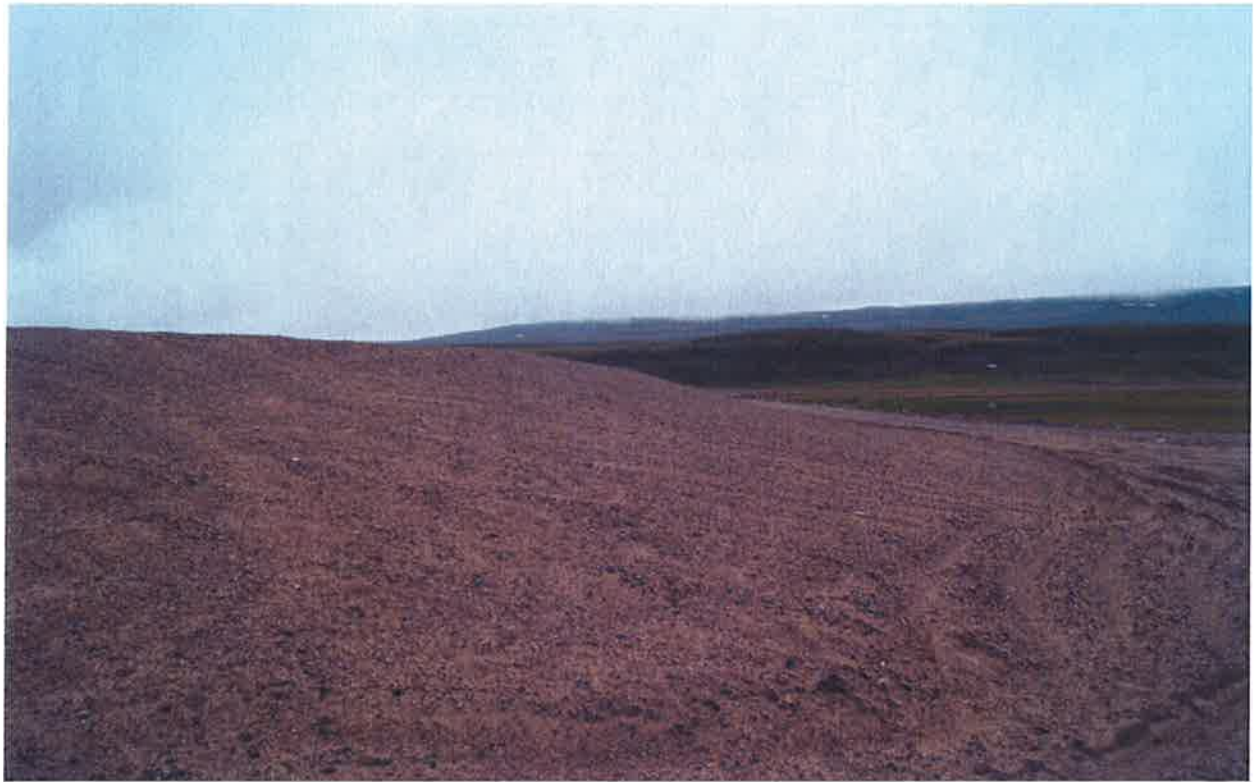
Outside slope of dyke at PWSP No. 3.

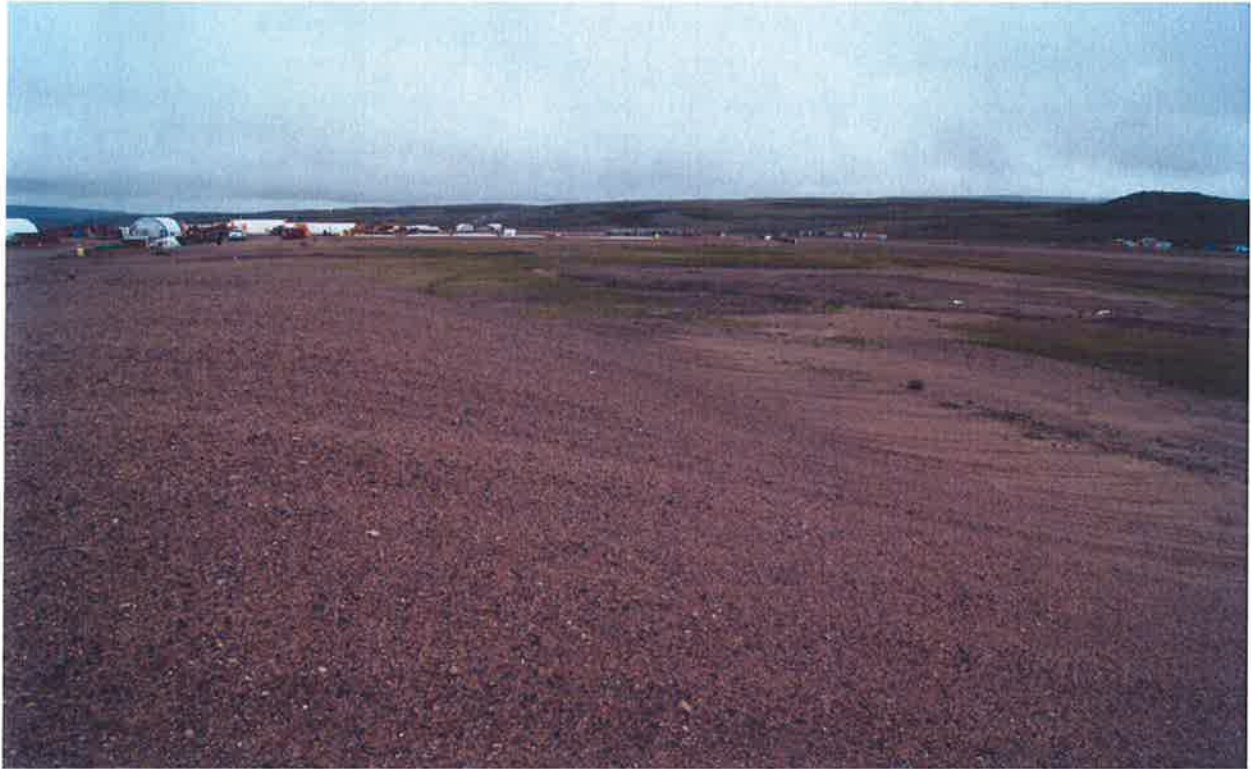
Outside slope of dyke at PWSP No. 2

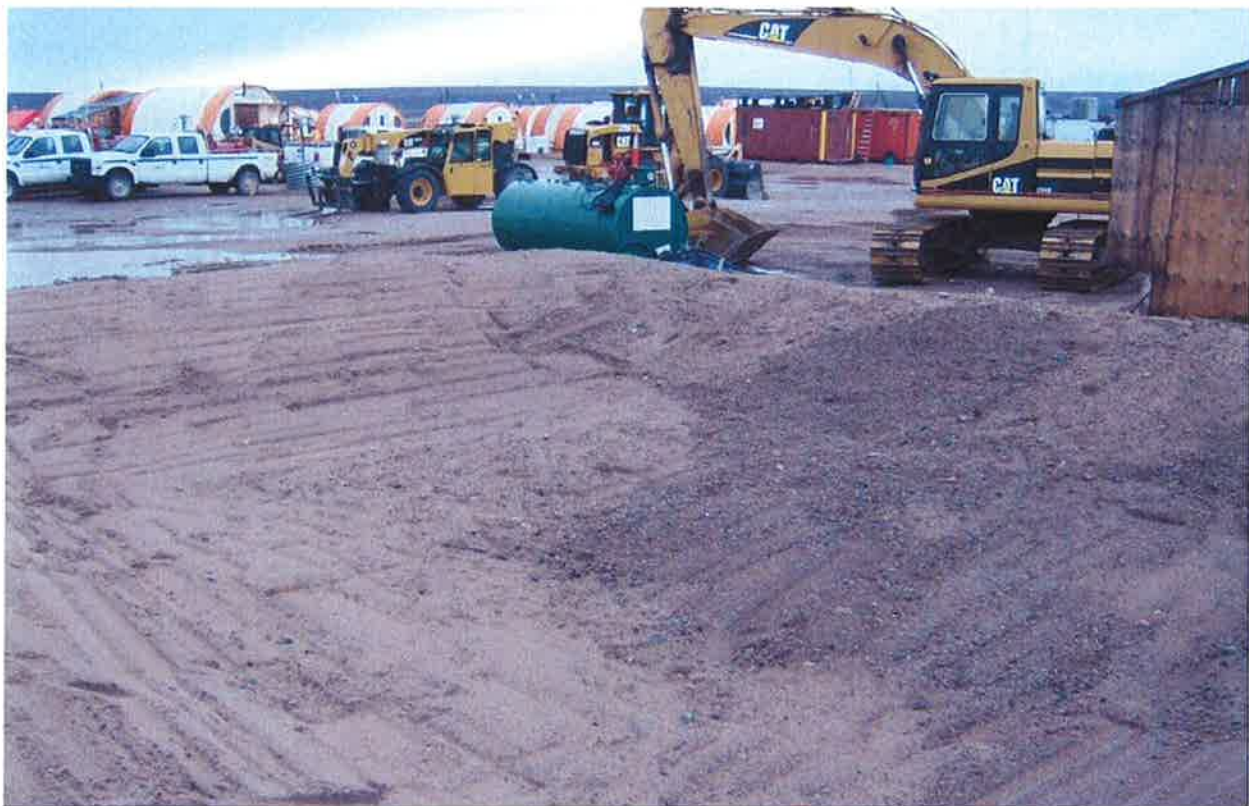
Our review of the area around the pond at the base of the slopes showed no sign of seepage. There is a minor amount of water ponding in the bottom indicating the integrity of the liner.

A review of the exterior and the top of the berms showed no sign of cracking or settlement which would indicate stress within the structure.

Helicopter Fuel New Containment Cell, recently reconstructed.

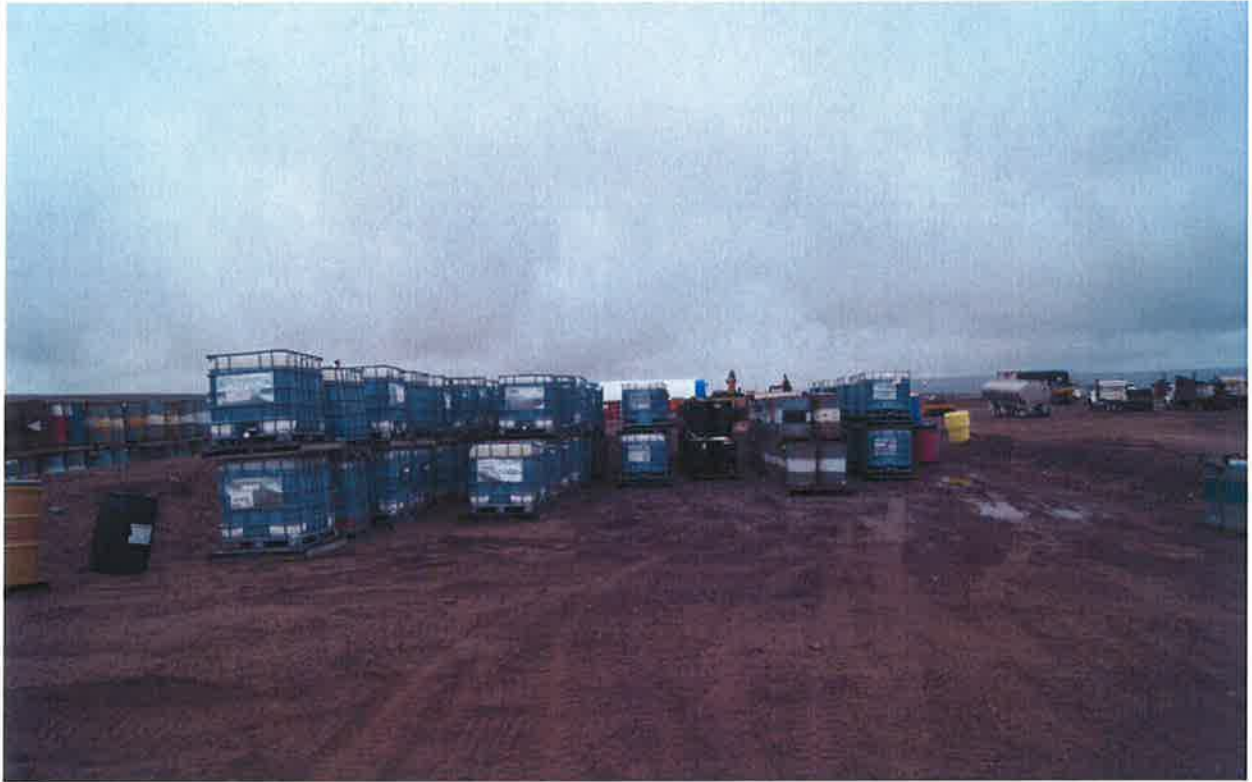
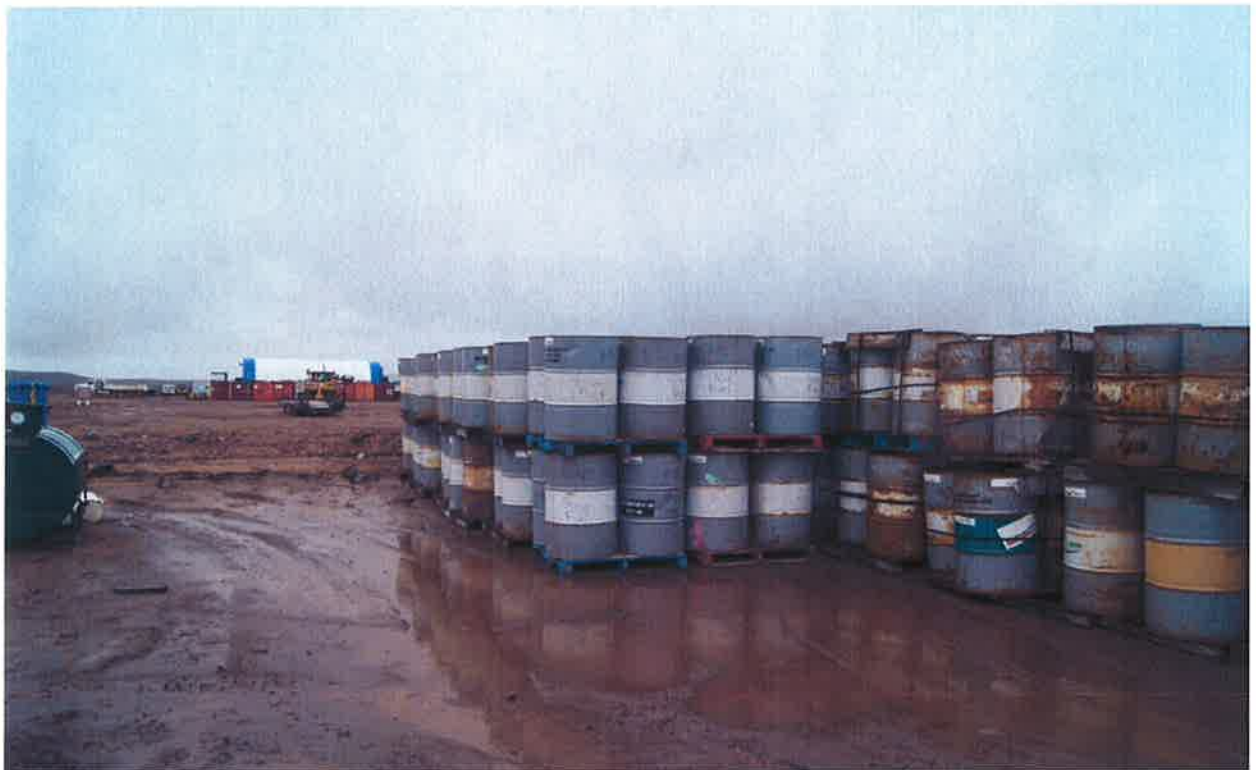
Our review of the area around this containment structure showed no sign of seepage. This shows that there is reasonably little chance of tearing or rupture of the membrane.

A review of the exterior and top of the dyke showed no sign of cracking or settlement which would indicate stresses within the structure.

Barrel Fuel Containment Cell.

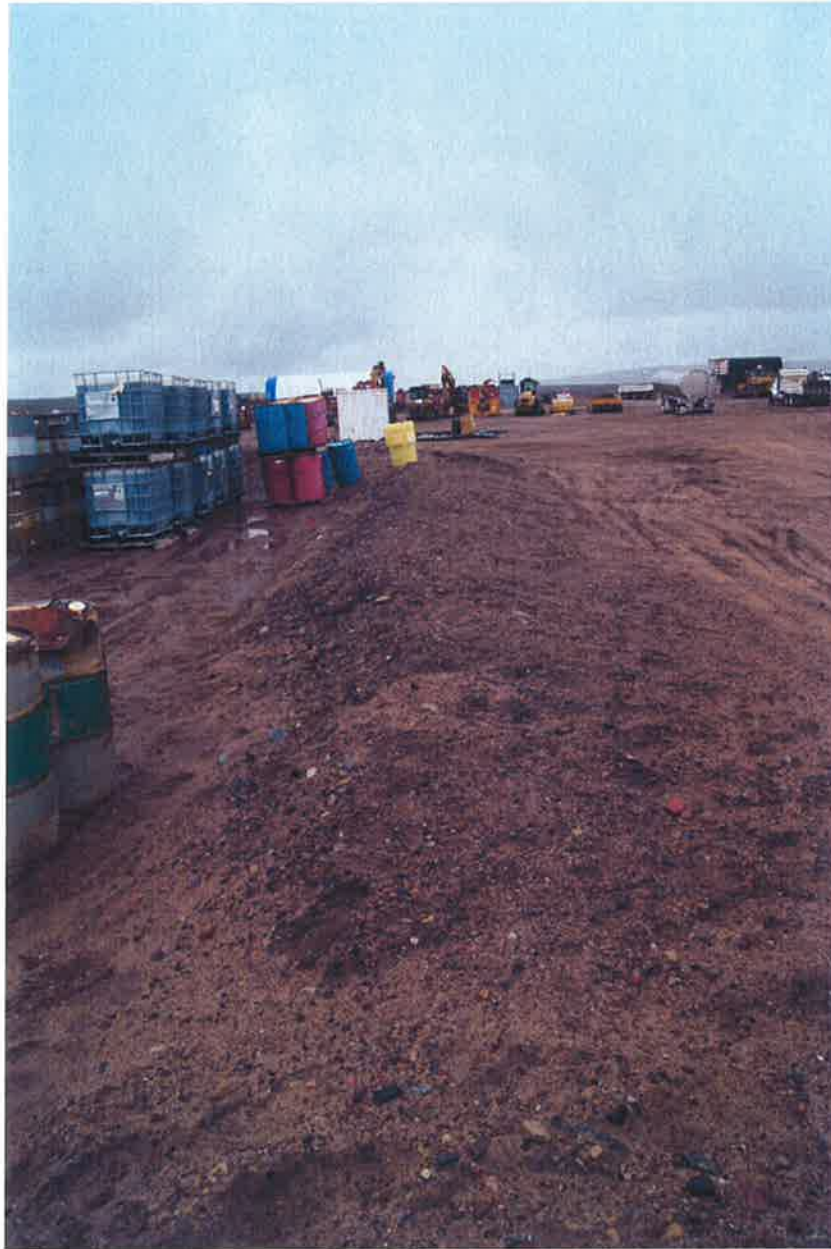
Outside slope of dyke at Barrel Fuel Containment Cell.

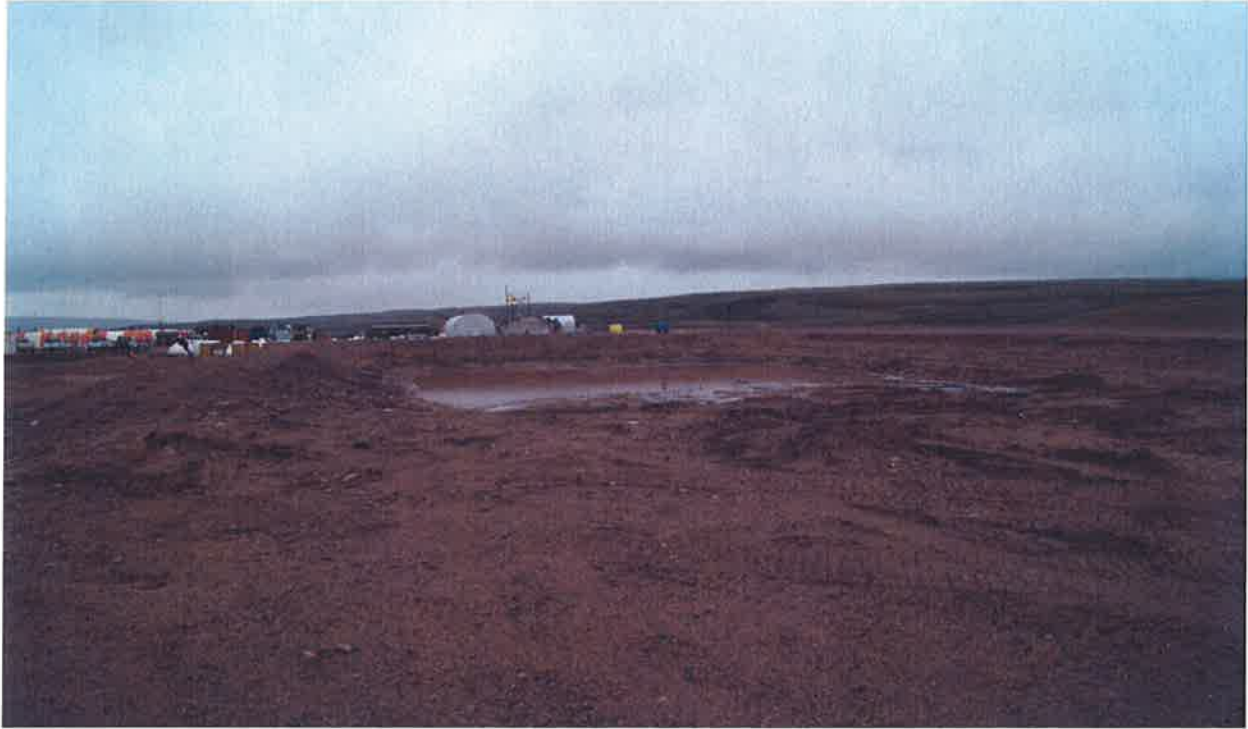
Our review of the area around the containment structure shows no signs of seepage. This shows that there is reasonably little chance of tearing or rupture of the membrane.

A review of the exterior and top of the dyke showed no sign of cracking or settlement which would indicate stresses with the structure.

Stove Oil Storage now empty.

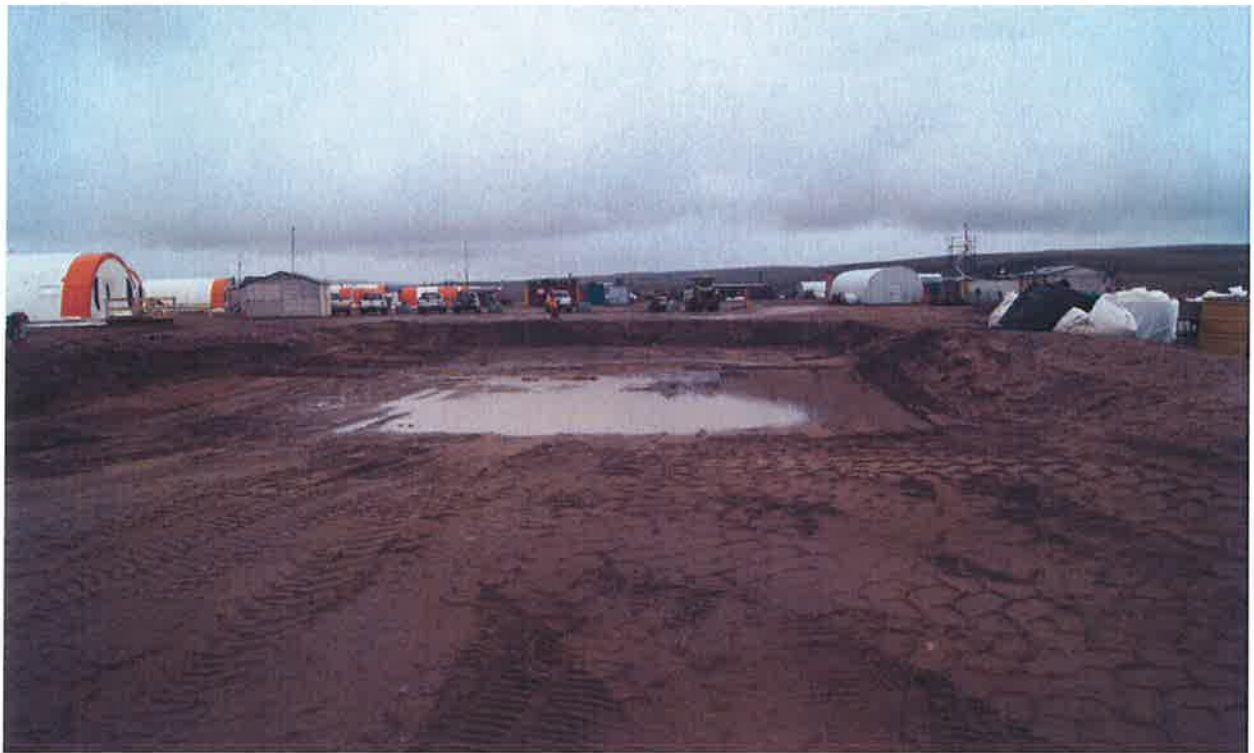
Our review of the area around this cell at the base of the slopes, showed no sign of seepage.

Hazardous Waste Storage now empty. Note water just at top of gravel.

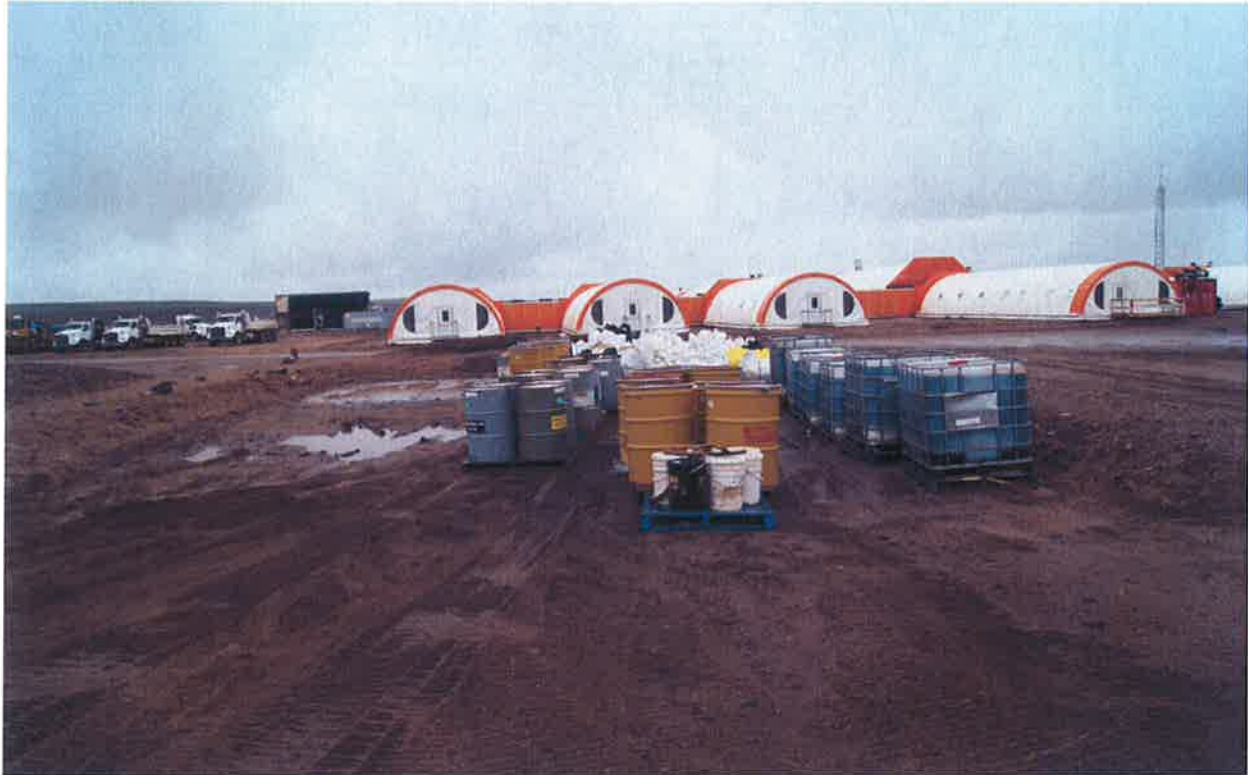
Our review of the area around this cell at the base of the slopes showed no sign of seepage.

Enviro Tank Storage now used as hazardous waste and lubricant cube storage.

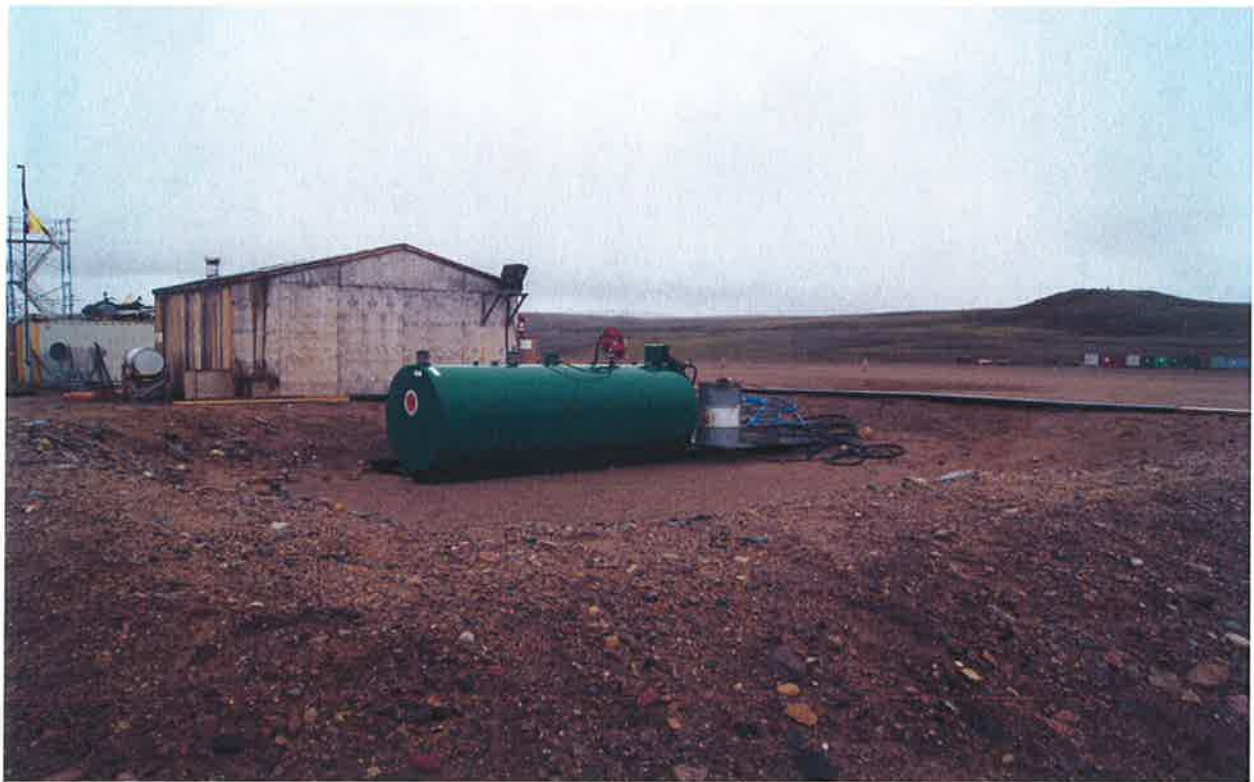
Past review of this structure has indicated that a one piece liner was installed under the sand/gravel but no geotextile was installed as protection over or under the liner.

However, there was no water ponding in the containment. This was brought to the attention of administration on site.

Jet Fuel Tank and Pump Containment.

On August 14th and 15th, at the recommendation of the inspecting Engineer, the containment was reconstructed as intended with geotextile installed on both the underside and top of a new one piece liner.

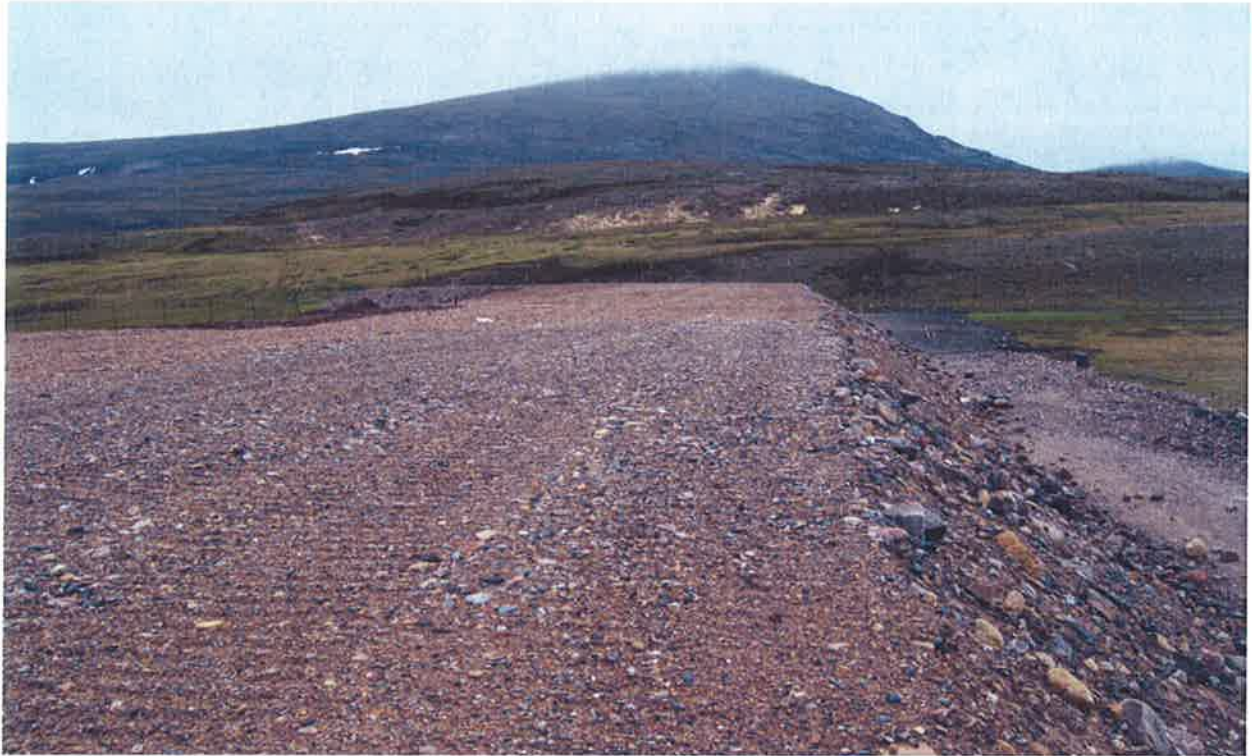
Berms appear stable and garbage is being placed and covered as it is placed within the berm structures.

South east containment berm at solid waste disposal site looking north east.

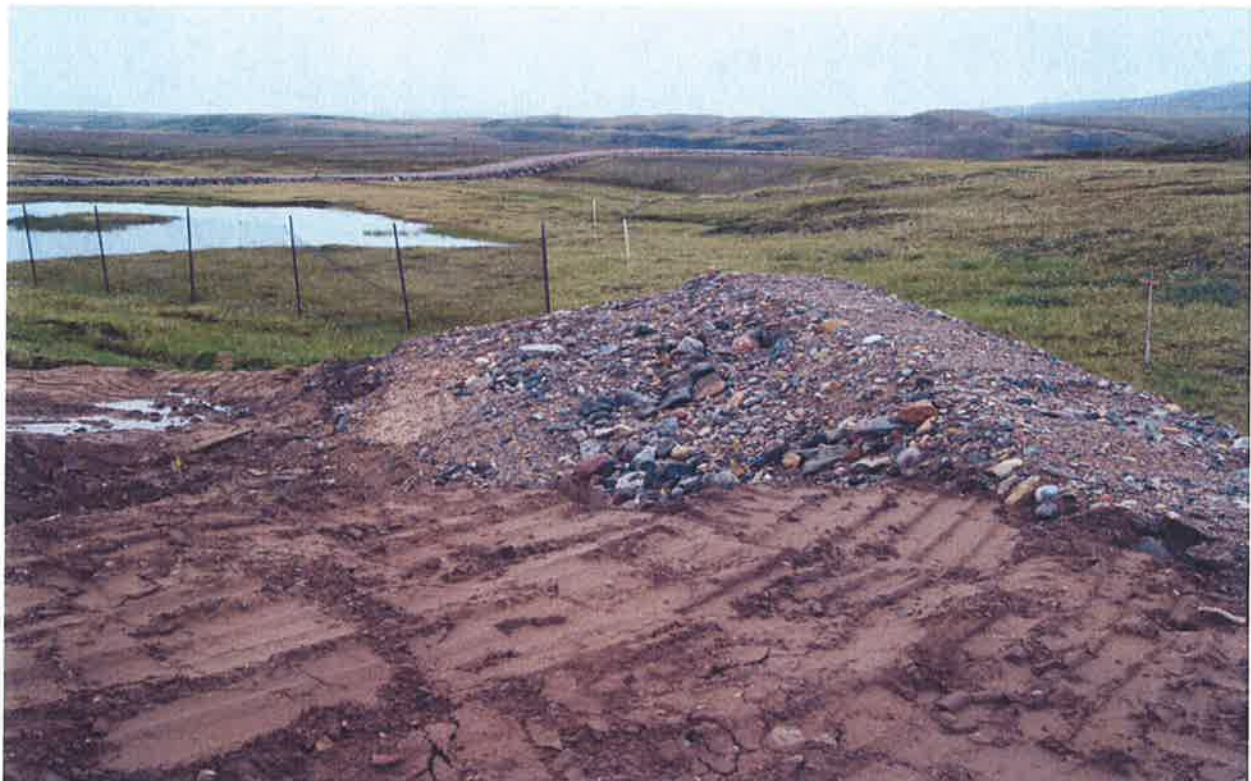
North east containment berm at solid waste disposal site looking north west.

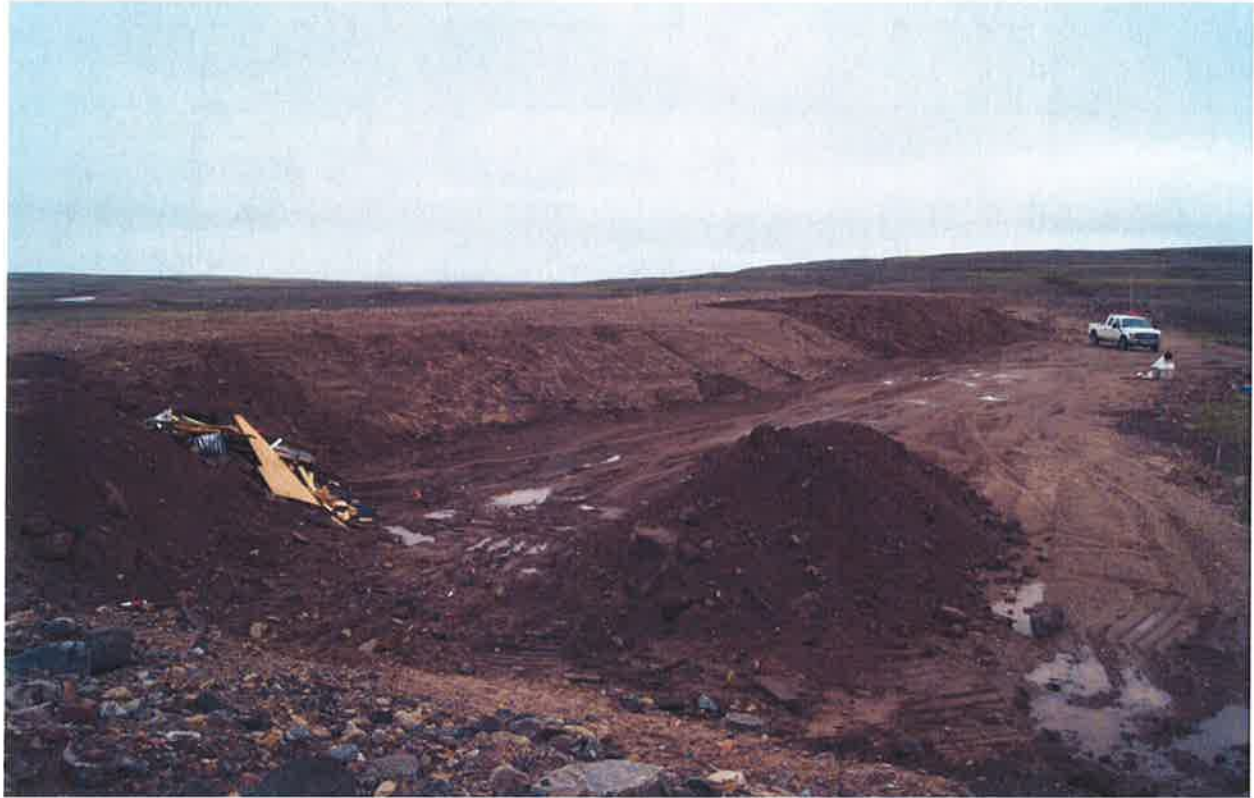
Solid waste disposal site looking west showing solid waste ready to be covered.
