GEOSYNTHETICS INVENTORY LOG

PROJECT NUMBER: 07C-015 PROJECT TITLE: Fuel Farm.
OWNER: Boffinland Iron Mine CONTRACTOR: _____
LOCATION: Mary River

GEOMEMBRANE DEFECT / REPAIR LOG

Bulk Fuel
Storage Facility

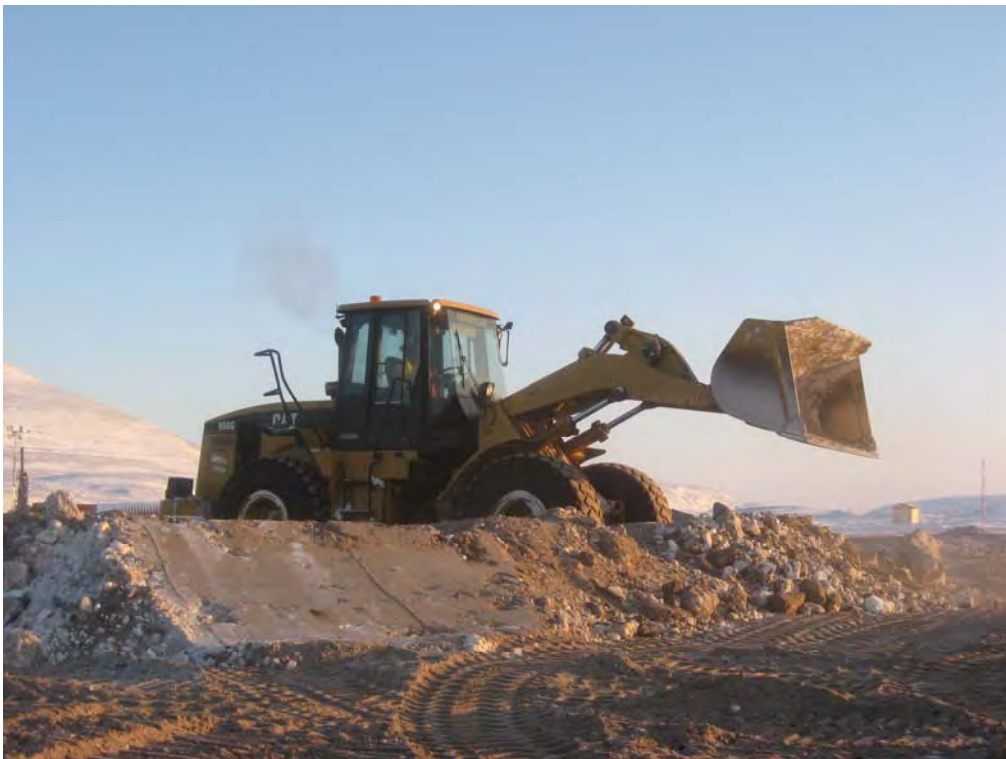
Photo 2: The slopes of the berms are prepared as per the design.

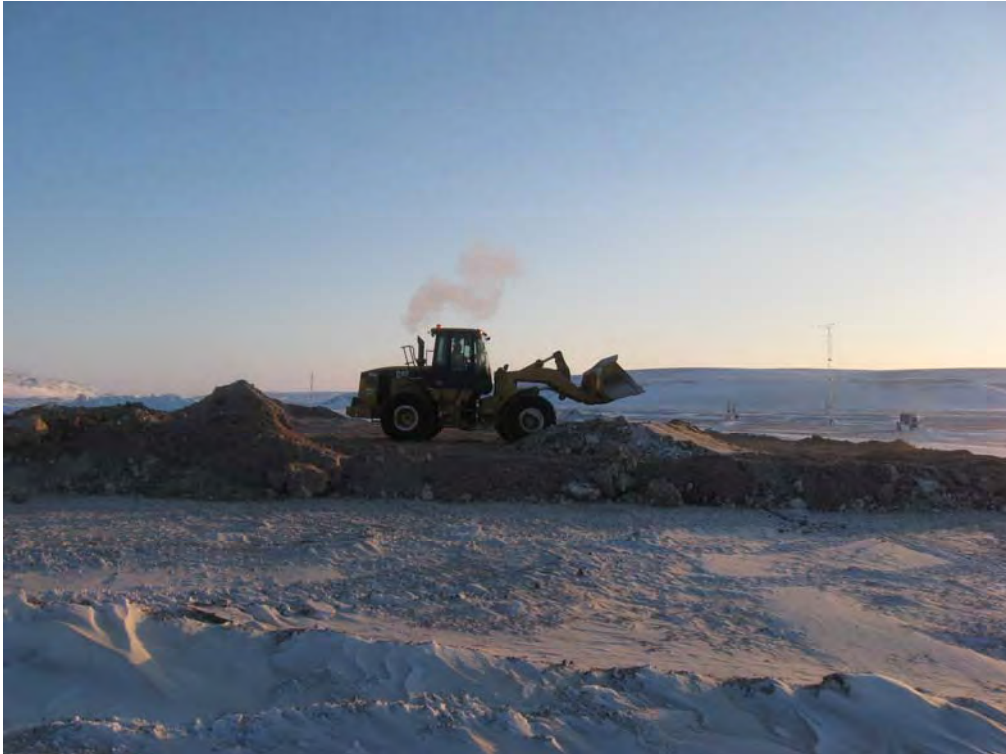
Photo 3: The base of the containment area is being prepared.

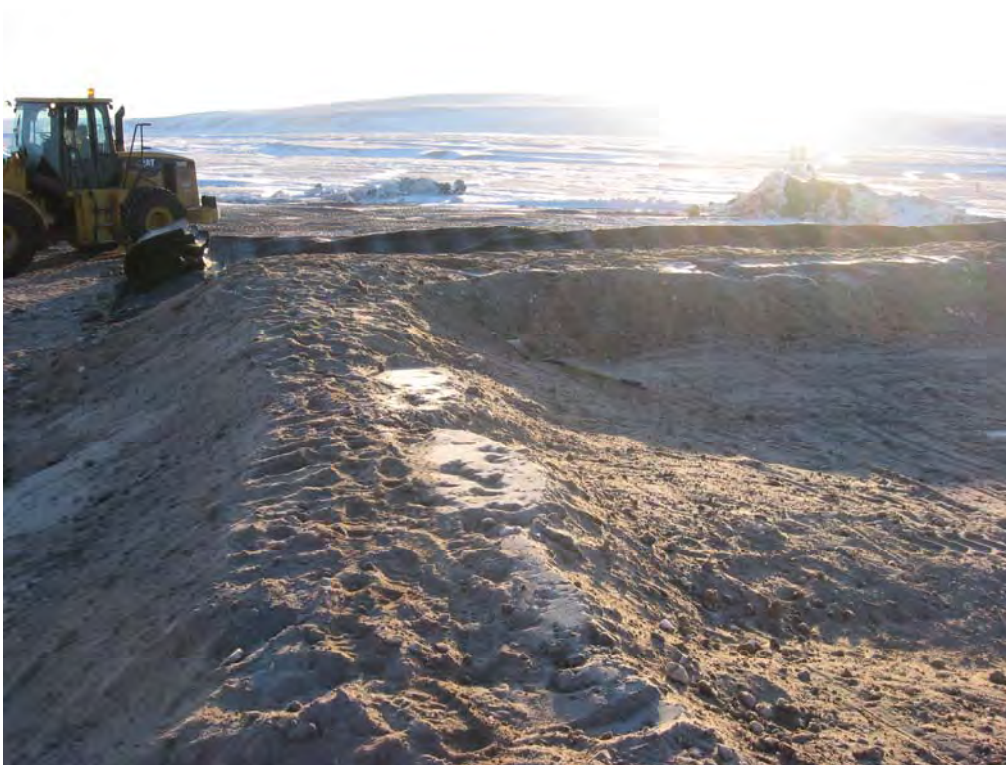
Photo 4: The slopes and the base are ready for the installation of the liner.

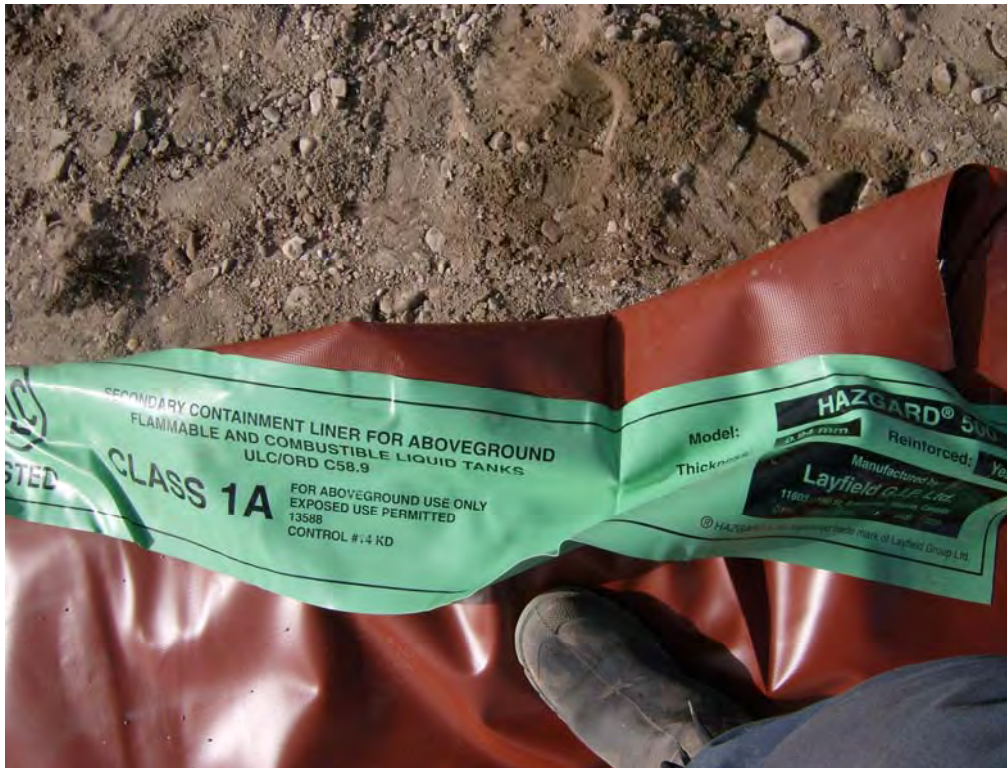
Photo 5: The liner material is shown above.

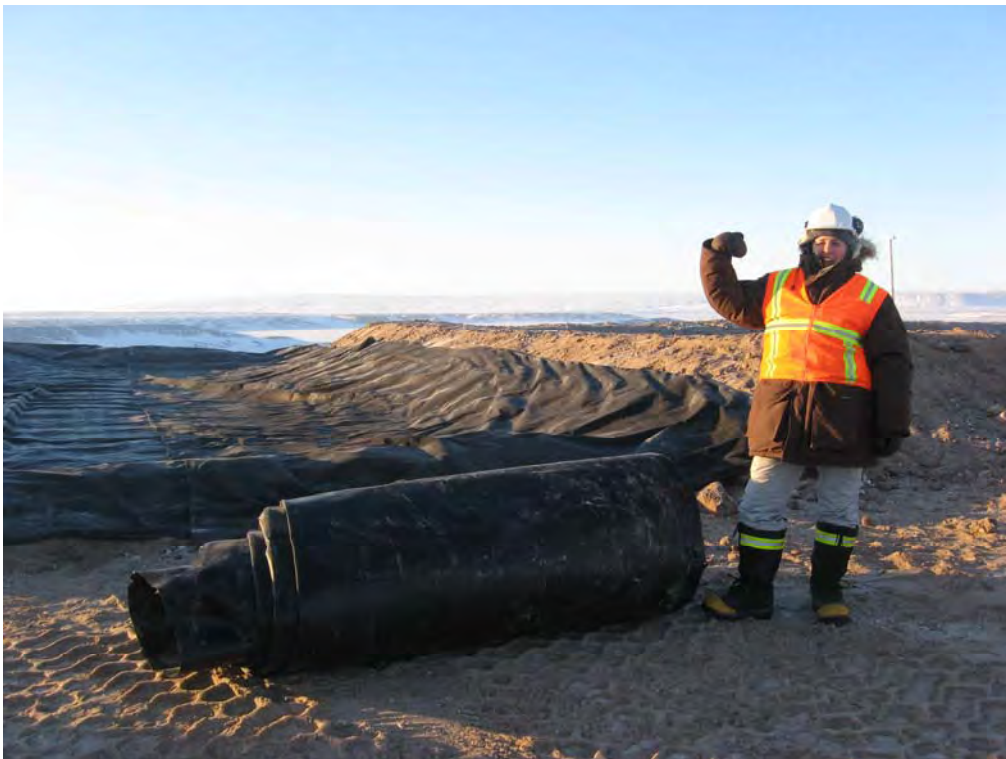
Photo 6: The liner is being installed within the containment and slopes.

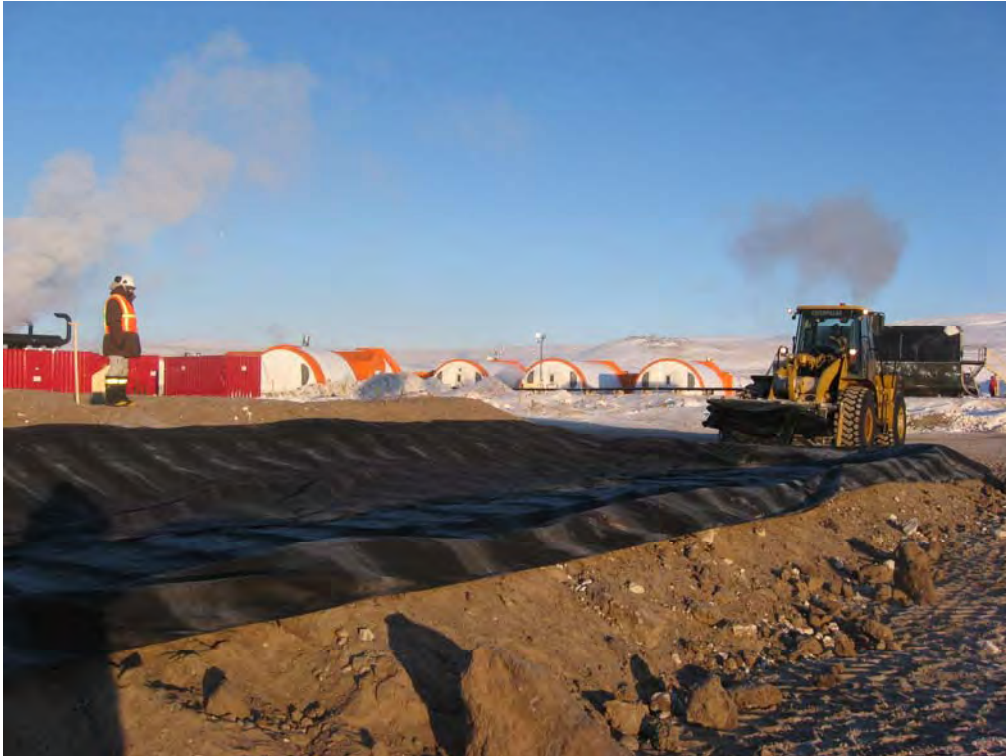
Photo 7: Liner is installed over the slopes. The slopes and the base of the liner will then be protected with appropriate thickness of granular material.

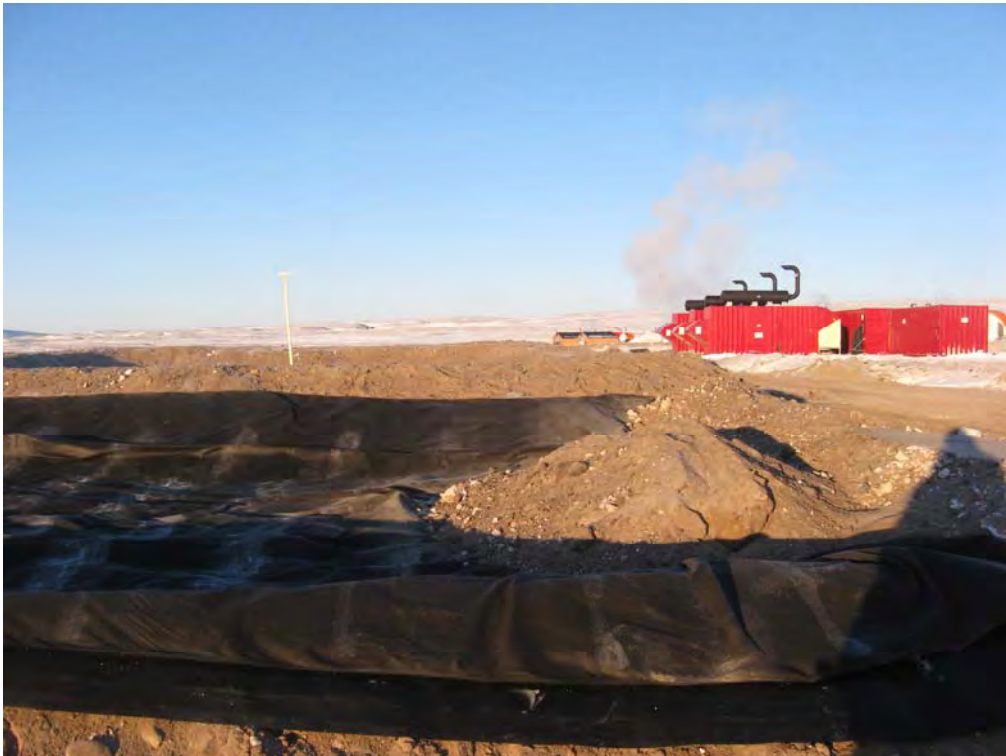
Photo 8: Granular material is being placed over the liner.

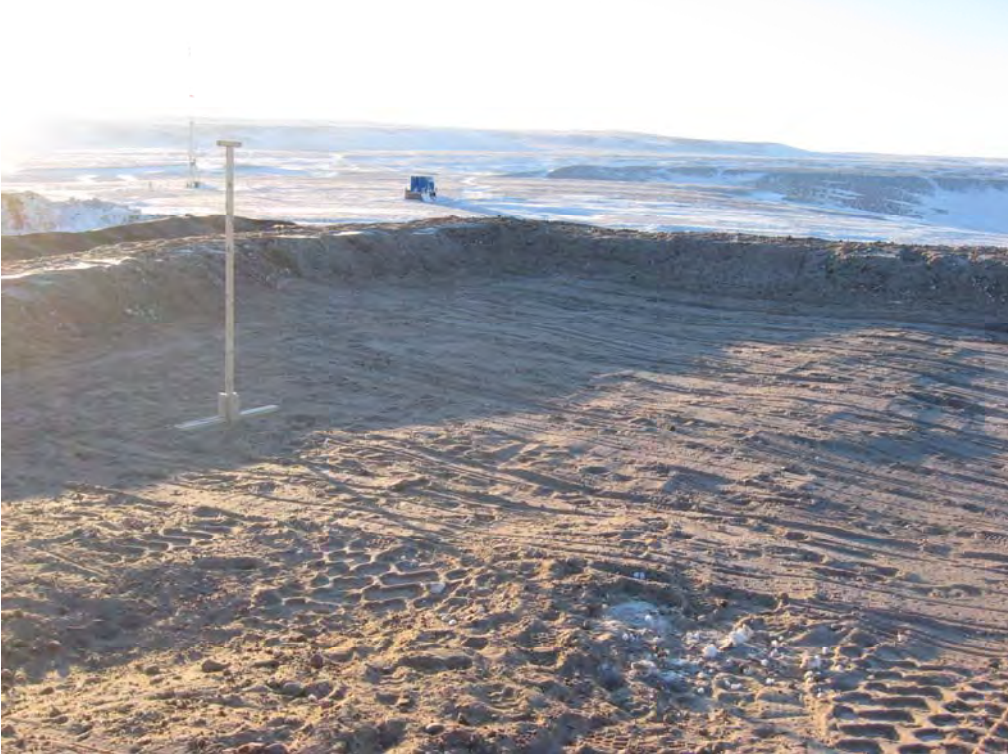
Photo 9: Appropriate amount of cover is being placed over the liner.

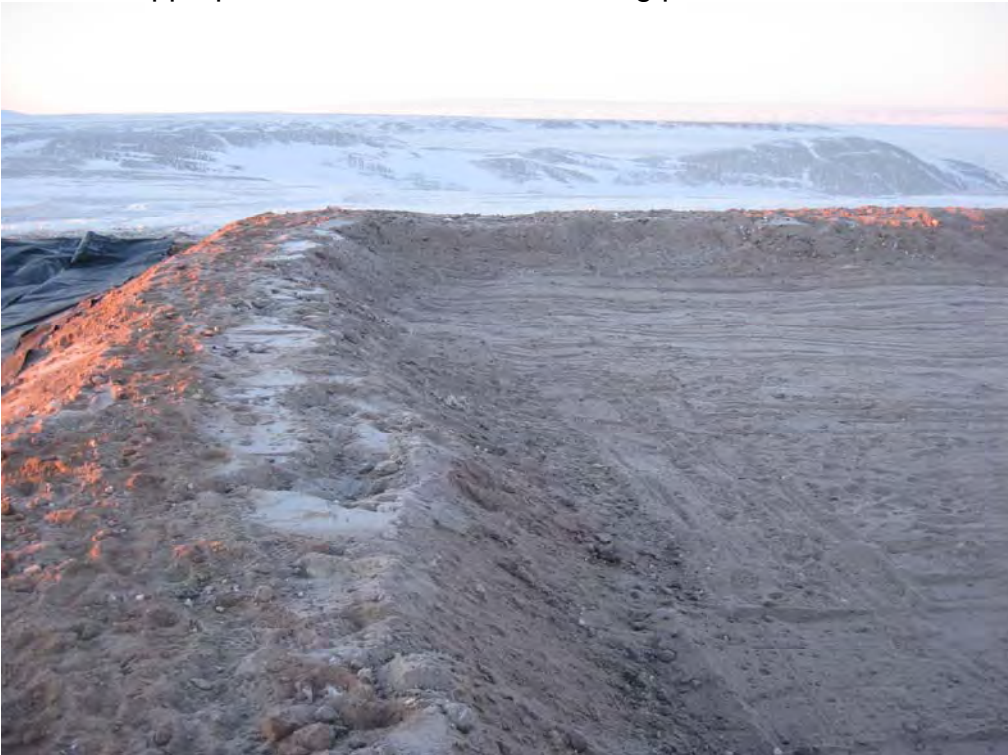
Photo 10: Completed containment is seen above.

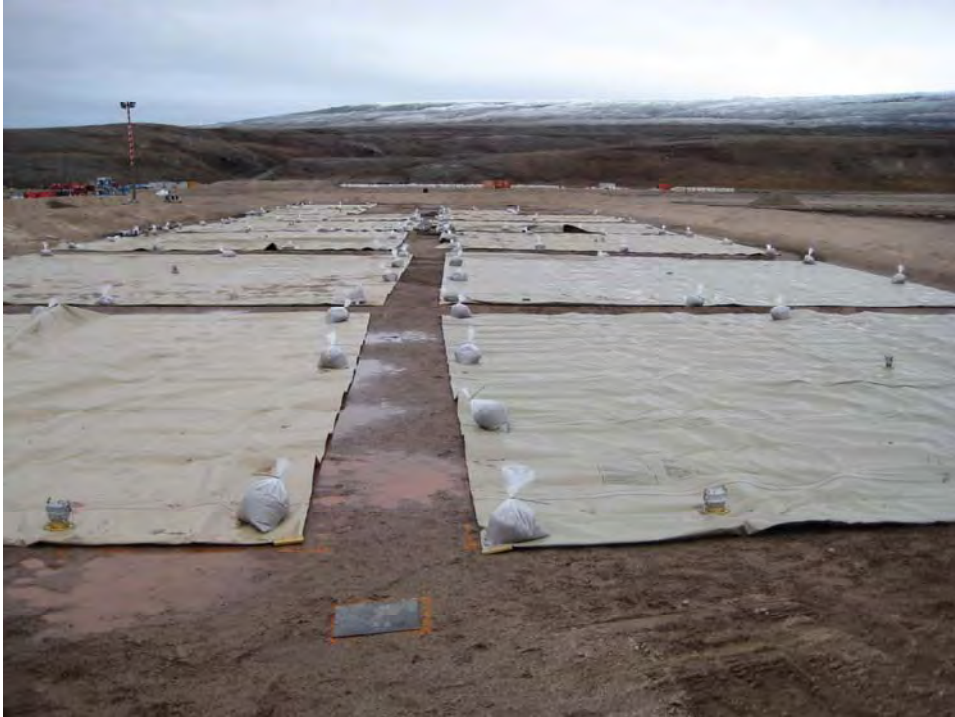
Photo 11: Fuel bladders are placed at their appropriate locations as per the design.

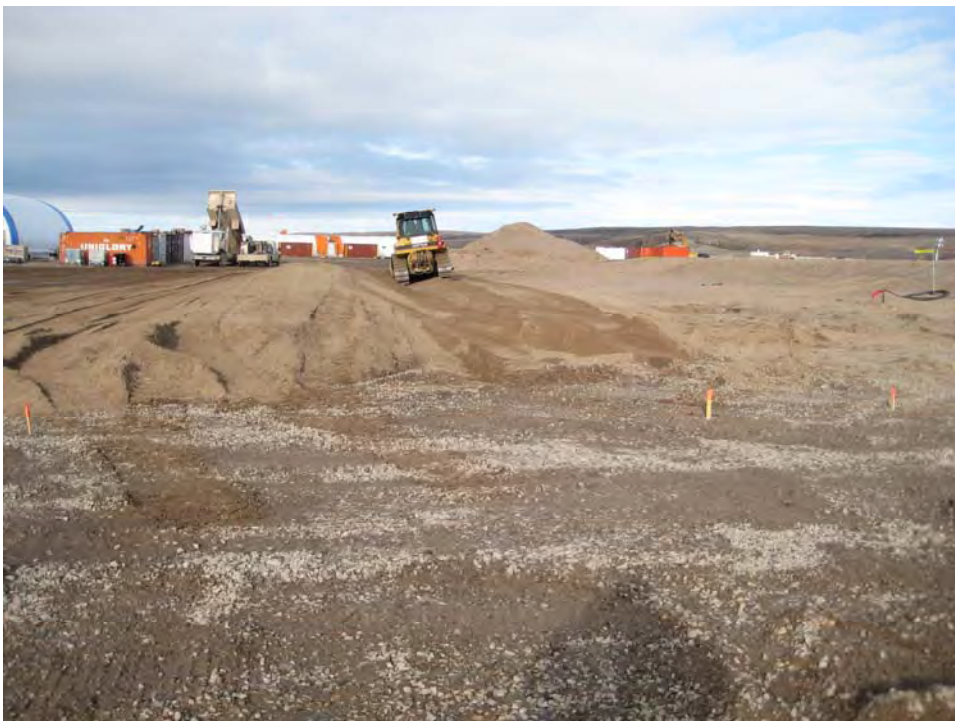
Photo 12: Fuel dispensing area is being prepared.

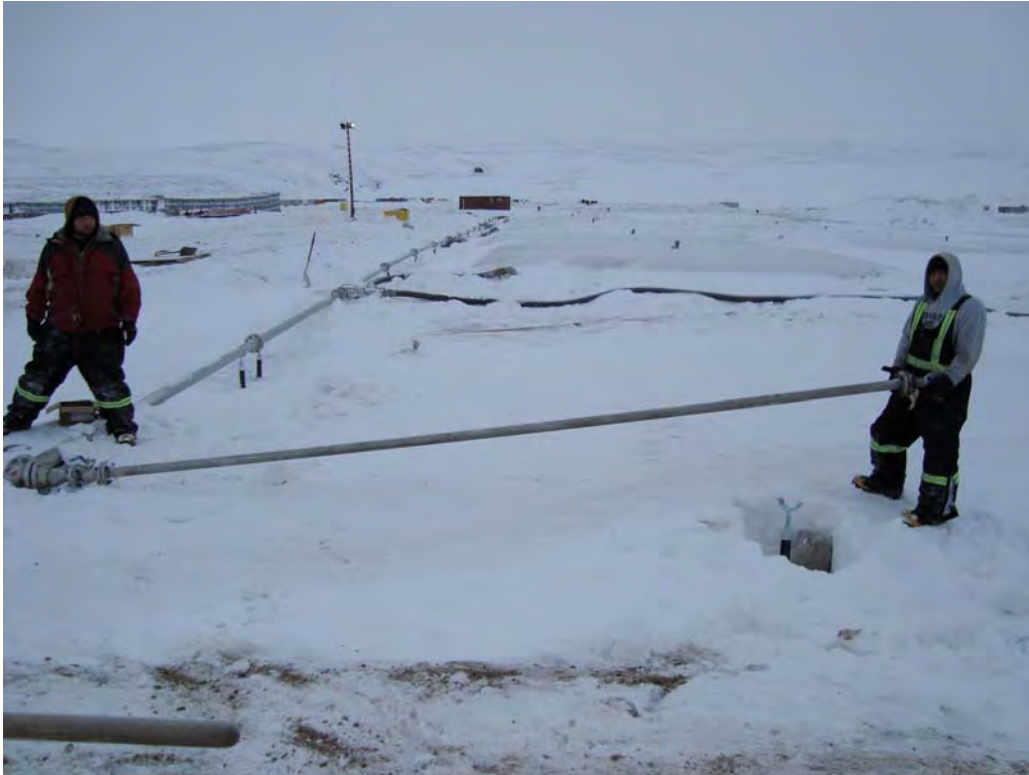
Photo 13: Mechanical crew installing the piping as per the design by SEI.

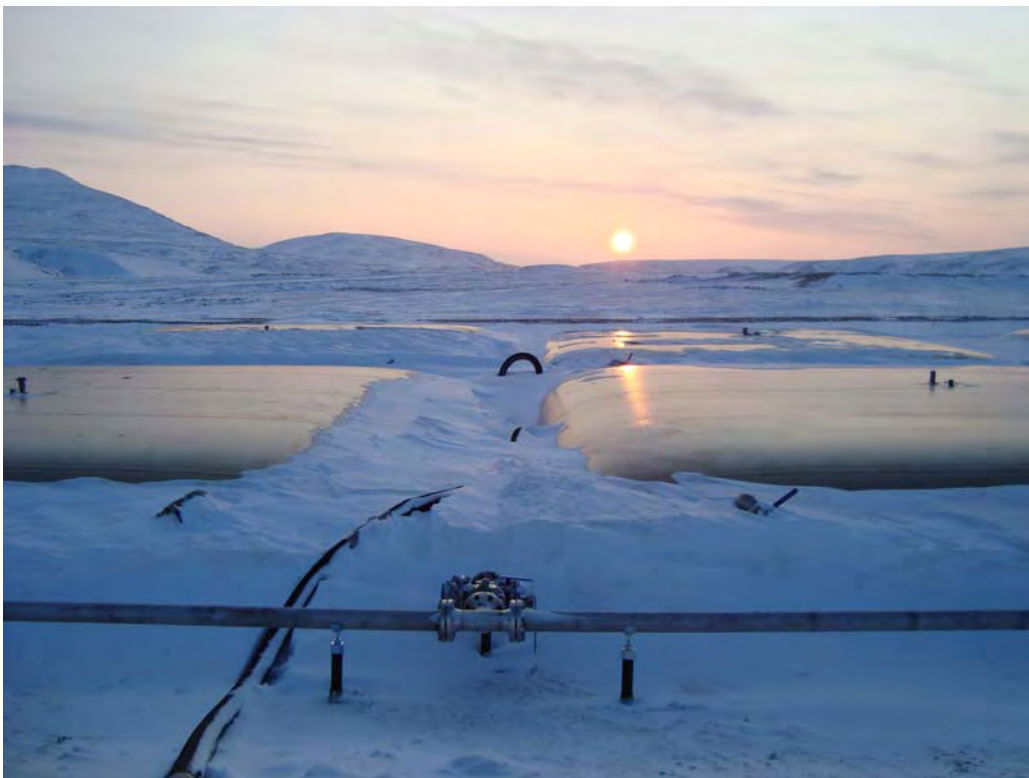
Photo 14: Bulk Fuel Storage Facility at completion.
