## September 30, 2018 WTP Road

GN reference # : 2018-408

### Spill Description

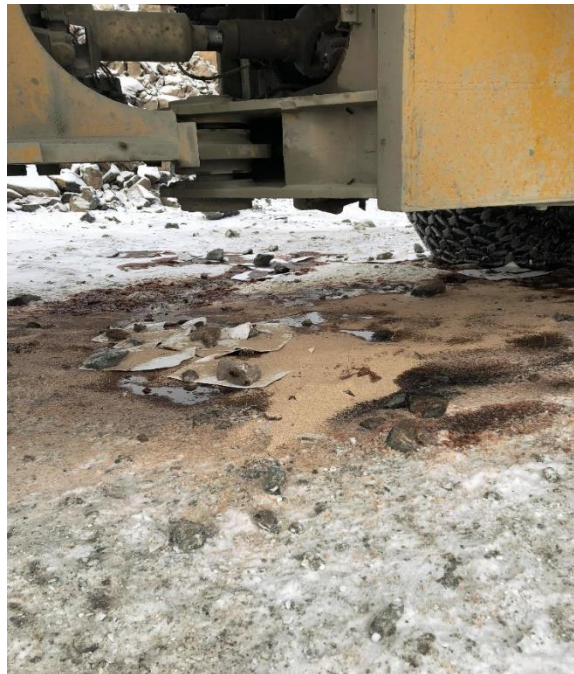
During operations at Quarry 35 along WTP road, a loose solenoid on the hydraulic pump caused oil to spill on the ground.

There were no off site impact or discharge to any receiving watercourses. The distance to the closest lake is estimated at 200 meters.

A solenoid on the hydraulic system pump of a loader working at Quarry 35 along the WTP road came loose causing hydraulic oil to spill on the ground.

Regular pre-operation checks are completed on equipment also including visual inspection of the hydraulic systems.
