## September 30, 2018 WTP Road

GN reference # : 2018-410

Please find the following information as a follow up to the Spill report submitted September 30<sup>th</sup>, 2018 by Agnico Eagle Meadowbank division. This detailed report is submitted to the Inspector in compliance with the conditions under the Nunavut Water Board License 2BC-WTP1819, Part G, Item 5c.

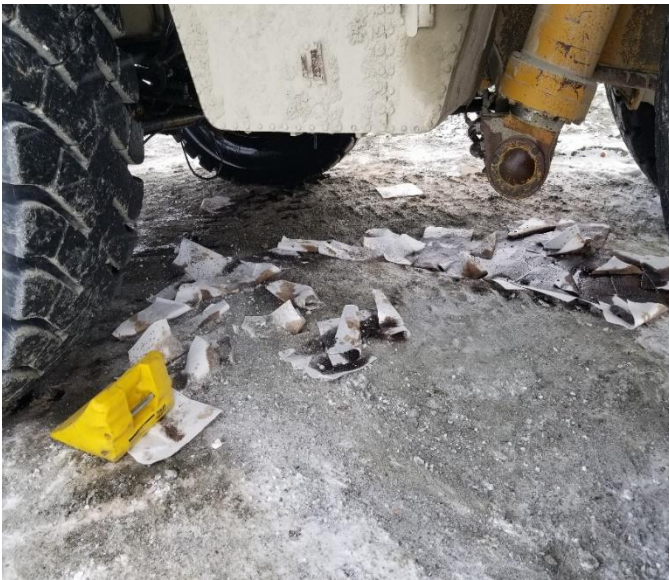
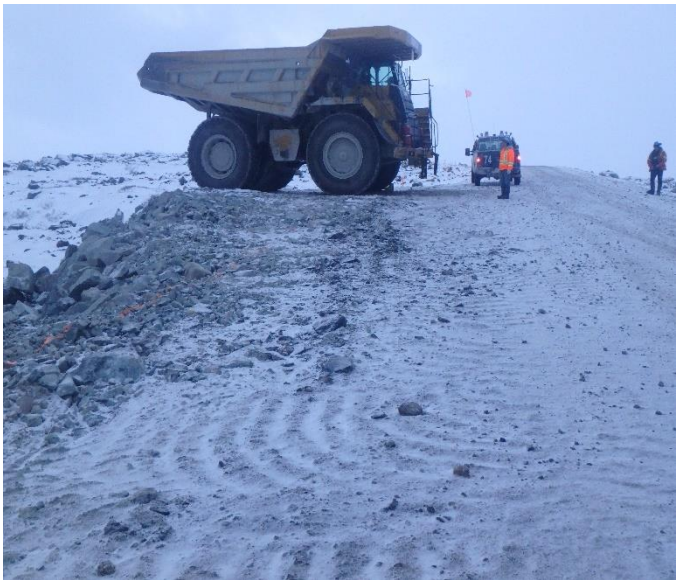
While parked on the WTP road, the hydraulic pump on a haul truck failed causing oil to leak on the ground.

There were no off site impact or discharge to any receiving watercourses. The distance to the closest lake is estimated at 180 meters.

Hydraulic pump failed on a Haul truck on the WTP road causing hydraulic oil to spill on the ground.

The equipment was immediately stopped. Absorbent pads were laid out to contain the spill on the ground. Once the truck was fixed and moved out of the area, the ground was scrapped clean and contaminated material was brought to the Meadowbank Landfarm area.

Regular pre-operation checks are completed on equipment also including visual inspection of the hydraulic systems.
