NT-NU SPILL REPORT

Kivalliq Energy Corp.
Photo Document to accompany June 23, 2014 NU Spill Report

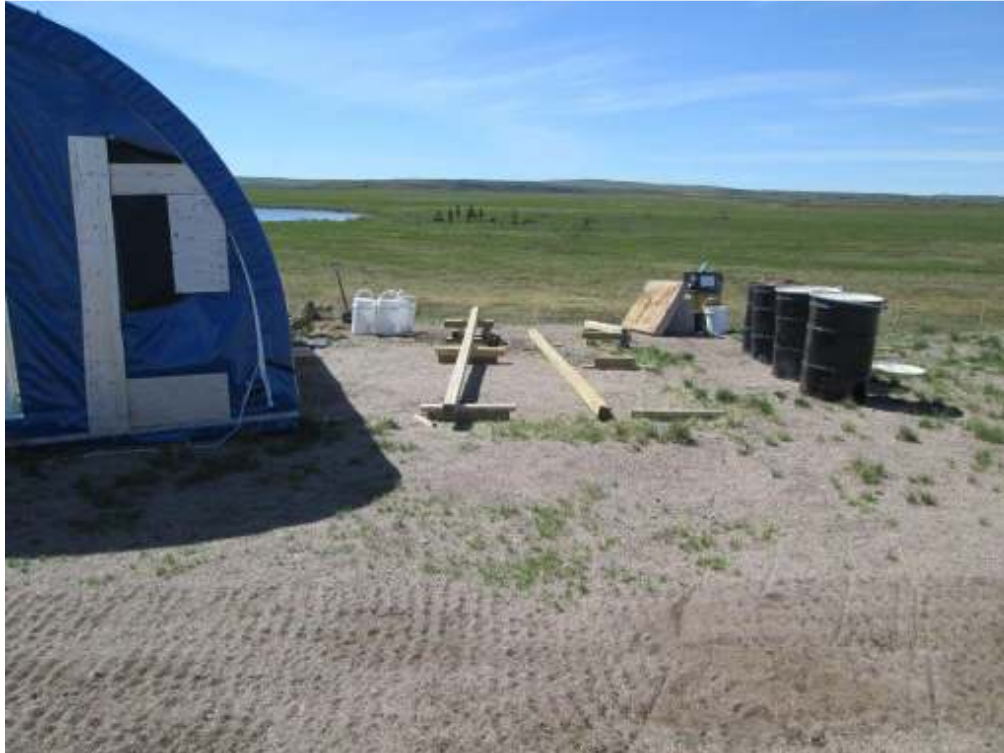
Photo 1: Tent W5 Shifted 4m South From Tent Footings (note: Nutaag Lake 200m West)

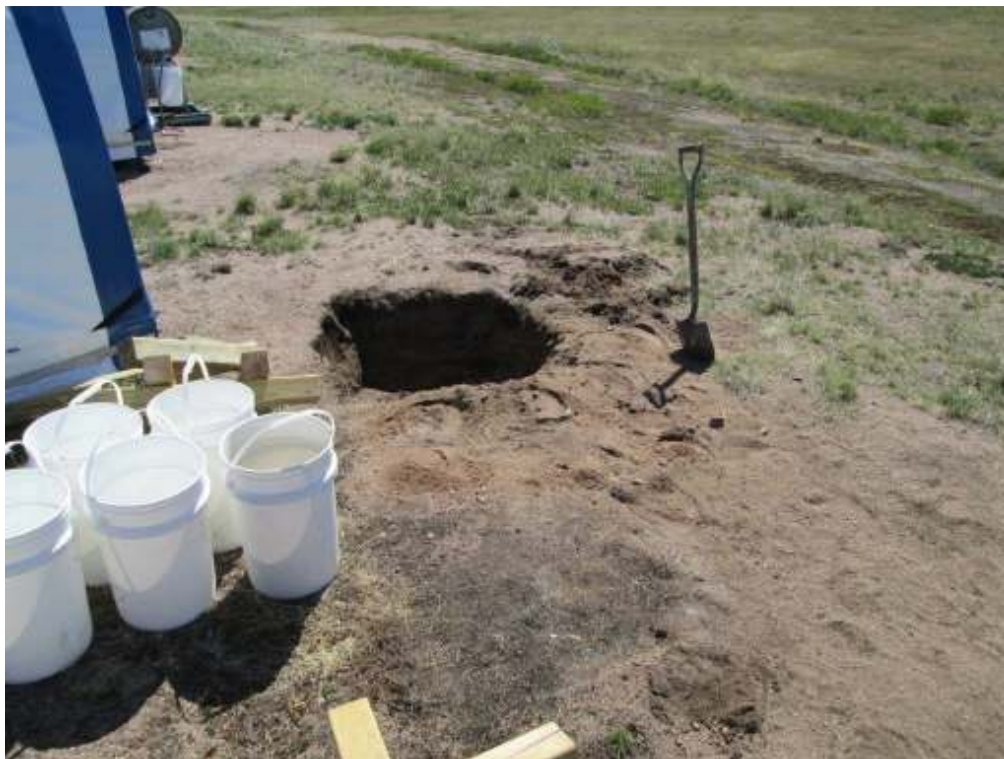
Photo 2: Spill Location and Excavated Pit

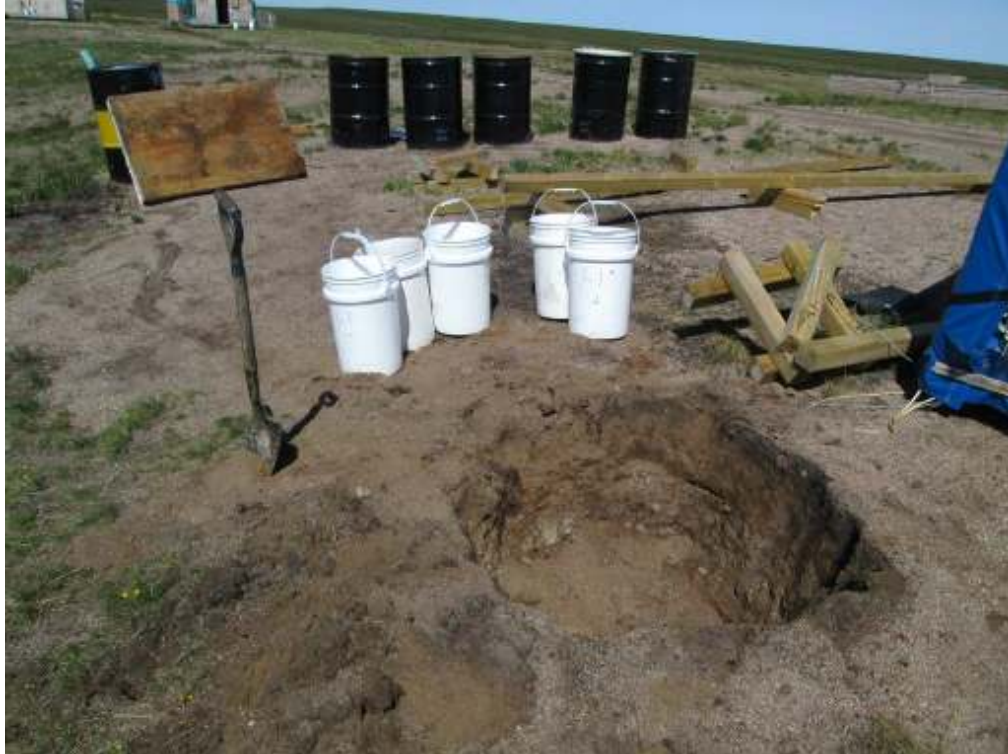
Photo 3: Excavated Pit behind Tent W5 & Toppled Tent Footings

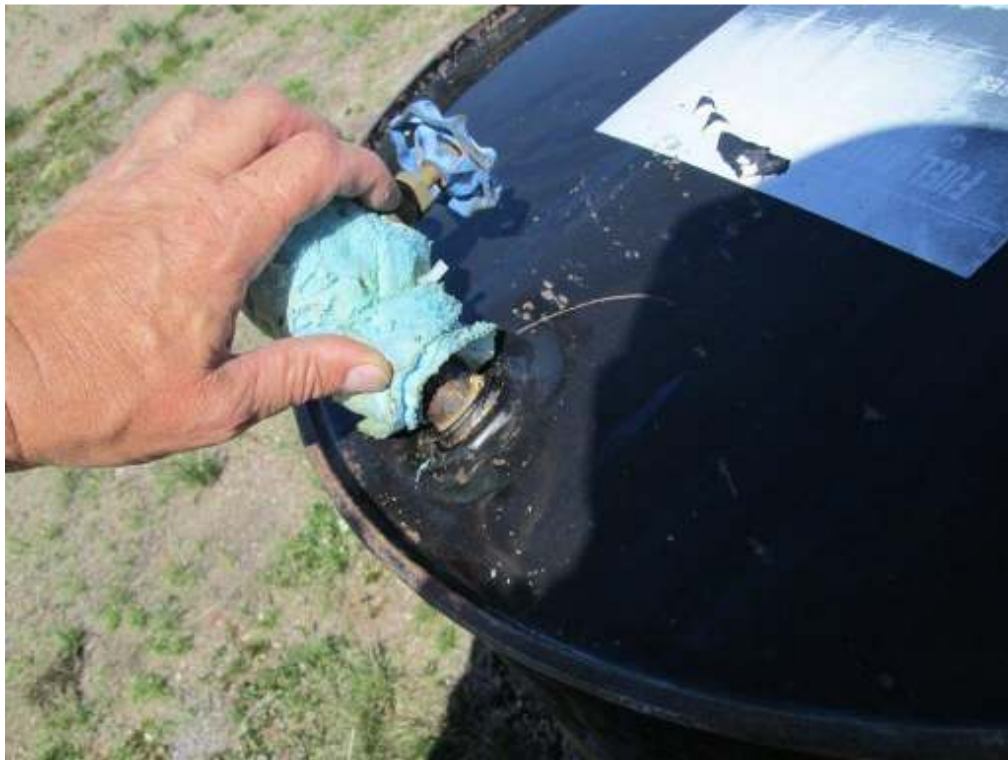
Photo 4: Broken Valve on Fuel Drum
