Photos of Inspection

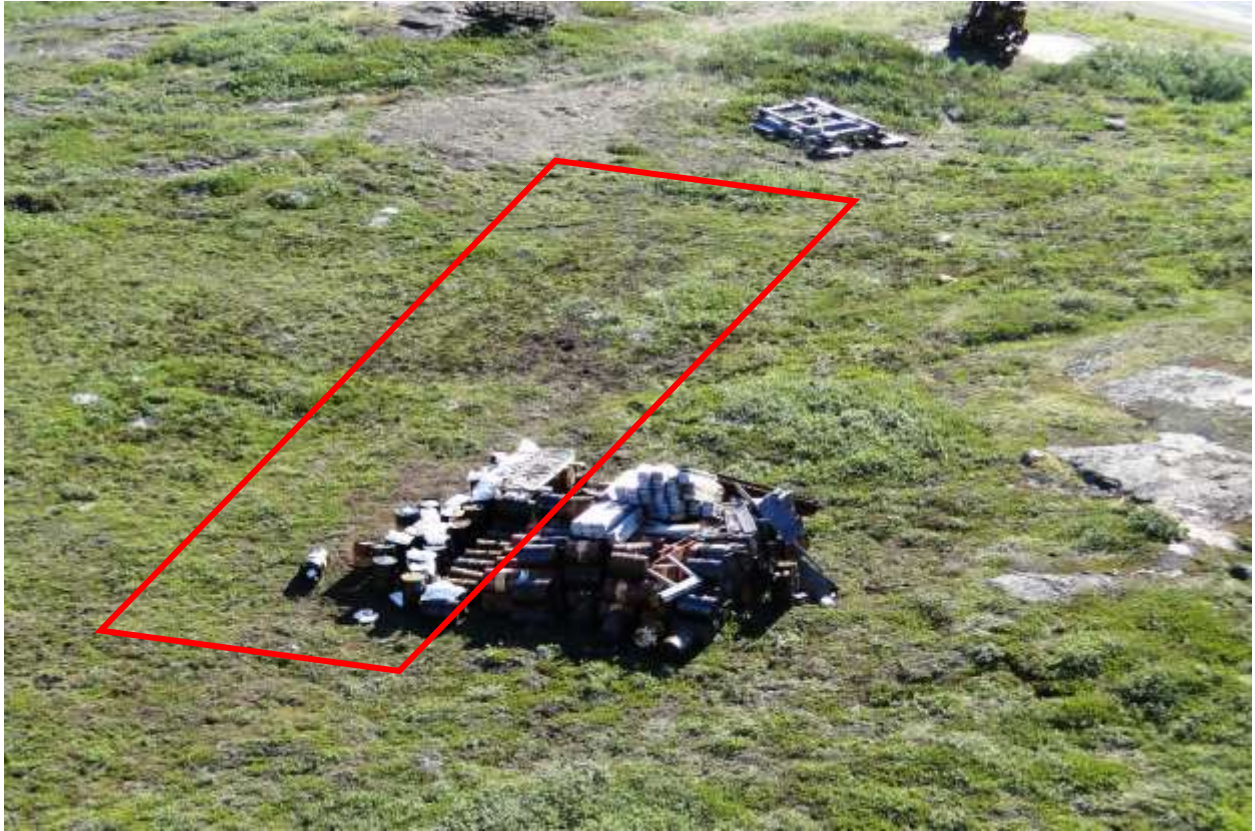
Figure 1. Staging area / Barge area found at **N67°44'29.8" W111°22'07.4"**

Figure 1 shows the main waste pile at the barge area. Barrels on the left are punctured, open, or at risk of leaking. Salt bags are at varying stages of dissolution. Vegetation is heavily impacted and the impacts are migrating downhill.

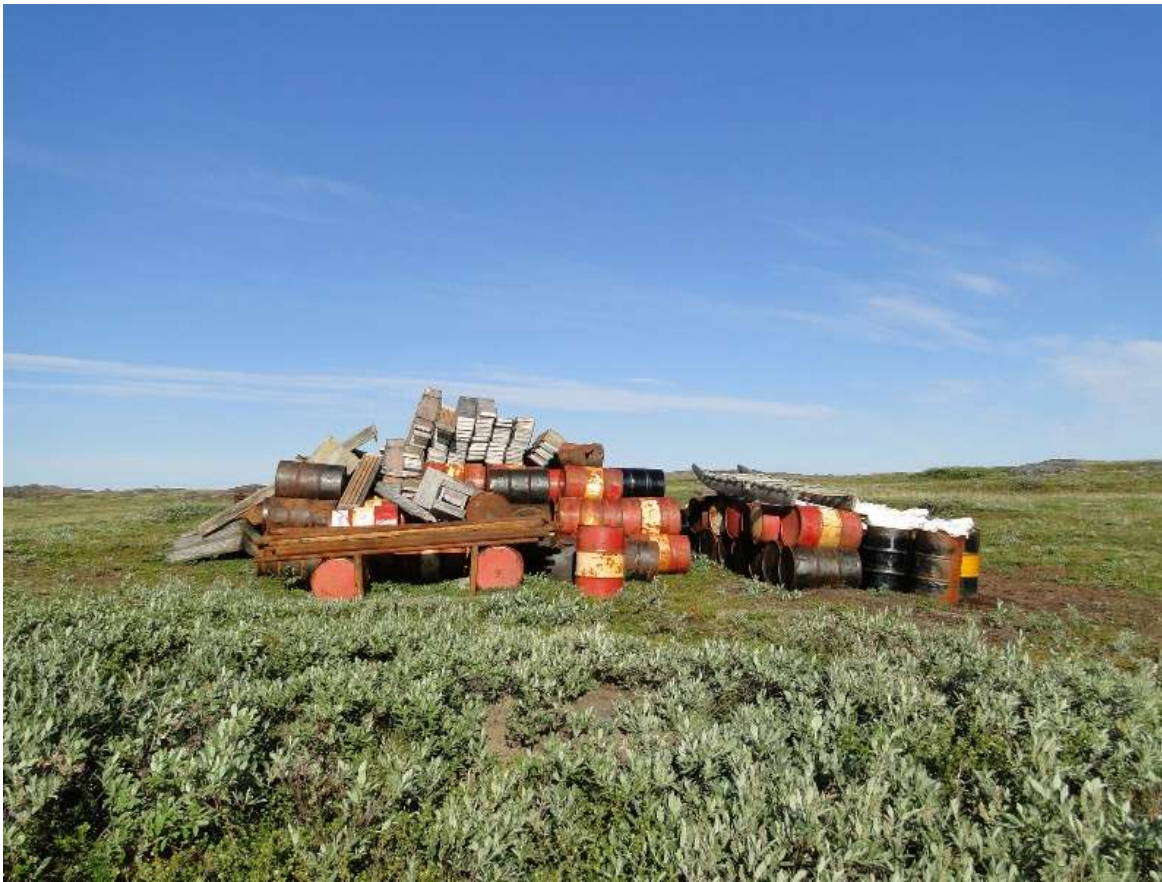
Figure 2. Front view of waste pile. Barrels on left mostly empty (not all). Barrels on right mostly full or leaking.

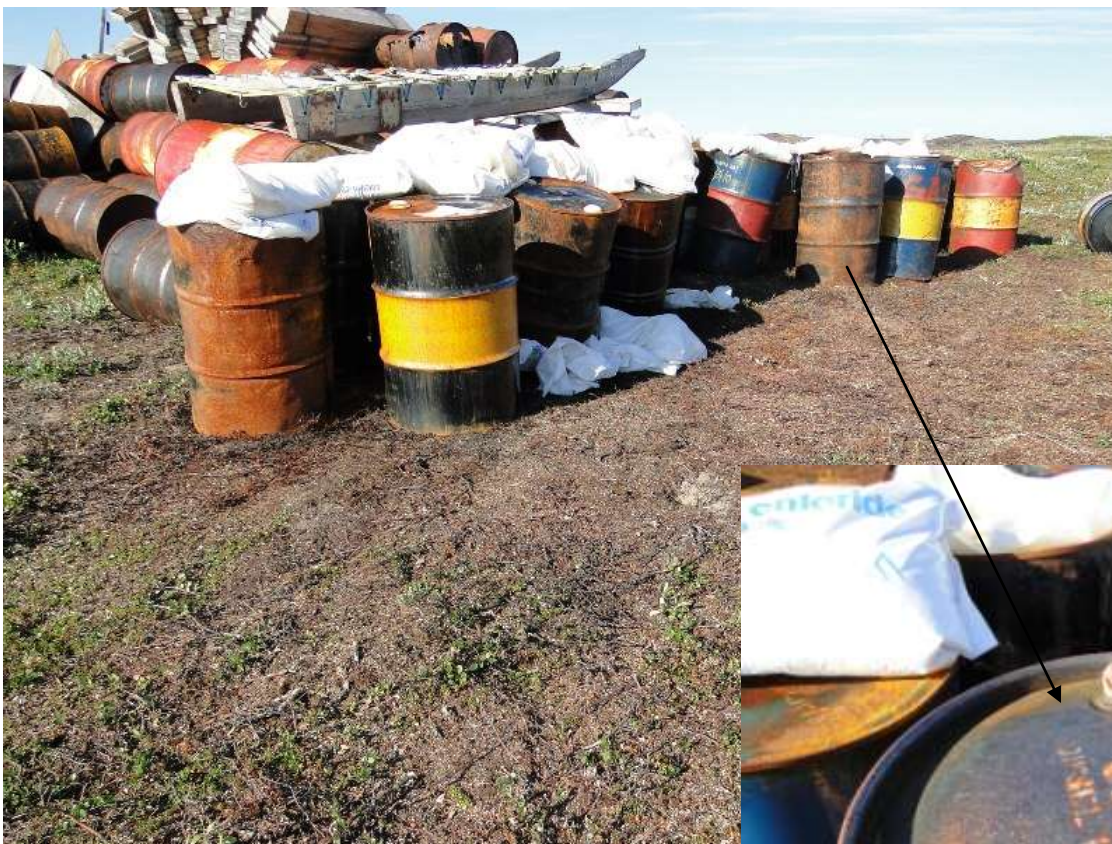
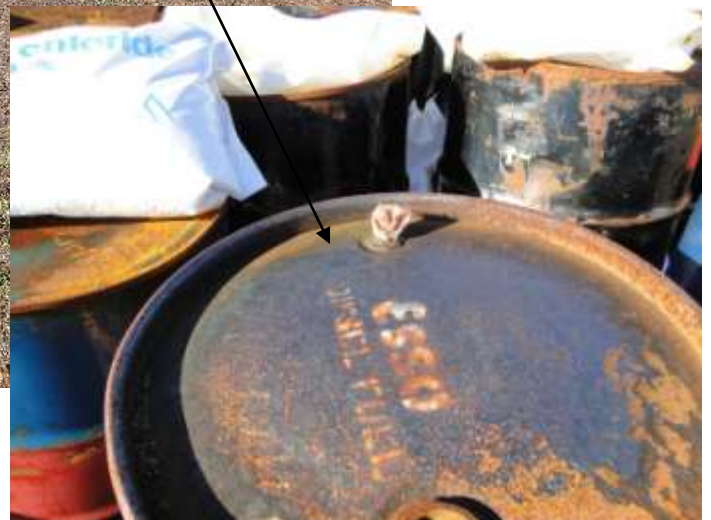
Figure 3. Shows characteristic red of salt-burned vegetation.

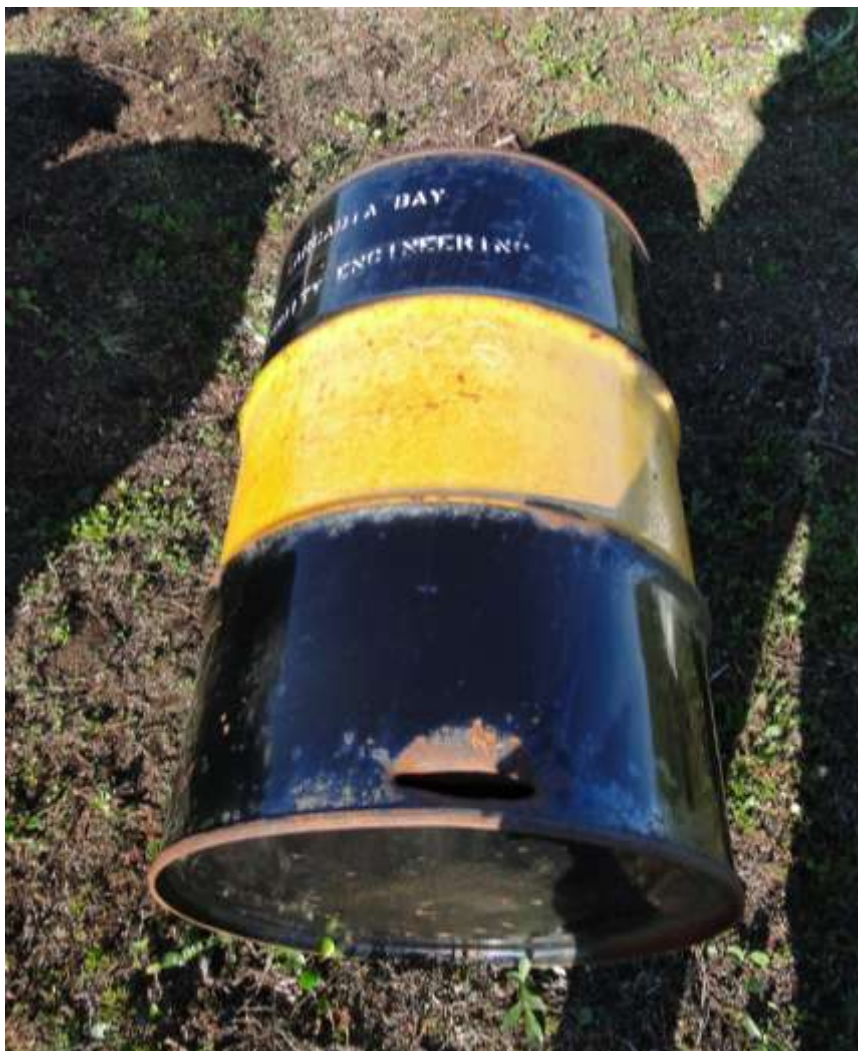
Figure 4. Punctured drum - still half-full of fuel. [117324.2]

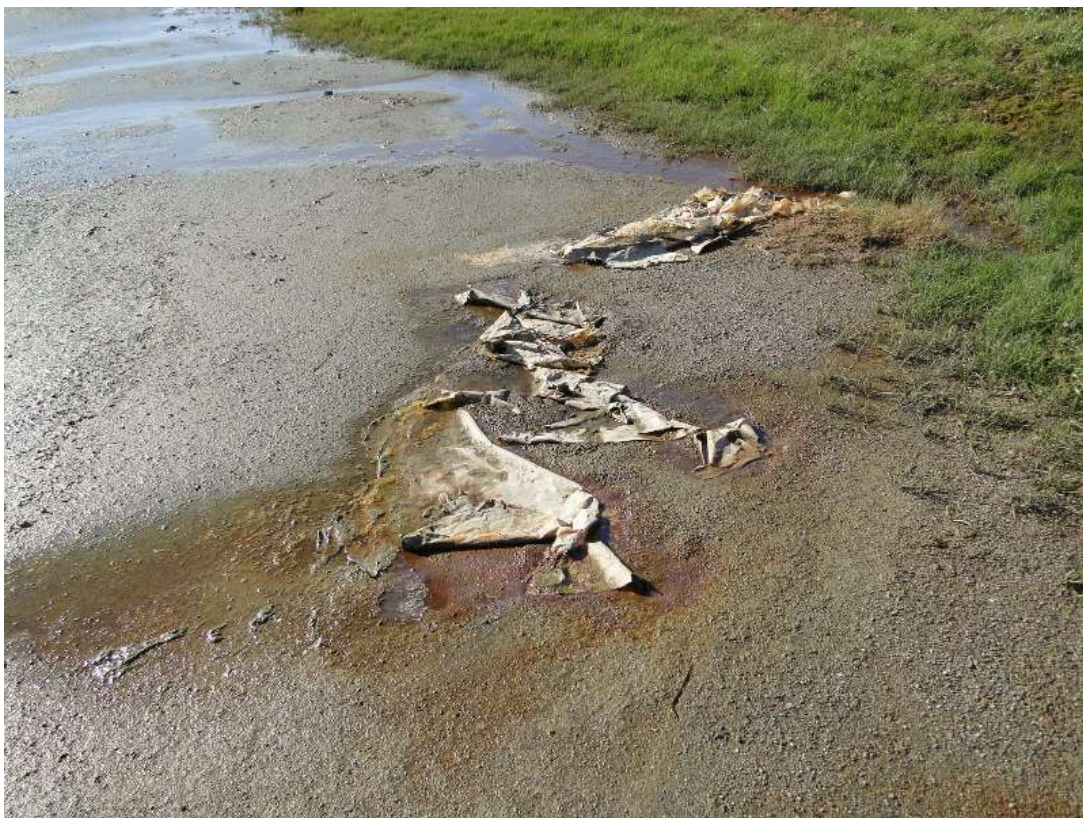
Figure 5. Staining on the shore downhill from waste. Water sampling tested positive for Hexane Extractable Materials.

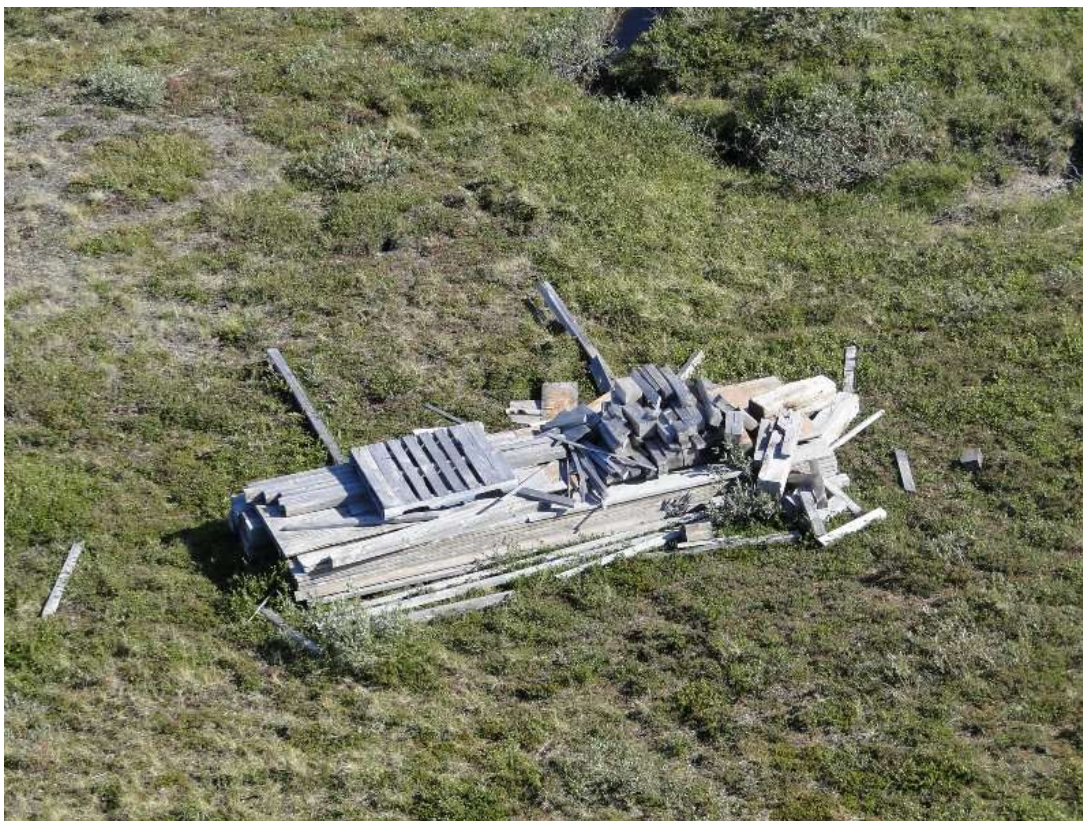
Figure 6. Wooden timbers from drill program found at drill coordinates provided in annual report. N67°42'52" W111°21'49"

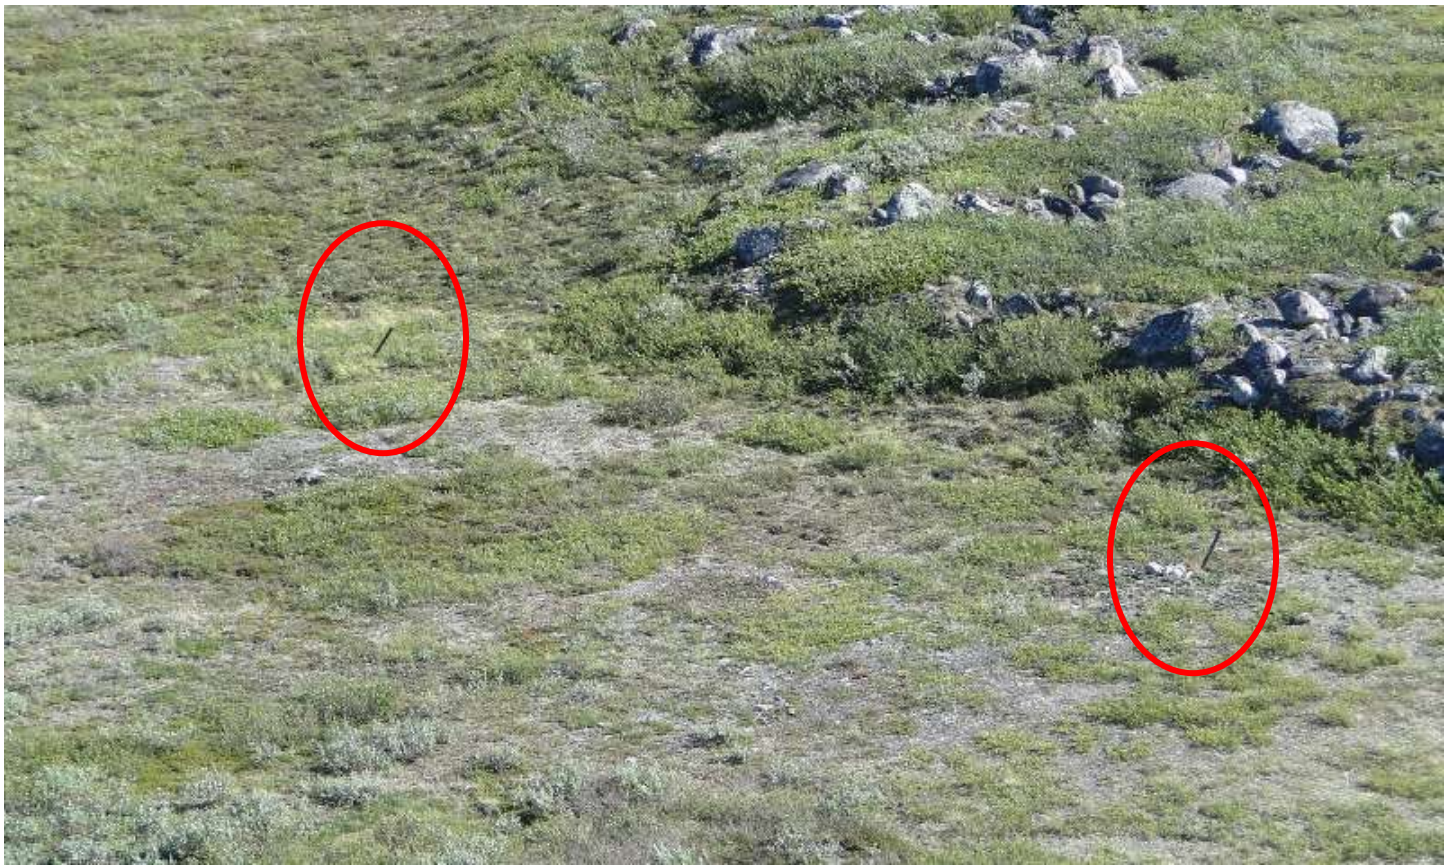
Figure 7. Drill sites appear clean, but casing needs to be removed or cut off as per licence.

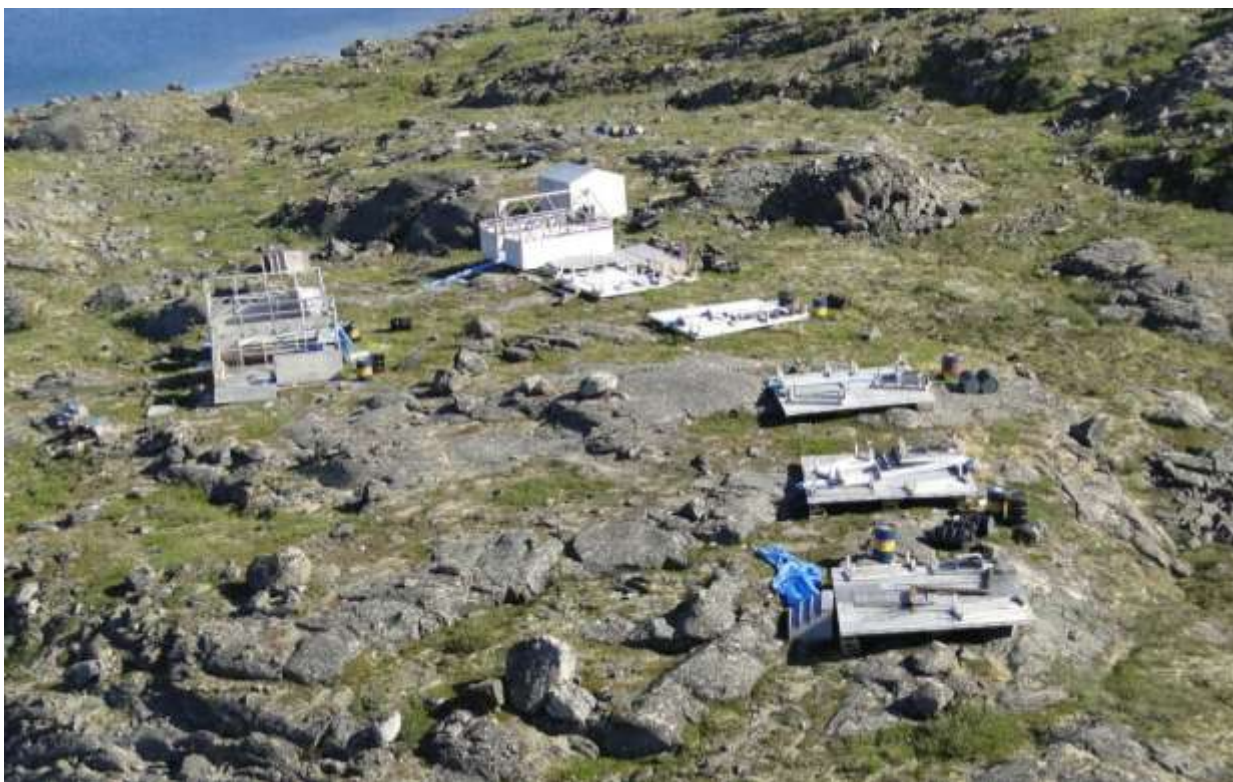
Figure 8. Camp structures have weathered fairly well; fuel stock has not.

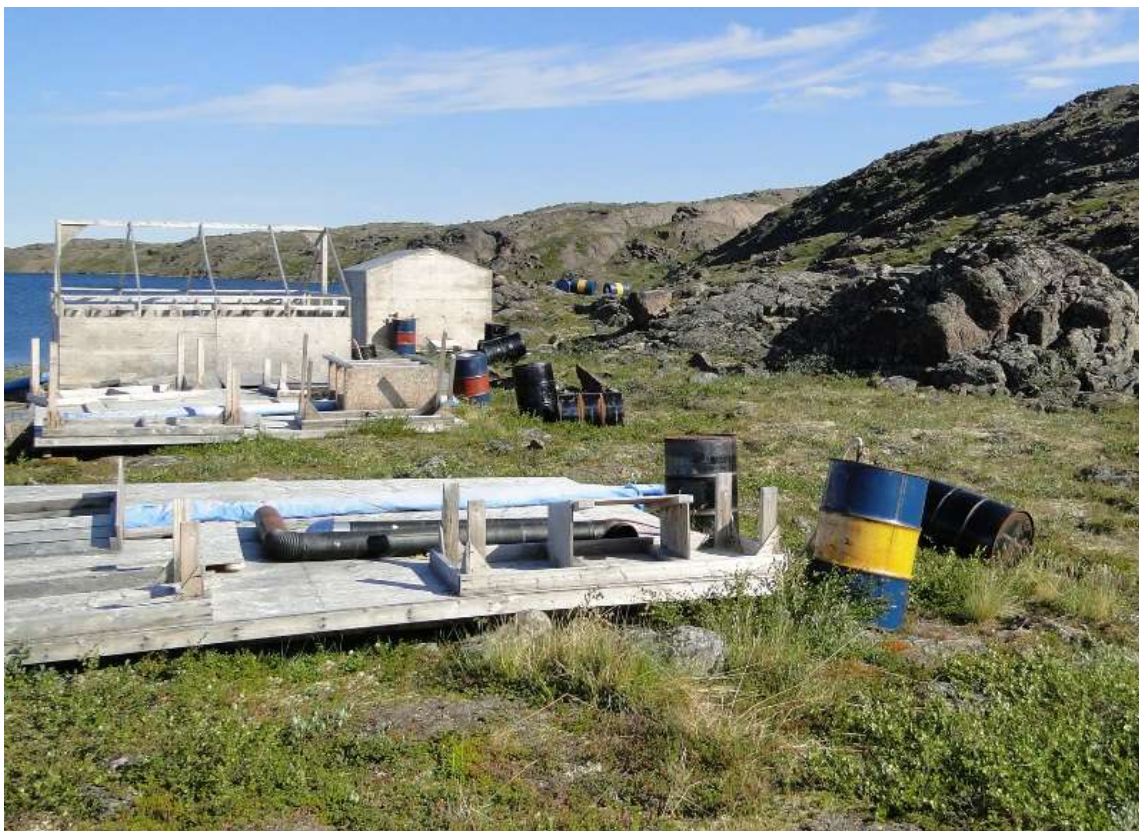
Figure 9. No secondary containment was used on-site; many barrels have leaked over time.

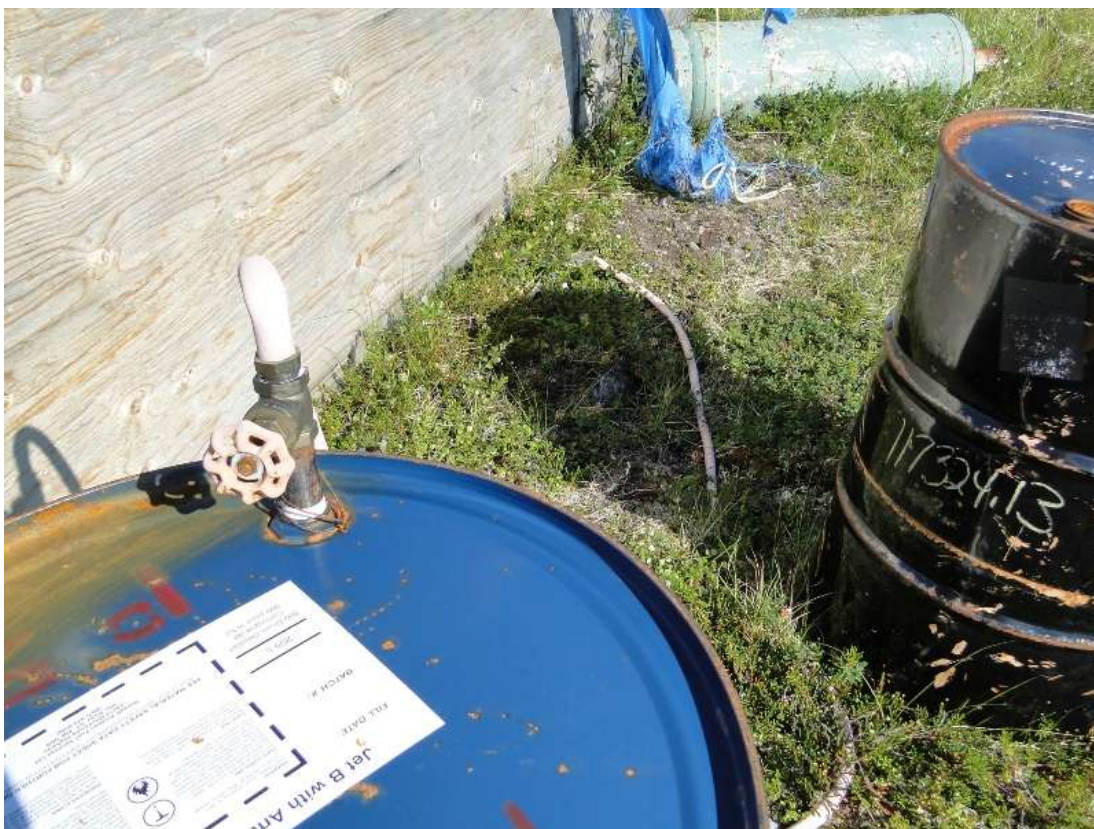
Figure 10. Hoses left on drums, propane tanks fallen over, no containment of barrels. [117324.13]

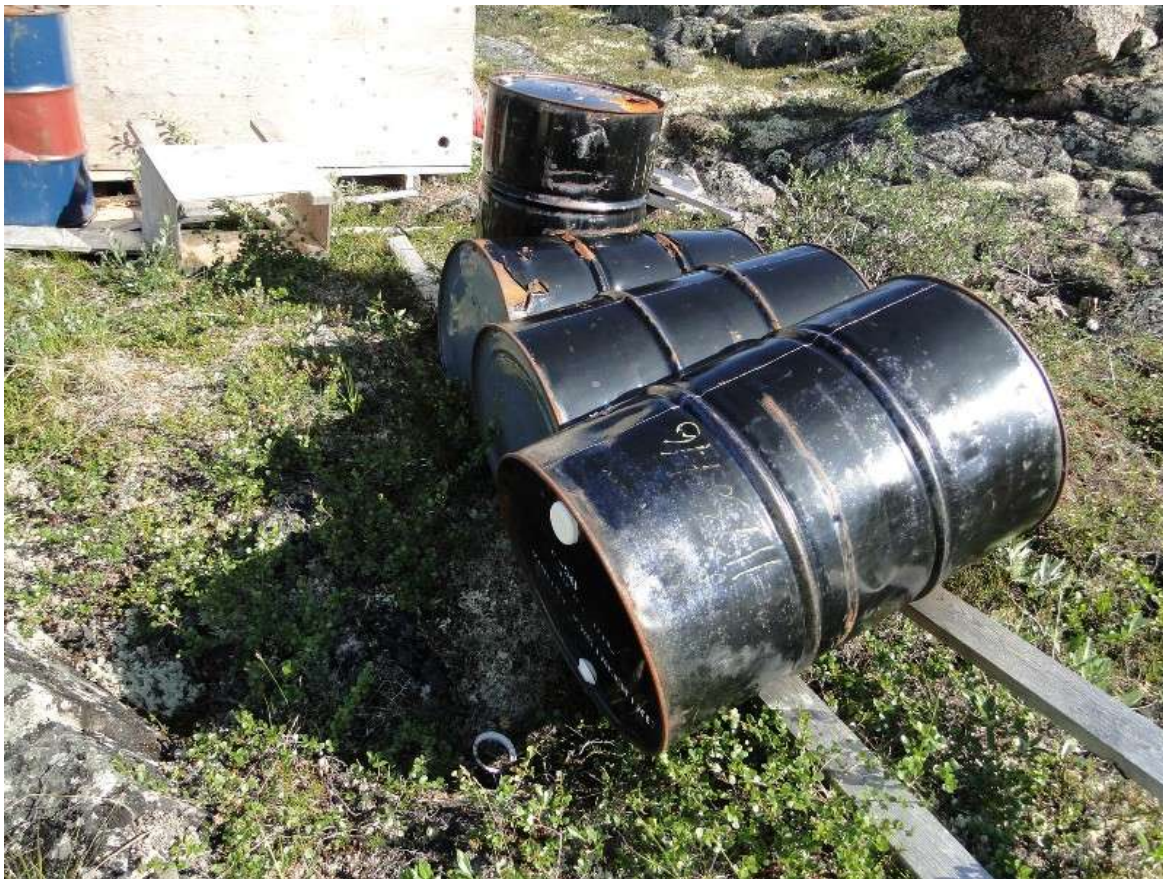
Figure 11. Drums, tilted downward, at risk of leaking.

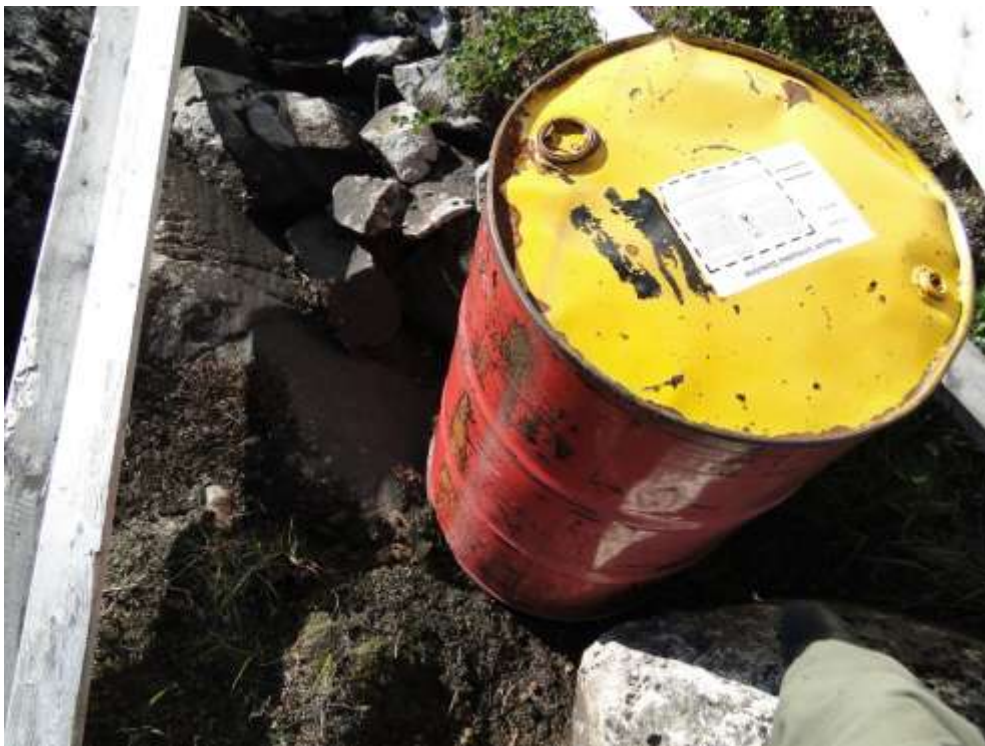
Figure 12. I righted this barrel, but it is now empty, and the contamination of the ground is evident.

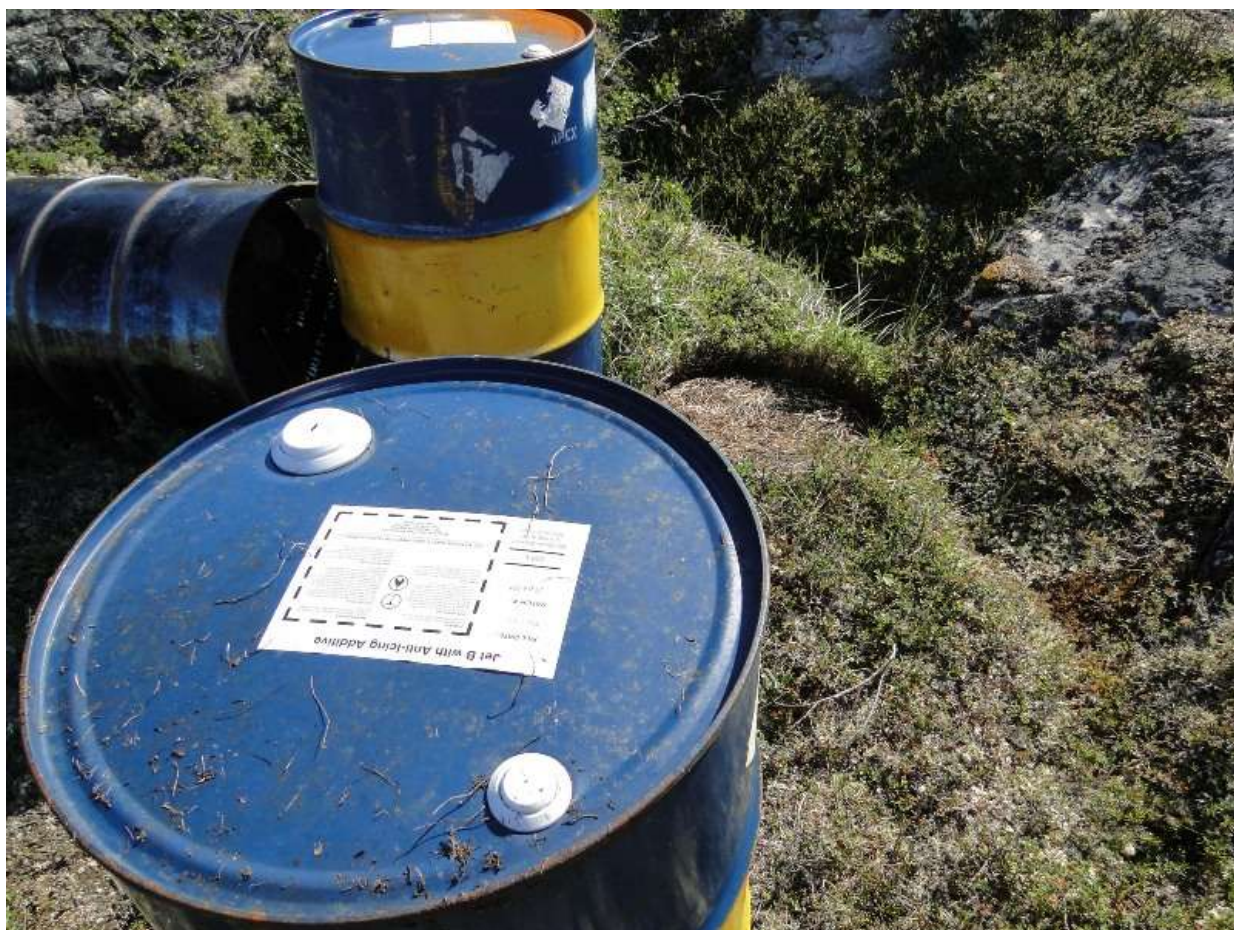
Figure 13. This barrel was upside-down, with caps on, and is now empty.
