WATER LICENCE INSPECTION FORM

Licensee		Licensee Representative	
Alix Resources Corp.		Mike England	
Licence No. / Expiry		Representative's Title	
2BE-ARC0813 (expired)		President & Director	
Land / Other Authorizations		Land / Other Authorizations	
Date of Inspection		Inspector	
07/07/2016		Eva Paul	
Activities Inspected			
<input checked="" type="checkbox"/> Camp	<input checked="" type="checkbox"/> Drilling	<input type="checkbox"/> Mining	<input type="checkbox"/> Construction
<input type="checkbox"/> Roads/Hauling	<input checked="" type="checkbox"/> Other: Trenching	<input type="checkbox"/> Reclamation	<input checked="" type="checkbox"/> Fuel Storage
<input type="checkbox"/> Other:

PHOTO LOG

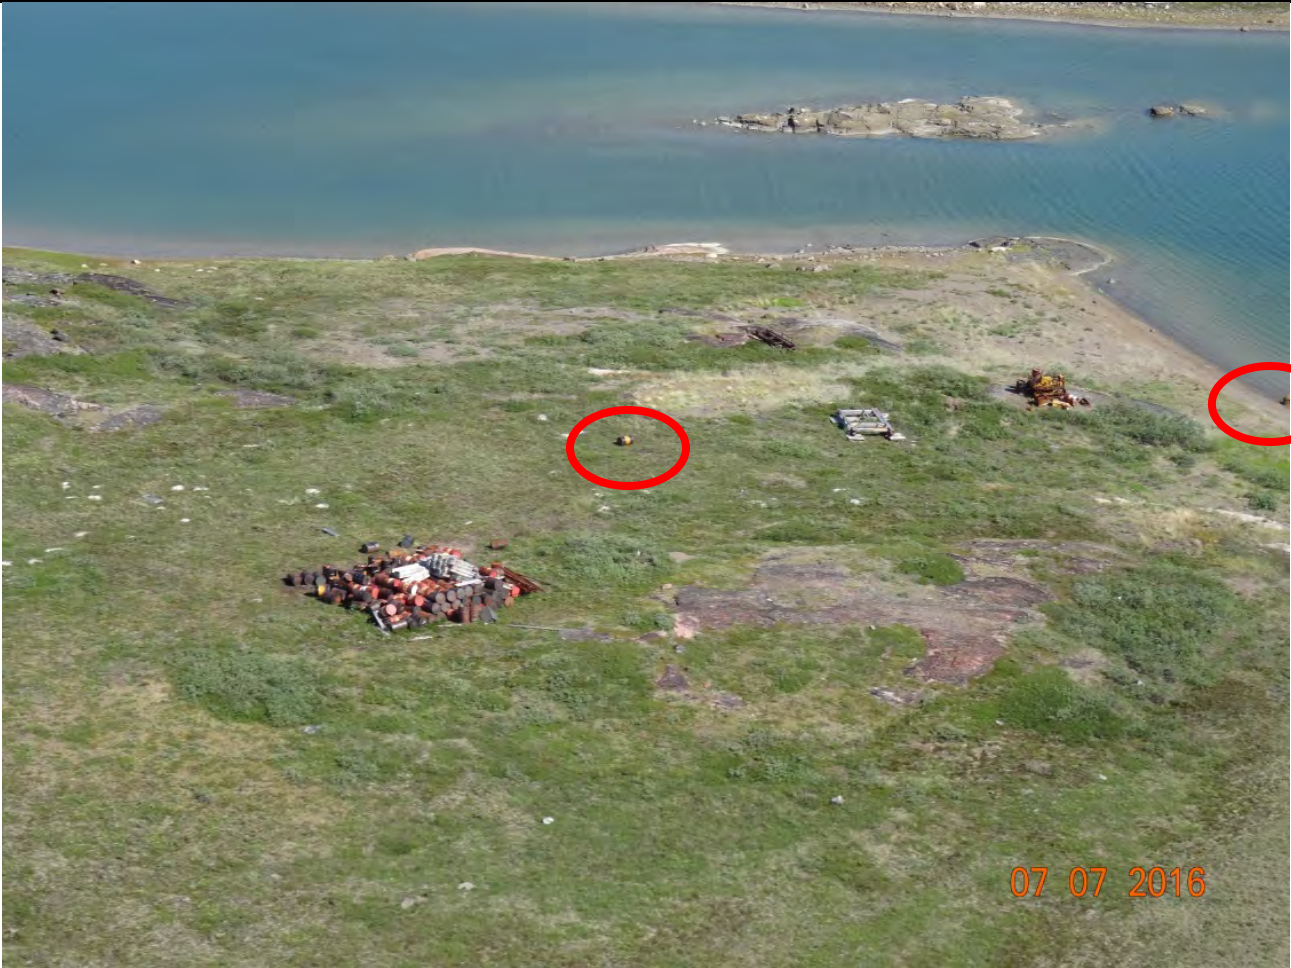
Date	Camera	Inspector	Authorization
July 07 2016	SONY DSC-HX50V	Eva Paul	2BE-ARC0813
Photo Log #		Location (NAD 83 DD MM SS.SS)	
Photo DSC05778		N67 44 29	W111 22 07

**Description:** Barge/staging area from the air. Waste is migrating towards and into the water.

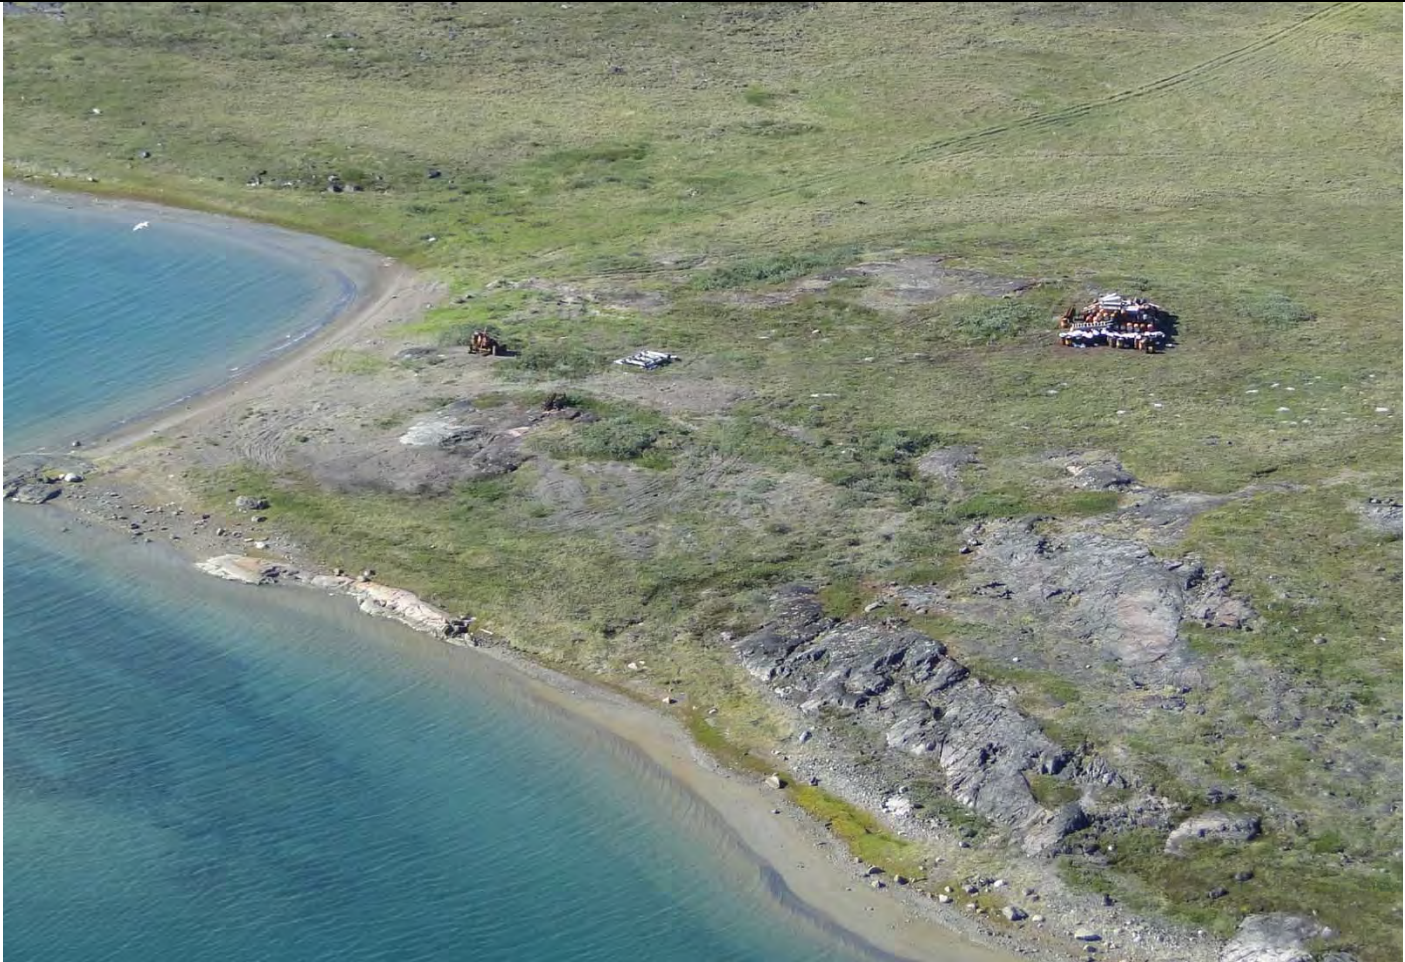
Photo Log #	Location (NAD 83 DD MM SS.SS)	
Photo DSC07108 (2012)	N	W

**Description:** 2012 photo of same site. Barrels are piled neatly, plastic is seen in the water, but no barrel.

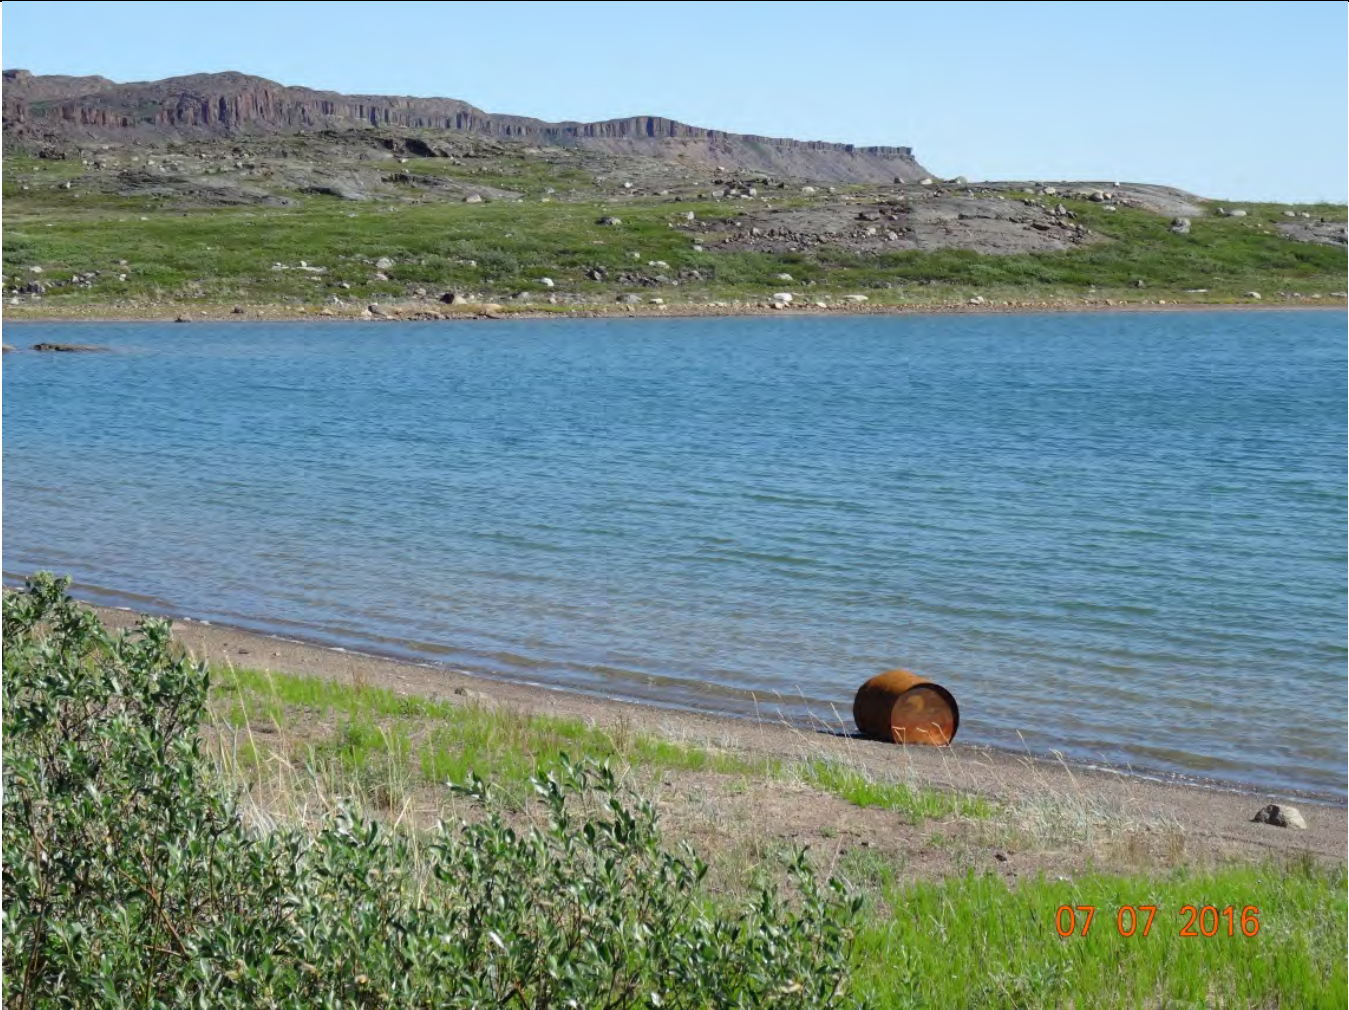
Photo Log #	Location (NAD 83 DD MM SS.SS)	
Photo DSC05789	N67 44 29.6	W111 22 1.2

- 1. Solid and hazardous waste in the form of barrels (both empty and full, some punctured and leaking), drill salts, scrap metal, and timbers remain at the locations listed above, the worst of which is the Barge site. Conditions have worsened since the 2012 inspection: barrels are strewn around (including punctured and leaking barrels) and bags of drill salts have dissolved into the ground, causing further salt contamination. A barrel of metal waste has rolled down from the barge site and now sits in the water of the Coronation Gulf.

**Description:** Barrel of waste metal is now in the water.

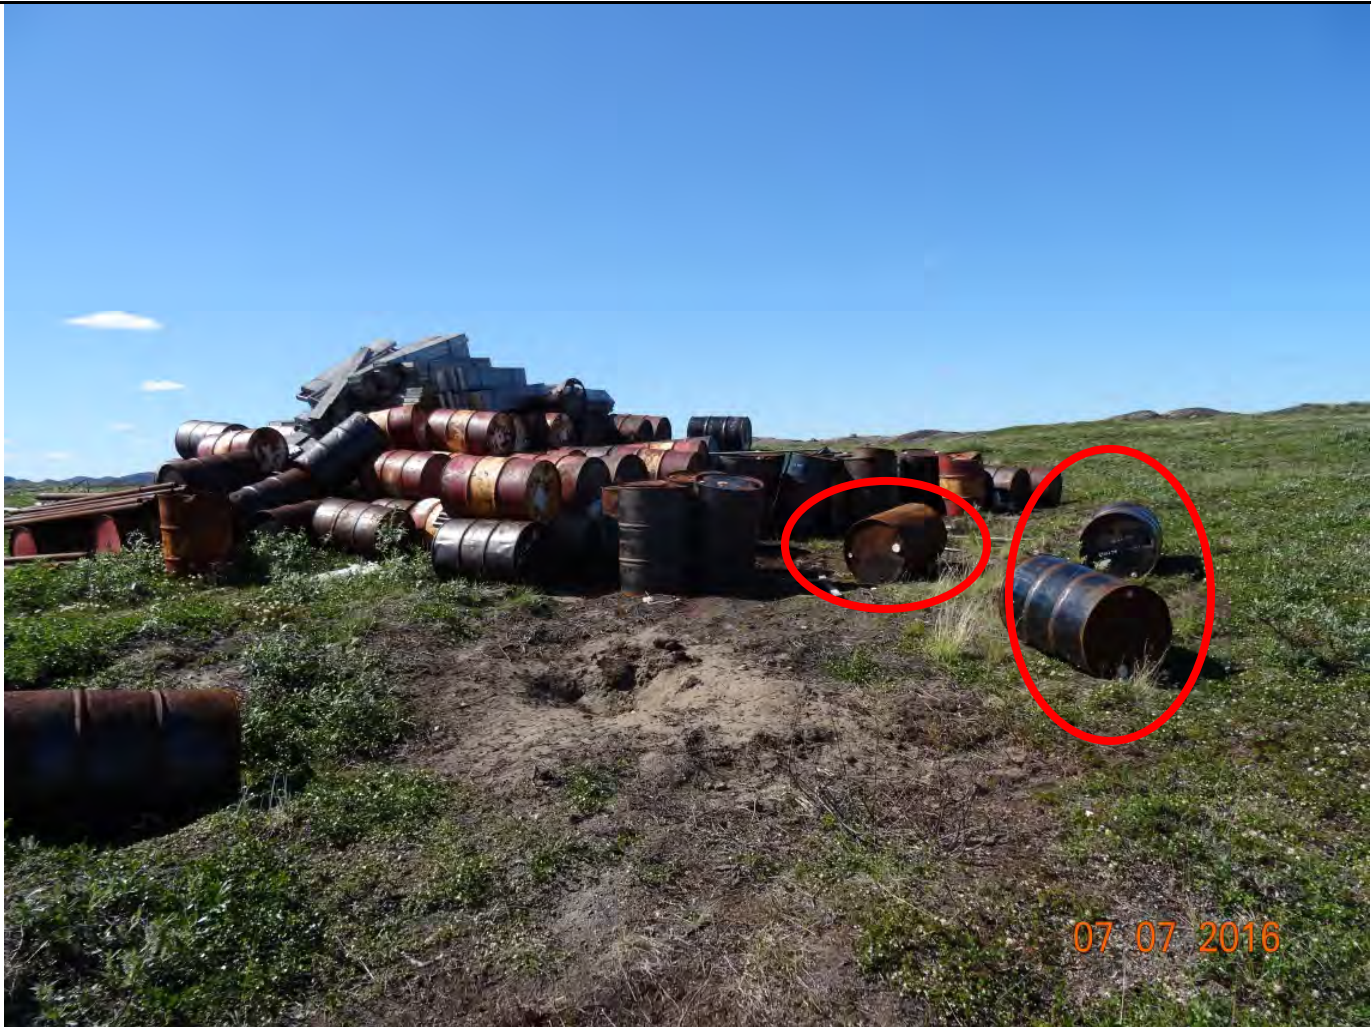
Photo Log #	Location (NAD 83 DD MM SS.SS)	
Photo DSC05795	N67 44 29.9	W111 22 04.6

**Description:** As seen in 2016. Punctured barrels, and barrels with caps that are now empty (leaked into soil). Digging in soil may be from wildlife; salt is an attractant, however, the soil is also heavily contaminated with hydrocarbons.

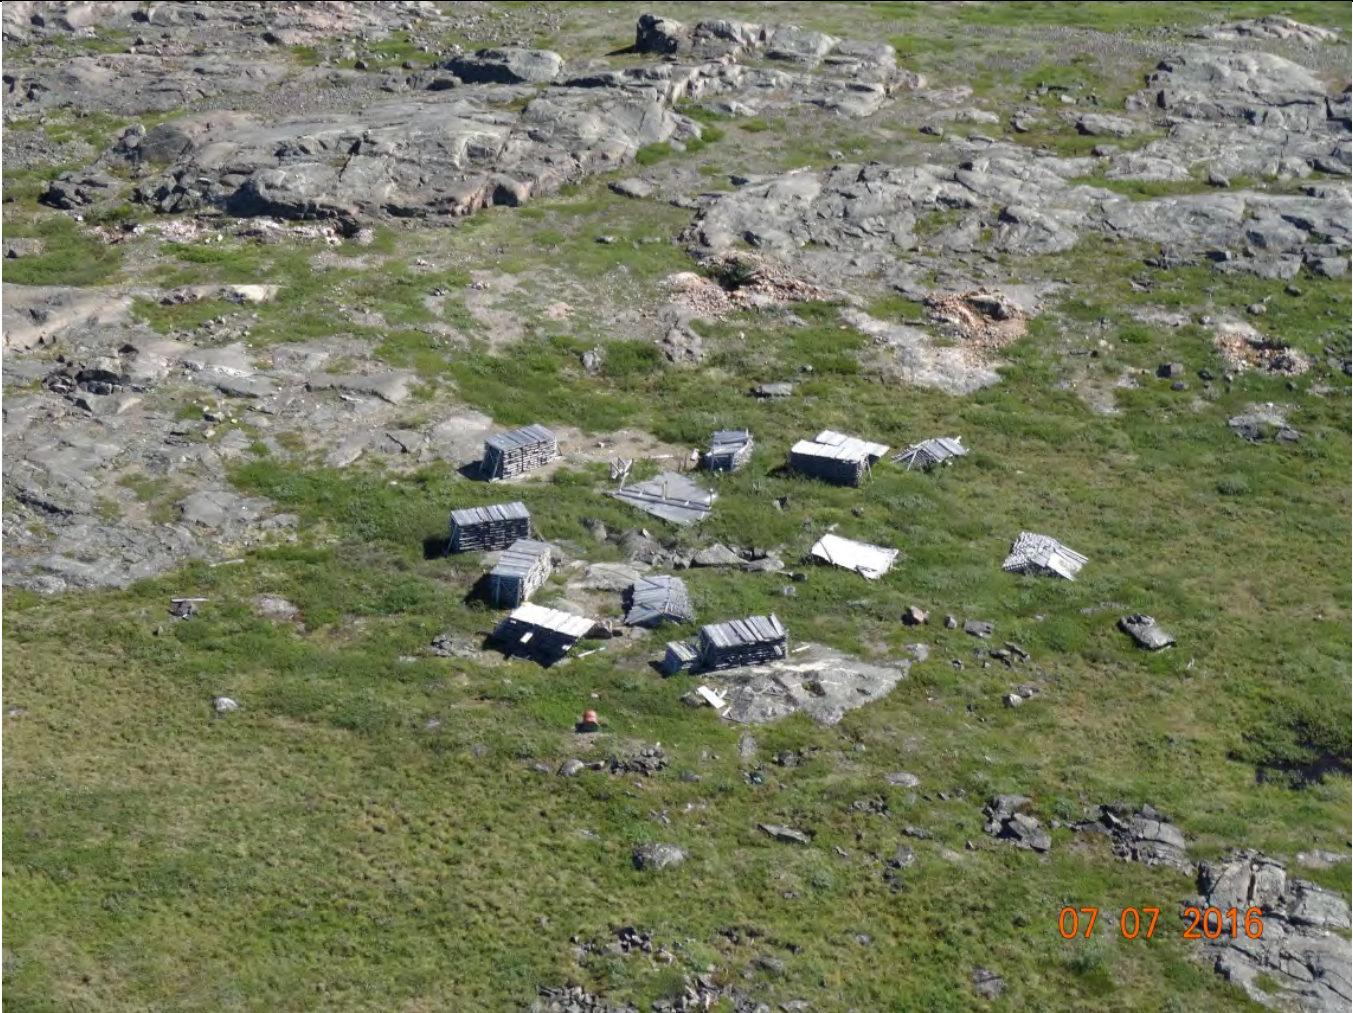
Description: Another core storage area, seen in flight.

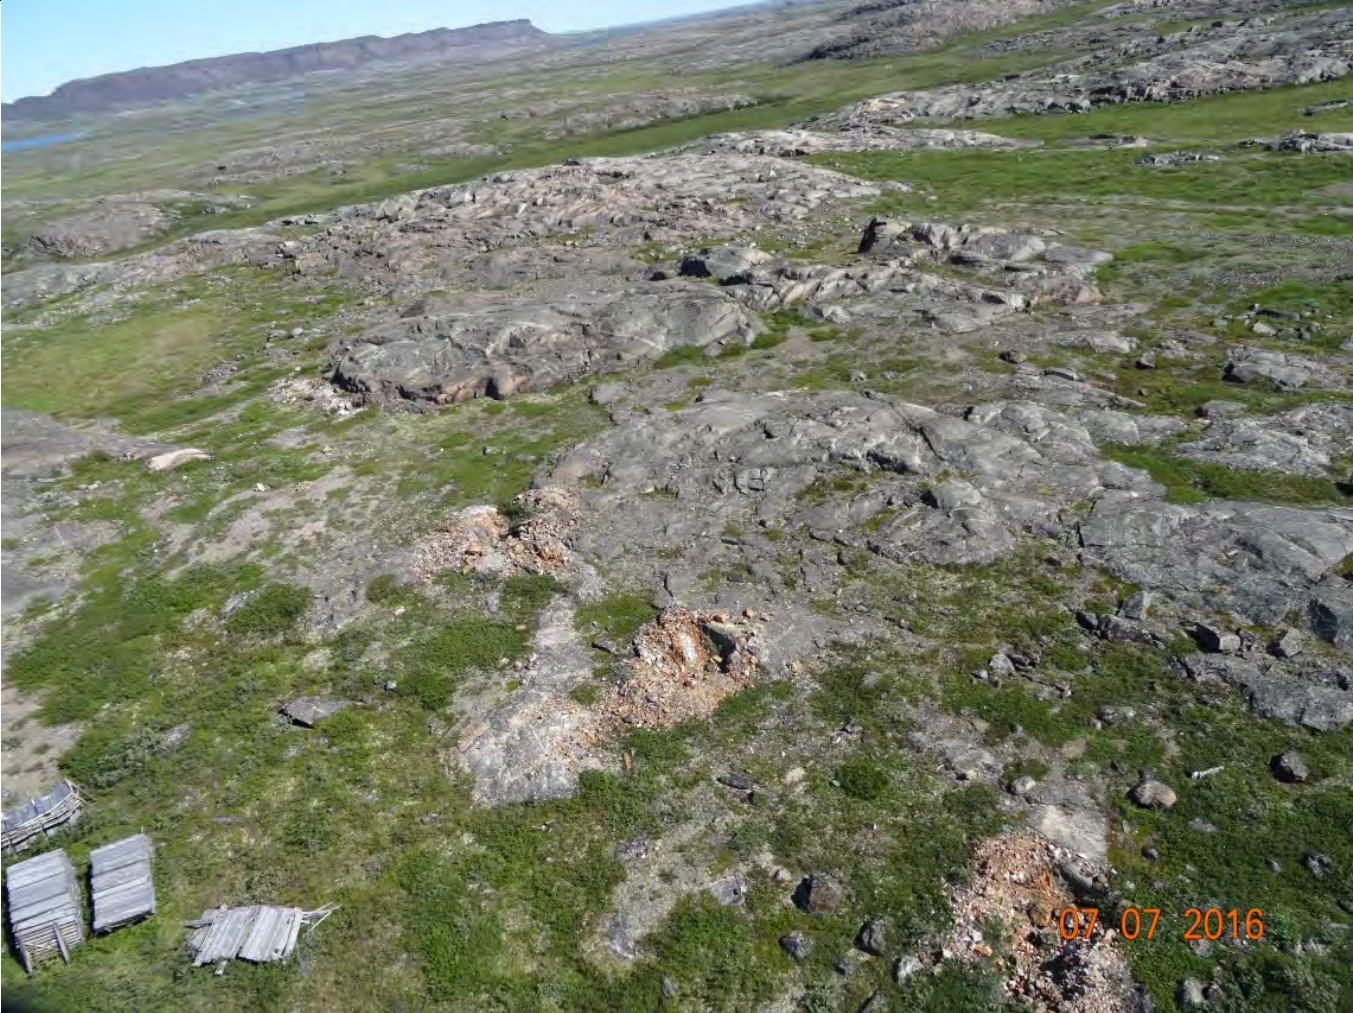
Description: Note pits that were created and have not been reclaimed. Others were seen in flight en-route to 2008 camp.

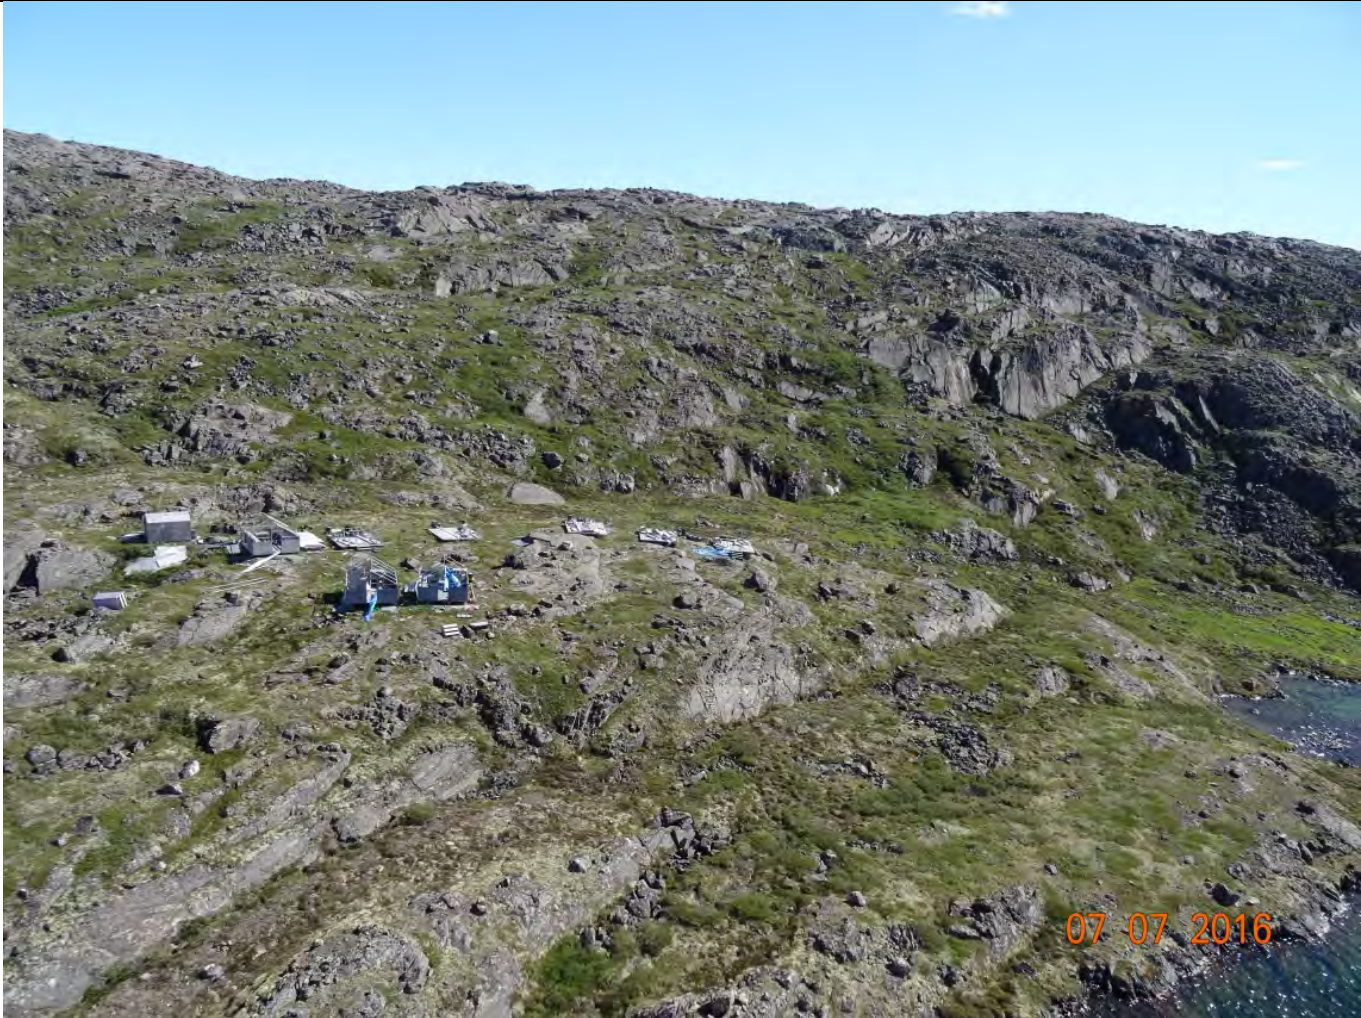
**Description:** Camp remains in similar condition to 2012. See 2012 report for further details.
