WATER USE INSPECTION REPORT

Date: August 8, 2010	Licensee Rep. (Name/Title): Site(s) inactive on inspection (closure requested)	
Licensee: Kennecott Canada Exploration Inc.		Licence No.: 2BE-ARN0507 (Arnak Project/Frost Lake Camp); LUP N2004H0033

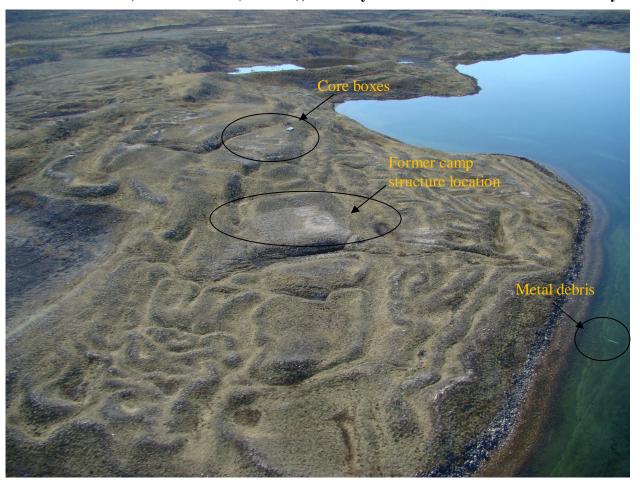
- Large piece of metallic debris observed in the water
- Ground disturbance observed (from camp structure placement)
- Core boxes

Photograph 1: Aerial view of former camp site for 2BE-ARN: core boxes, former structure location and metal debris are visible from helicopter

As per Part B, G and I of the licence 2BE-ARN, closure cannot be recommended for this site until the Licensee submits the required information as per the final closure plan noted above. This is to include the locations of all fuel storage areas associated with the project activities and confirmation of their removal, confirmation of wastes backhauled and location of final disposal. The Licensee is also responsible to arrange for removal of the metal debris.

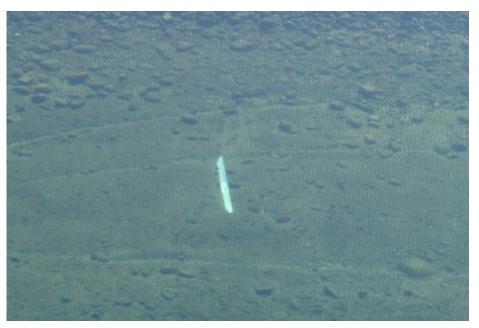
Photograph 2 (2BE-ARN): Metal debris in the water

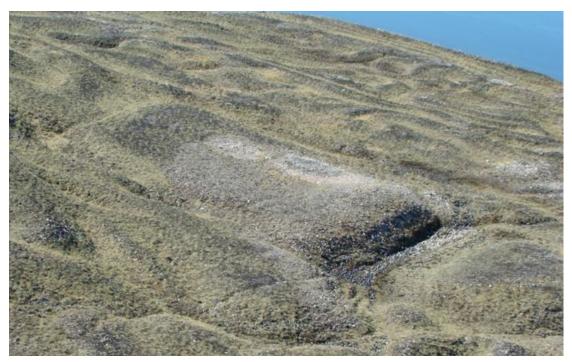
Photograph 3 (2BE-ARN): Former camp structure(s) location

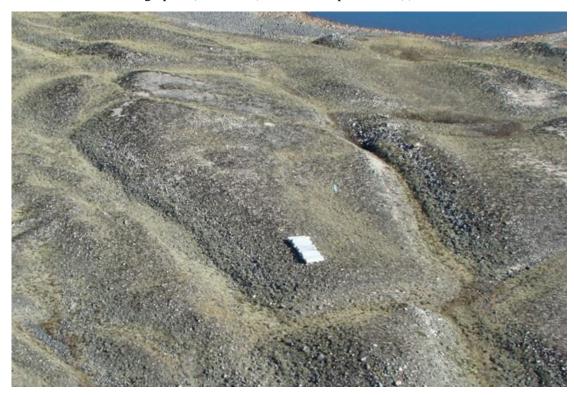
Photograph 4 (2BE-ARN): Core boxes
