RE: Inspection of Water Licence 2BE-ASH0611, September 16 2013

WATER LICENCE INSPECTION REPORT

Date: September 16, 2013	Licensee Rep. (Name/Title): N/A
Licensee: Vaaldiam Mining Inc.	Licence No.: 2BE-ASH0611

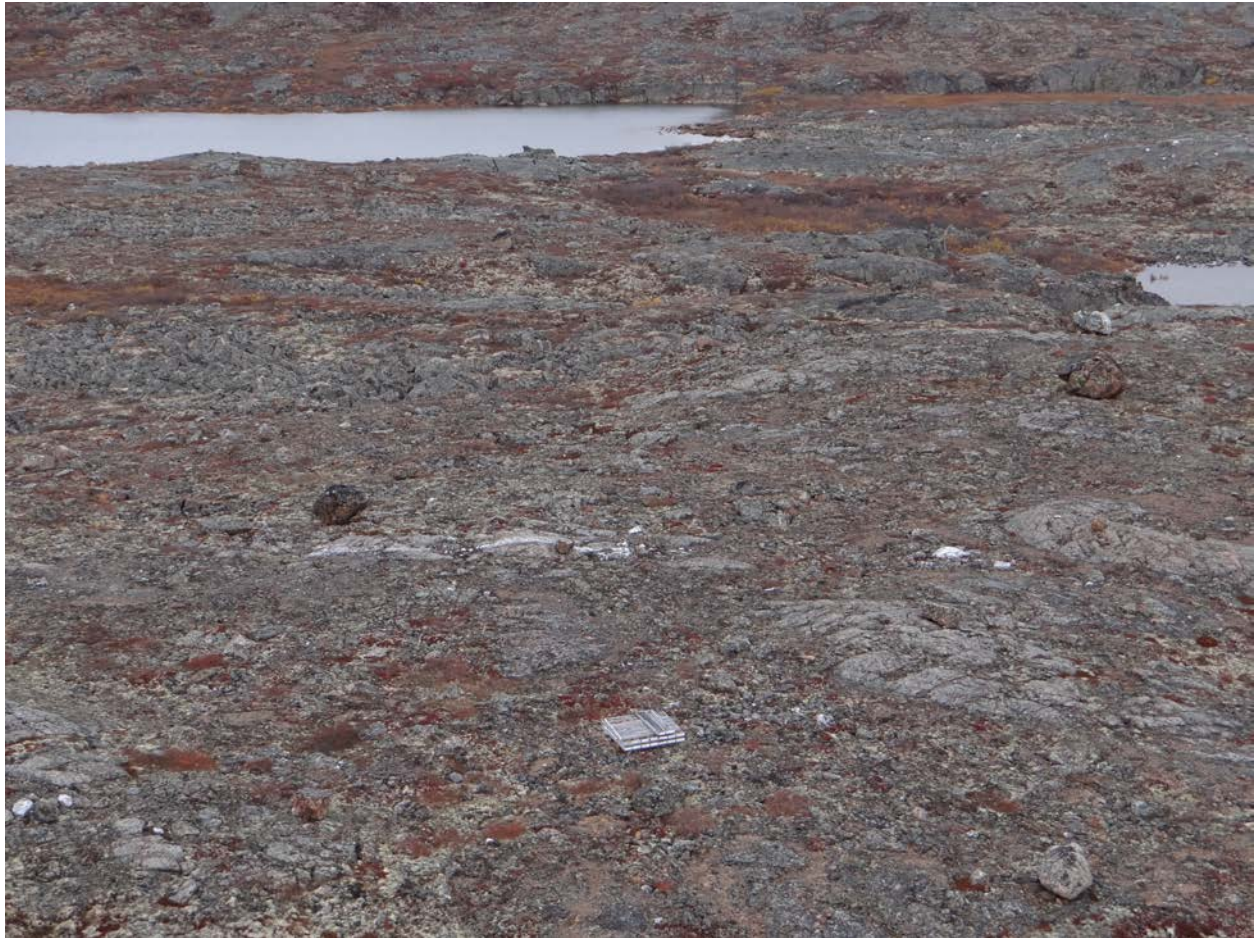
Figure 1. Core rack upslope from Drill hole 3 (approx. N66°41'34.7" W112°53'04.4").

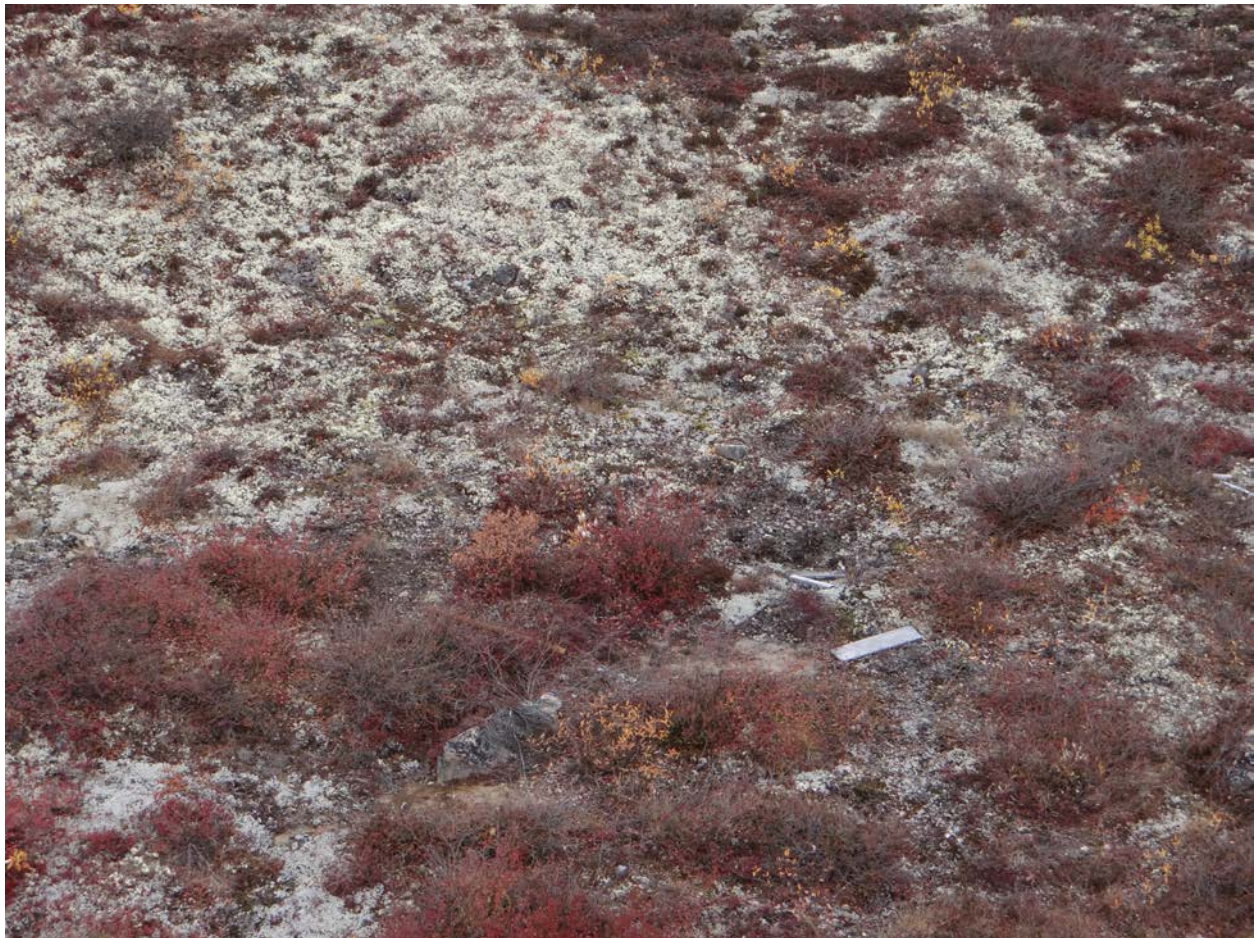
Drill Hole 3 (N66°41'34.7" W112°53'04.4"): Drill hole was located. The drill rod and pieces of board were noted downslope of the core rack.

Part H Item 9: Drill holes shall be restored to natural conditions immediately upon completion of the drilling.

Figure 2. Drill hole 3 with drill rod and boards remaining (N66°41'34.7" W112°53'04.4").

As one of the two randomly chosen drill sites was not adequately reclaimed, I require that reclamation be conducted and proven at all the drill locations. The work shall be conducted during the snow-free period of 2014 and a report with photographs is to be submitted by September 30, 2014.
