Ashton Drill Site Restoration Under Water Licence 2BE-ASH0611

Water Licence 2BE-ASH0611 Reclamation-August11-2014

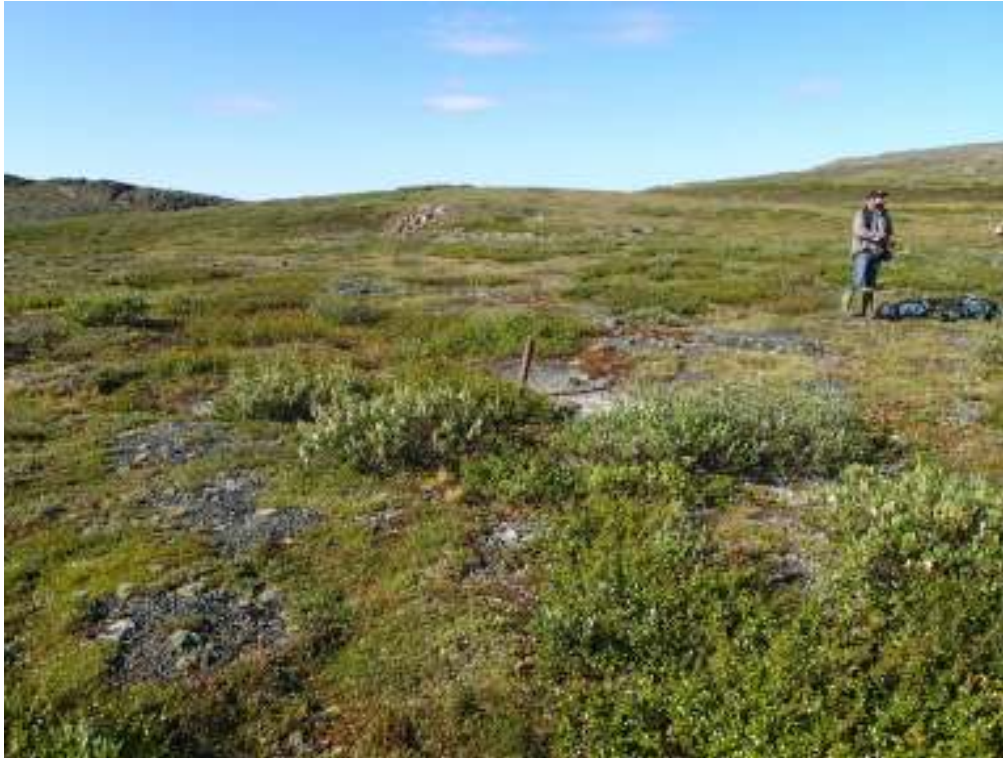
Photo 1: Before photo of anchor at site AP71-05-01. Looking west.

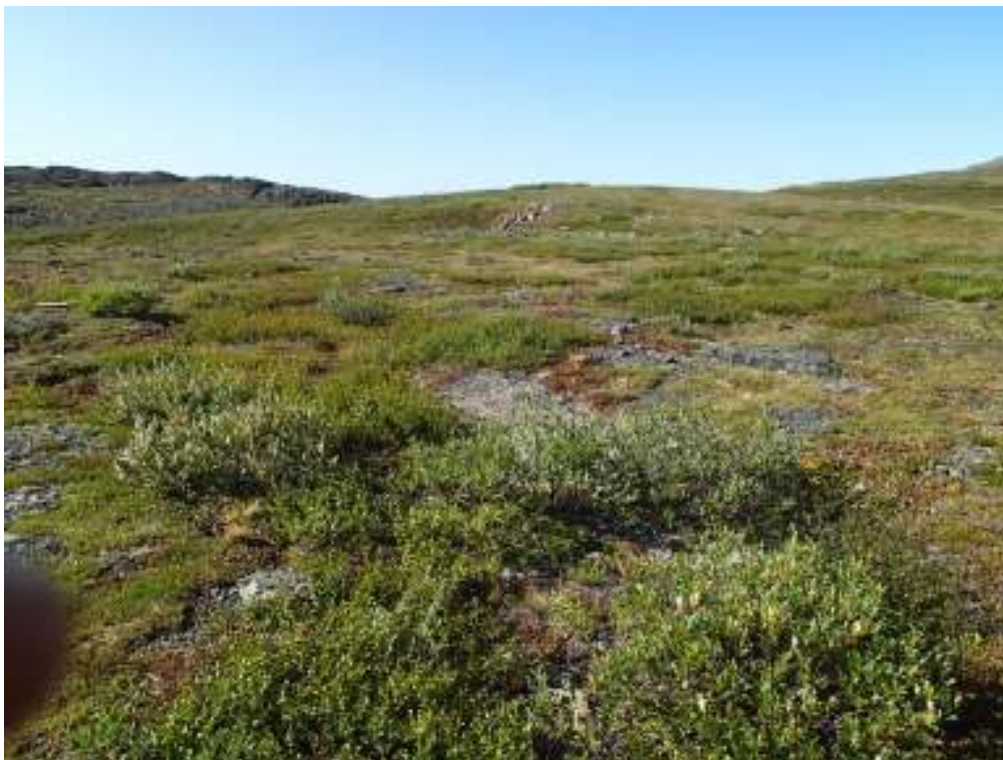
Photo 2: After photo of site AP71-05-01-anchor cut off and removed. Looking west.

Drill anchors where present were cut off within 6" of ground level and the steel removed. In addition any wood debris or garbage found in the area of the drills sites were removed. Photos of all sites before the cleanup and after the cleanup are presented in the following pages, arranged according to the 4 main areas starting in the north and progressing southward. No debris, steel or other garbage remains at any of the sites visited and all sites and have been restored to their natural conditions.

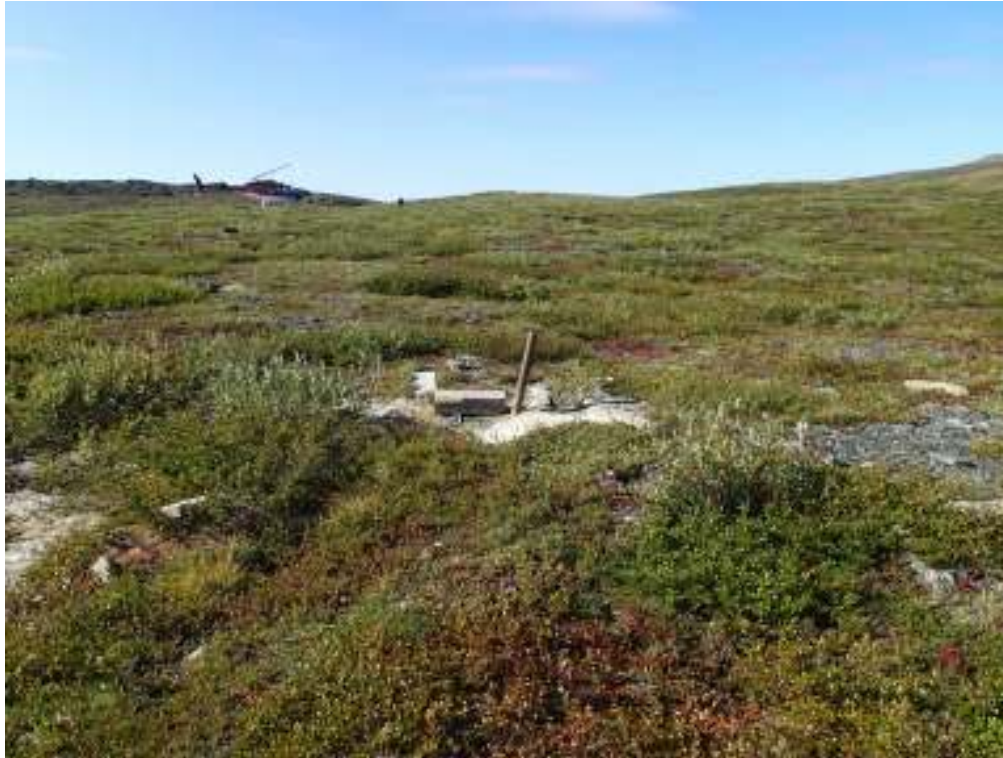
Photo 3: Before photo of anchor at site AP71-05-02 & -03 (same setup). Looking west.

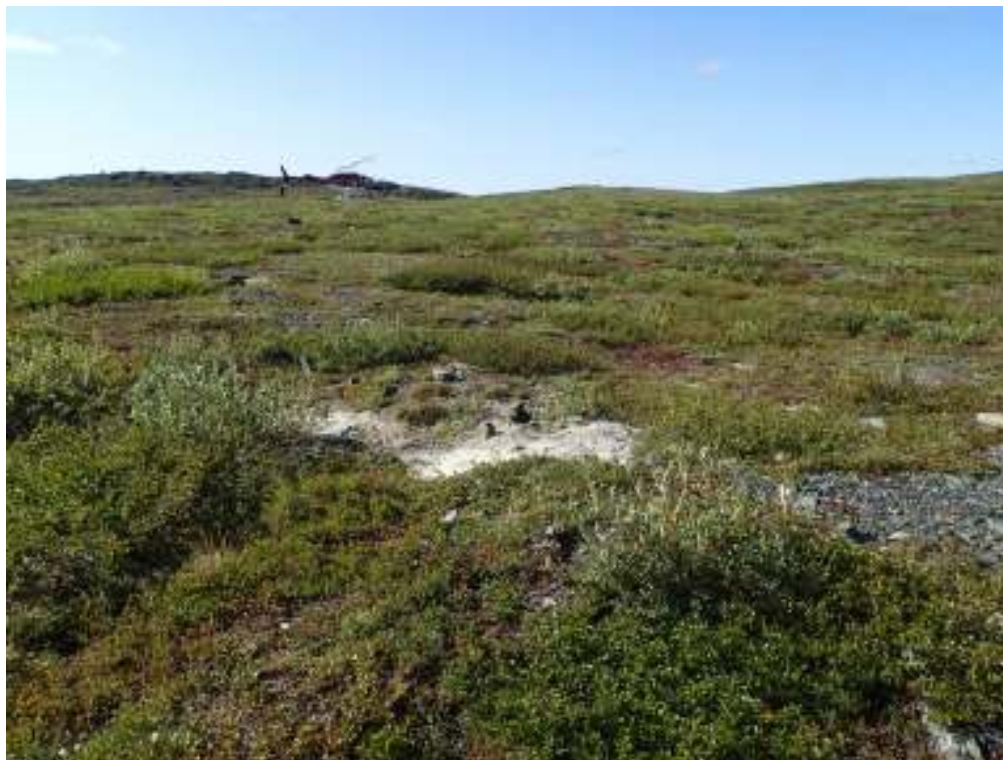
Photo 4: After photo of site AP71-05-02 & -03_anchor cut off and site cleaned up. Looking west.

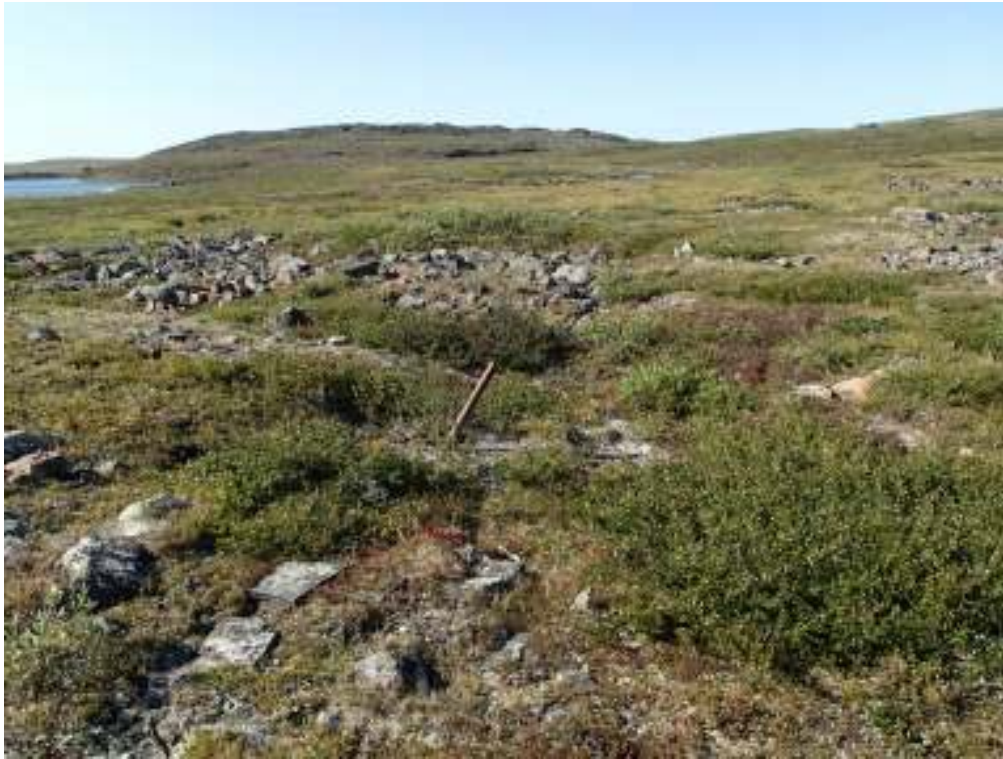
Photo 5: Before photo of anchor for drill hole AP71-05-04. Looking southwest.

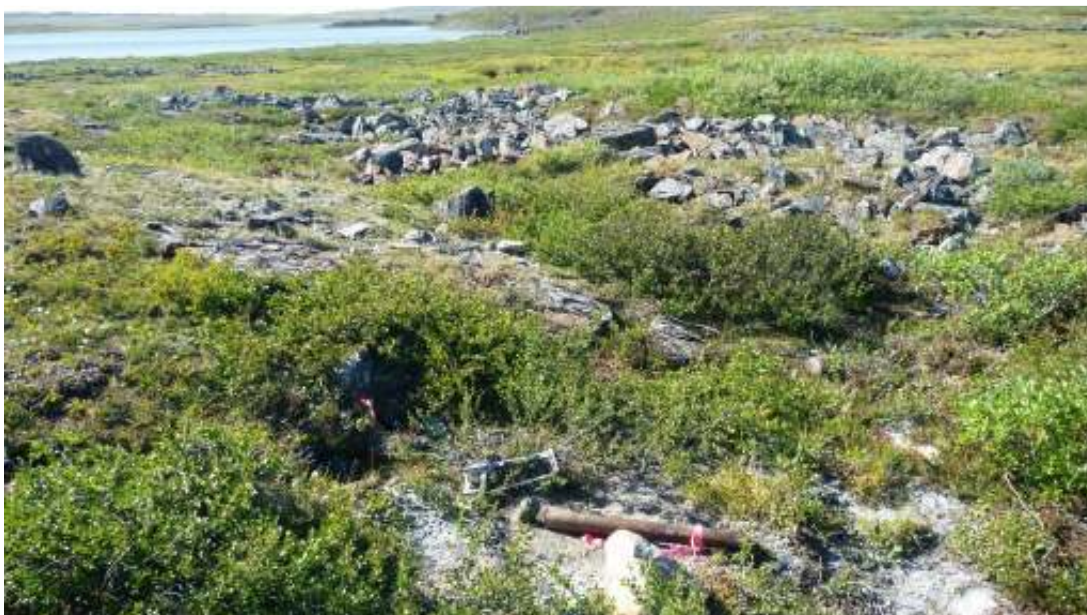
Photo 6: After photo of site AP71-05-04. Looking southwest. The drill anchor, shown here lying on ground with hacksaw that was used to cut it off beside it, had just been cut-off and was removed from site with the helicopter.

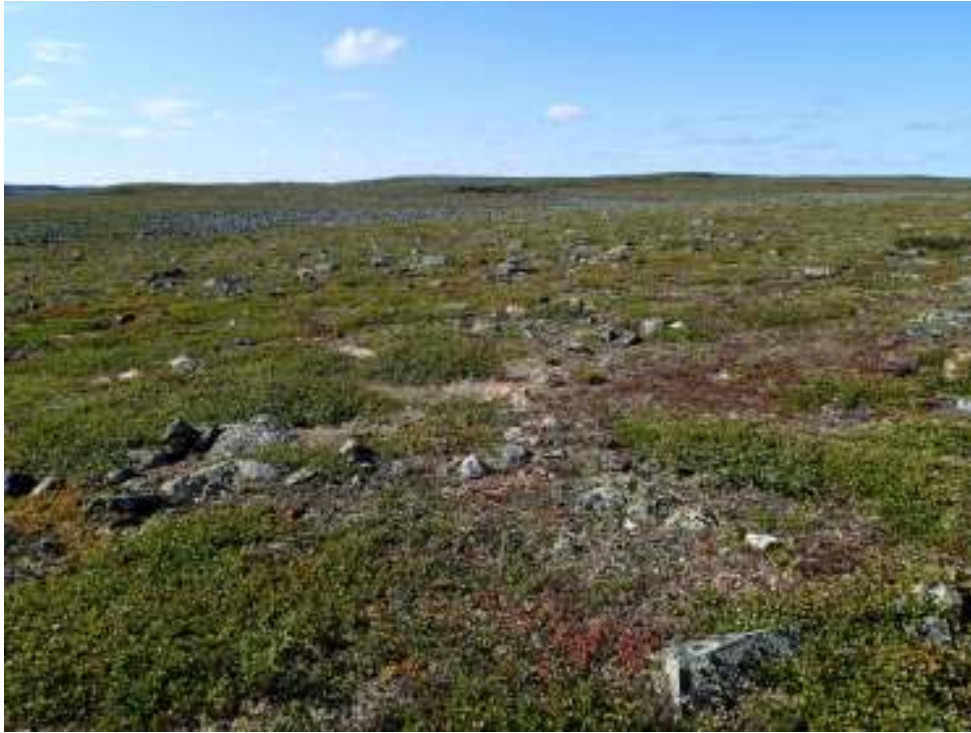
Photo 7: Before photo of site AP66-05-02. Collar was located but no anchor or casing was left here. Looking west.

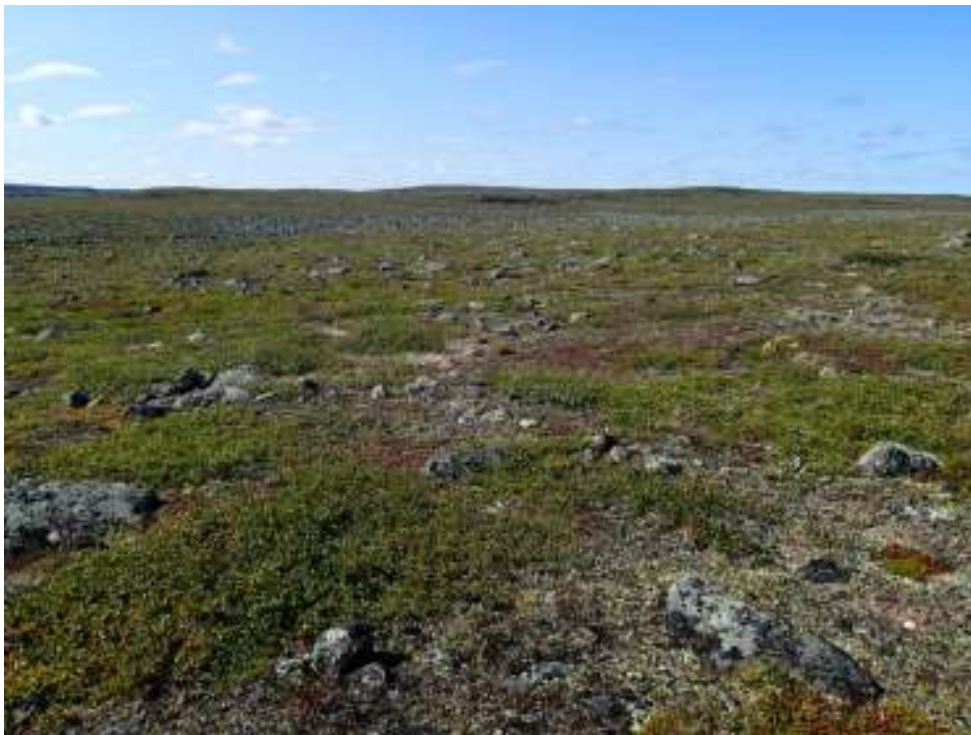
Photo 8: After photo of site AP66-05-02. No anchor or casing was left here but all debris associated with the site (a few scraps of wood) were removed. Looking west.

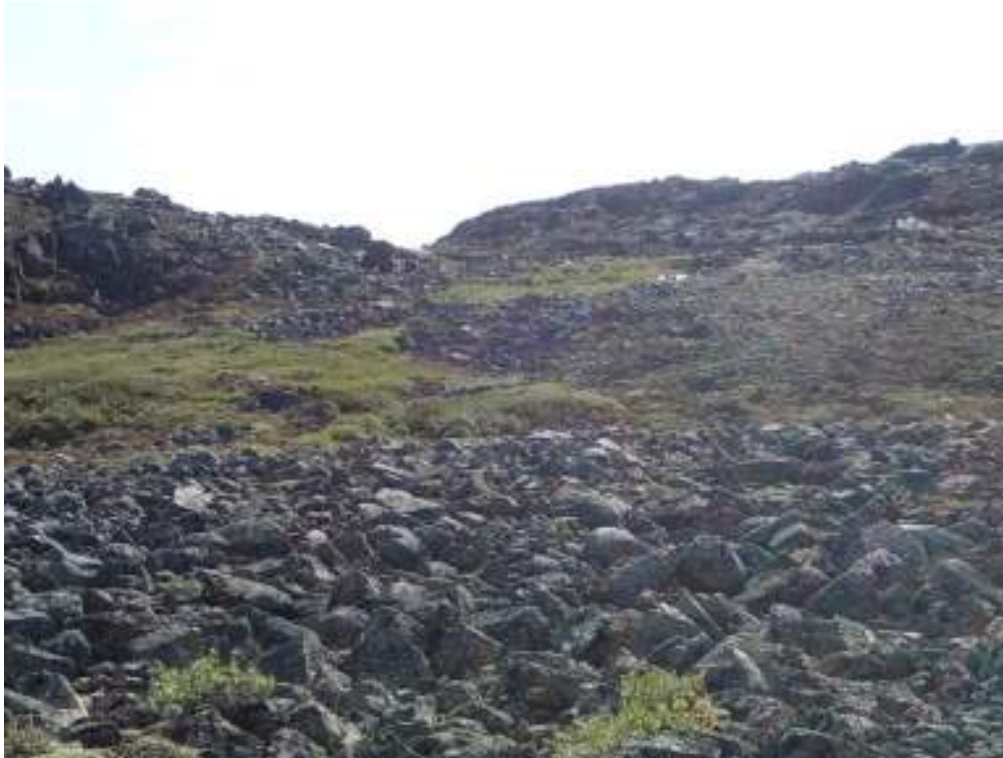
Photo 13: Before photo of area south of AP66-05-01 with blue tarp amongst rocks. Looking south.

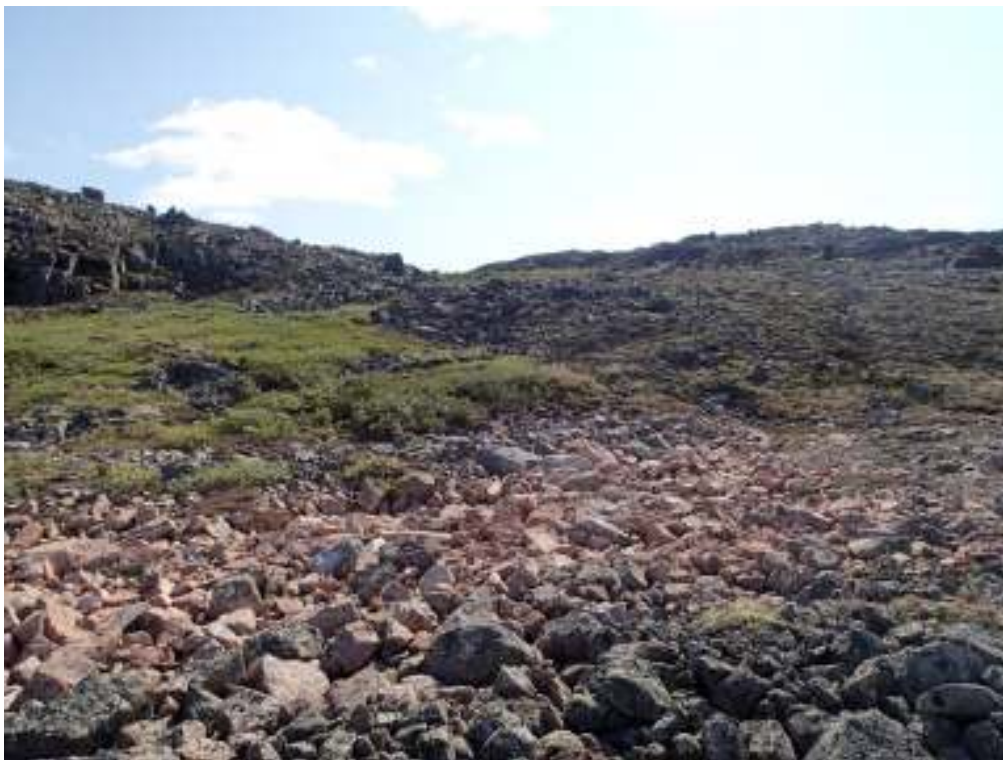
Photo 14: Before photo of area south of AP66-05-01. Blue tarp amongst rocks (Photo 13) has been removed. Looking south.
