COMPLIANCE STATUS REPORT - LICENSE 2BE-BAF0611 JULY 2011

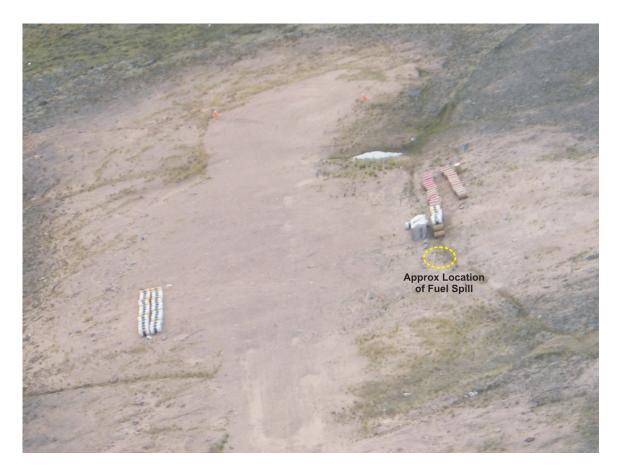
The fuel cache inspection noted a fuel spill covering an area of approximately 3m x 3m to a depth of 1m (Figure 1).

Figure 1. Fuel spill noted August 2010.

Remediation of this fuel spill consisted of filling 10 sealable 45-gallon (205 litre) drums with the contaminated soil (Figure 2). The resultant depression was filled with sorbent spill matting and backfilled with clean soil.

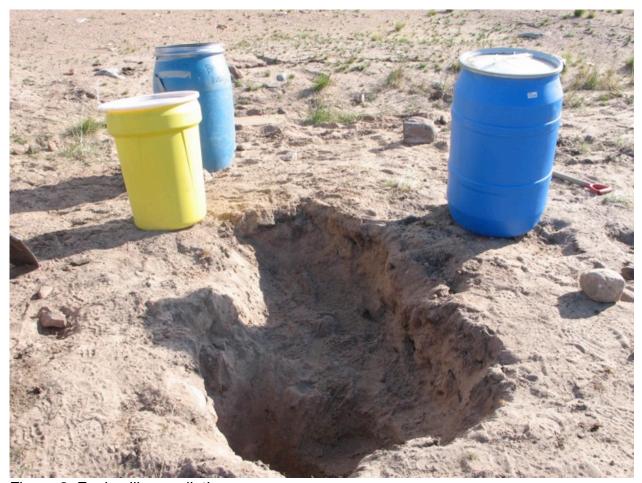
Figure 2. Fuel spill remediation.
