RE: Inspection of Water Licence 2BE-BLU0812, July 7 2013

WATER LICENCE INSPECTION REPORT

Date: July 7, 2013	Licensee Rep. (Name/Title): N/A
Licensee: Skybridge Development Corp.	Licence No.: 2BE-BLU0812

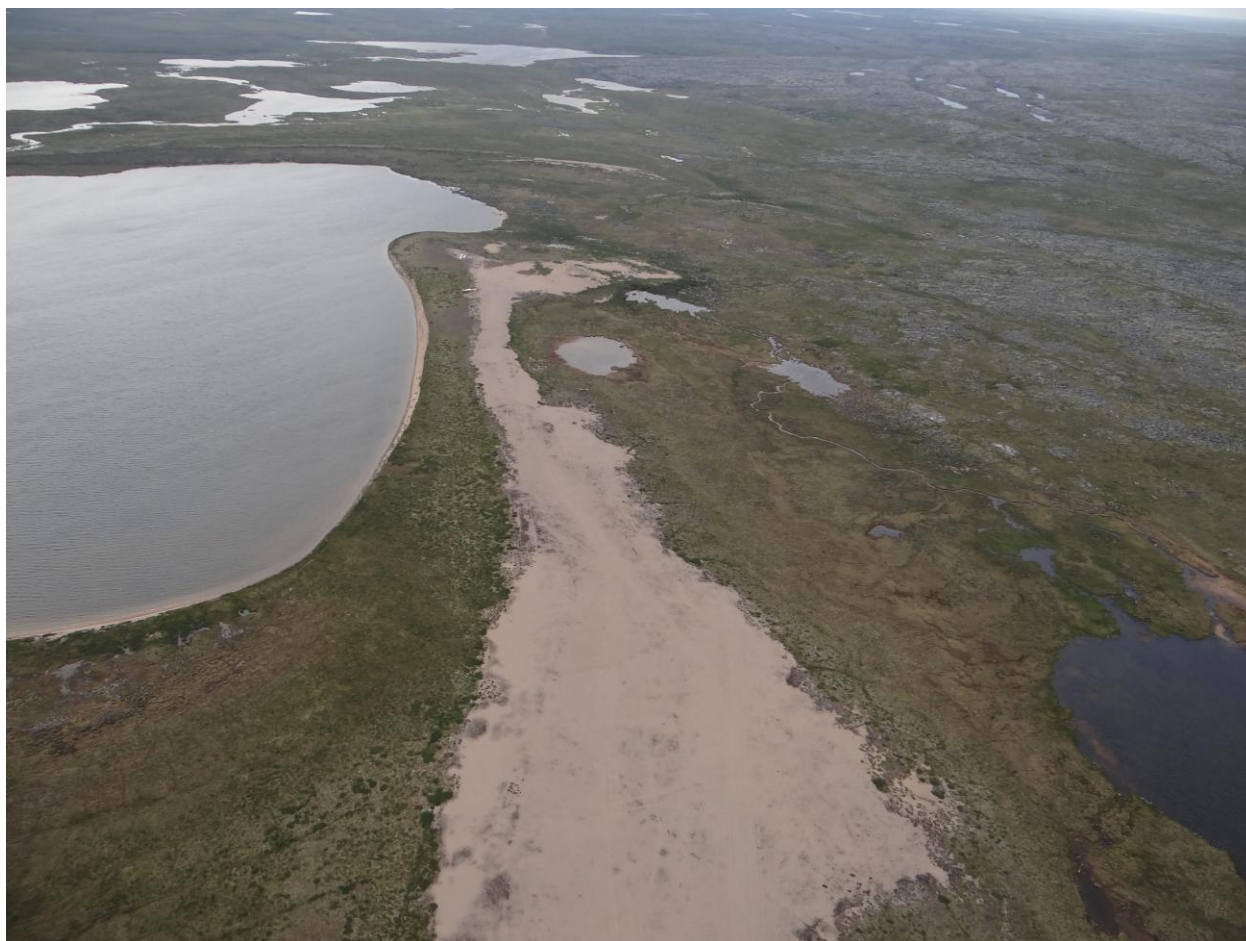
Figure 1. Esker airstrip with core racks at the far end.

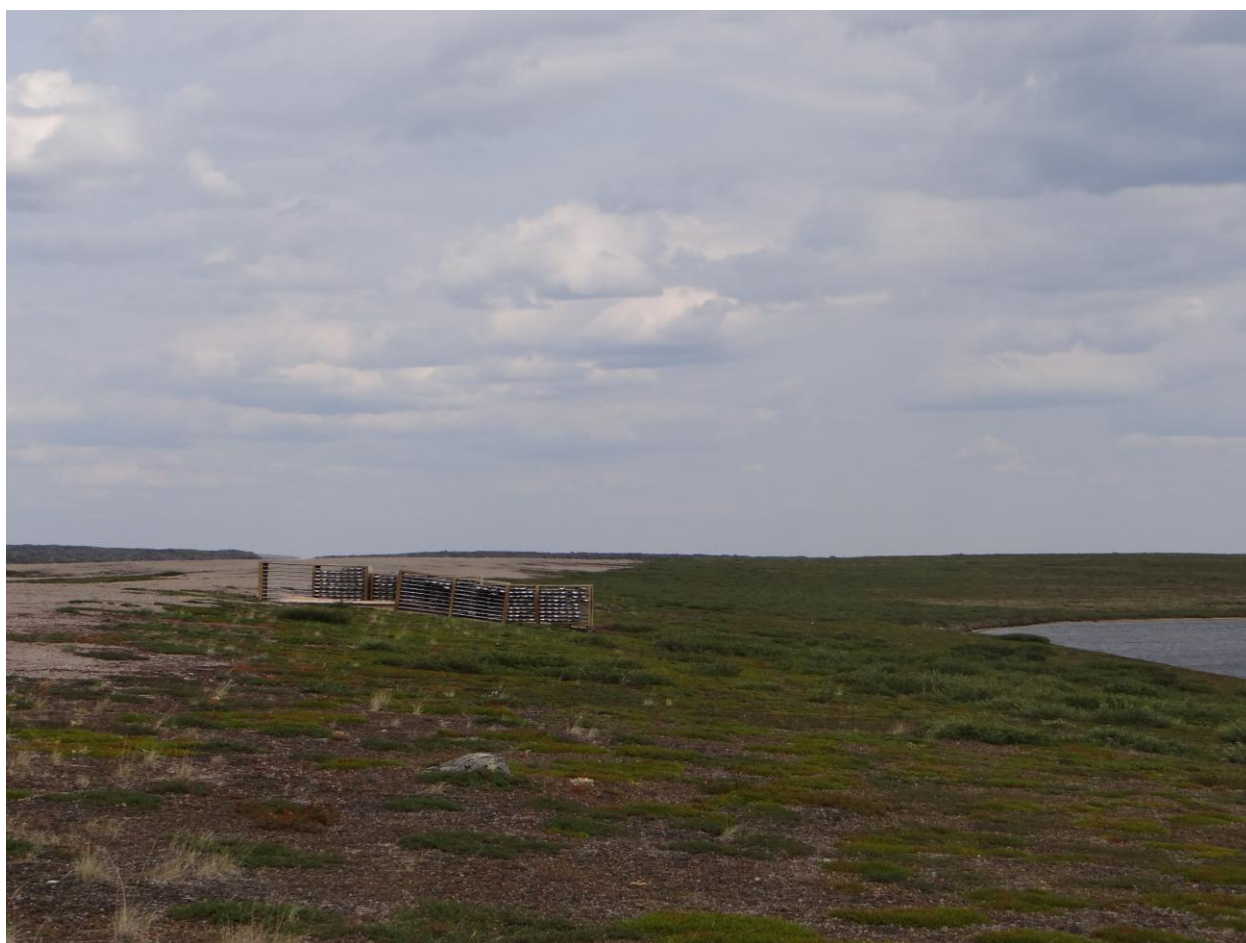
Camp cleanup appears to have been thorough. All that remains on site are the core racks. One set of core racks may be within 30 m of the high water mark of the lake, contrary to Part I item 12.

Part I item 12: Drill core may be stored onsite, at least 30 m from the ordinary high water mark of any adjacent water body.

Figure 2. Core racks - distance to high water mark to be verified.

- **All** drill sites for the project are to be reclaimed. Casings and anchors must be removed or cut to ground level and capped. Debris is to be collected and backhauled.
- Verify the distance of the core racks from the water. Core racks are to be moved if within 30 m of the high water mark.
- A report with photographs detailing the completion of this work (including the verification of all drill sites for reclamation purposes) is to be submitted to the Inspector before this licence can be recommended for cancellation.

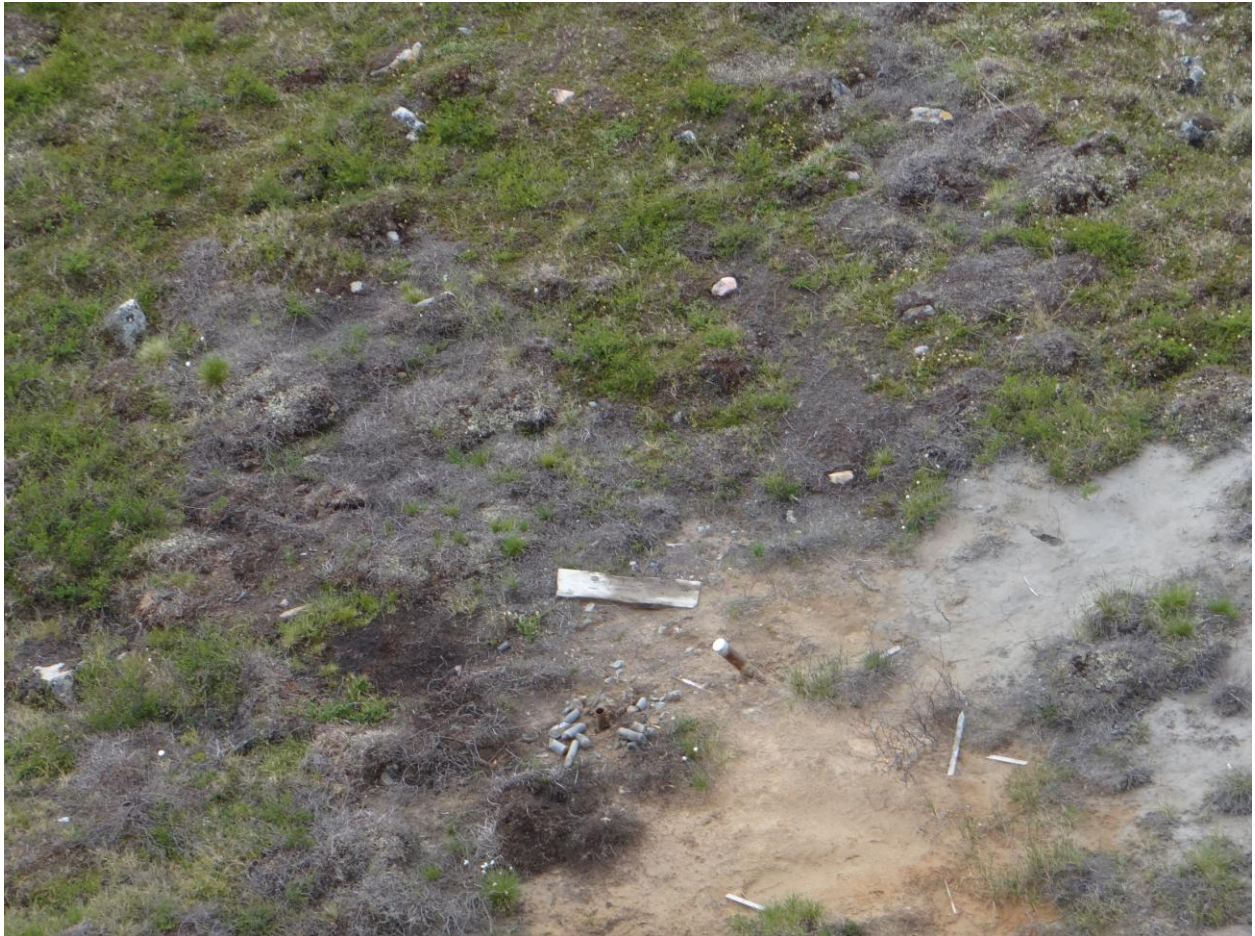
MP09-1 and MP09-2 (UTM 13W: 428122, 7235800 and 427206, 7235336). The two drill coordinates that were visited (and I flew over others in the immediate vicinity) show incomplete reclamation. Drill casings and anchors remain visible, and debris litters the areas. As per Part I item 11, drill casings are to be removed and the site restored to natural conditions.

Part I item 11: Drill holes and disturbed areas will be restored to natural conditions.

Figure 3. MP09-1: Core and anchor left sticking out, and debris littering the site.

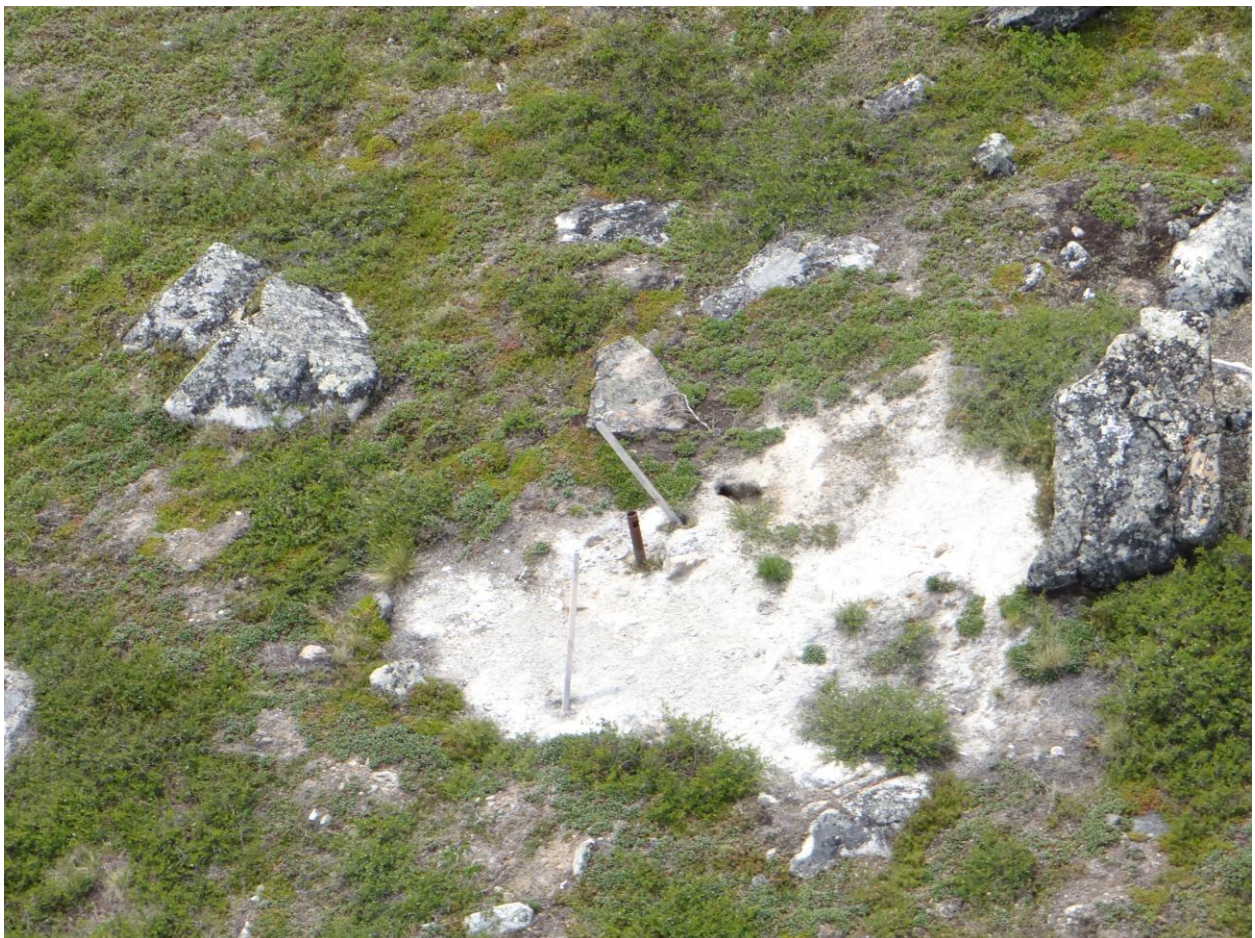
Figure 4. A drill hole nearby to MP09-1 and 2 which also requires reclamation.

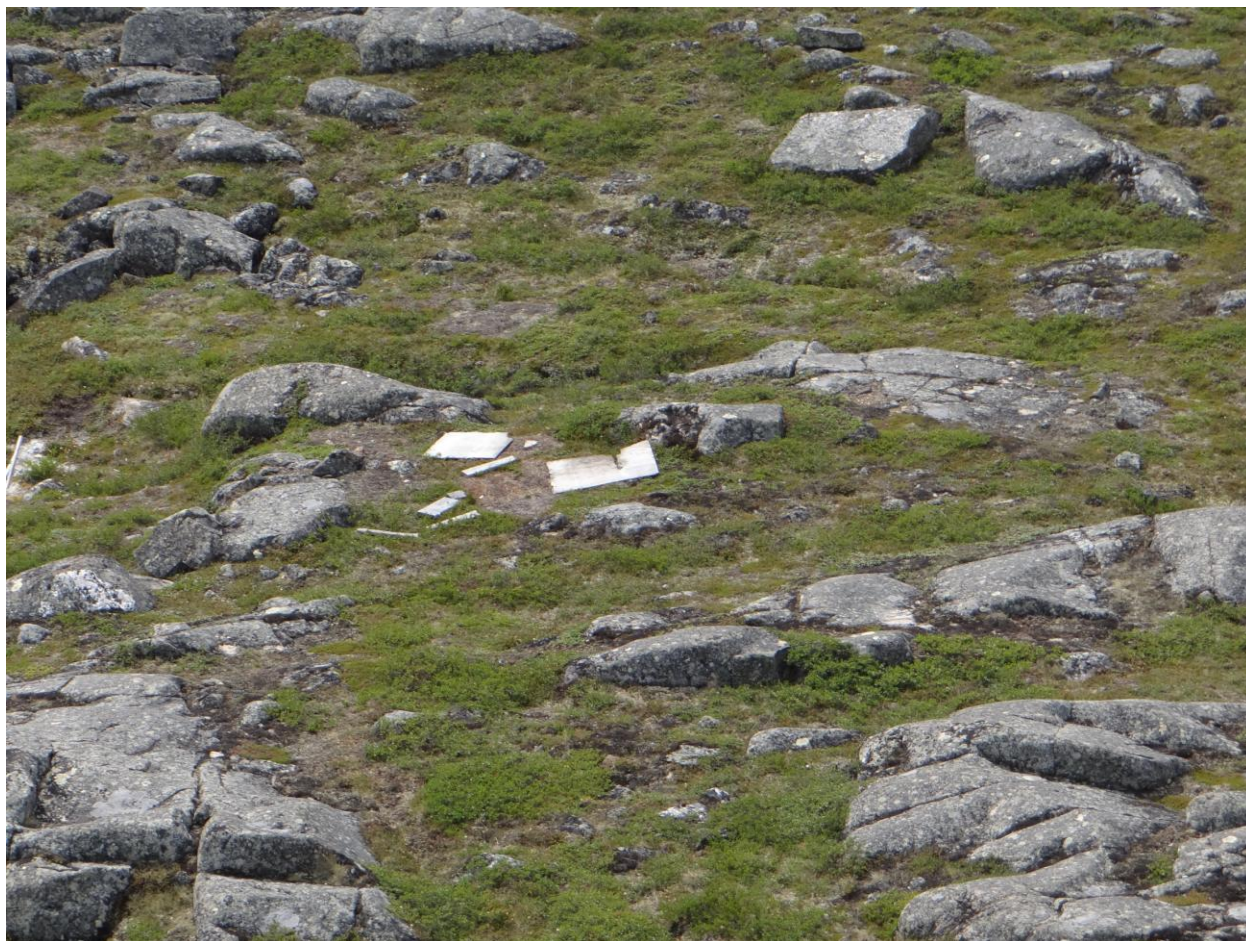
Figure 5. Other debris noted near to the inspected drill sites.
